# 1.0 Introduction

Following improved access to the rear of 26 Denmark Street and the East Gable of 22 Denmark Place, we have identified a number of discovery item issues that are addressed in the corresponding application drawings as well as summarised within this document.

Application Reference: 2015/6937/L

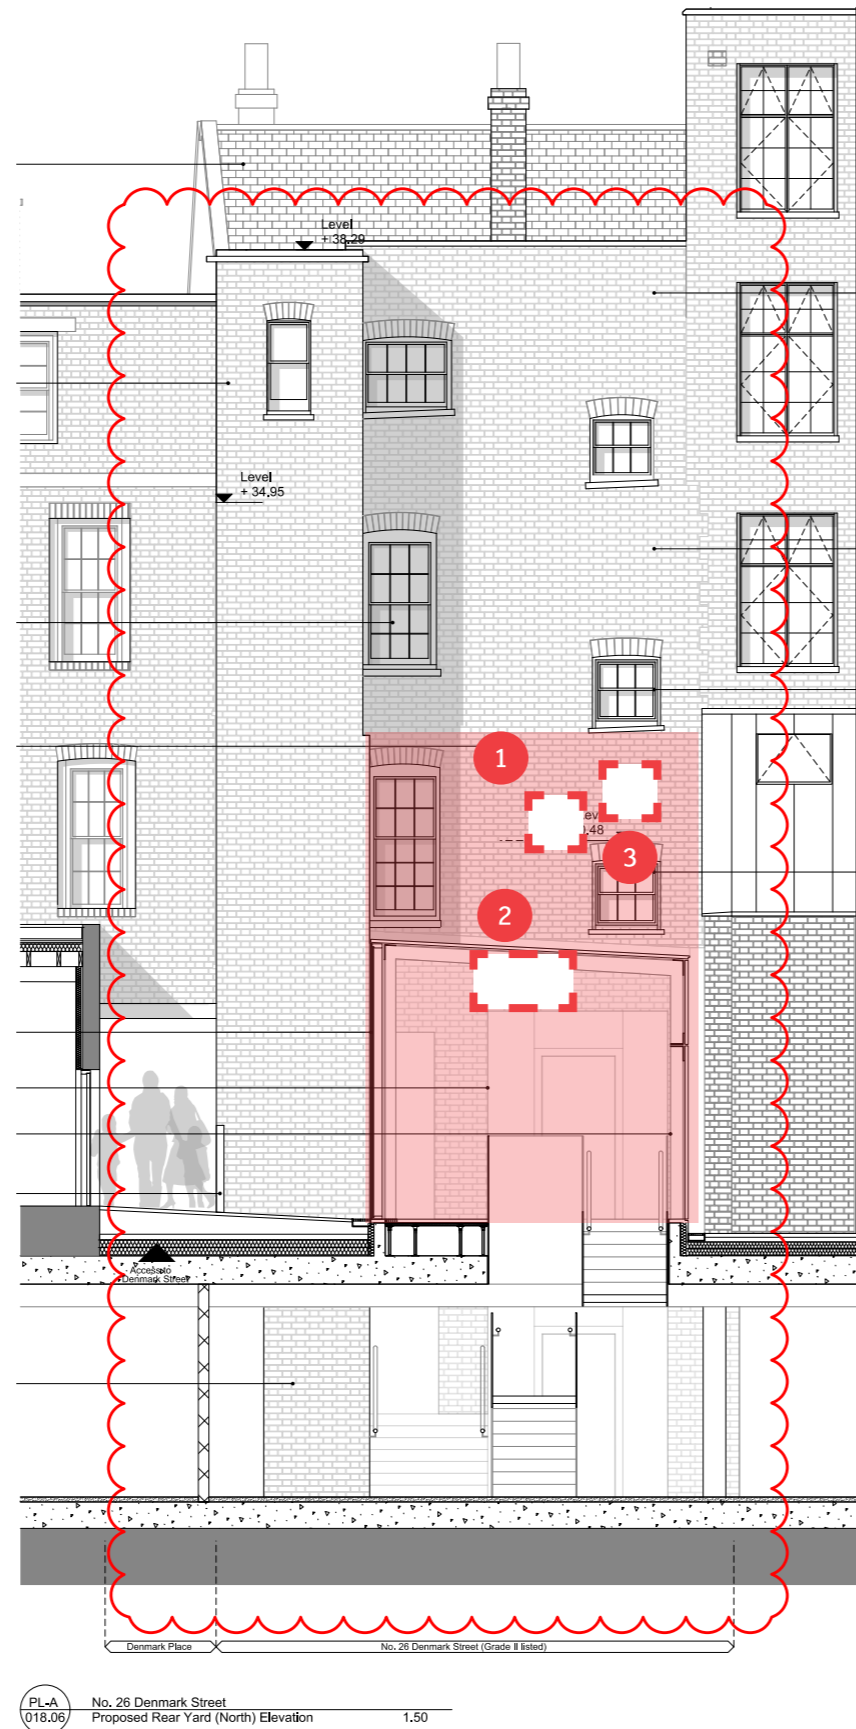
1

Samples areas of existing render have been removed in three locations.

This has revealed masonry of varying quality. It is assumed that historically the facing brickwork has been scabbled to provide a key for the render.

As a result the brickwork below the existing render is not of quality to expose, without substantial cutting out and replacement of existing brickwork, which would significantly affect the existing building fabric.

We propose to finish the existing scabbled brickwork with a lime render finish to replace the existing cementitious render.

We propose a lime render in order to protect the existing friable scabbled brickwork from weather damage, whilst also providing a more period appropriate finish than the existing cementitious render.

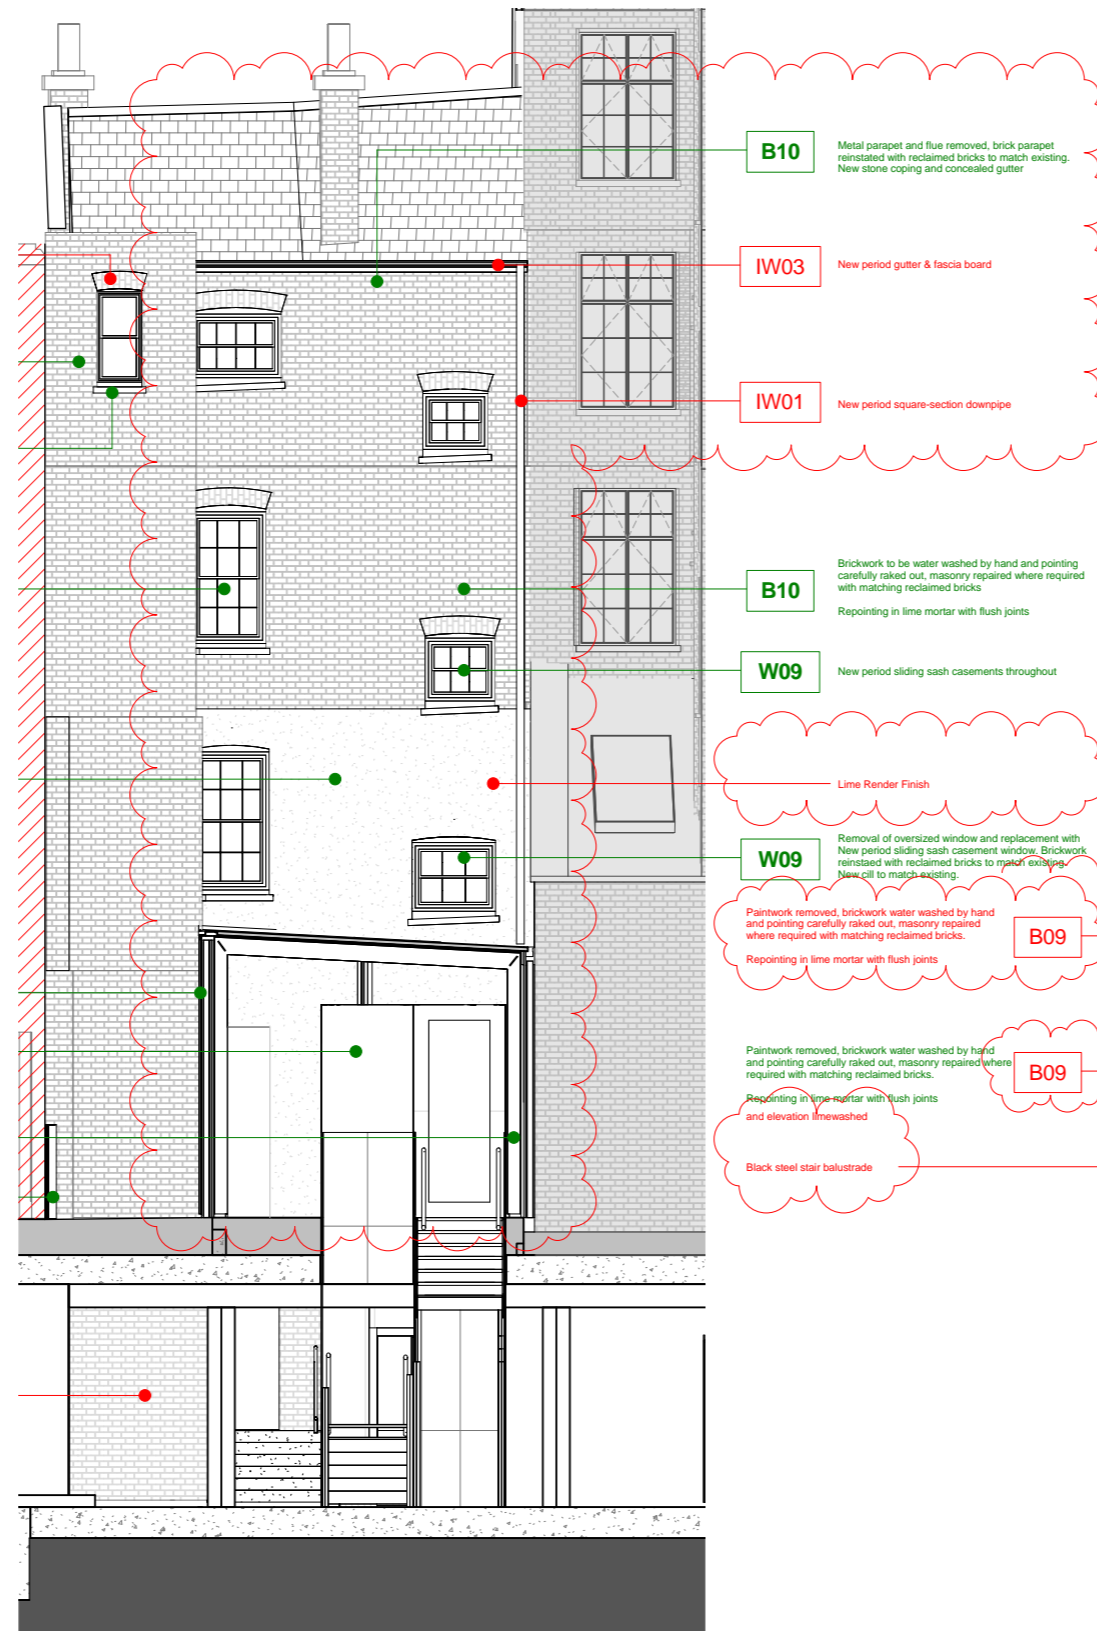
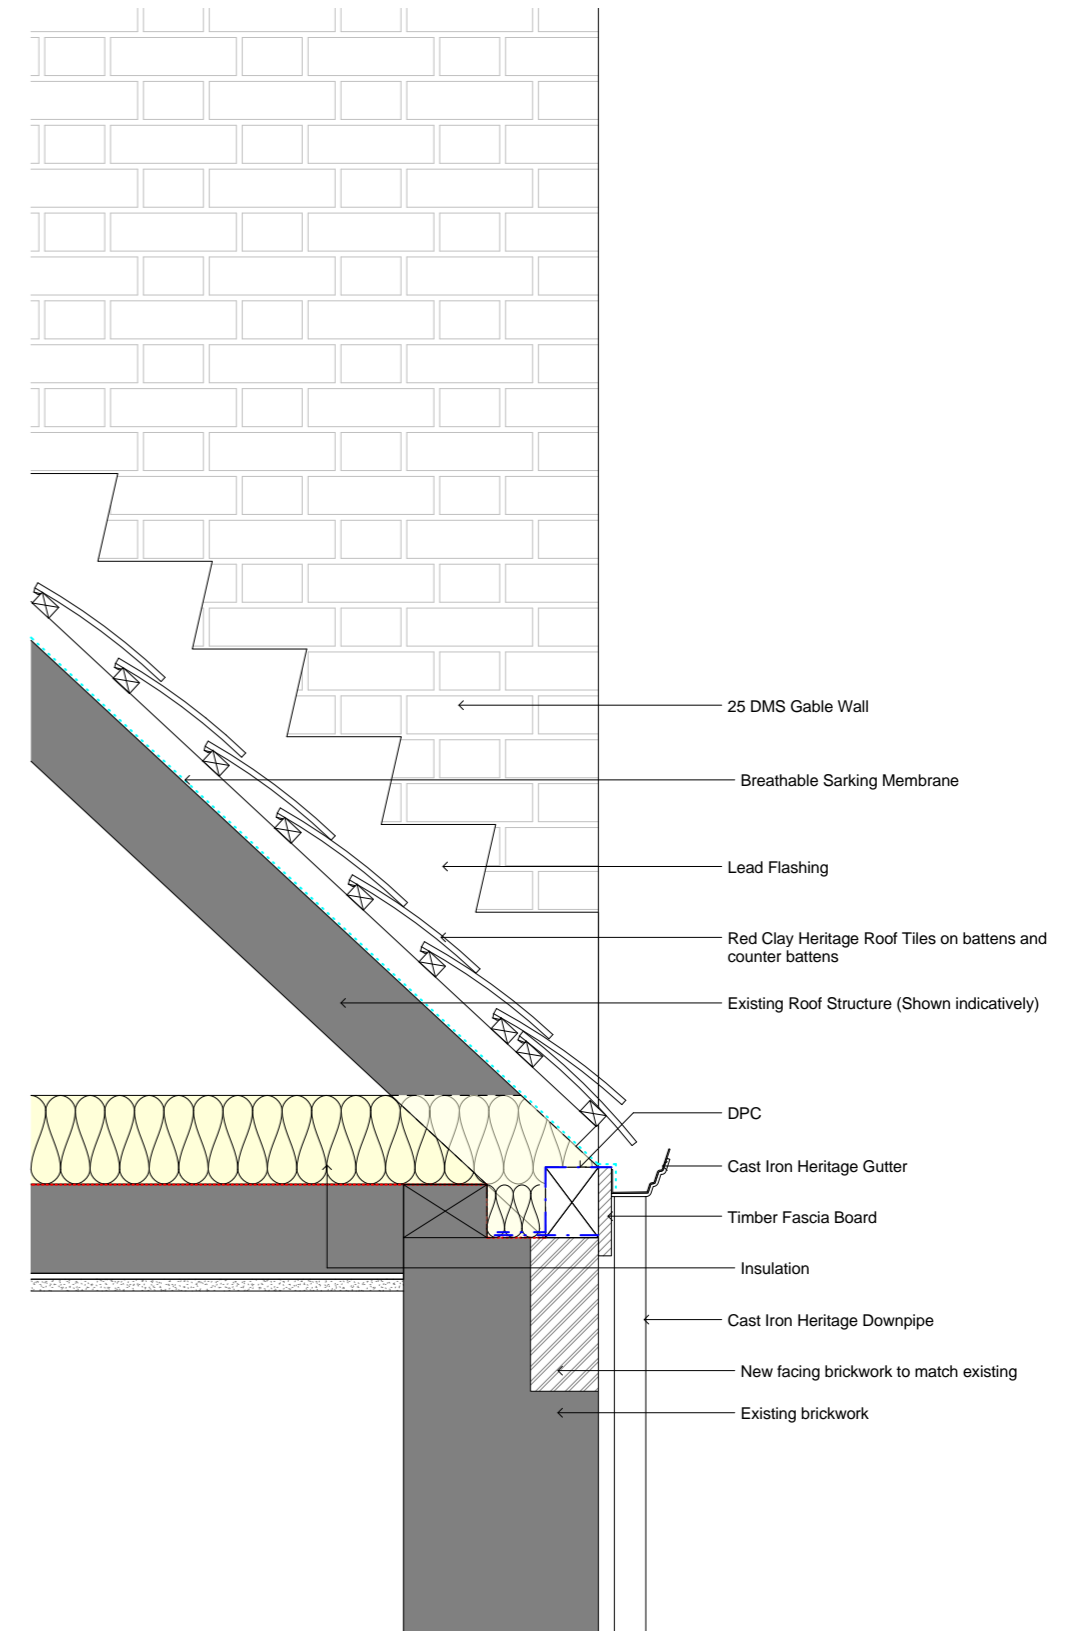
The existing roof arrangement prevents a brick parapet with box gutter being installed due to the current arrangement.

We propose removing the existing metal parapet and rebuilding with brick to the existing joist level.

We propose installing a heritage profile gutter affixed to a fascia board. A lead scupper will flash into the gutter at the junction between the closet wing and rear of 26 DMS.

This heritage profile gutter will feed into a downpipe to drain the rear section of the roof.

NOTE: Final detailing subject to site assessment

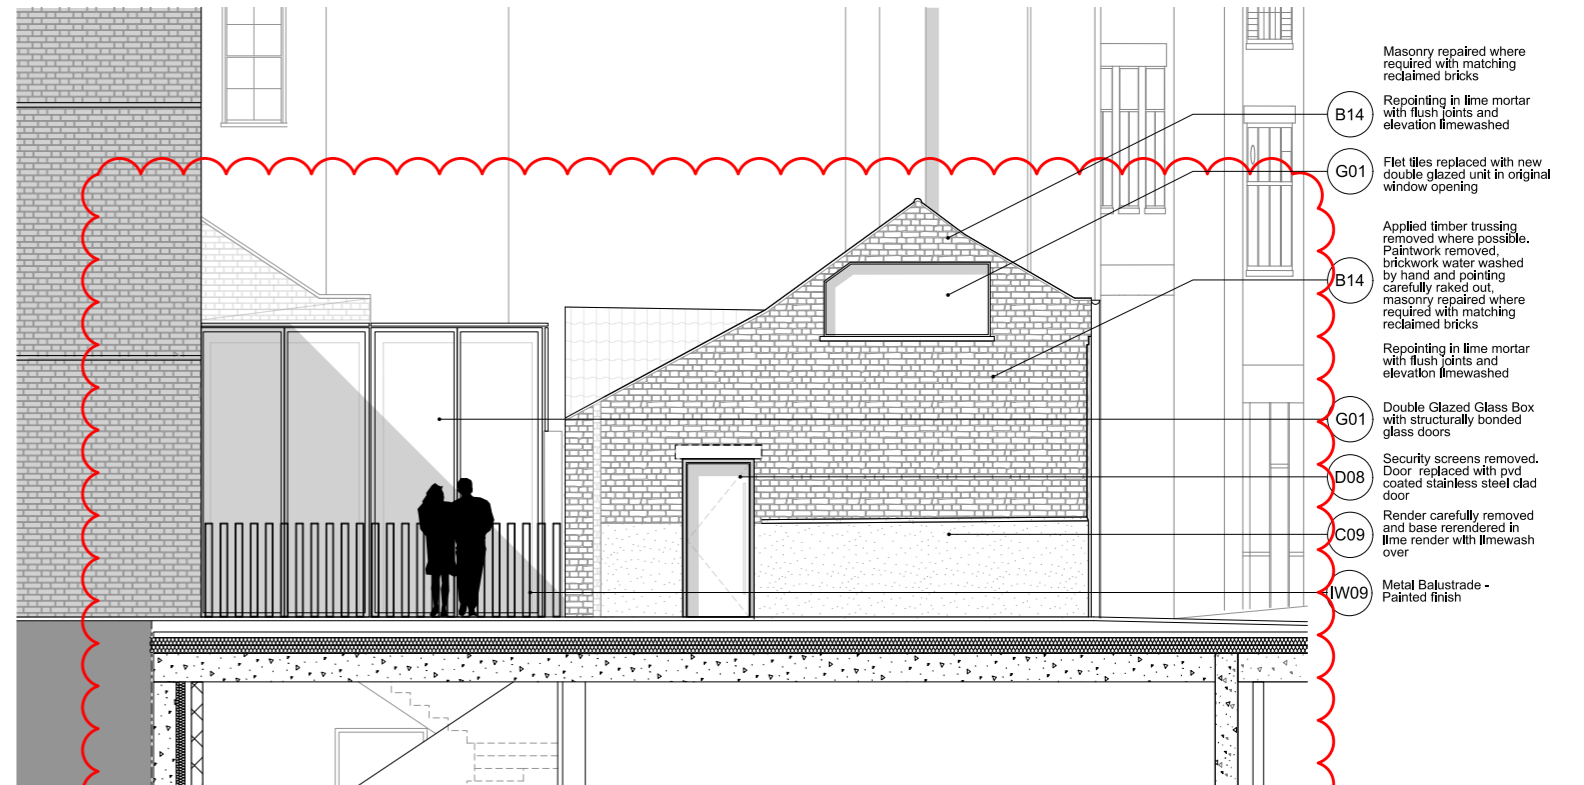
Extract of Consented Elevation

3 The existing window appears to be not have been originally for the building - this is evident from the window frame being cut at corners to fit the existing roof profile

The removal of the felt tiles has revealed that there is no facing masonry above the existing, as previously expected. Present is tongue and groove timber boarding

4 The removal of the existing felt tiles has revealed a embedded timber, spanning across the elevation

- 3 New timber framed window with infill tongue and groove timber boarding above to reflect the existing arrangement

- 4 The existing embedded timber will be retained in place and repaired/refurbished.

This retention of the embedded timber is subject to specialist contractor assessment to whether this can be retained. In the event that the beam is irreparable the beam will be replaced to match the existing.

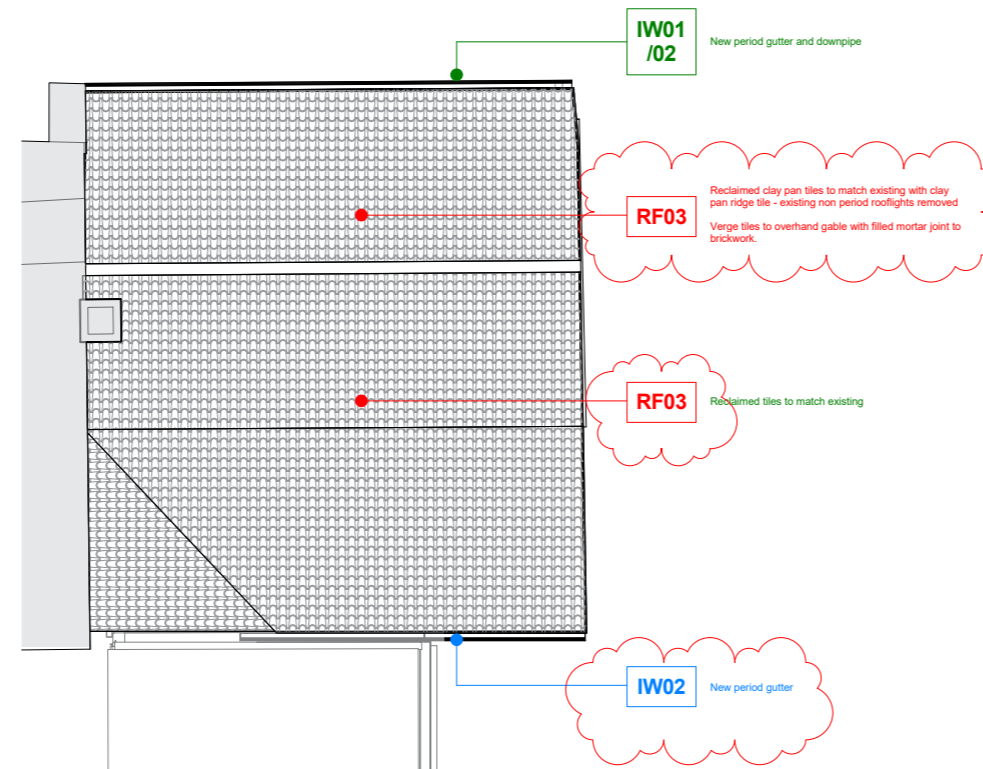
Proposed Roof Plan Extract

Following review of the existing slate roof tiles, many of which are damaged and/or coated with bituminous paint with a large quantity requiring replacement.

As can be seen from the image the existing roof tiles are generally in poor condition and the removal and re-hanging will cause further damage to the slates.

Following assessment of the existing slates and consultation with ABA and discussion with Camden, it was agreed that a red heritage clay tiles would be more appropriate intervention for a building of this age.

In response to this and the proposed works to 26 Denmark Street we propose to match the existing red clay pan tiles for like for like replacements.
