# MEDIUS HOUSE - STRUCUTRAL METHOD STATEMENT

Report to Discharge Condition 44

15-21

Façade Survey DMAG-1521-02-FS October 2018

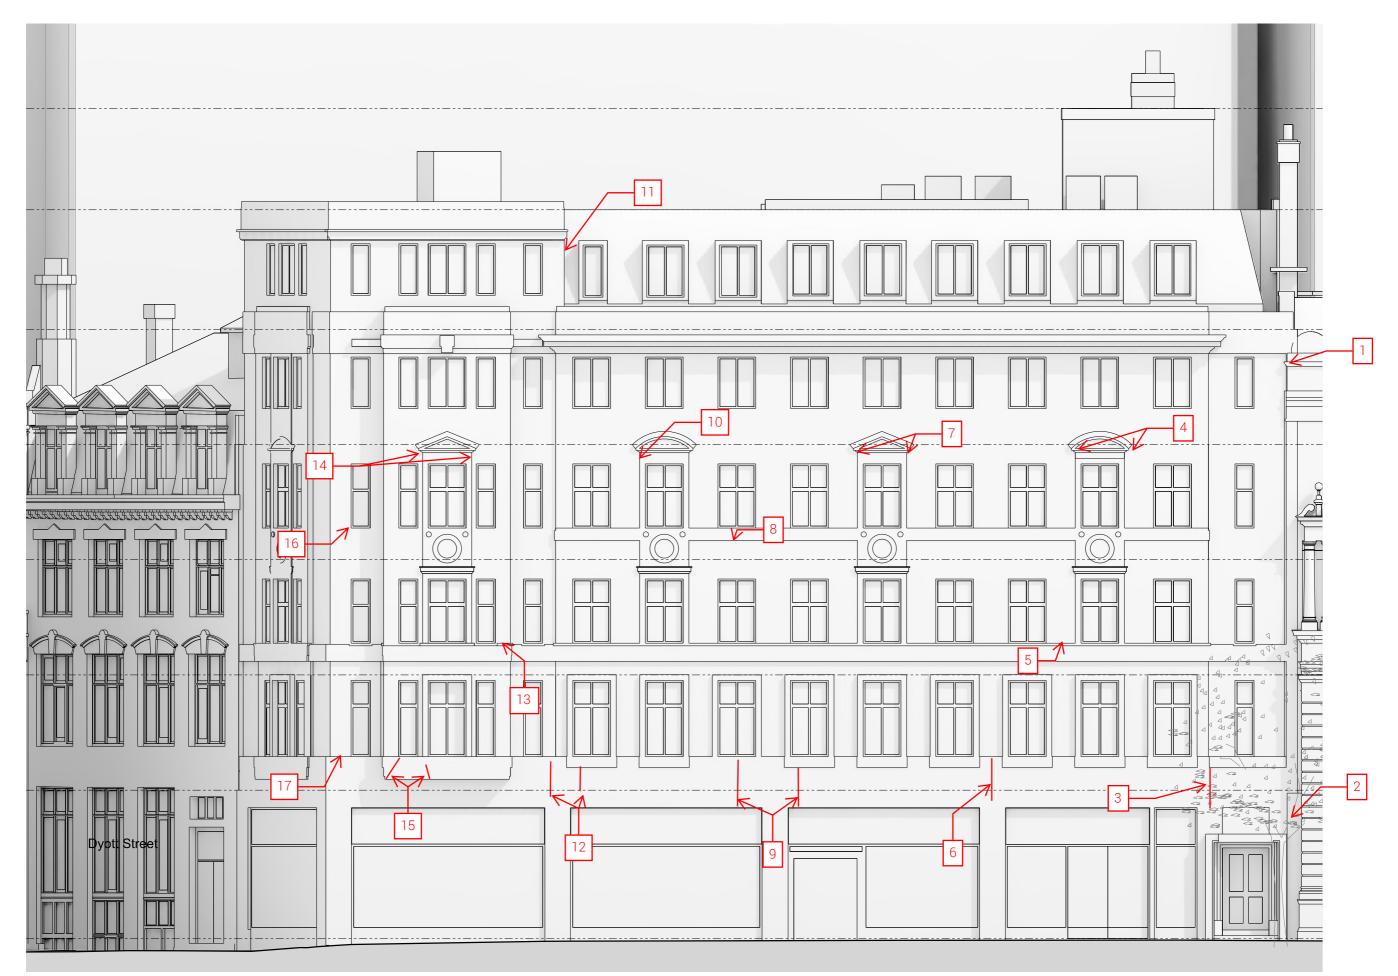
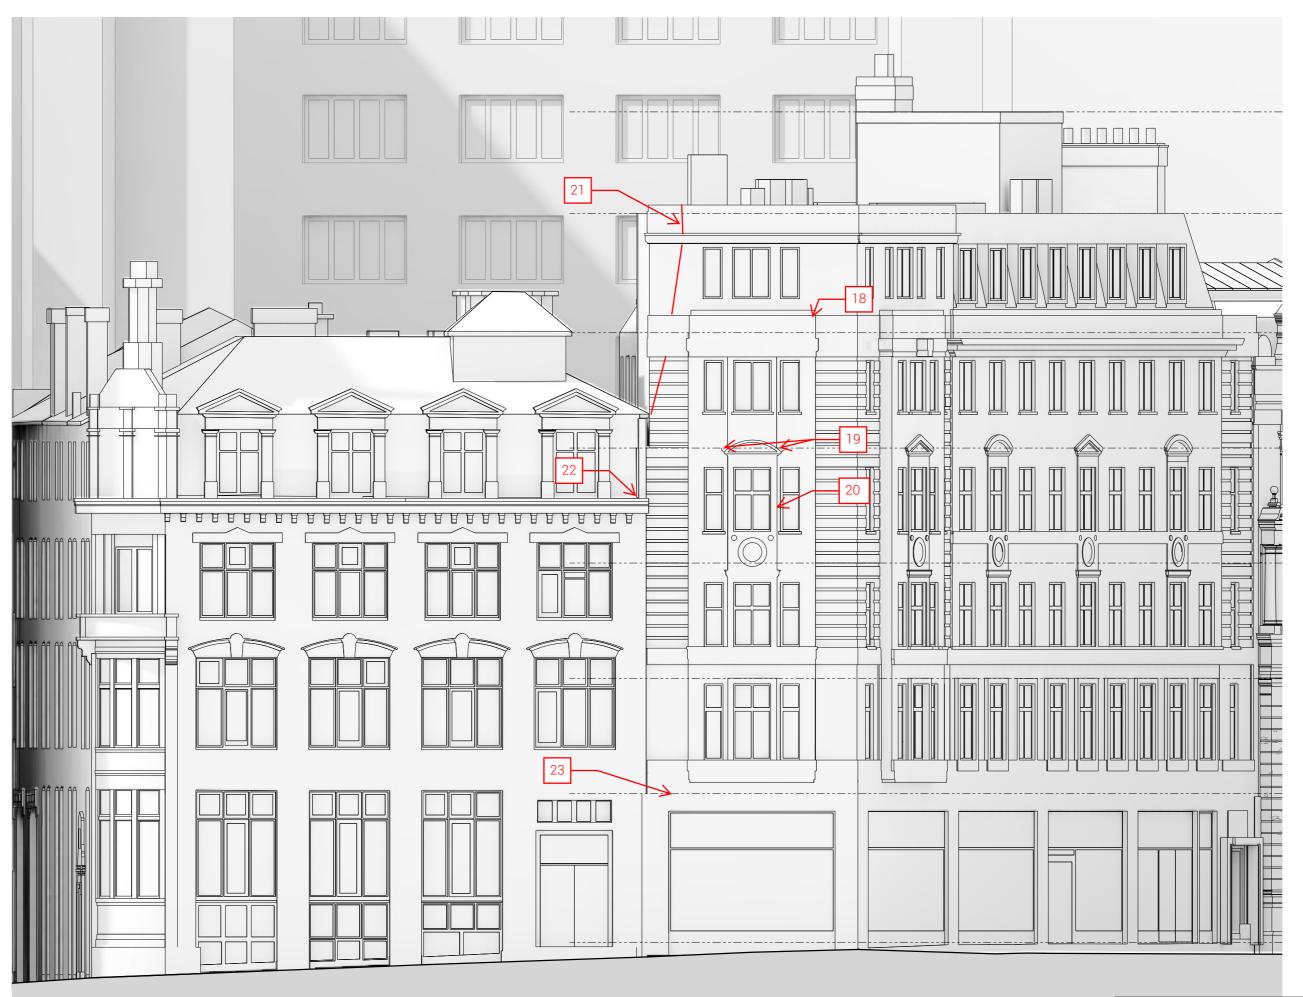
Number	Issue	Image	Repair
- Turnber	10000	inage	
1	Ambiguity in the building line, there are elements of stonework from each building which overlap. Medius façade is due to be demolished at this level.		Required  Additional propping is likely to be required during construction, and careful detailing of the proposed works.

2	The boundary between Toni&Guy and Medius house is not straight vertically, with the stone stepping below first floor level	Additional propping is likely to be required during construction, and careful detailing of the proposed works.
3	Cracks in façade stone with evidence of previous repair	Structure to be reviewed internally to assess if cracks are result of ongoing movement or previous damage to the structure, and any repairs specified as necessary.
4	Wash out of mortar around portico	Mortar repairs required and repointing

5	Loose mortar and damage to masonry from water sitting on cornice	Local repairs to the masonry and repointing
6	Cracks to stone façade around column head, with evidence of previous repair	Structure to be reviewed internally to assess if cracks are result of ongoing movement or previous damage to the structure, and any repairs specified as necessary.
7	Wash out of mortar around portico	Local repairs to the masonry and repointing

10 Wash out Local repairs of mortar to the around masonry portico 11 This section Cracking to mansard is to be return and demolished evidence of and replaced previous in the repair proposed works; note there may be damage to the structure behind the cracked masonry.

12	Cracks to stone façade around column head, with evidence of previous repair	KINGS	Structure to be reviewed internally to assess if cracks are result of ongoing movement or previous damage to the structure, and any repairs specified as necessary.
13	Mortar cracking and damage to masonry from water sitting on cornice		Local repairs to the masonry and repointing
14	Wash out of mortar around portico		Local repairs to the masonry and repointing
15	Cracking to bottom of bay window structure		This implies the cantilever structure behind may be damaged or otherwise inadequate. Structure to be investigated during strip out; allow for

local repairs to façade such as helifix repair details
16	Wash out of mortar	Local repairs to the masonry and repointing
17	Cracking and damage to the stonework from water sitting on cornice	Local repairs to the stonework

20 Washed Local repairs out mortar to the masonry and repointing 21 Part of this is Crack running to be demolished down through at higher level as part masonry of the and causing proposed works.The expansion in the structure stone internally is cornice to be joint at reviewed high level during strip out to assess any inadequacies. Allow for repair to masonry including helifix bars

22	Bucknell street warehouse drain evidently blocked in the past, leading to widespread damage to the masonry	The drain should be unblocked on Bucknall street warehouse, and the structure reviewed more locally for any permanent damage. Allowance to be made for any repairs required.
23	Water damage washed out mortar	Local repairs to the masonry and repointing
