Flat A, 1 New Square, Lincoln's Inn

Internal alterations, replacement windows and rooflights.

PHOTOGRAPHIC REPORT

August 2017

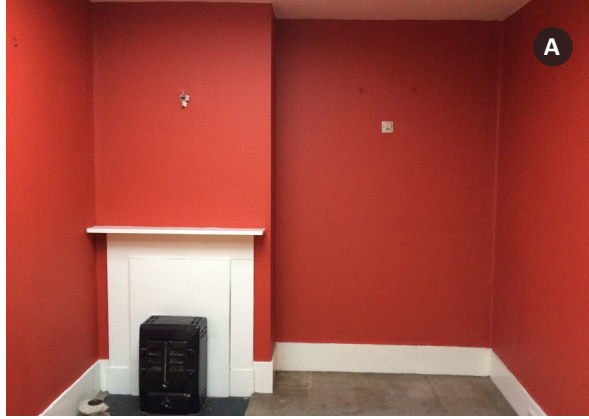
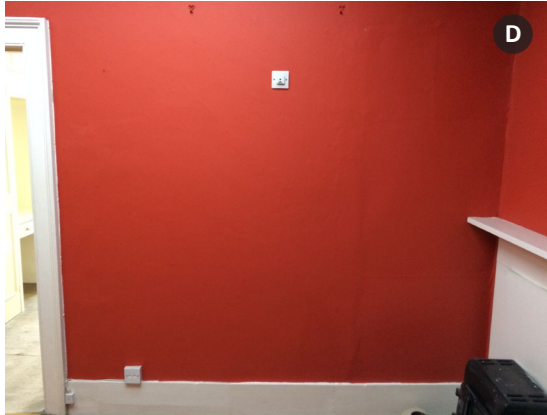
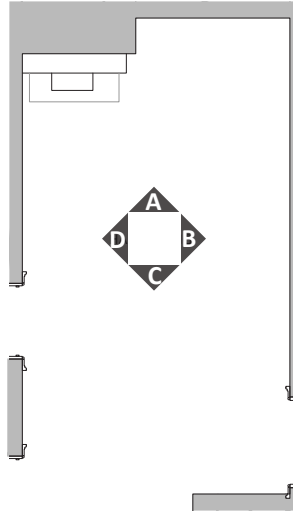
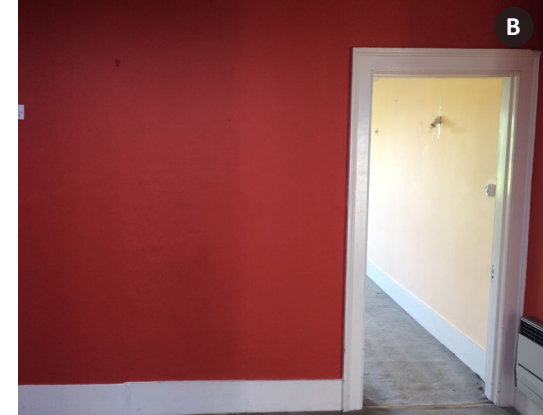
2 Dining

Coal stove

The fireplace surround and coal burning stove is not an original feature and appears to be a 19th century addition to the apartment.

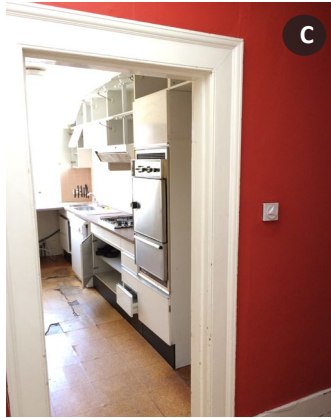
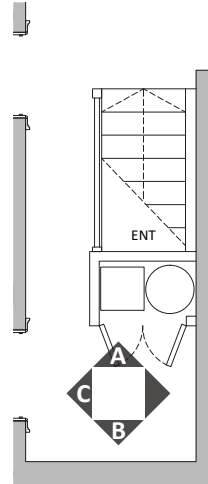
3 Hall

Boiler Cupboard
Asbestos lined boiler cupboard recently removed following an asbestos survey.

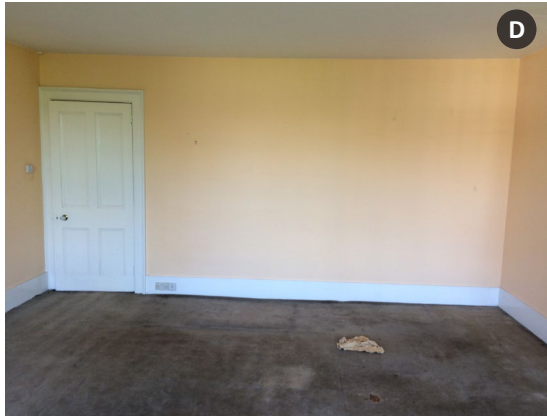
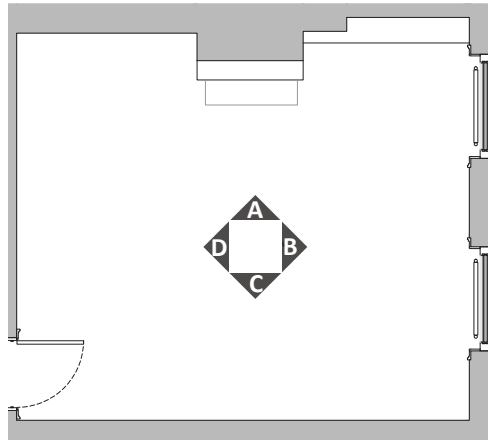
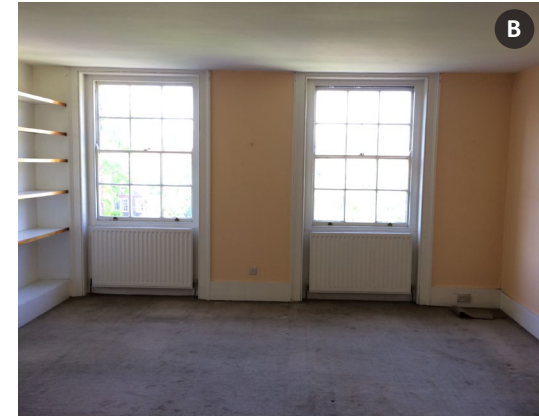
4 Reception Room

Fire place surround

The fireplace surround origin is unknown. The gas fire within is an 19th century feature.
