**REGENTS CANAL 140 -
146 CAMDEN STREET
VISUAL SURVEY REPORT**

JANUARY 2019
1858-BRL-01-XX-RP-C-0001

CLIENT	ROK Planning Ltd					
PROJECT TITLE	Regents Canal 140 - 146 Camden Street					
SUBJECT	Waterway Wall Inspection					
DOCUMENT TITLE	Visual Survey Report					
DOCUMENT REF	1858-BRL-01-XX-RP-C-0001					
REVISION RECORD						
REV	STATUS	DATE	SUMMARY OF CHANGES	PREP	CHK	APP
P01	S3 – Suitable for review & comment	11/01/2019		NN	JM	ID
P02	S2 – Suitable for information	22/01/2019		NN	JM	ID
P03	S2 – Suitable for information	20/02/2019	Additional survey information of Section 4 - Concrete Covered Masonry Wall	NN	ID	ID

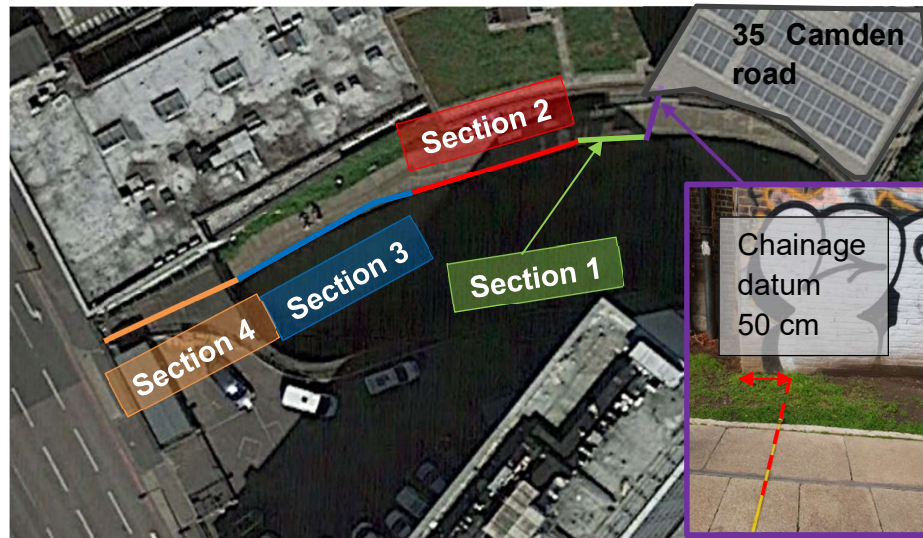
Figure 2.1: Wall Sections under consideration and Datum of Wall survey

2.1.5 The chainage datum of the wall survey is indicated in Figure 2.1 and begins 50cm before the end of the south-western side of 35 Camden road building.

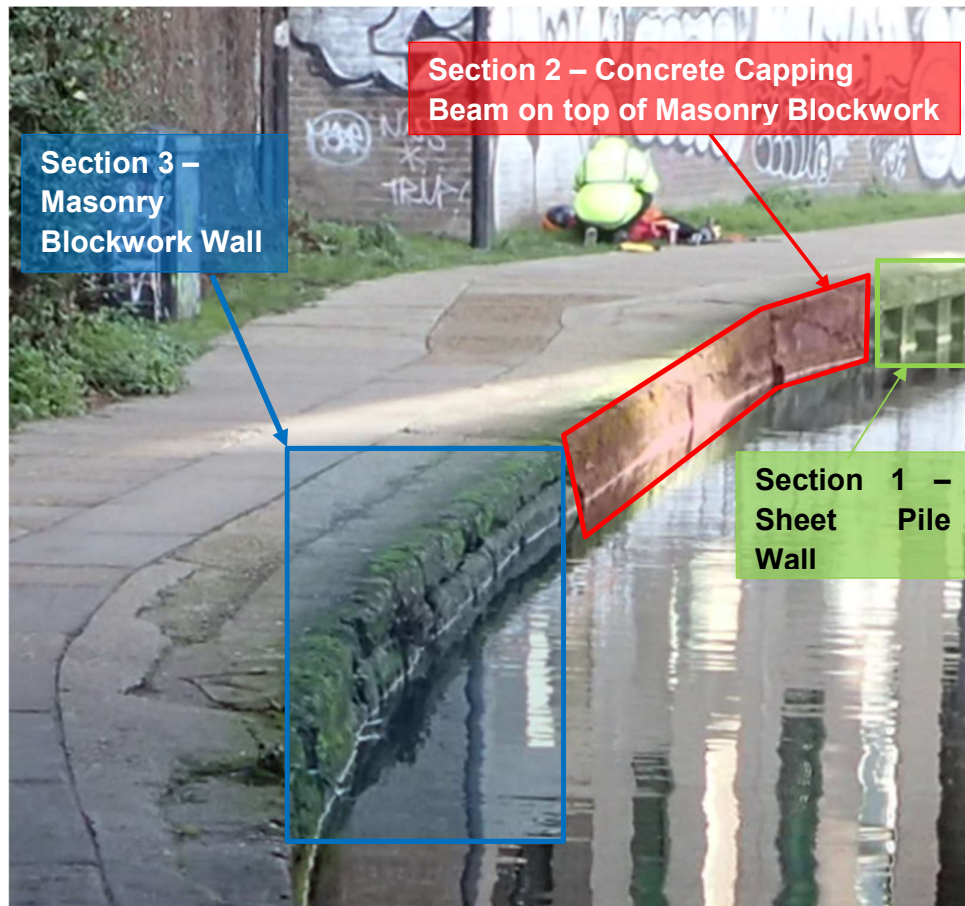
Figure 3.3: Photograph indicating Wall Section 1,2 & 3

3.2.2 The capping beam extends below the water level and its total height is approximately 70cm. During the inspection of the beam, a number of cracks were observed. It is believed these have been caused by the settlement of the masonry wall and are not thought to be a source of concern. The condition of the capping beam is considered fair. A typical crack is shown in Figure 3.4.

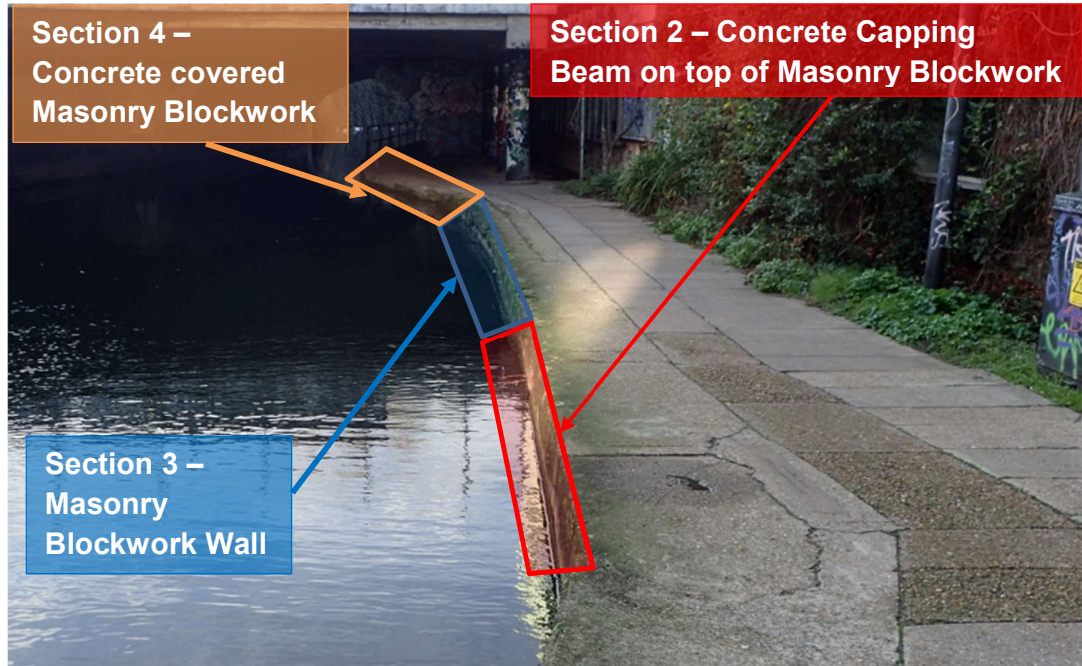
Figure 3.8: Photograph indicating Wall Section 2, 3 & 4

3.3.1 This section, represents approximately 9m of the total surveyed wall and is located on the west side of Section 2 as shown in Figure 3.8. The wall section is composed of masonry blockwork and concrete topping to finished level.

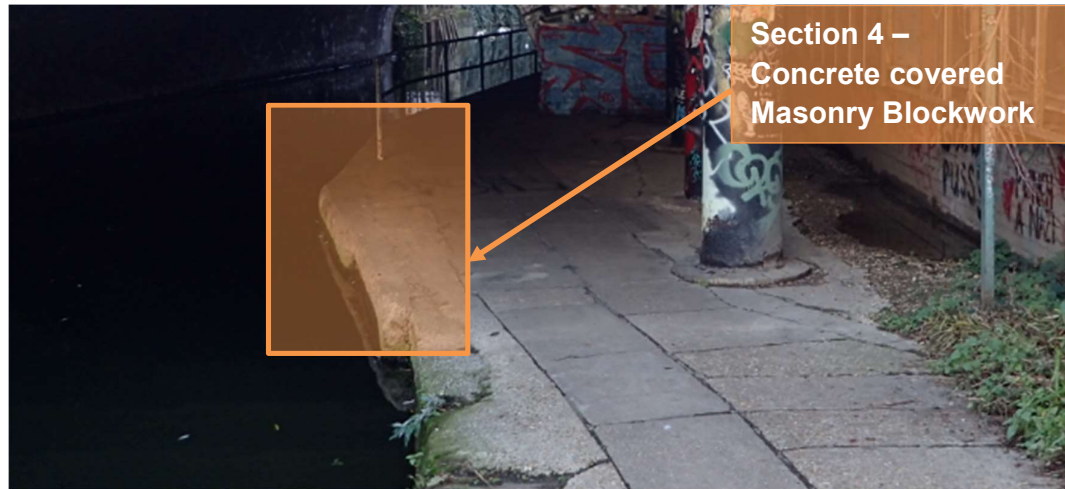
Figure 3.11: Photograph indicating Section 4 - Concrete covered Masonry Blockwork Wall

- 3.4.2 From observations on site it was assessed that this section of the wall is composed of masonry blockwork structure, with a façade of concrete layered over the front blockwork of the wall. The concrete layer is thought to be approximately 20cm thick.

- 3.4.3 The submerged surface of the concrete layer is rough, with a thin layer of marine growth.
- 3.4.4 The concrete layer covering the first 1.5m of the wall (eastern side) did not show any signs of significant damage or deterioration, with no obvious signs of structural deformation, cracking or failure.
