INTERVENTION REPORT

MONMOUTH ST

Client: Shaftesbury Covent Garden Ltd
Address: 22 Ganton Street, Carnaby, London, W1F 7FD
Date: April 2019
REF: 1923
AT: 2nd and 3rd Floor, 42 Monmouth Street, London
Written by: VT
Checked by: NH

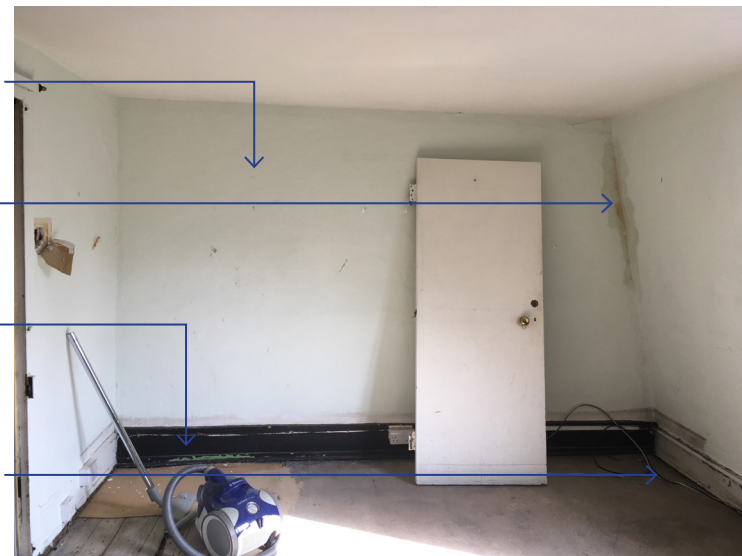
Blown Plaster to walls needs to be removed and replaced
 Damp
 Modern skirting to be removed and replaced
 Modern electrical cabling to be removed and run underneath floor

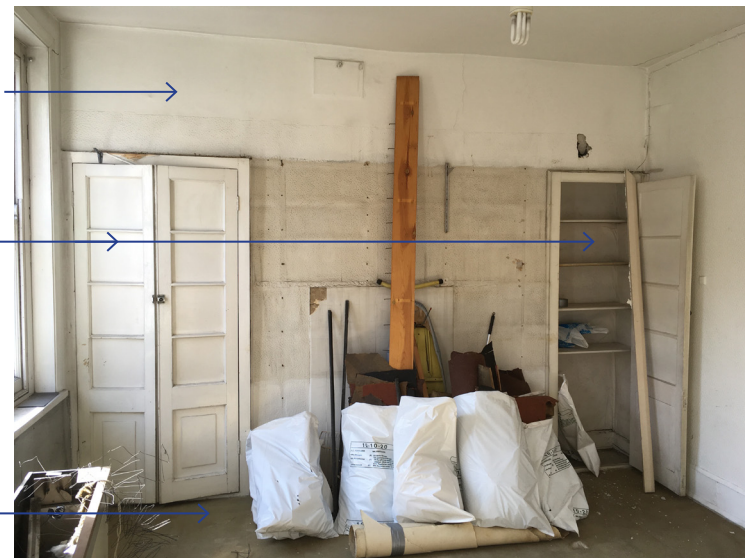
Blown Plaster to
lathe and plaster
walls needs to
be removed and
replaced

Modern skirting
to be removed
and replaced

Floor finish to be
stripped back. If
possible original
floor to be
restored
