1 CHESTER PLACE  
REGENTS PARK  
LONDON NW1 4NB

REPAIR DETAILS TO  
FIRST FLOOR

DRAWING NUMBER  
02962L/03

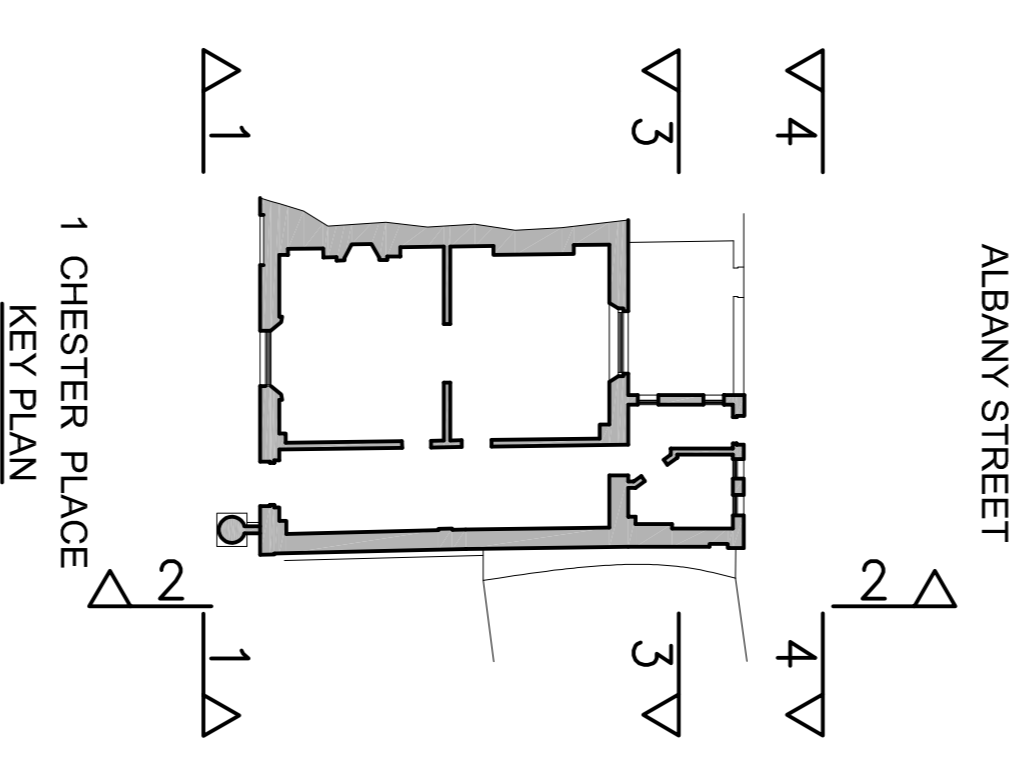
EXISTING FIRST FLOOR PLAN  
SCALE 1:50

ALLOW FOR REPAIR B SUBJECT TO CLOSER INSPECTION

SUSPECTED CRACKING BEHIND BOARDS TO BE INVESTIGATED REPAIR A BEHIND JOINERY

- Repair A**  
Hack off plaster to full length of crack. Replace any cracked bricks using NHL 3:5 mortar in 1:2½ mix. Install hallow every third course of brick in accordance with manufacturers details and instructions. Make good plaster and finishes for completion.

- Repair B**  
Repair as schedule A but with external stucco/render. Make good stucco/render and decorate on completion.
- Repair C**  
Install hallow bowties and bowtie HD's to floor, including nogging, fully in accordance with manufacturers instructions at approx 1200mm centres.

- Repair D**  
Form hallowbar bar bonds from 4 no. bars in 5mm stainless steel at 225mm vertical centres fully in accordance with manufacturers instructions at each floor plate.

- Repair E**  
Strip back plaster and finishes. Fix existing timber stud back to flank wall with resin bolts – see details.
- Repair F**  
Hack off plaster from brickwork inspection. Allow for partial rebuild/making good of masonry and possible additional hallowbar to two faces as per repair A.
