Tree Inspection Report

22 Churchill Road, London NW5 1AN

13th March 2019

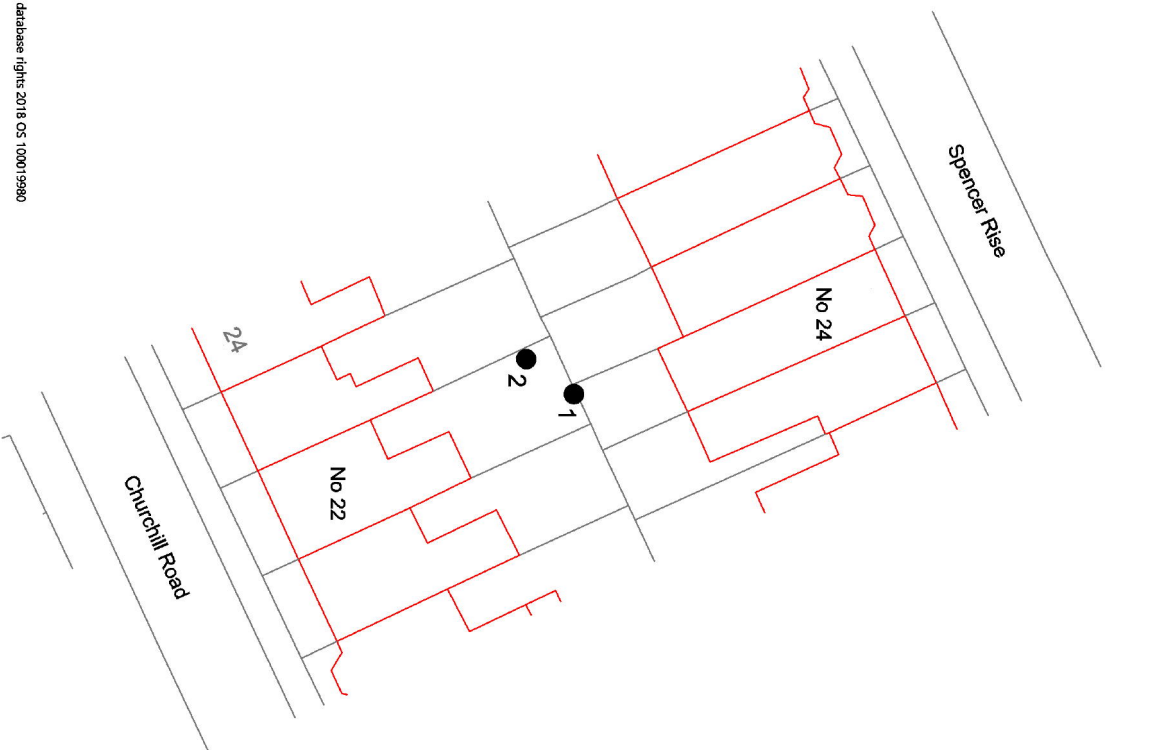
- 5.2.1 The tree has a single, upright, ivy-covered stem to a height of 7 metres. The view of the tree's top is obscured by ivy; however it is apparent that it has been subjected to the same management as Tree 1, and it is likely that there are large decaying wounds where the primary scaffold branches were severed in the past. The tree has re-grown from past pollarding undertaken since the previous inspection with 1-2 seasons' re-growth.
- 5.2.2 Use of a sounding mallet implied the presence of decay on the east side. I undertook drill tests in three locations where the tree could be accessed on the north, east and south sides (see Figures 4-6)

- 6.1 It is apparent that the tree has significant decay on its eastern side; however from the north and south sides it has sound wall thickness of 36 - 37cm which I consider provides good support, particularly given the tree's small size and upright form.
- 6.2 It is possible that with time the tree's condition might deteriorate to a point where the stem becomes unstable; however this is unlikely to occur for several years at least and I consider that the tree can reasonably be retained on the basis that it is re-pollarded every two to three years.

- 7.1 I recommend that Tree 1 is removed within the next three months.
- 7.2 I recommend that Tree 2 is re-pollarded within the next twelve months, and that this be repeated every 2-3 years.
- 7.3 I recommend that Tree 2 is re-inspected in three years' time.
