## Arboricultural Appraisal Report

### Subsidence Damage Investigation at:

31 Inglewood Road  
London  
NW6 1QT

| REPORT DATE: | 29/03/2019 |

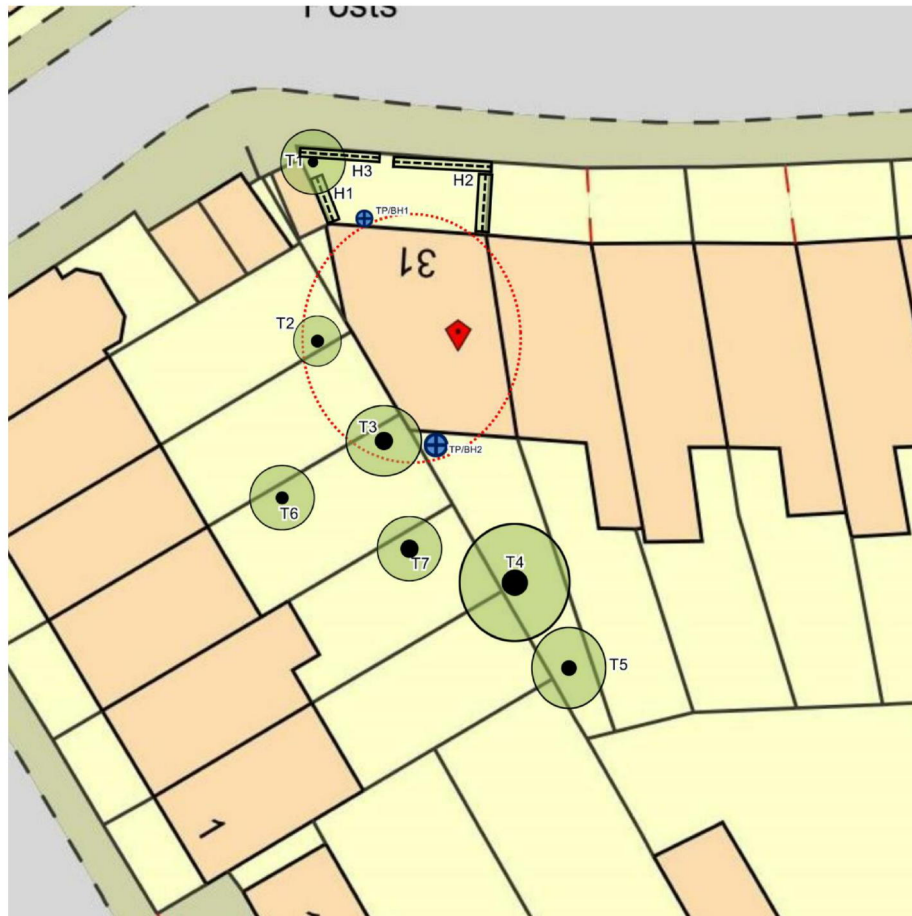
Site Plan

Approximate areas of damage

If an arboricultural solution is to be implemented to mitigate the influence of the implicated trees/vegetation we recommend that T1, T2, T3, and T4 are removed.
