## Arboricultural Appraisal Report

### Subsidence Damage Investigation at:

31 Inglewood Road  
London  
NW6 1QT

CLIENT:	Crawford & Company
CLIENT REF:	██████████
MWA REF:	██████████
MWA CONSULTANT:	George Peters BSc. (Hons)
REPORT DATE:	29/03/2019

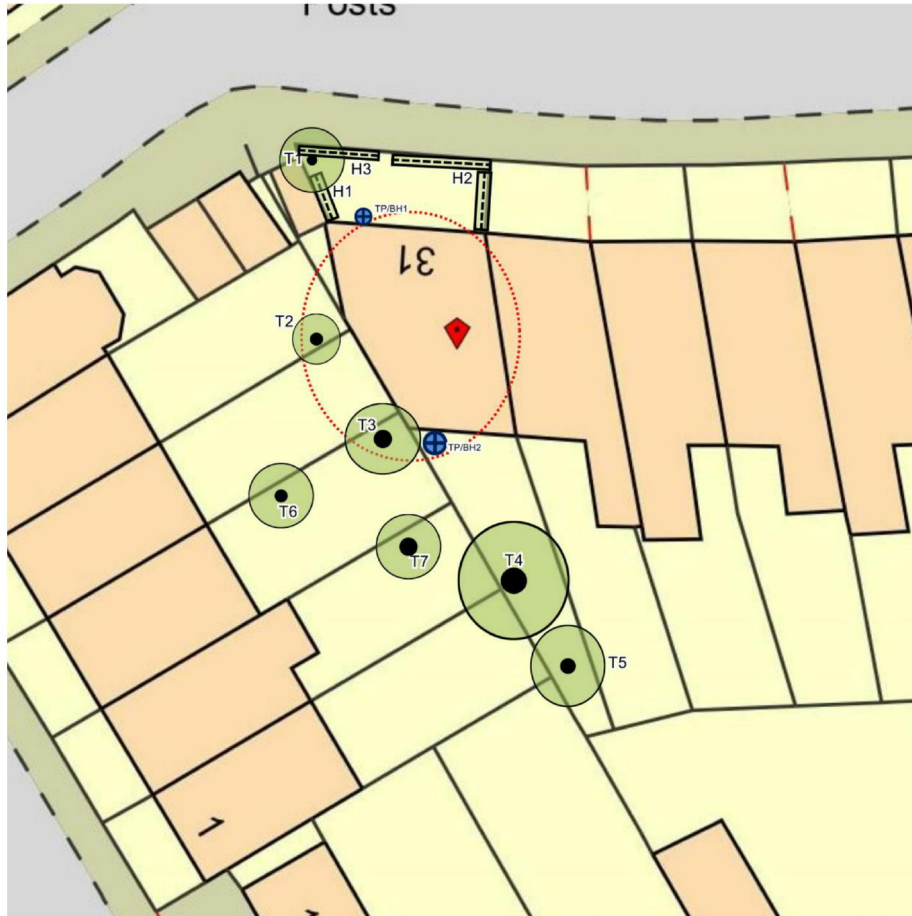
Site Plan

Approximate areas of damage

If an arboricultural solution is to be implemented to mitigate the influence of the implicated trees/vegetation we recommend that T1, T2, T3, and T4 are removed.
