Project Name 79 Guildford Street, London WC1N 1DR	Project Number	Project Date 14/05/2018
---	-----------------------	-----------------------------------

Section Inspection - 14/05/2018 - MH01X

Site Report

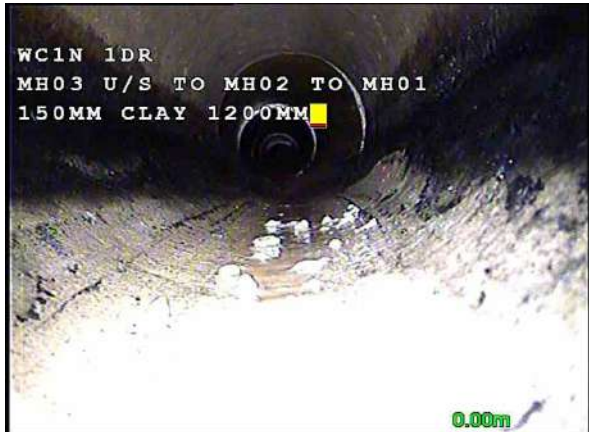
MH01X_919b053e-3c15-42d0-ad76-d10e264feae5_20180520_170657_789.jpg, 00:00:00, 0.00 m
Start node type, inspection chamber, reference number: MH03

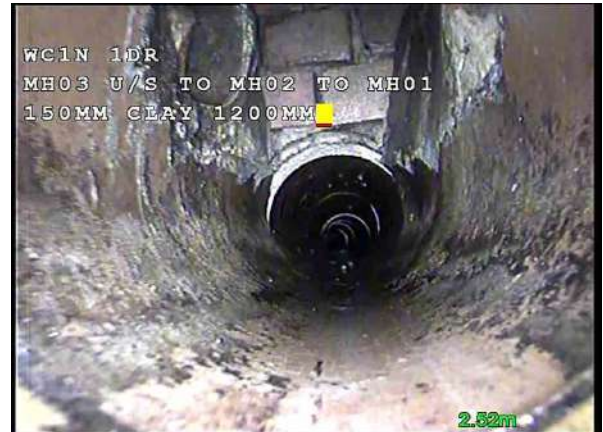
MH01X_af1f0fd8-07d0-43ad-a8e1-10c938e7c251_20180520_170848_875.jpg, 00:00:34, 2.52 m
Start node type, inspection chamber, reference number: MH02,

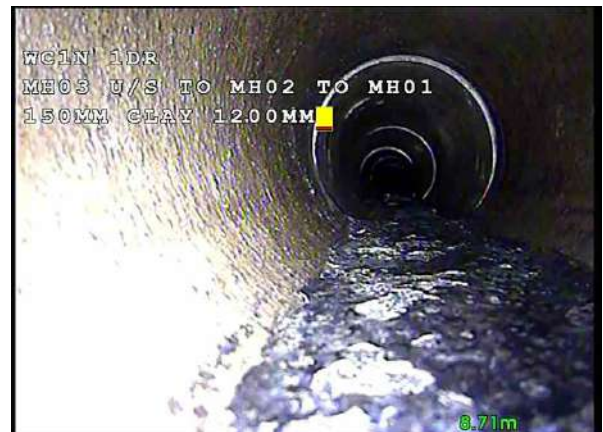
MH01X_852157e0-1cd5-4193-be50-e3176276f317_20180520_171044_689.jpg, 00:01:44, 8.71 m
General photograph taken at this point, PHOTO OF SCALE

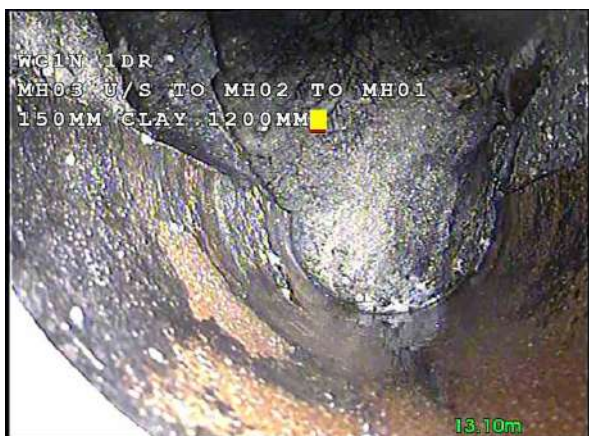
MH01X_of4d0968-b5be-494c-b313-a1e3eadce7a3_20180520_171201_880.jpg, 00:02:29, 13.10 m
Finish node type, inspection chamber, reference number: MH01,

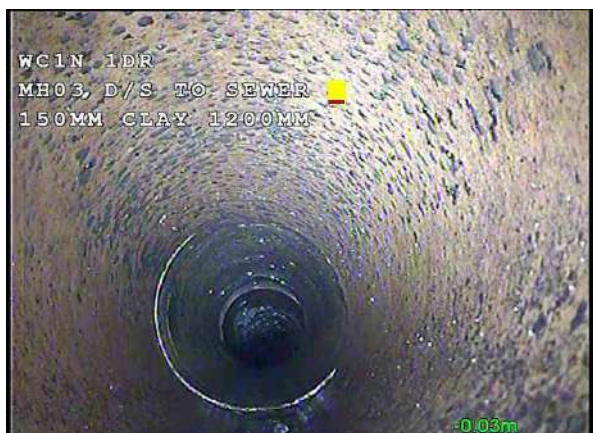
MH03X_866941c8-3dbc-41b9-970f-964bc9294d16_20180520_171457_908.jpg, 00:00:00, 0.00 m
Start node type, inspection chamber, reference number: MH03

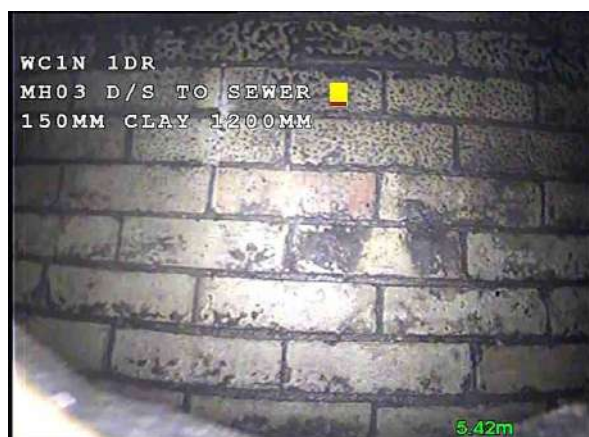
MH03X_c99818b7-19b7-4326-bfa4-27cbf5ff8a6f_20180520_171729_205.jpg, 00:00:47, 5.42 m
Finish node type, major connection without manhole, reference

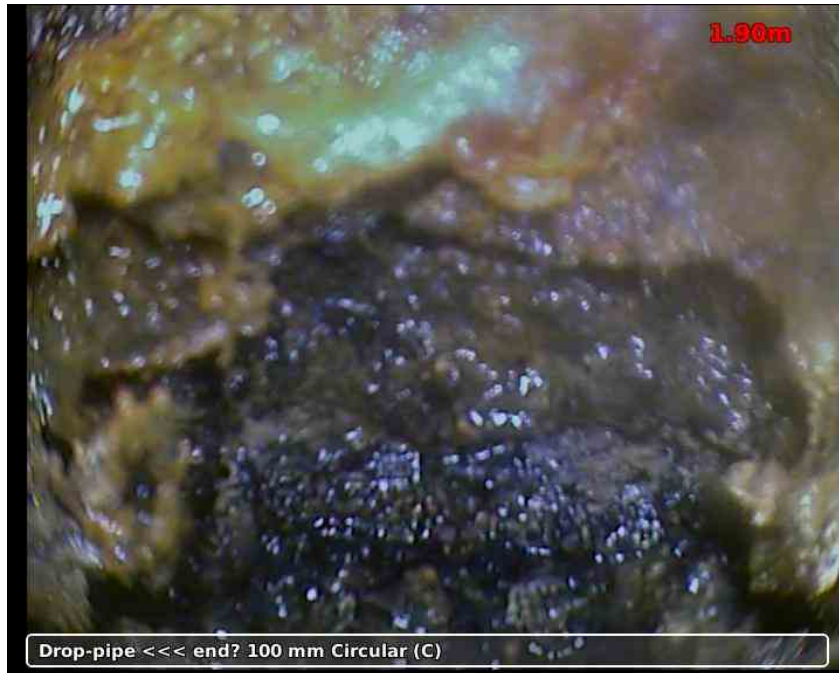
A CCTV survey was successfully carried out upstream to find it leads to either a gully or a discharge pipe at 1.9 metres.

20190305-120013-snap0000.jpg, 00:01:30, 1.90 m
Finish node type, gully, reference number: gully
