Decay Detection Investigation

Bedford Square
Fitzrovia
London
WC1B 3DR

April 2019

160523-DID-02

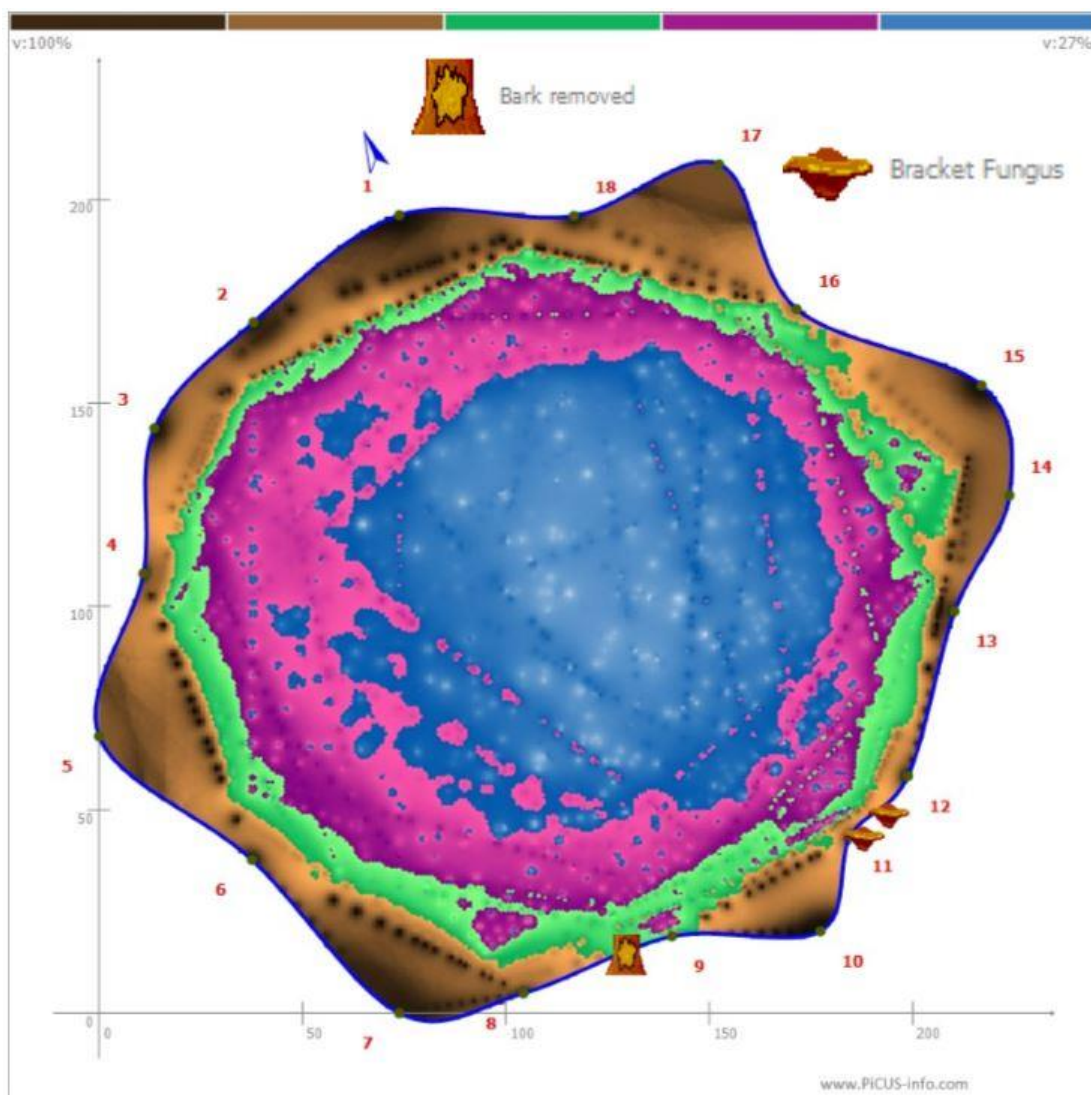
The above tomogram shows extensive internal decay (blue, pink) which continues to develop across the stem (green, yellow/light brown) with some sound wood (dark brown) remaining around the circumference

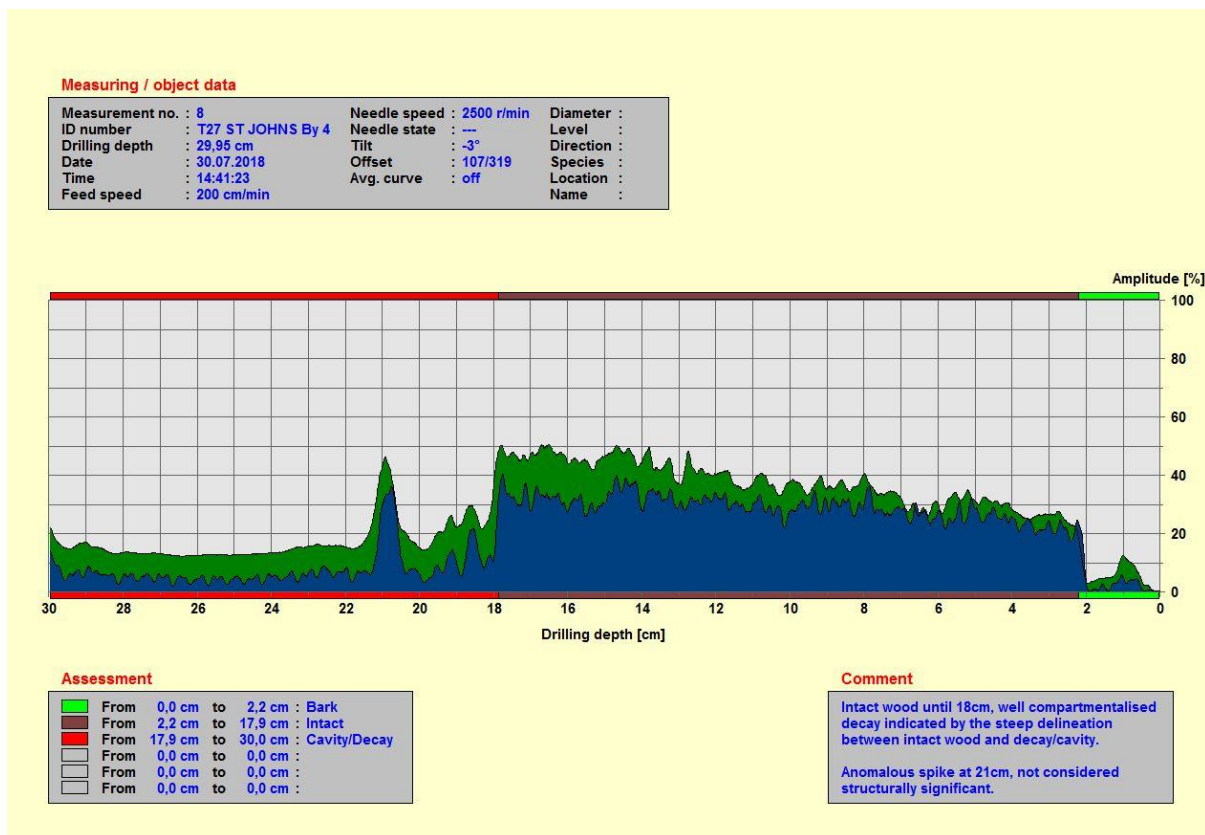
The above RESI PD trace (read from right to left) shows bark to 2cm, intact wood with high resistance until 18cm where resistance drops sharply, indicating well compartmentalised decay throughout the remainder of the trace
