# **Decay Detection Investigation**

**PiCUS / RESI PD**

Bedford Square  
Fitzrovia  
London  
WC1B 3DR

**160523-DID-02**

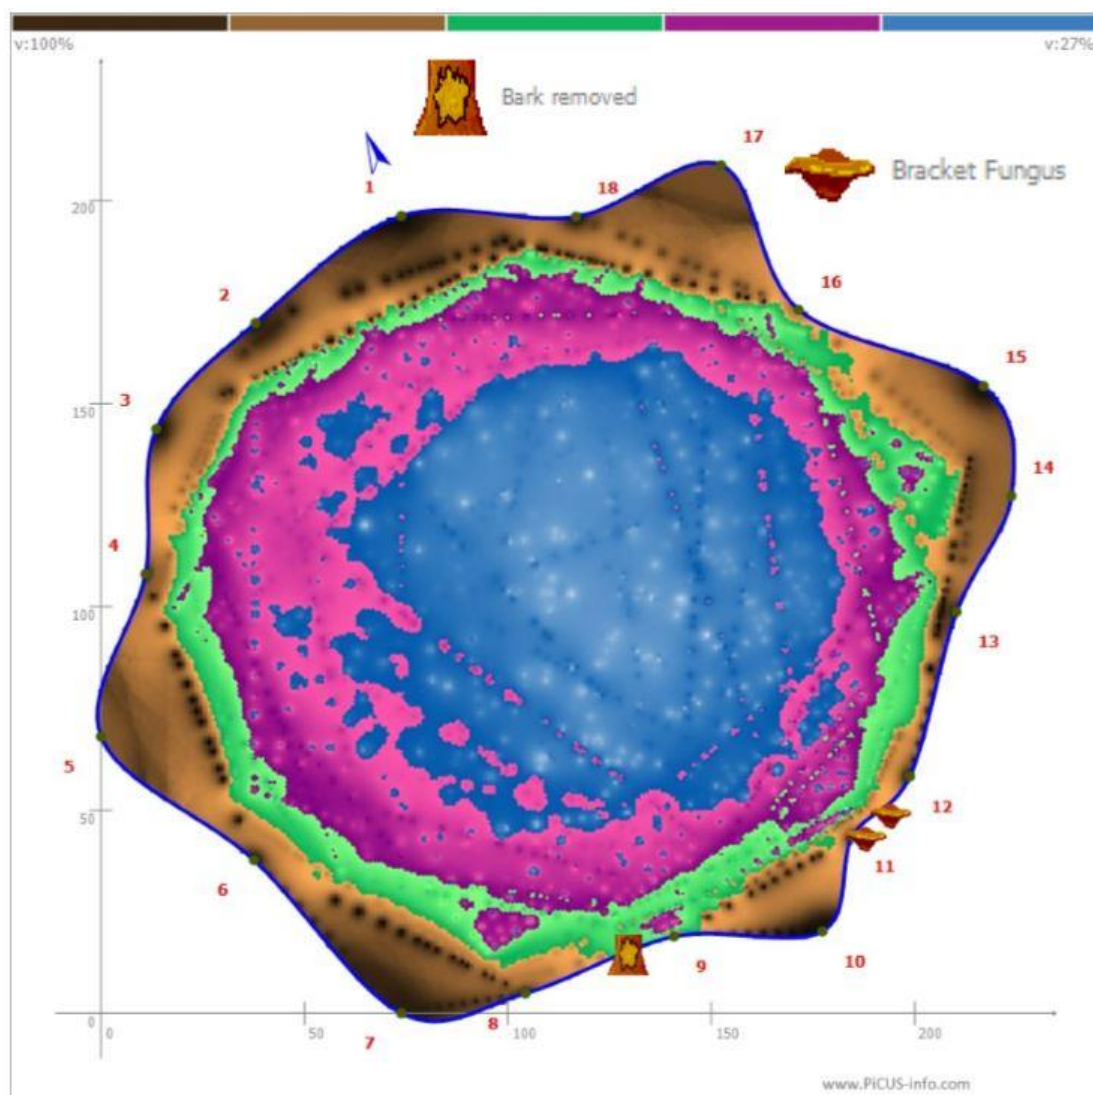
The above tomogram shows extensive internal decay (blue, pink) which continues to develop across the stem (green, yellow/light brown) with some sound wood (dark brown) remaining around the circumference

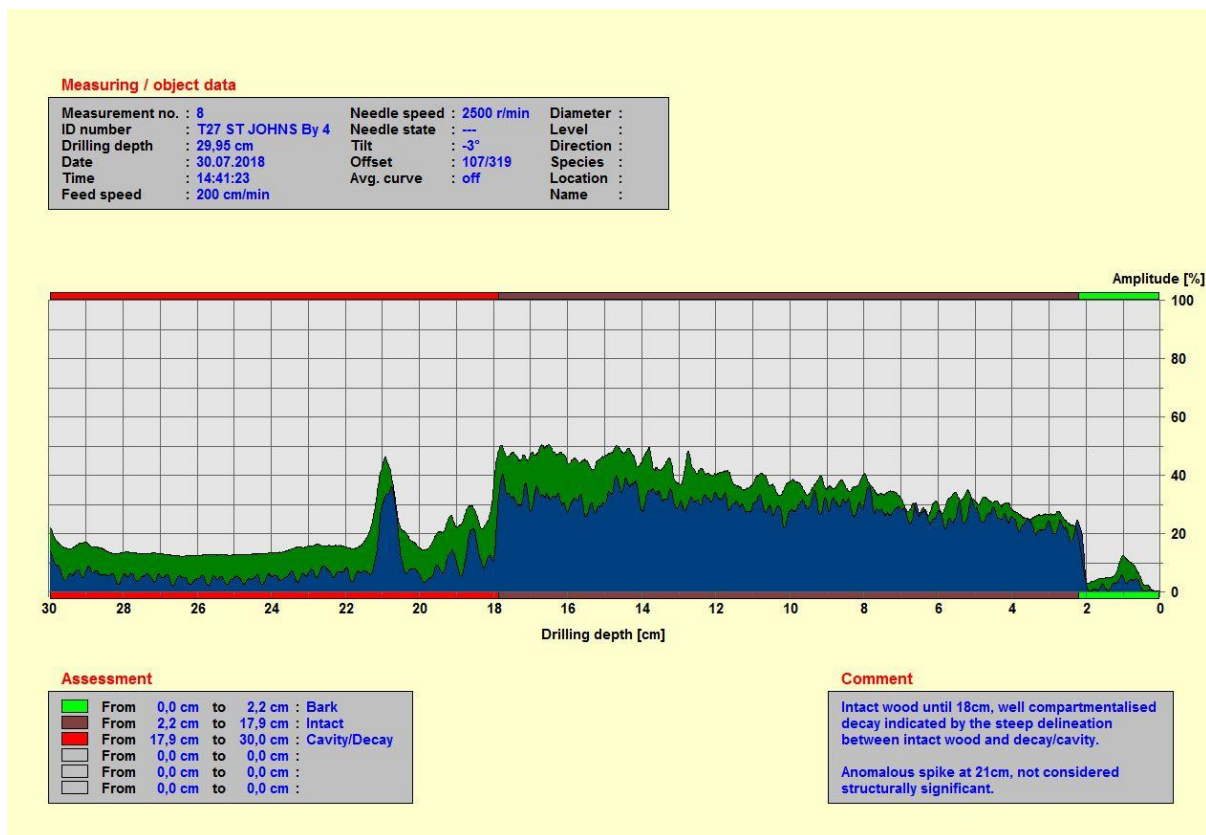
The above RESI PD trace (read from right to left) shows bark to 2cm, intact wood with high resistance until 18cm where resistance drops sharply, indicating well compartmentalised decay throughout the remainder of the trace
