# **Decay Detection Investigation**

Bedford Square  
Fitzrovia  
London  
WC1B 3DR

**April 2019**

**160523-DID-02**

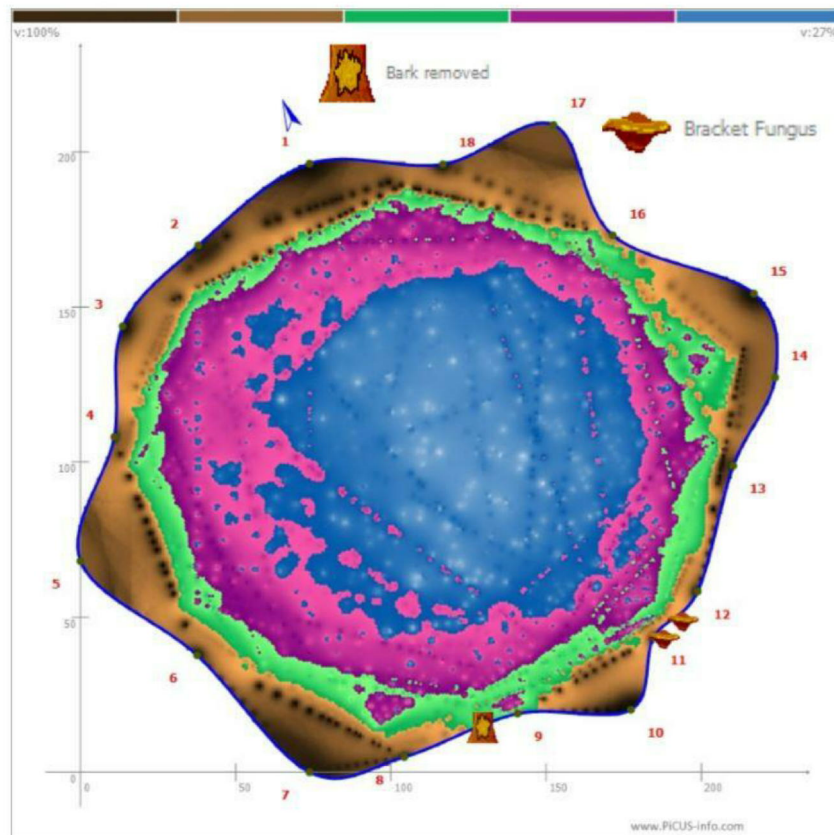
The above tomogram shows extensive internal decay (blue, pink) which continues to develop across the stem (green, yellow/light brown) with some sound wood (dark brown) remaining around the circumference

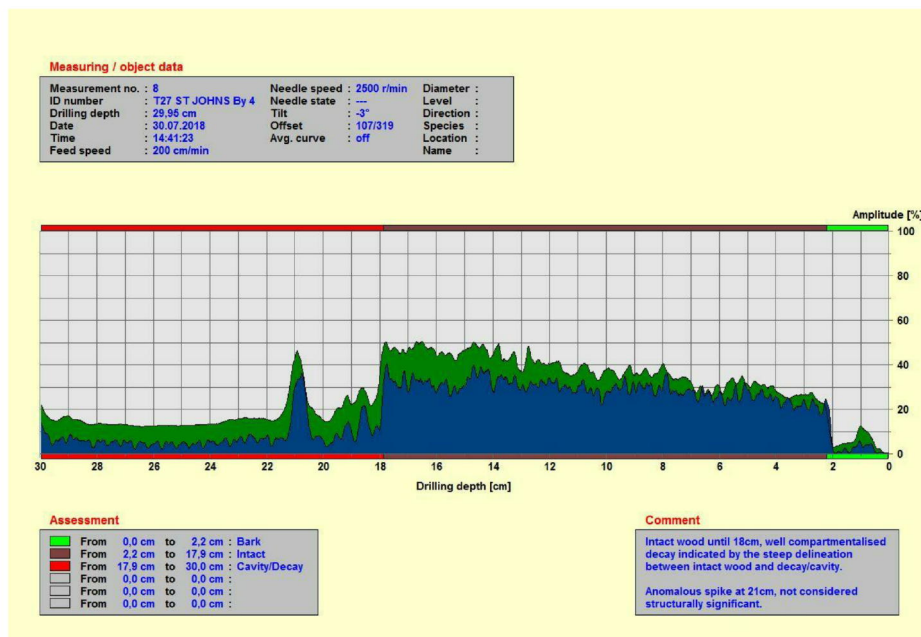
The above RESIPD trace (read from right to left) shows bark to 2cm, intact wood with high resistance until 18cm where resistance drops sharply, indicating well compartmentalised decay throughout the remainder of the trace
