Simon Pryce Arboriculture

Date: 16 June 2019
Your ref:
My ref 19/032
FAO Brian Kernahan
By e mail

51 Belsize Park Gardens - site for new bin store at the front

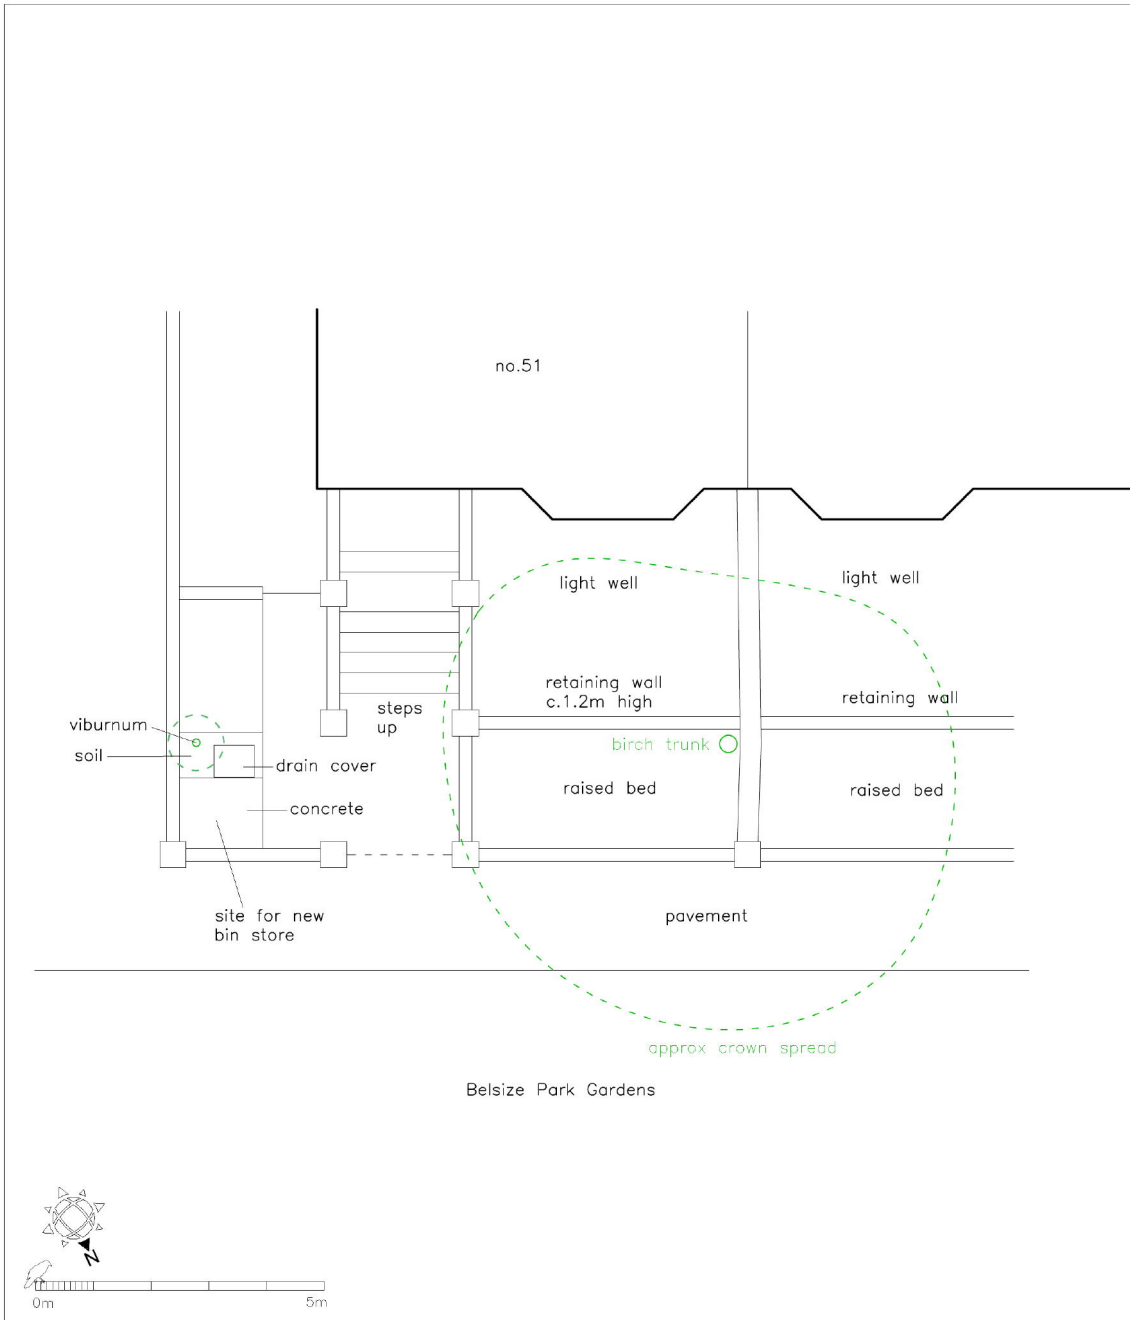
Belsize Park Gardens

4. We lifted the cover to inspect the drain, which is about 3m deep. The shaft has severe cracking showing that it was built with bricks and lined with concrete. The uppermost section has vertical cracks in each of the shorter sides and has displaced about 30mm laterally towards the front wall, i.e. away from the shrub. The joints between the sections and the shaft and cover base have opened and there are numerous roots growing through them and the cracks. I did not take samples of these, there is a small pink flowered thorn in front of no.53, but that is the other side of the boundary wall and the only likely source of these roots is the viburnum.

5. The local subsoil is London clay, which creates a potential for subsidence where roots dry the soil beneath structures, so that it shrinks. However the damage here is clearly due to direct pressure from the main roots of the viburnum pushing the uppermost section of the inspection shaft. It appears that the forward side is now being restrained by the concrete slab, but the other side of the shaft is still under pressure from the roots and the distortion and cracking is particularly severe in the rear left hand corner near the base of the shrub. The cover frame is heavy duty so has not distorted, which makes the damage less obvious than it might otherwise be.

6. The viburnum is mature, but healthy and capable of some more growth, so the problem will worsen if it is left. Pruning can address indirect clay shrinkage problems, but is not effective where the problem is due to direct pressure from the main roots of the tree or shrub. The upper section of the shaft would need to be rebuilt and the cover base refitted, which would inevitably involve major damage to the shrub. It is unlikely to survive that, so the only practical option is to remove it.
