## HERITAGE STATEMENT

### 64 Delancy Street

Camden NW1 7RY

February 2019

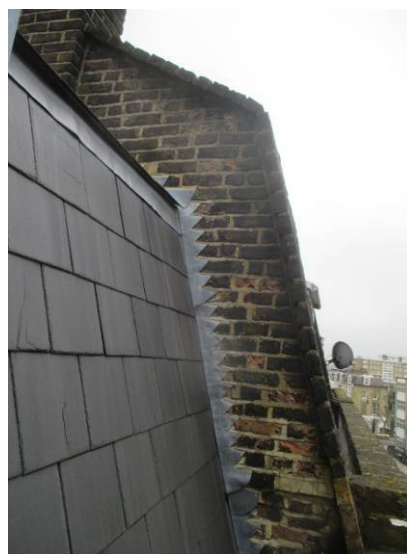
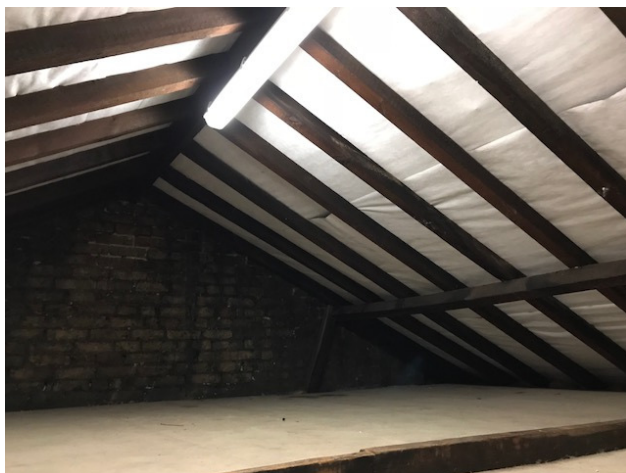
Roof interior

generally in good condition as it appears to have been completely replaced in the refurbishment.

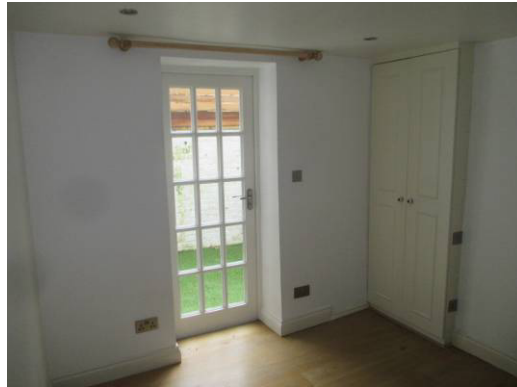
Rear bedroom

The basement has no retained features. The recent refurbishment included new kitchen and bathroom, with door to rear area. The steps from the rear area have been covered over with decking.

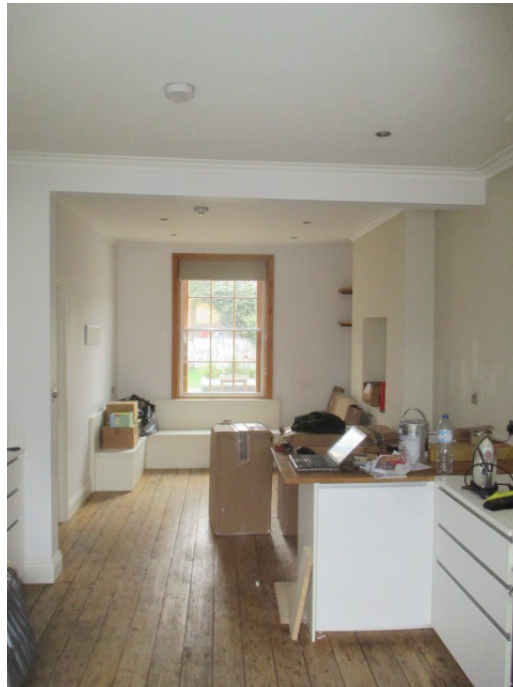
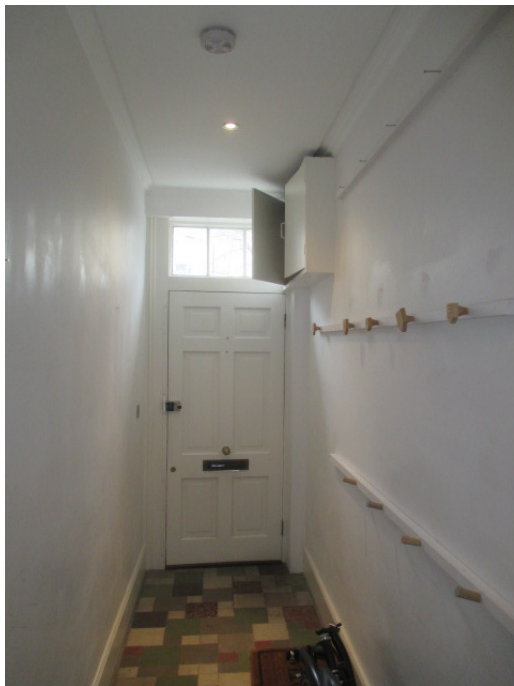
Hall

The first floor has been stripped of the fireplaces with new radiators. Original ceiling roses and cornices have been removed with new cornices. Modern downlights have been installed. A new kitchen and joinery has been installed. The windows have modern secondary glazing. Windows and doors have been stripped of paint.
