Wheatsheaf Yard

Structural Appraisal of Front Façade to 50c Red Lion Street

Document: 1742.R03.P1
Date: 10.06.2019

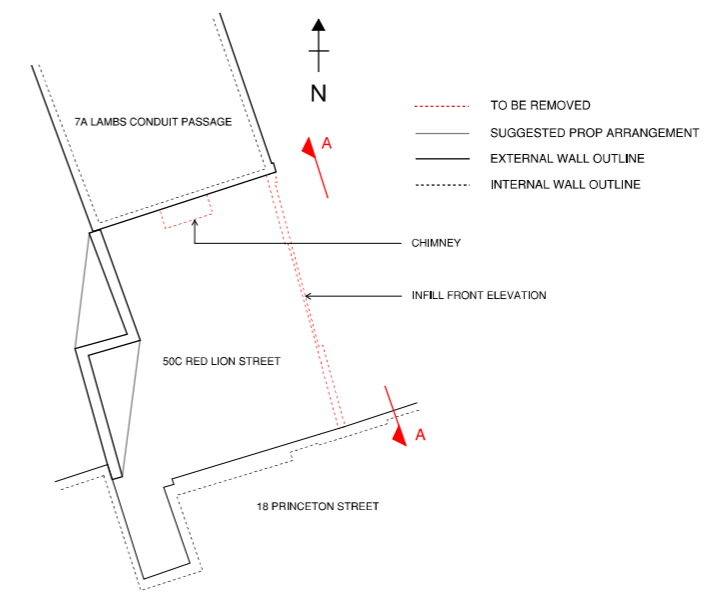
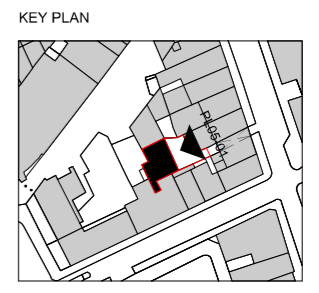
Appendix A – Structure Workshop drawing 1742.SK05.I1 highlighting all structural defects

David Kohn Architects (DKA) drawing 218-PL02-01 shows a 300mm thick masonry wall to the north side of 50c Red Lion Street (see 'Site Schematic Plan' on 1742.SK05), the 300mm thick wall is likely to resemble the original external wall to 7a Lambs Conduit Passage. The masonry wall to the front façade of 50c Red Lion Street is stack bonded to the south wall of 7a Lambs Conduit Passage with a vertical joint (see figure 4a). Large cracks can be seen in the spandrel panel near the junction of these two walls that would suggest the wall to 50c Red Lion Street has pulled away from 7a Lambs Conduit Passage (see figure 7). Similarly, large cracks can be seen internally where the two walls meet at ground floor level (see figure 4a). The same bonded junction exists between the front wall and 18 Princeton Street (see figure 4b). Based on this information, we believe it reasonable to assume the current rear and front walls to 50c Red Lion Street were constructed after both 7a Lambs Conduit Passage and 18 Princeton Street were complete.
