# Subsidence Report

## For Westways

**12 Greville Road, London, NW6 5JA**

<b>Insured:</b>	TBC
<b>Insurer:</b>	TBC
<b>Our Reference:</b>	02929Rv2
<b>Client Ref:</b>	NA
<b>Consultant:</b>	Keiron Hart (BSc Hons, C.Env, F.Arbor.A, MICFor, MEWI)
<b>Report Date:</b>	18.7.2019

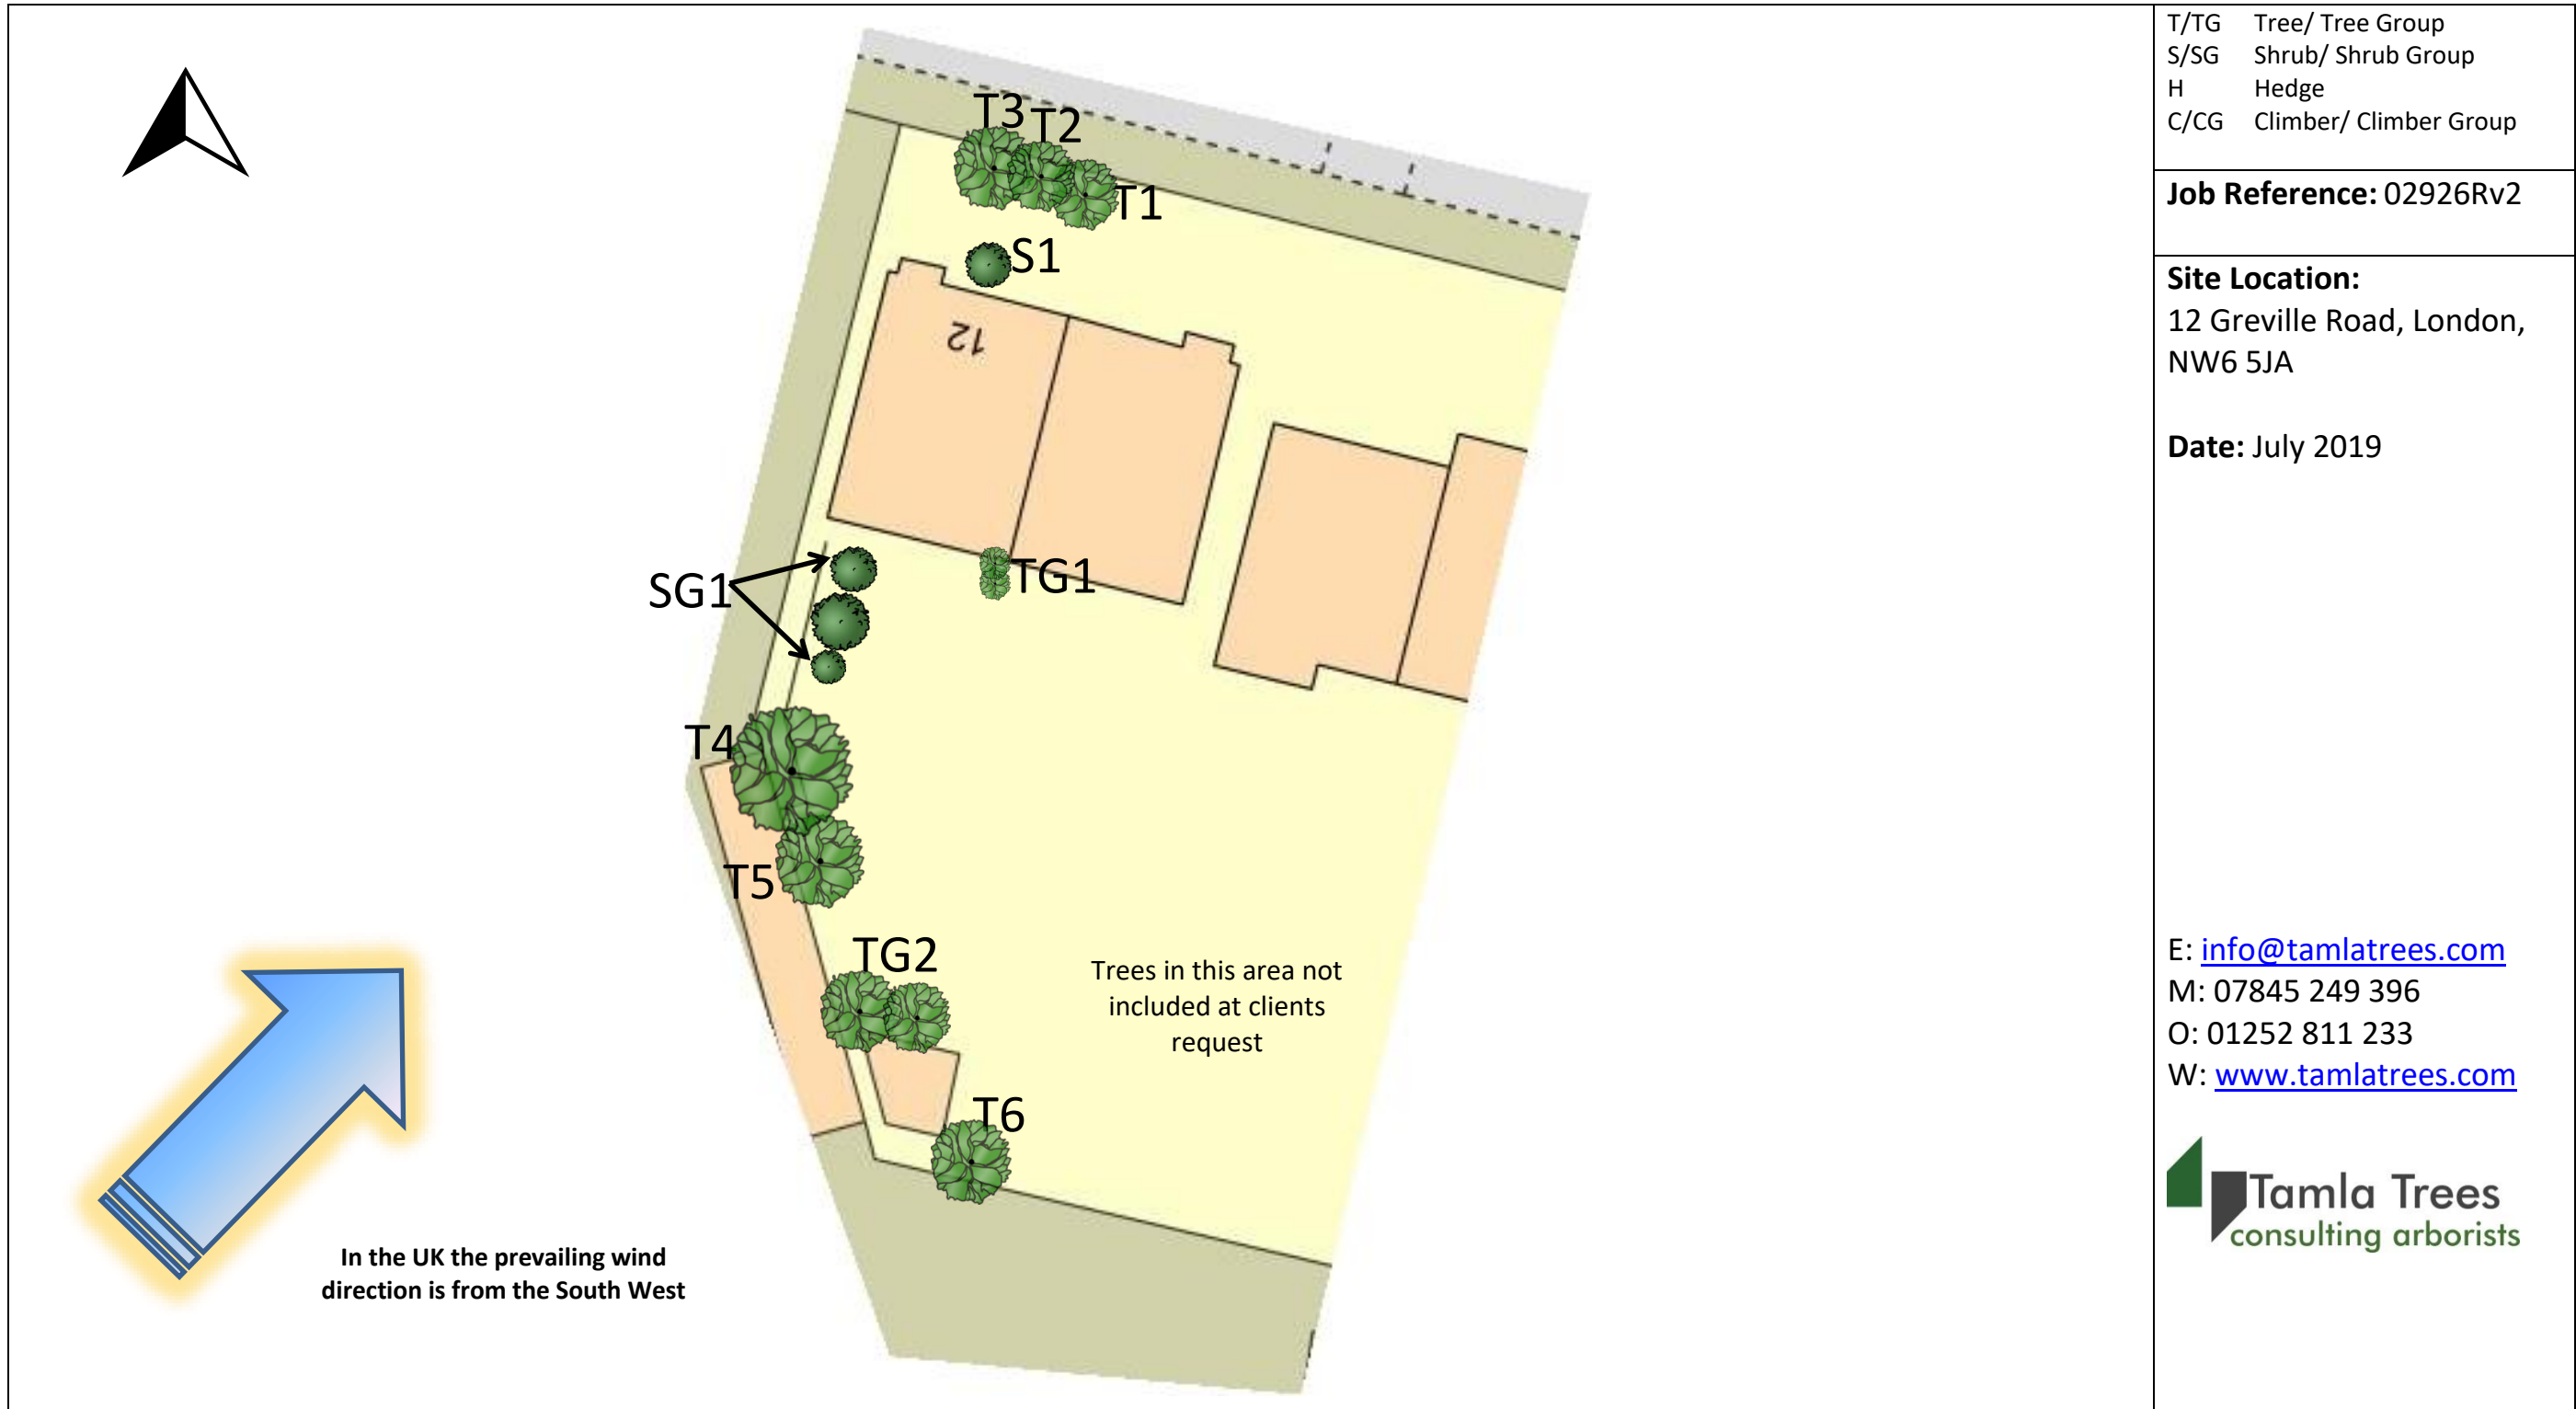
7. Site Plan

It should also be noted that the presence of a Conservation Area means notification for tree works to T3 & T4 would be required. In our experience without evidence to demonstrate their role in any movement there is a real risk that a notification seeking to remove T4 (Lime) would result in a TPO being served on this tree.

It is noted that the pruning works to T4 (Lime) and implementation of cyclical management to trees T1 – T3, & T5 have not been initiated following advice in 2018. These recommendations remain.

TG1 (Ash) has been reduced but we would recommend complete removal given location and proximity to the building.

To aid future inspections we would recommend the removal of undergrowth from around the base of T4 & T5 (Lime).
