12-22 Theobalds Road
London WC1X 8PF

**Heritage Assessment
of the 3rd Floor Ceilings**

July 2019

12-18 Theobalds Road Offices – 3rd Floor

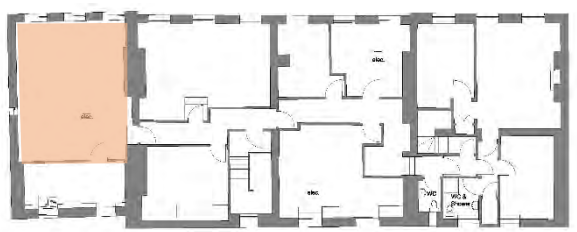
No 12

- **Roof rafters and boards:** modern fabric (95%) + historic (5%)
- **Primary ceiling beams:** historic (100%)
- **Ceiling joists:** historic (80%) + modern repairs; replacements; missing joists (20%)
- **Ceiling finish:** modern plasterboard (100%) – removed

Modern repairs and missing joists

Primary ceiling beams to be retained

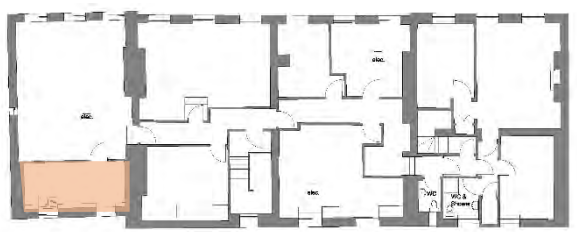
No 12

- **Roof rafters and boards:** modern fabric (95%) + historic (5%)
- **Primary ceiling beams:** historic (100%)
- **Ceiling joists:** historic (50%) + modern repairs; replacements; missing joists (50%)
- **Ceiling finish:** modern plasterboard (100%) – removed

Modern reinforcement for the water tank above and damage to historic fabric

Modern repairs and missing joists

Primary ceiling beams to be retained

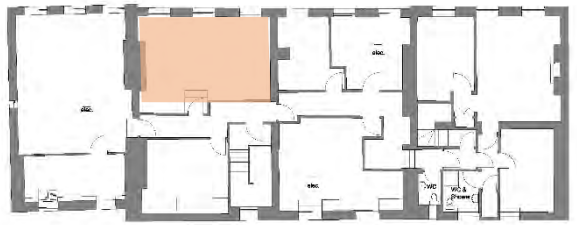
No 14

- **Roof rafters and boards:** modern fabric (95%) + historic (5%)
- **Primary ceiling beams:** historic (100%)
- **Ceiling joists:** historic (70%) + modern repairs/insert; replacements; missing joists (30%)
- **Ceiling finish:** modern plasterboard (100%) – removed

Modern insert/damage to historic joists and missing joists

Primary ceiling beams to be retained

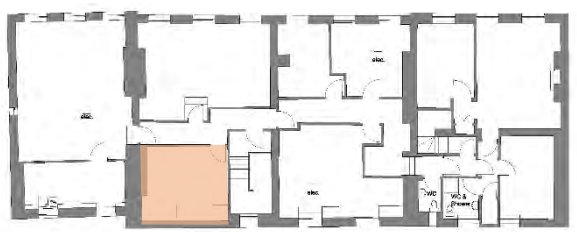
No 14

- **Roof rafters and boards:** modern fabric (95%) + historic (5%)
- **Primary ceiling beams:** historic (50%) + modern replacement (50%)
- **Ceiling joists:** historic (50%) + modern repairs/insert; replacements; missing joists (50%)
- **Ceiling finish:** modern plasterboard (100%) – removed

Primary ceiling beams – modern replacements

Modern damage to historic joists and missing joists

Primary ceiling beams - historic

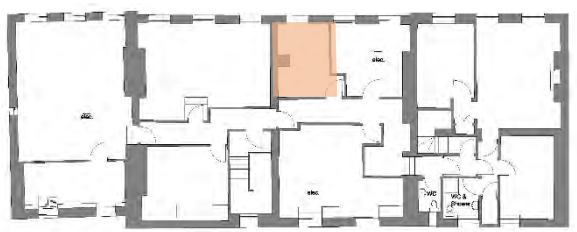
No 16

- **Roof rafters and boards:** modern fabric (95%) + historic (5%)
- **Primary ceiling beams:** historic (100%)
- **Ceiling joists:** historic (60%) + modern repairs/insert; replacements; missing joists (40%)
- **Ceiling finish:** modern plasterboard (100%) – removed

Modern reinforcement steel beams for the water tank above and damage to historic fabric

Modern repairs and missing joists

Primary ceiling beams to be retained

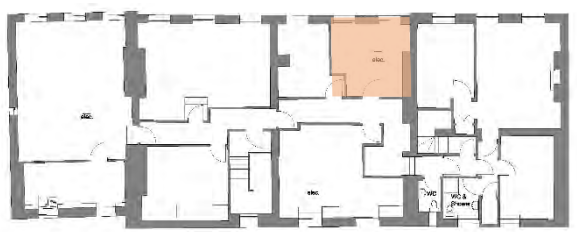
No 16

- **Roof rafters and boards:** modern fabric (95%) + historic (5%)
- **Primary ceiling beams:** historic (100%)
- **Ceiling joists:** historic (60%) + modern repairs/insert; replacements; missing joists (40%)
- **Ceiling finish:** modern plasterboard (100%) – removed

Modern reinforcement steel beams for the water tank above and damage to historic fabric

Modern damage and missing joists

Primary ceiling beams to be retained

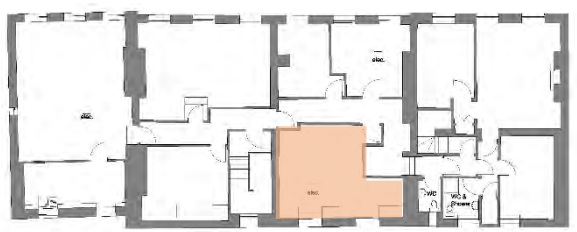
No 16

- **Roof rafters and boards:** modern fabric (95%) + historic (5%)
- **Primary ceiling beams:** historic (95%) + modern replacement (5%)
- **Ceiling joists:** historic (50%) + modern repairs/insert; replacements; missing joists (50%)
- **Ceiling finish:** modern plasterboard (100%) – removed

Modern reinforcement for the boarding/walkway above and damage to historic fabric

Primary ceiling beam – modern replacement

Primary ceiling beams to be retained

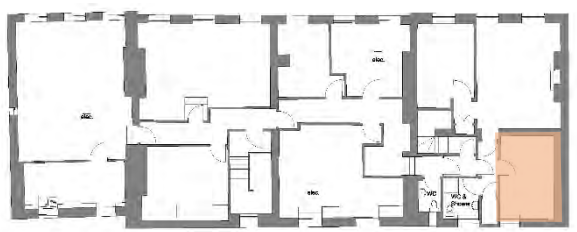
No 18

- **Roof rafters and boards:** modern fabric (95%) + historic (5%)
- **Primary ceiling beams:** historic (100%)
- **Ceiling joists:** historic (20%) + modern repairs/insert; replacements; missing joists (80%)
- **Ceiling finish:** modern plasterboard (100%) – removed

Modern damage and missing joists

Ceiling joists – modern replacement

Primary ceiling beams to be retained and repaired as needed

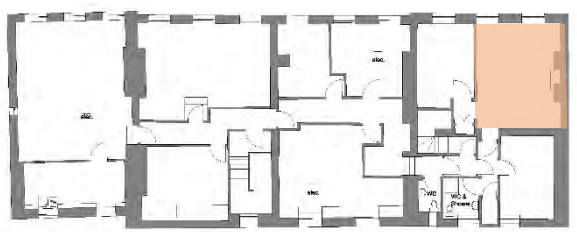
No 18

- **Roof rafters and boards:** modern fabric (95%) + historic (5%)
- **Primary ceiling beams:** historic (100%)
- **Ceiling joists:** historic (90%) + modern repairs/insert; replacements; missing joists (10%)
- **Ceiling finish:** modern plasterboard (100%) – removed

Ceiling joists – modern replacement

Primary ceiling beams to be retained

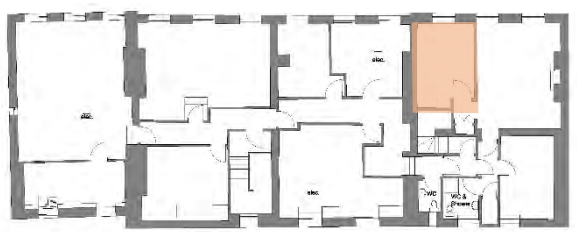
No 18

- **Roof rafters and boards:** modern fabric (95%) + historic (5%)
- **Primary ceiling beams:** historic (100%)
- **Ceiling joists:** modern replacements (100%)
- **Ceiling finish:** modern plasterboard (100%) – removed

Ceiling joists – modern replacement

Primary ceiling beams to be retained

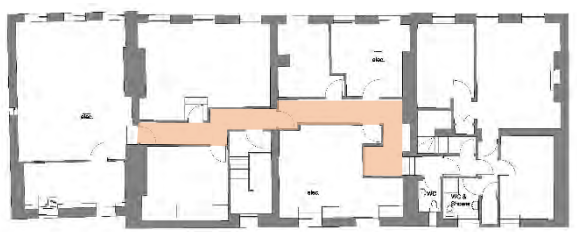
- **Roof rafters and boards:** modern fabric (95%) + historic (5%)
- **Primary ceiling beams:** historic (90%) + modern repairs/inserts (10%)
- **Ceiling joists:** historic (50%) + modern repairs/insert; replacements; missing joists (50%)
- **Ceiling finish:** modern plasterboard (100%) – removed

Primary ceiling beams to be retained and repaired as needed

Valley beam to be retained and repaired as needed

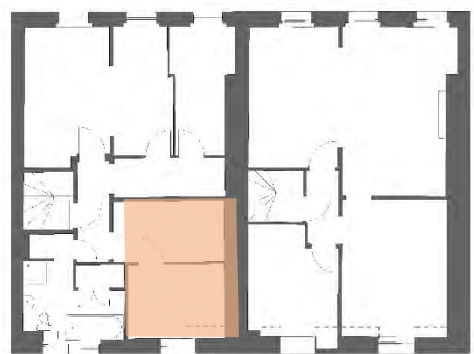
No 20

- **Roof rafters and boards:** modern fabric (95%) + historic (5%)
- **Primary ceiling beams:** historic (100%)
- **Ceiling joists:** historic (100%)
- **Ceiling finish:** modern plasterboard (100%) – removed

Primary ceiling beams to be retained

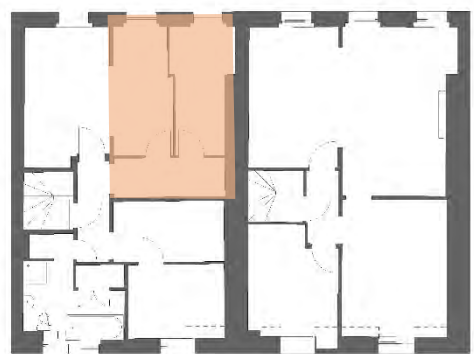
No 20

- **Roof rafters and boards:** modern fabric (95%) + historic (5%)
- **Primary ceiling beams:** historic (100%)
- **Ceiling joists:** historic (90%) + modern repairs/insert; replacements; missing joists (10%)
- **Ceiling finish:** modern plasterboard (100%) – removed

Modern repairs and services above the ceiling

Primary ceiling beams to be retained

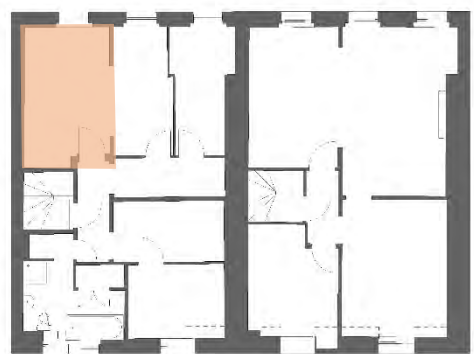
No 20

- **Roof rafters and boards:** modern fabric (95%) + historic (5%)
- **Primary ceiling beams:** historic (100%)
- **Ceiling joists:** historic (80%) + modern repairs/insert; replacements; missing joists (20%)
- **Ceiling finish:** modern plasterboard (100%) – removed

Modern repairs/missing joists and services above the ceiling

Primary ceiling beams to be retained

Ceiling joists to be removed

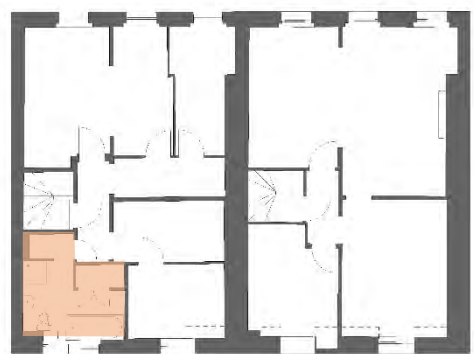
No 20

- **Roof rafters and boards:** modern fabric (95%) + historic (5%)
- **Primary ceiling beams:** historic (100%)
- **Ceiling joists:** historic (90%) + modern repairs/insert; replacements; missing joists (10%)
- **Ceiling finish:** modern plasterboard (100%) – removed

Modern repairs/missing joists and services above the ceiling

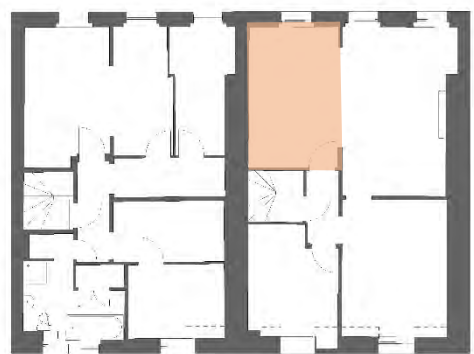
No 22

- **Roof rafters and boards:** modern fabric (95%) + historic (5%)
- **Primary ceiling beams:** historic (100%)
- **Ceiling joists:** historic (90%) + modern repairs/insert; replacements; missing joists (10%)
- **Ceiling finish:** modern plasterboard (100%) – removed

Modern reinforcement/addition for the water tanks above caused damage to historic fabric

Primary ceiling beams to be replaced due to structural damage – see Structural Investigation of Roof Structure by GDC Partnership

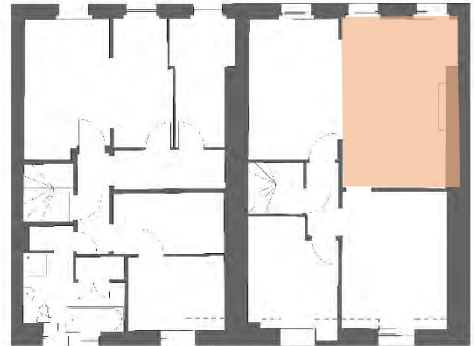
No 22

- **Roof rafters and boards:** modern fabric (95%) + historic (5%)
- **Primary ceiling beams:** historic (100%)
- **Ceiling joists:** historic (90%) + modern repairs/insert; replacements; missing joists (10%)
- **Ceiling finish:** modern plasterboard (100%) – removed

Modern repairs/replacements

Modern reinforcement/addition for the water tanks above caused damage to historic fabric

Ceiling joists to be removed

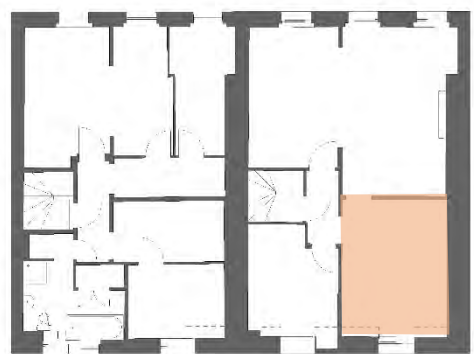
No 22

- **Roof rafters and boards:** modern fabric (95%) + historic (5%)
- **Primary ceiling beams:** historic (100%)
- **Ceiling joists:** historic (90%) + modern repairs/insert; replacements; missing joists (10%)
- **Ceiling finish:** modern plasterboard (100%) – removed

Modern reinforcement/addition for the water tanks above caused damage to historic fabric

Primary ceiling beams to be retained

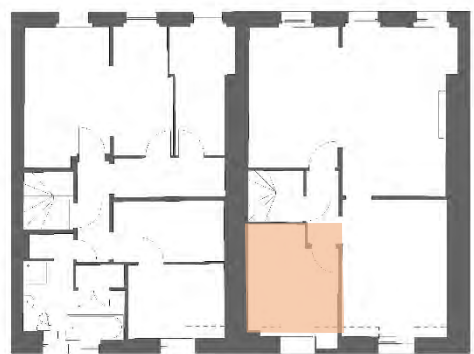
No 22

- **Roof rafters and boards:** modern fabric (95%) + historic (5%)
- **Primary ceiling beams:** historic (100%)
- **Ceiling joists:** historic (60%) + modern repairs/insert; replacements; missing joists (40%)
- **Ceiling finish:** modern plasterboard (100%) – removed

Modern repairs/replacements and missing joists

Primary ceiling beams to be retained
