**Status:** Interim Report  
**Date:** 27/07/2018  
**Revision:** A  
**Job no:** 1444  
**Prepared by:** Harry Johnston  
**Approved by:** James Morgan

HTS undertook a site visit on the 12th June 2018 to inspect the steel truss which supports the dome and the western roof of Koko night club. The truss was found to have suffered from severe corrosion which was possibly caused by water ingress over the life of the building.

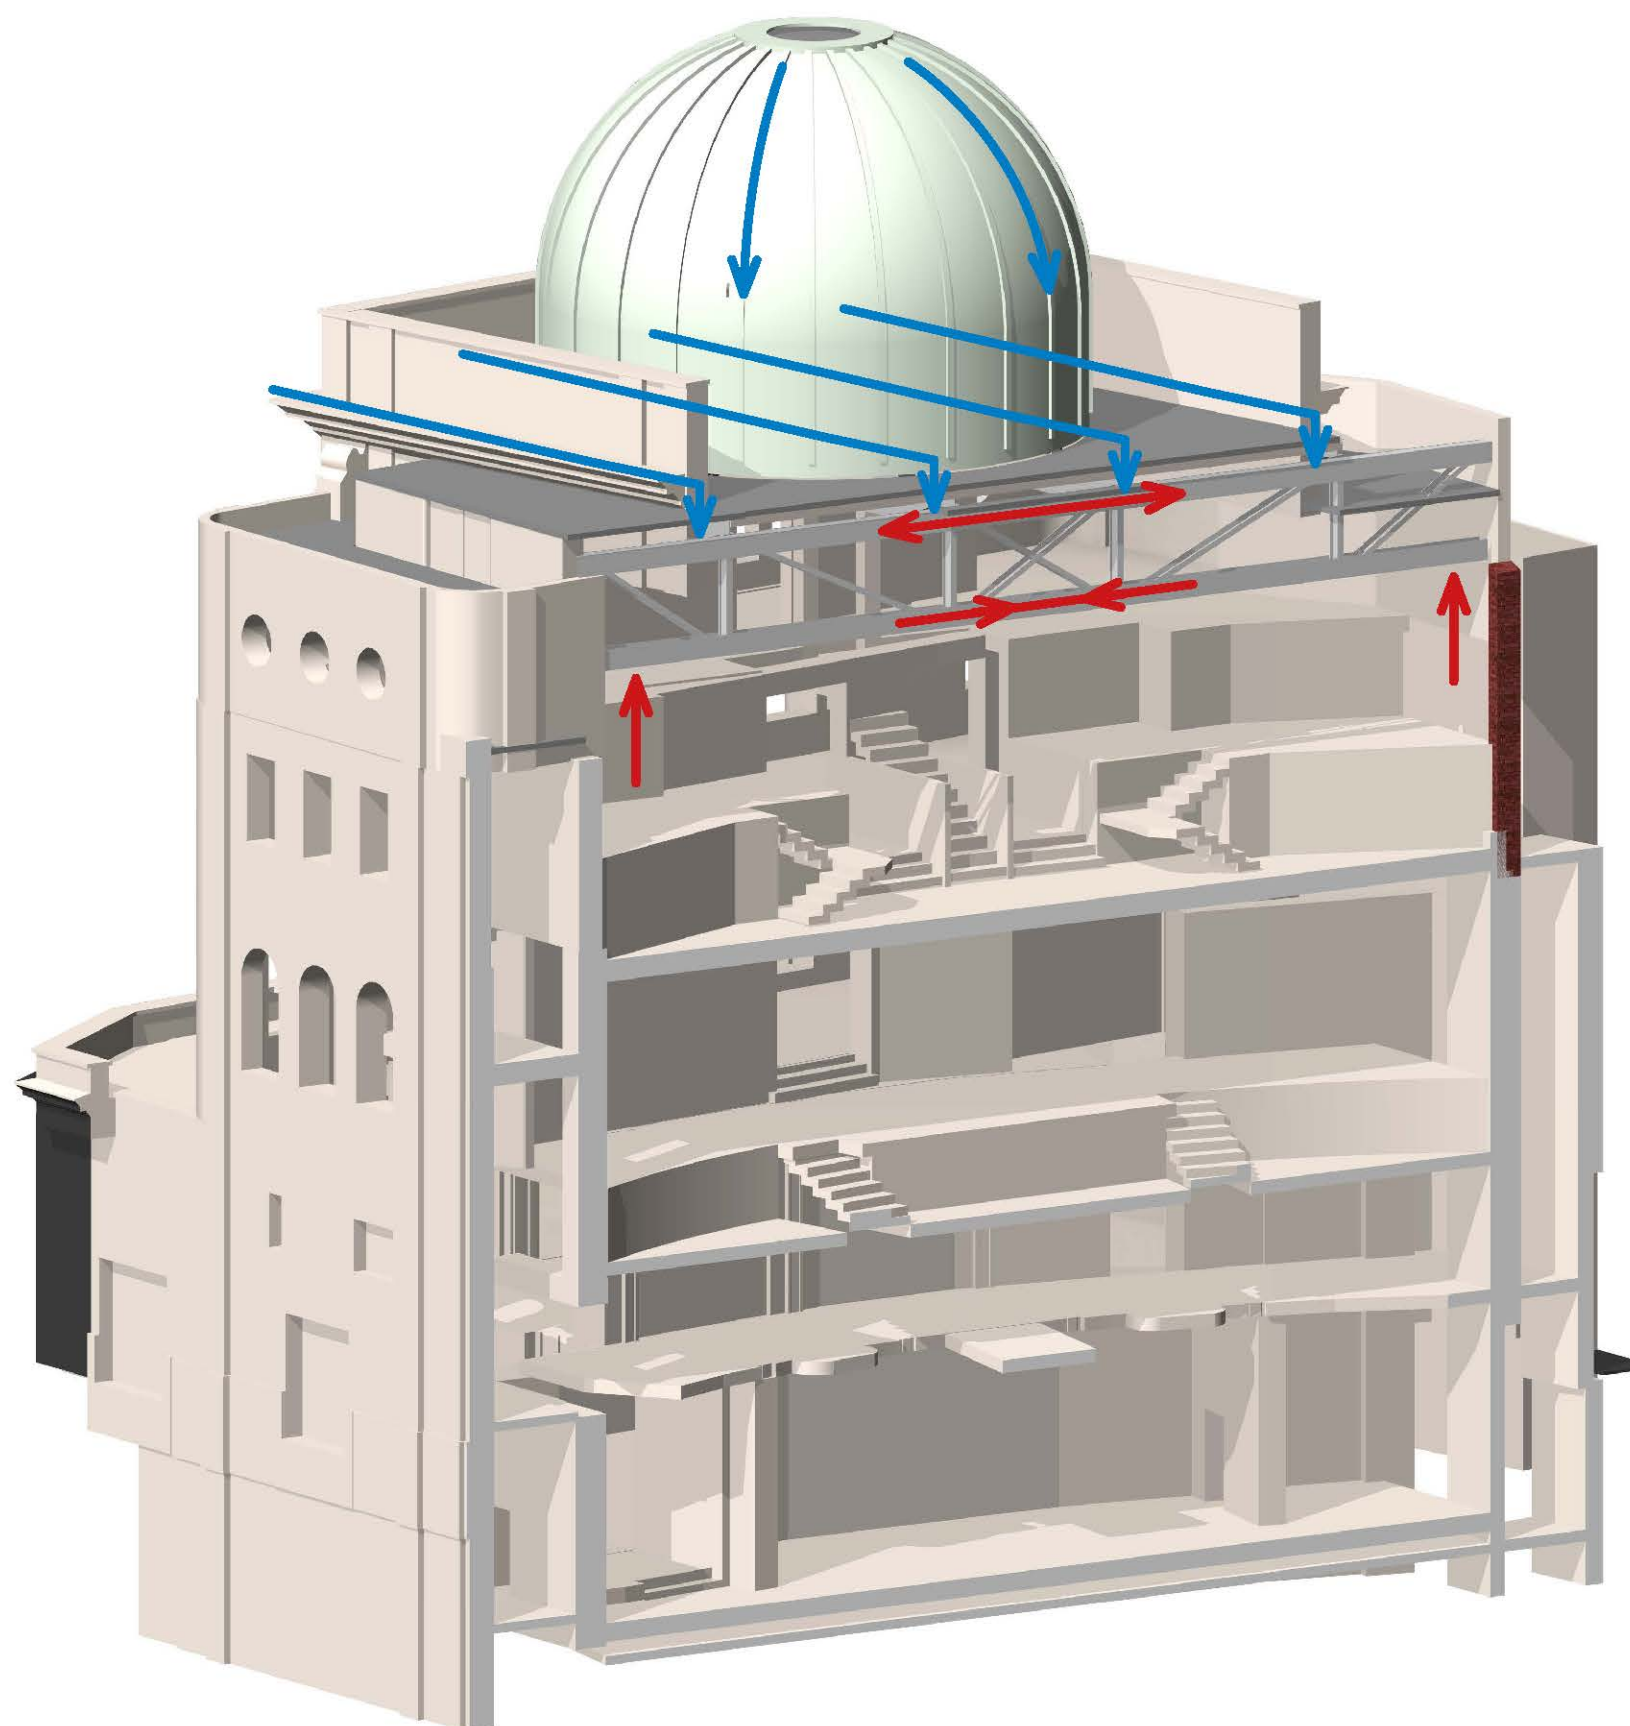
The existing truss member consists of rolled steel sections riveted together to form a 2.5m deep element with a clear span of 18m across the rear of the auditorium.

The truss is assumed to be supported by the north and south masonry walls of the auditorium. Opening up has not yet been done to expose the bearing condition.

The truss supports the western roof above the entrance to Koko, the copper clad dome and a strip of sloped filler joist slab to the plant roof.

The entrance roof appears to be formed of filler joist slab spanning north-south onto four fabricated steel beams and the masonry walls of the auditorium. The domed roof appears to be supported directly on the steel beams and roof slab. Parapets at roof level appear to be formed of 2m tall masonry supported on the steel beams. The four steel beams appear to be supported on the vertical elements of the truss.
