99 South End Road  
LONDON NW3 2RJ

PRE-PLANNING ENQUIRY

SIDE EXTENSION ROOF  
EXISTING SITUATION

ER-001

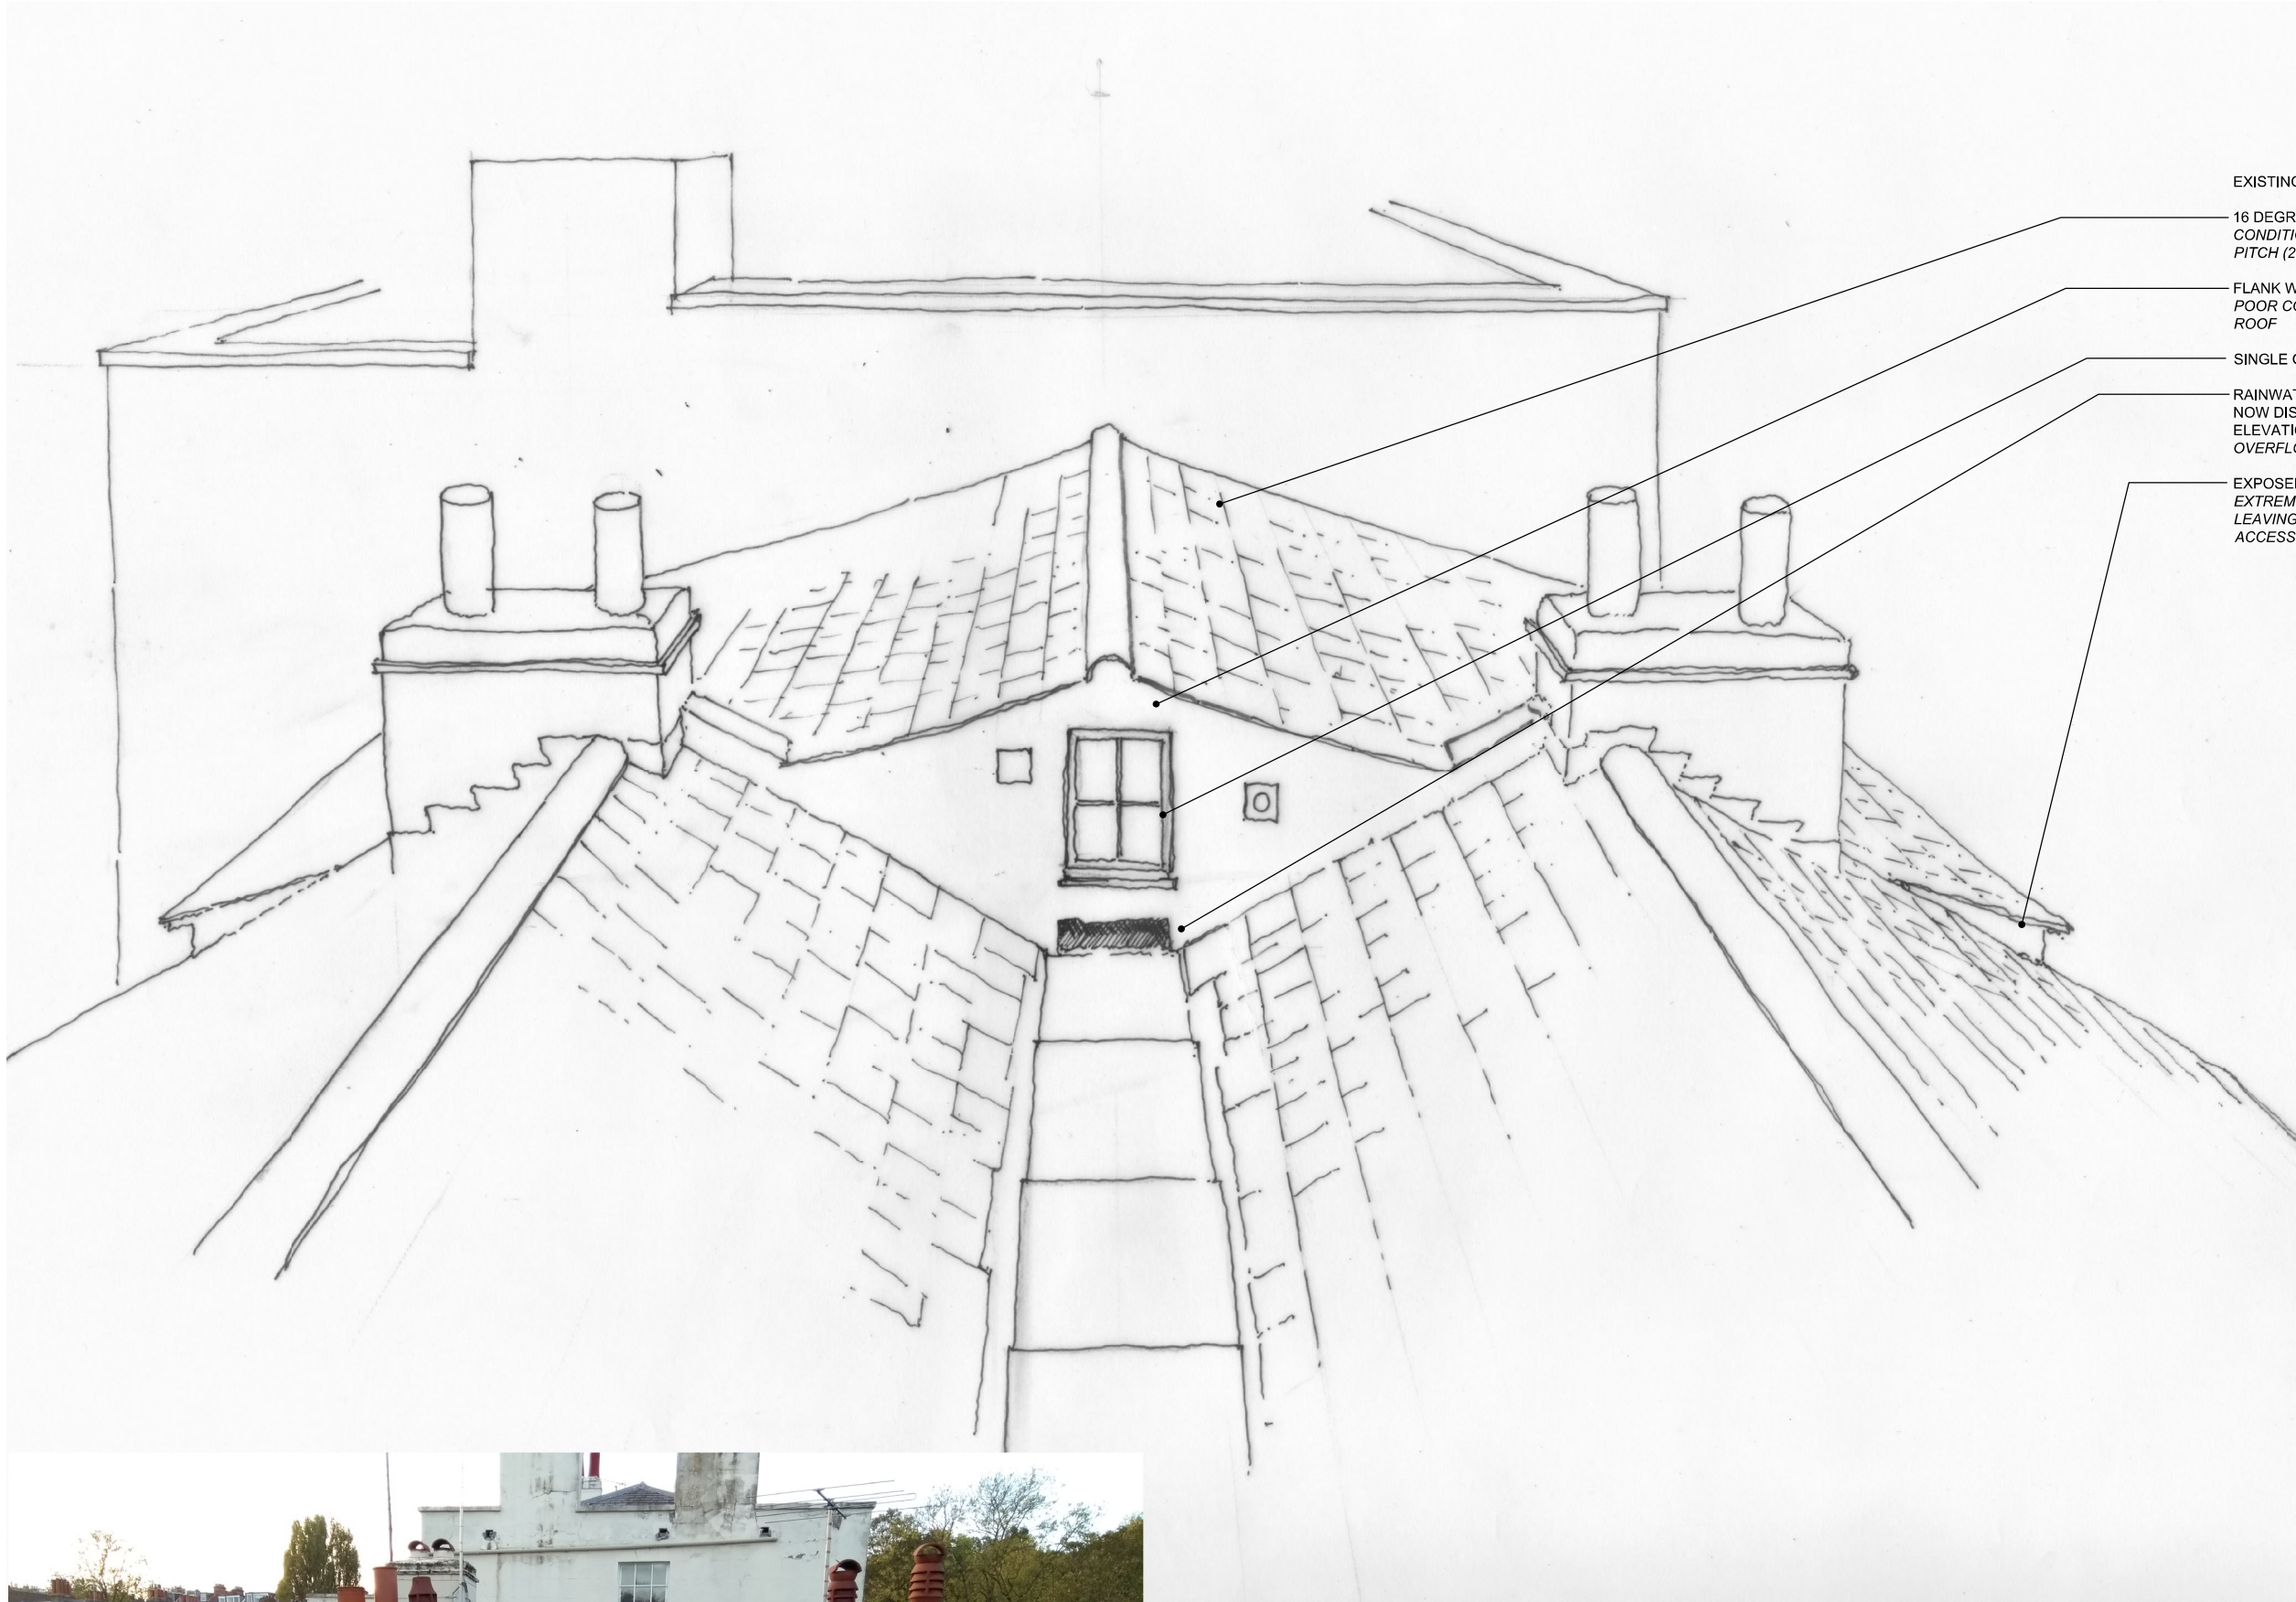
EXISTING ROOF TO SIDE EXTENSION:  
16 DEGREE PITCH SLATE ROOF ON TIMBER RAFTERS - NO INSULATION - POOR CONDITION, TIMBERS UNDERSIZED AND ROOF SAGGING, SLATE ROOF INADEQUATE PITCH (20 DEGREE MIN RECOMMENDED) - "JERRY BUILT"  
FLANK WALL CONSTRUCTED OFF ORIGINAL PARAPET WALL, RENDERED FINISH - POOR CONDITION, WATER INGRESS DUE TO INADEQUATE VERGE DETAIL TO SLATE ROOF  
SINGLE GLAZED TIMBER CASEMENT WINDOW - ROTTEN, REQUIRES REPLACEMENT  
RAINWATER OUTLET - ORIGINALLY FROM BEFORE SIDE EXTENSION - RAINWATER NOW DISCHARGES TO OPEN LEADED HOPPER INTERNALLY, THENCE TO REAR ELEVATION VIA OPEN CHANNEL DRAIN - DIFFICULT TO MAINTAIN WITH NO POSSIBLE OVERFLOW OTHER THAN INSIDE BUILDING  
EXPOSED FLANK TO EXTENSION ROOF WITH AD HOC LEAD AND RENDER FINISH - EXTREMELY POORLY CONCEIVED WITH DIFFERENT ROOF PITCHES CLASHING AND LEAVING VIRTUALLY IMPOSSIBLE WEATHERING DETAILS IN VERY DIFFICULT TO ACCESS LOCATIONS
