28th November 2017

Veteran Oak tree in Rear Garden of 7 Wedderburn Road

My November inspection of the tree

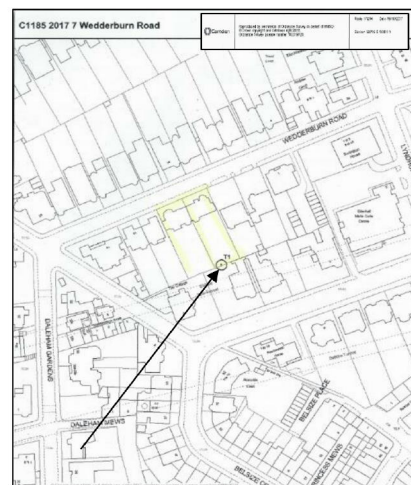
Fig. 2: TPO schedule map showing T1

The tree currently poses little risk of serious harm to Nos 7 and 9 Wedderburn Road (to west) where it is surrounded by gardens with characteristically low levels of use. On plan, T1 appears to be just within height range of the dwelling at 3 Lyndhurst Gardens (Figs 1 and 2). But this is in the context of a crown that has already been significantly reduced by past pruning with some upper die back (see Fig 3a). The tree also appears to have a slight weight bias to the north away from the property to the south. I conclude that the tree poses a low risk to its surroundings³ and that advised remedial pruning to invigorate the tree (see Management Recommendations) would serve to further reduce the current low level of risk.

The OS map shows the Belsize New Tunnel passing within some 10 m from the oak (Fig 2, Camden TPO accompanying map, 26/10/2017). This major construction in 1880 involved major ground changes close to the tree, which took place within twenty years of the construction of the original Belsize tunnel⁵, itself some 70 m distance from the oak tree.
