# **Historic Building Condition Survey**

**Firemen's Cottages, West End Lane Fire Station  
West End Lane, West Hampstead, London**

Reference: 18442A

**August 2019**

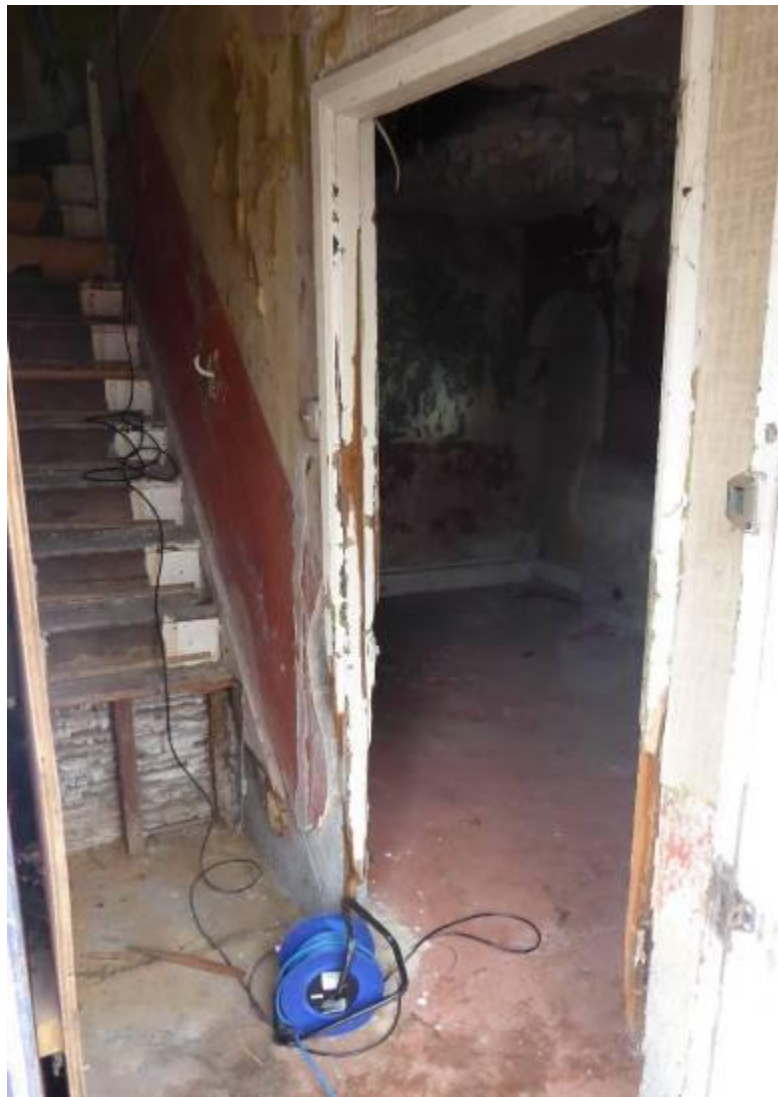
Fig 4.1: Entrance Lobby

- 4.1.1 This has a floor of concrete with granolithic type top.
- 4.1.2 The walls are all of solid construction where the internal face of the external wall is painted plaster on brickwork. The internal walls are of cast in situ concrete that has used timber boarding as formwork as indicated by casting marks that incorporated the stairs, so they were 'cast-in' at the time of building.
- 4.1.3 There was no indication of there having been a door at the bottom of the stairs to close them off.
- 4.1.4 The lining to the door to the sitting room is painted softwood with 10 mm stops and a simple ovolo architrave on both sides. The door was missing and was originally mounted on a pair of 75 mm steel butts.
- 4.1.5 The ceiling is a lath and plaster type that has been decorated.

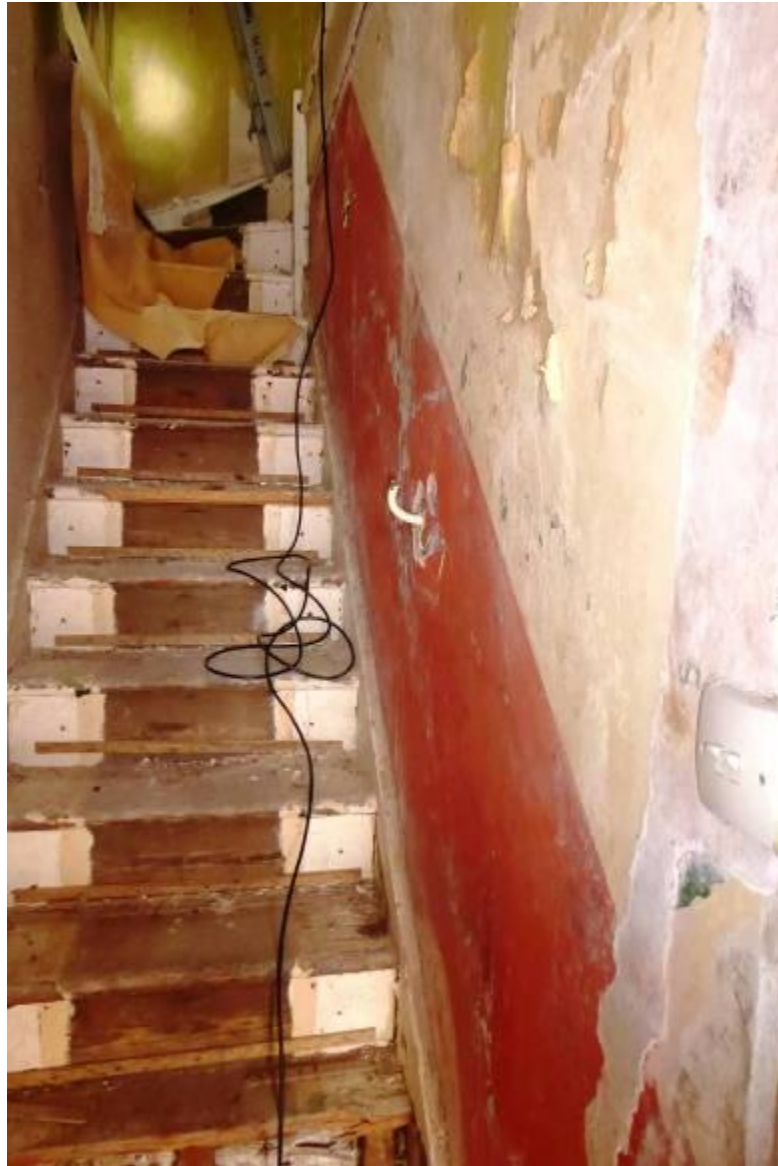
Fig 4.6: Ground to first floor stairs

- 4.6.1 These are a simple traditional string type staircase of softwood timber construction that run in a straight flight from the lobby at the base to a set of winders or tapered steps at the top where they turn onto the landing.
- 4.6.2 The walls are all of solid construction, generally as described previously including decoration. These have a red band along the base extending up to approximately 1.0 m above the top of the string line on the sitting room side.
- 4.6.3 The handrails are missing, but it could be seen where these were supported on traditional metal brackets. This would suggest that these were originally a timber handrail that stood off of the face of the wall.
- 4.6.4 The window is a heavy timber framed three light unit with a central metal opening light with fixed lights on either side.

- 4.6.5 The ceiling, where it extends from the entrance lobby space is as that previously described.

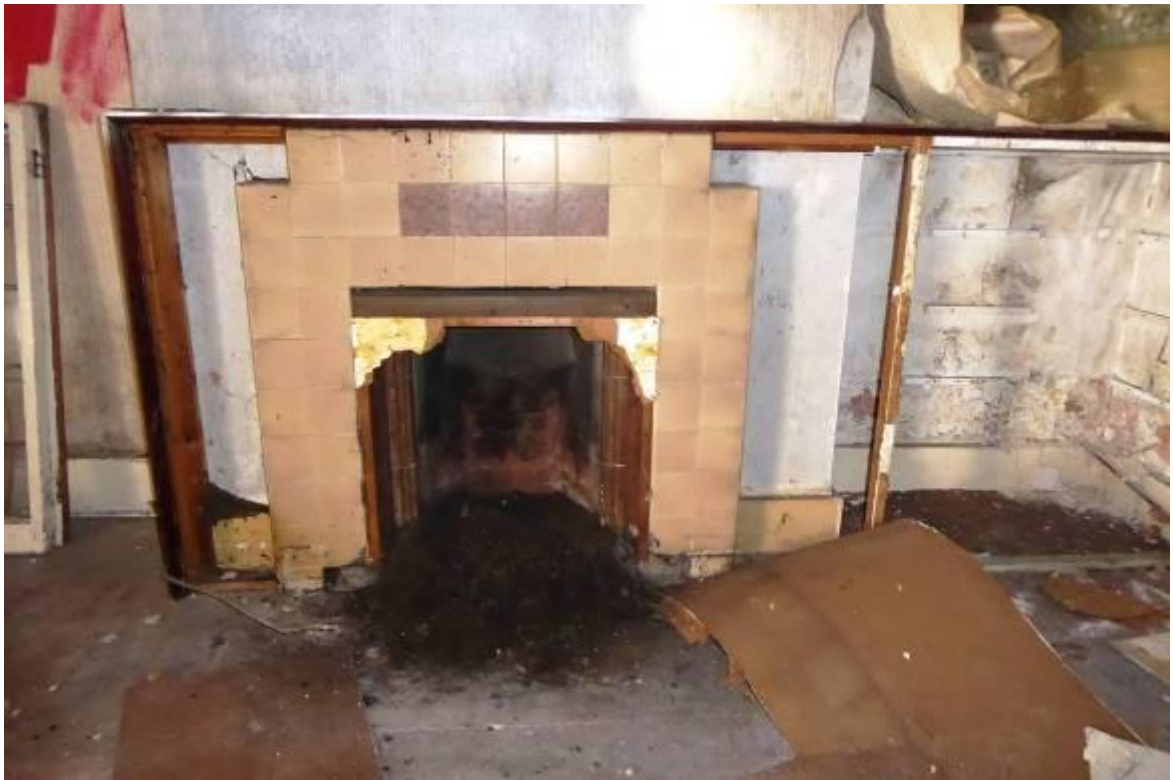
Fig 5.1.3: Sitting room fireplace

- 5.1.1 This is generally as described Cottage 4, but the staircase is more complete.
- 5.1.2 The four panel door from the entrance lobby to sitting room is possibly the original and which has been painted and faced on the entrance side with hardboard or similar, possibly to help make this more fire resistant. The panels on the back have had some form of textured coating applied to their face.
- 5.1.3 Within the sitting room the fireplace appears to date to the 1930s or possibly early 1950s as it has a glazed tile surround with an inner set of glazed tiling and a hearth that corresponds with the hearth seen in Cottage 4. This may be part of later refitting restyling at about this period.

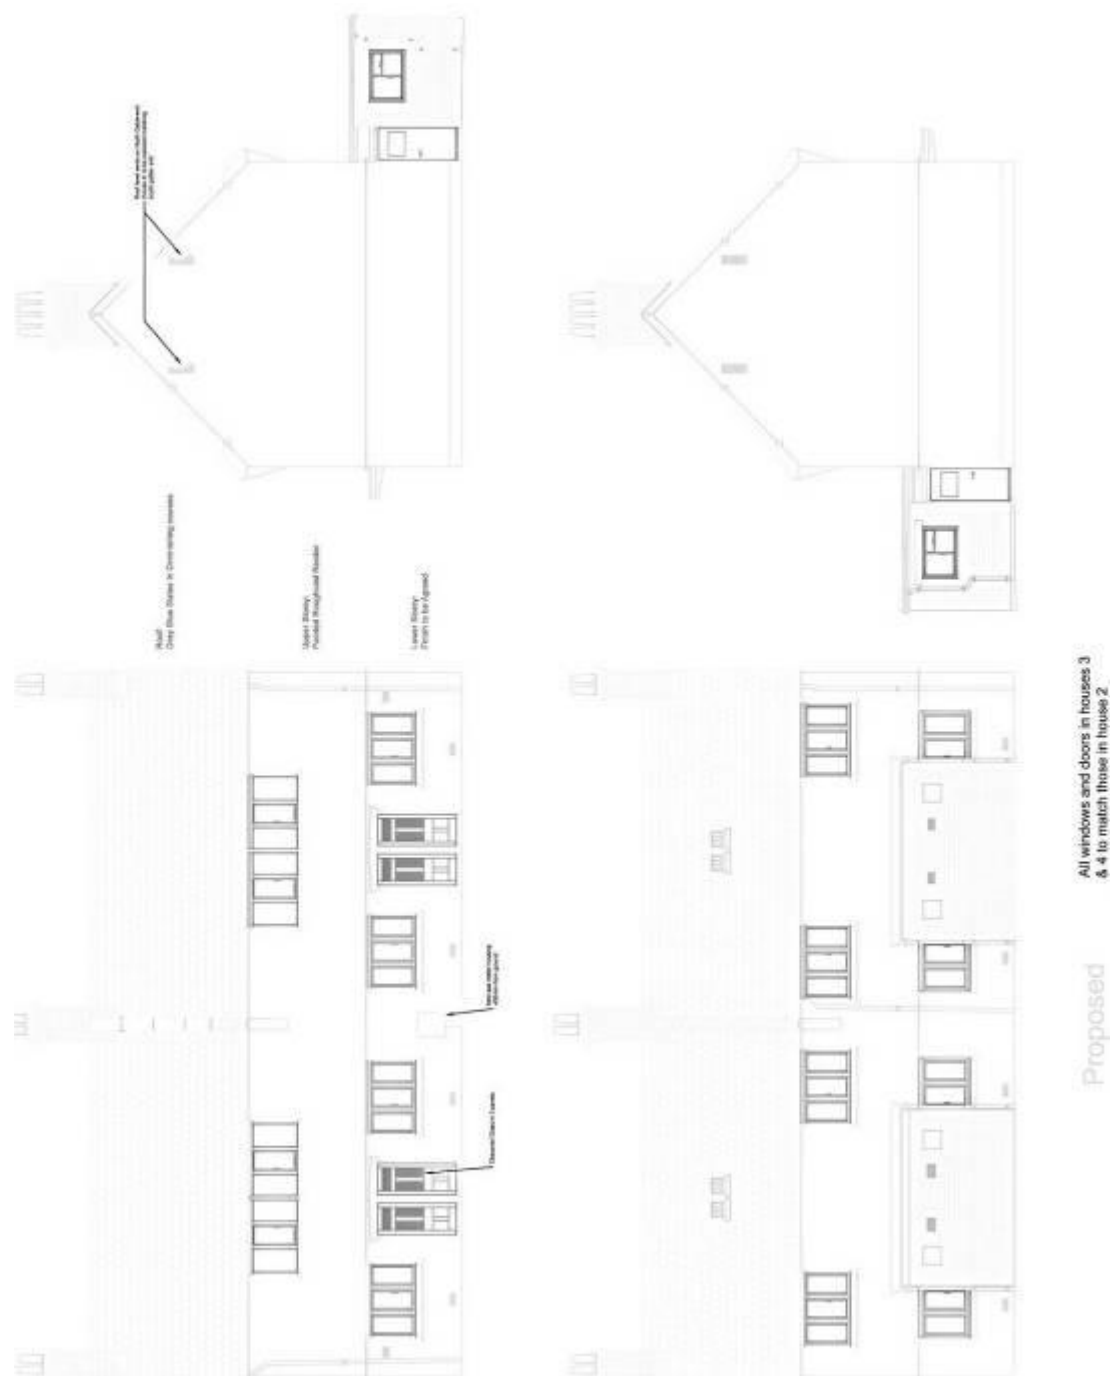
Fig 6.1: proposed external work

- 6.1.3 The external render to the lower section of the cottages has and is resulting in deterioration of the brickwork that it covers. This present material is to be removed and because of the severely deteriorated condition of the brickwork it is to be replaced with fully vapour permeable lime render with a smooth finish to contrast to the heavy textured finish above.

- 6.1.1 The primary aspect of the external work will be to restore the fenestration pattern around the building. This will create a unified appearance where all the windows are of a style and pattern that is appropriate for either the older part or the modern extensions.

- 6.1.2 The front doors to the cottages are to be restored to match the original form using what survives as templates for any replacement items that are required. The rear doors to the links to the extension are all modern joinery pieces that can readily be replaced on a like for like basis.

- 6.1.4 The roof covering over the rear extensions will be stripped and replaced with new matching coverings over new thermal insulation to be incorporated within the structure. At the same time the flashings to the rear walls of the cottages will be re-made and any necessary repairs implemented to the joinery at the eaves and ends.

- 6.1.5 Over the cottages the existing roof coverings to the main roof due to their poor state of repair is to be stripped and then recovered with the existing slates on battens to replicate the existing. Replacement slates where necessary will fully match the existing in size, texture and colour from the appropriate quarries.

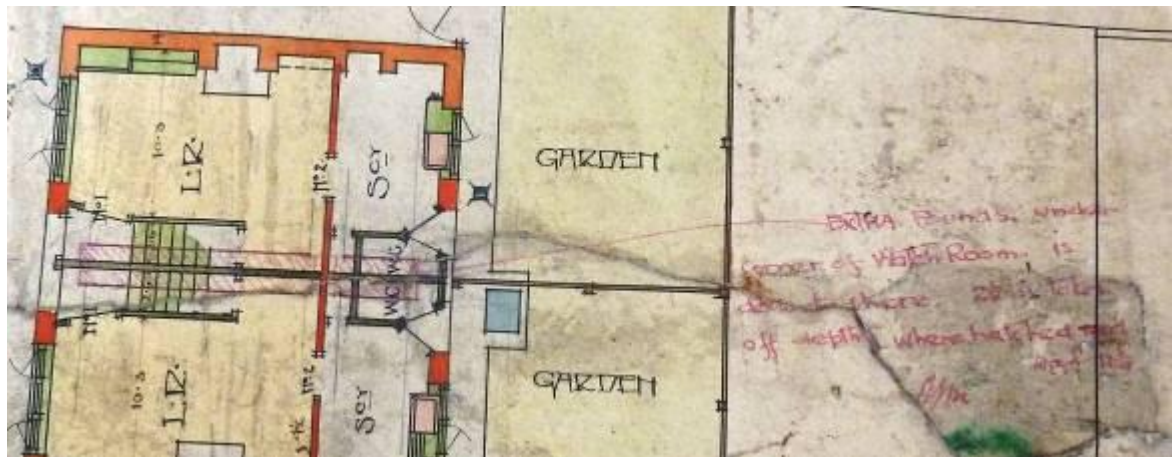
Fig 9.1.7: Highlighted note of reduced foundation concrete to dividing wall

- 9.1.7 During the construction of this site it appears that problems were encountered with the foundations under the corner of the watch room in the fire station. A note on the cottage plans show where the foundations under the wall between the two southern cottages were reduced to balance materials and costs for the project diverted elsewhere. As with many projects before and since cost over-runs have had detrimental impacts on buildings and so indicates that these were only ever seen as utilitarian structures rather than ones where money had to be lavished to ensure they were built to a high standard.

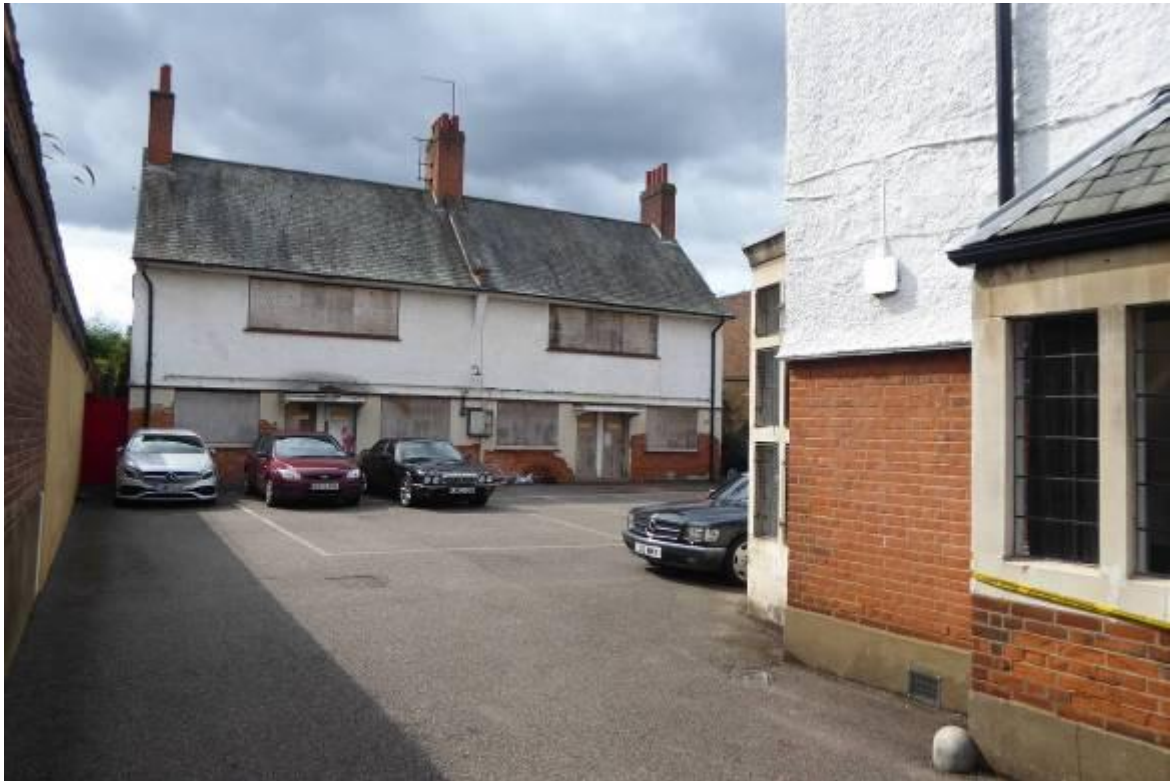
Fig 9.2.2: Cottage to rear of fire station from site entrance

- 9.2.2 The cottages were built as an adjunct to the fire station proper and were never considered as a separate development. They followed the design and appearance of the main building because it was undertaken by the same design team and that would have allowed for a commonality of construction methods and materials to be employed so as to achieve efficient and cost effective budgetary control of the project. That would indicate that their significance is their relationship to the front block.
