Schedule of Condition and Proposed Works

House No. 3
West Hampstead Cottages
West Hampstead Fire Station
325 West End Lane
London NW6 1RR

Dron & Wright

July 2019

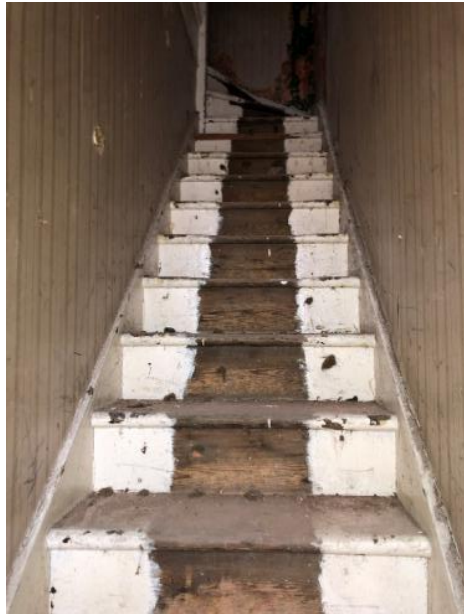
General view of staircase

The visible timber surfaces appear to be in fair condition with no visible defects.

- Retain timber staircase as existing.
- Redecorate exposed stair stringers with brush applied satinwood paint.
- Install new edge-fixed carpet floor coverings to staircase.
- Replace existing wall mounted timber handrail with new stained timber 'mopstick' handrail.

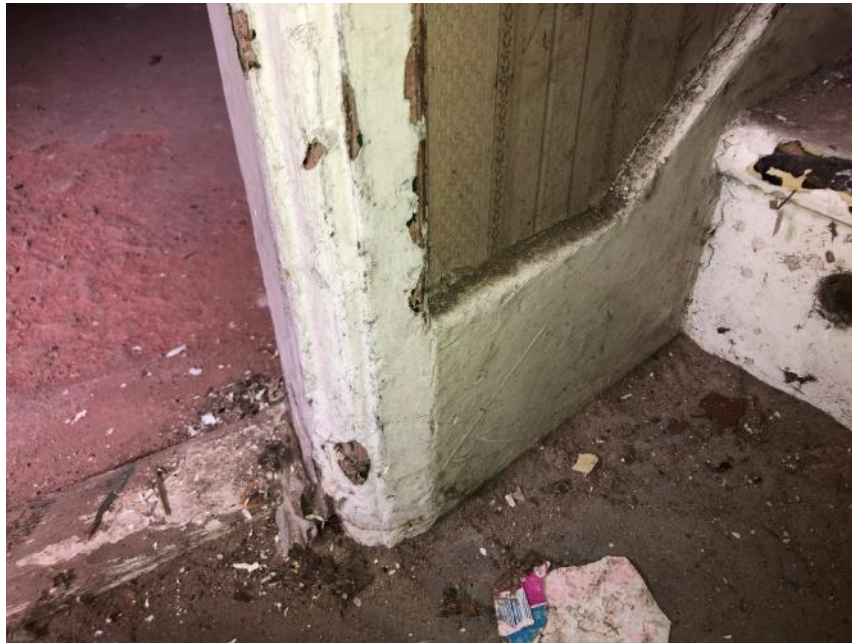
Typical view of hall skirting board

The decorated surfaces are discoloured and dirty throughout. The timber skirtings appear generally sound with minor areas of impact damage.

- Retain existing timber skirtings.
- Where missing, install new timber skirtings to match details and dimensions of the existing.
- Prepare all new and existing surfaces and decorate with new brush applied satinwood paint.

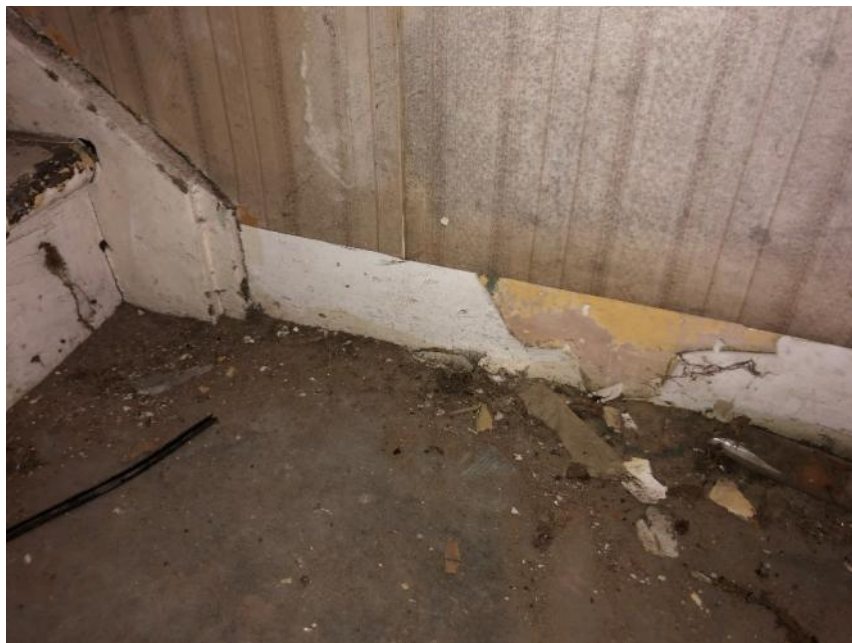
No skirtings fitted to north wall

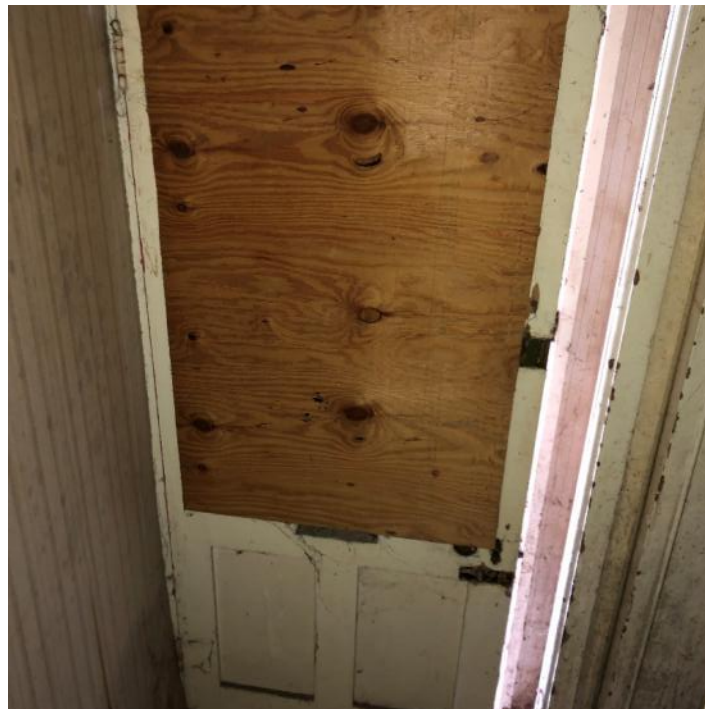
View of entrance main entrance door

The decorated surfaces are discoloured, damaged and in poor condition throughout. The timber surfaces appear to be in generally sound condition, although there are areas of surface damage and redundant fixing holes where door furniture has been removed.

- Remove timber boarding and assess condition of interior and exterior surfaces.
- Where defective timber surfaces are identified, carry out timber repairs as necessary to match the detail and dimensions of the existing.
- To glazed panels, install new obscured glazing with applied lead strips to external surface, as detailed in Appendix A.
- Prepare and redecorate all previously decorated surfaces; exterior surfaces to be decorated with brush applied exterior gloss paint and interior surfaces with brush applied satinwood paint.
- Install new interior and exterior ironmongery; ironmongery details to be confirmed.

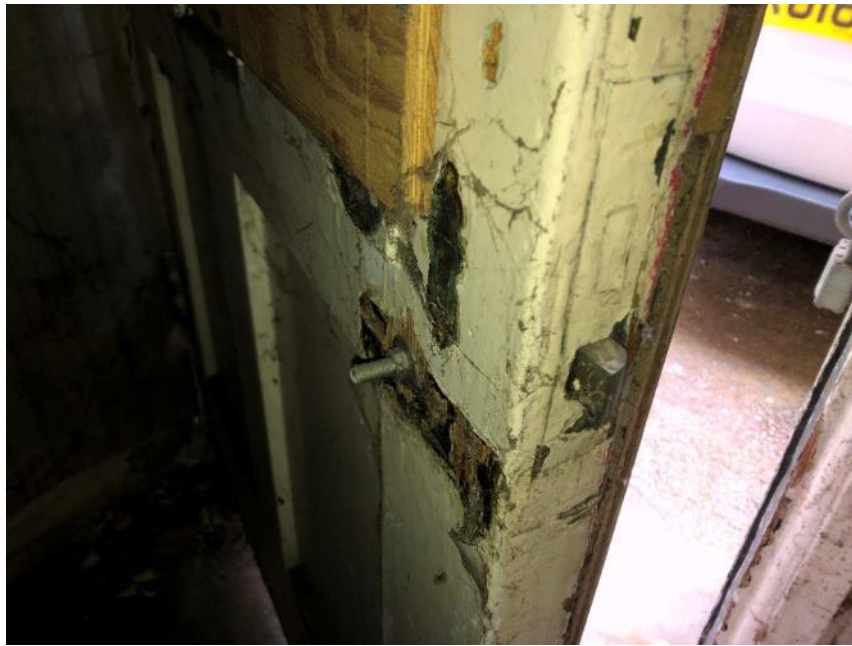
The door furniture has been removed leaving remnants of former fittings, as per the image below:

View of remaining interior ironmongery

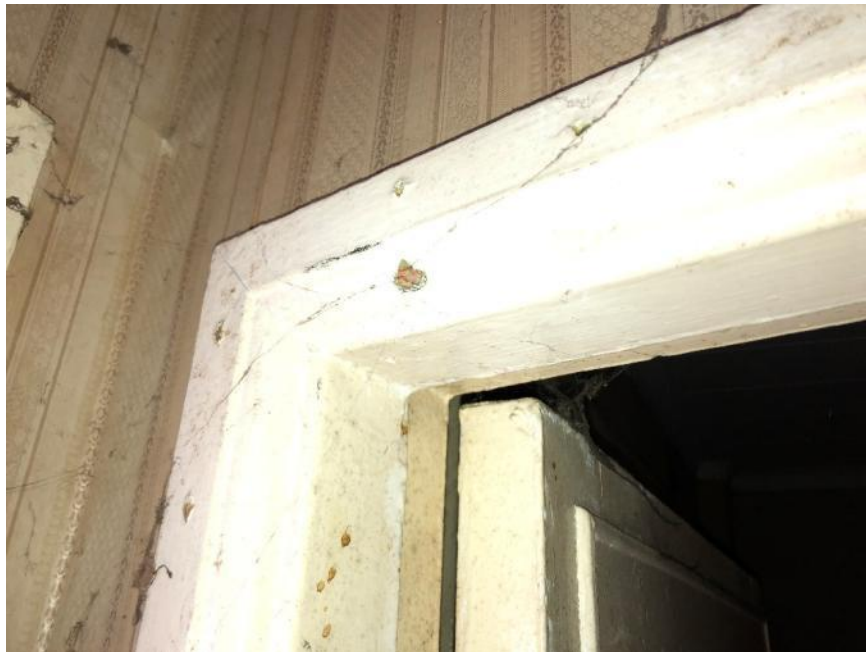
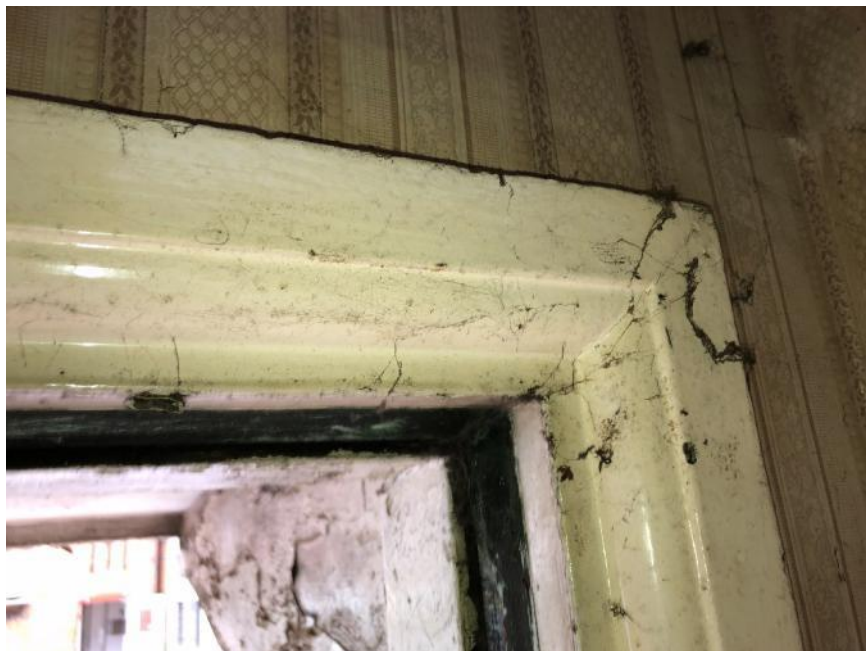
Living room door joinery detail

Main entrance door joinery detail

All timber surfaces appear to be in fair condition although the decorated are chipped and discoloured throughout.

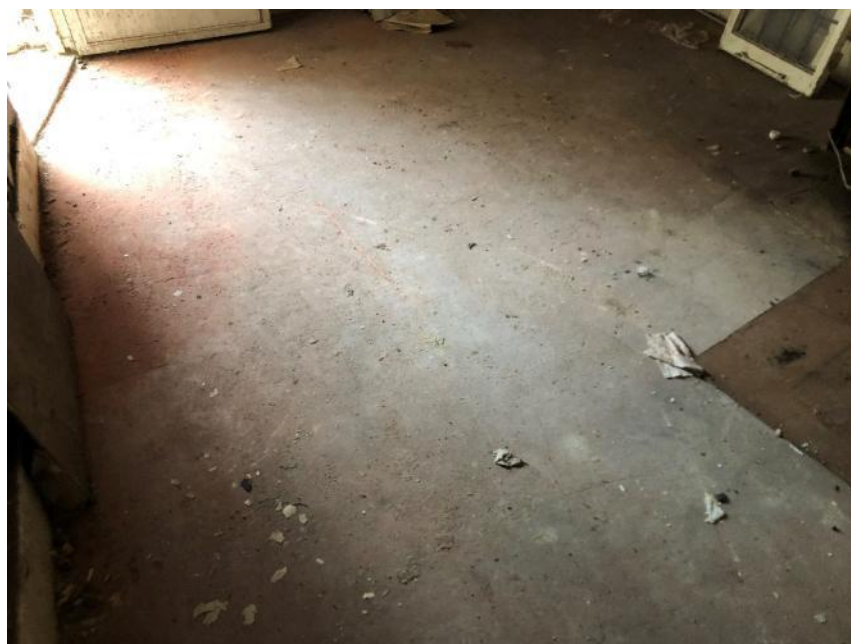
Living Room floor surface

There are localised areas of cracking to the screeded concrete surfaces alongside localised areas of surface abrasion as per the image below:

- Clear all surface dirt and debris.
- Once cleared, remove any loose and friable materials and repair as necessary to match existing,
- Install new edge-fixed carpet floor coverings throughout.

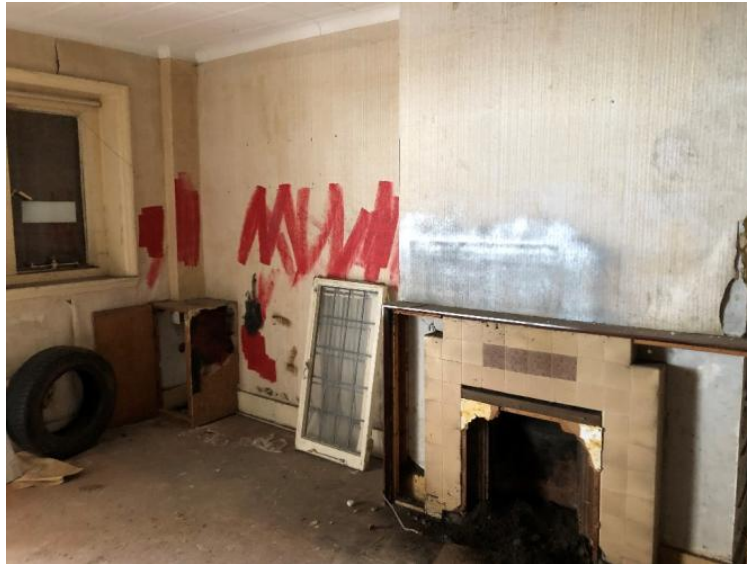
General view of Living Room walls

The wallpaper finishes are discoloured and stained throughout and appear to have been vandalised with graffiti in some areas as per the image below:

- All loose, friable and damp affected plaster surfaces are to be removed to a stable substrate. (The full extent of damaged plasterwork is to be assessed following removal of all decorative wall coverings).

- Where removed, plaster surfaces to be reinstated using non-hydraulic lime-based plaster applied to the level of the existing finishes.
 - All stable and un-damaged plasterwork will be retained.

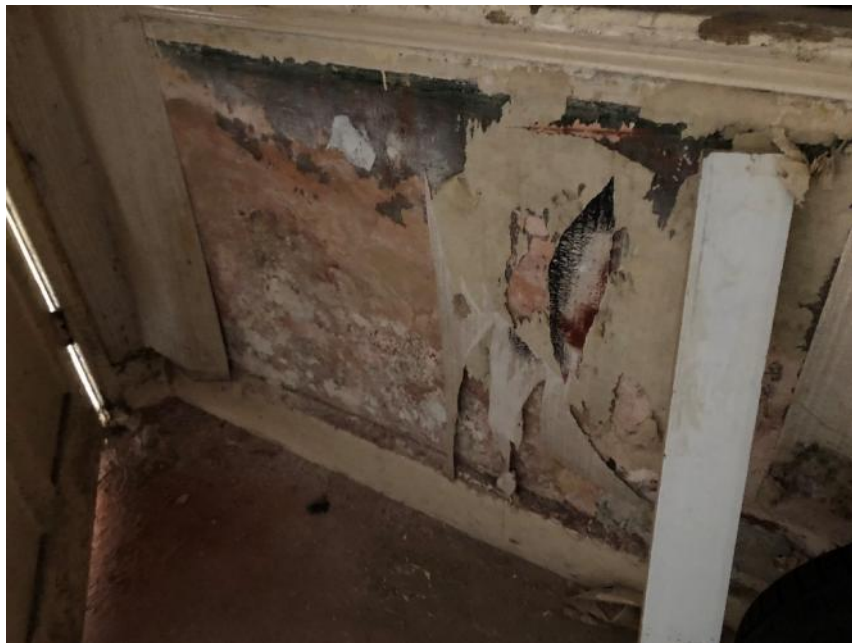
Damp affected wall surfaces to east wall

Damp affected surfaces are located between floor level and approximately 1.2 metres in height and extend to the east and south-west aspects of the room.

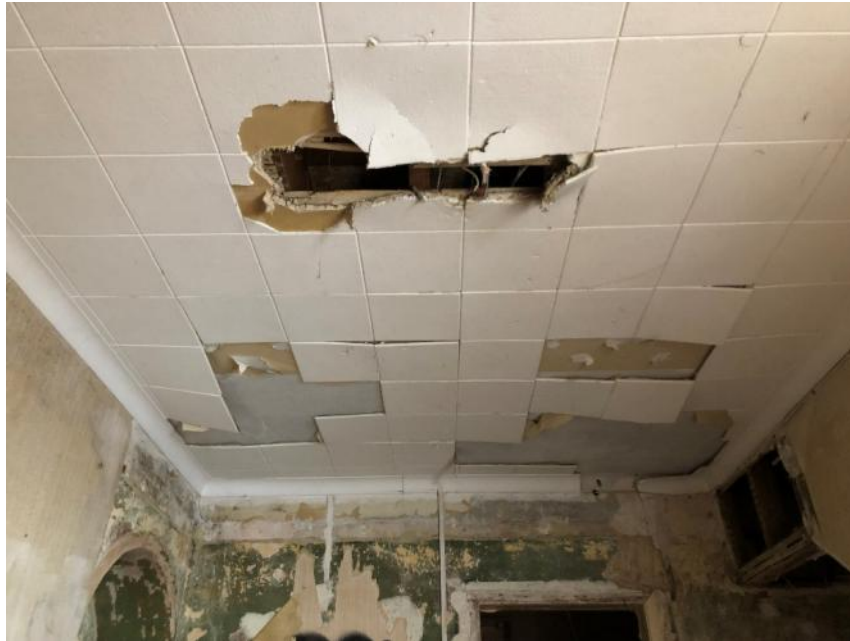
General view of Living Room ceiling

To the centre of the room is a damaged area of approximately 1 square metres in size. Here, the polystyrene tile finishes, plasterwork and underlying timber laths have been removed, exposing the underlying timber floor structure, as per the image below:

- Remove all modern plaster coving and polystyrene tile finishes and dispose.
- All loose or friable plaster surfaces are to be removed to a stable substrate. (The full extent of damaged plasterwork is to be assessed following removal of all decorative wall coverings),
- Where removed, all damp affected plaster surfaces to be reinstated using non-hydraulic lime-based plaster applied to the level of the existing finishes,
- Missing timber laths to be reinstated as part of this process
- All stable and un-damaged plasterwork will be retained,
- All new and existing plaster plasterwork to be decorated with emulsion paint.

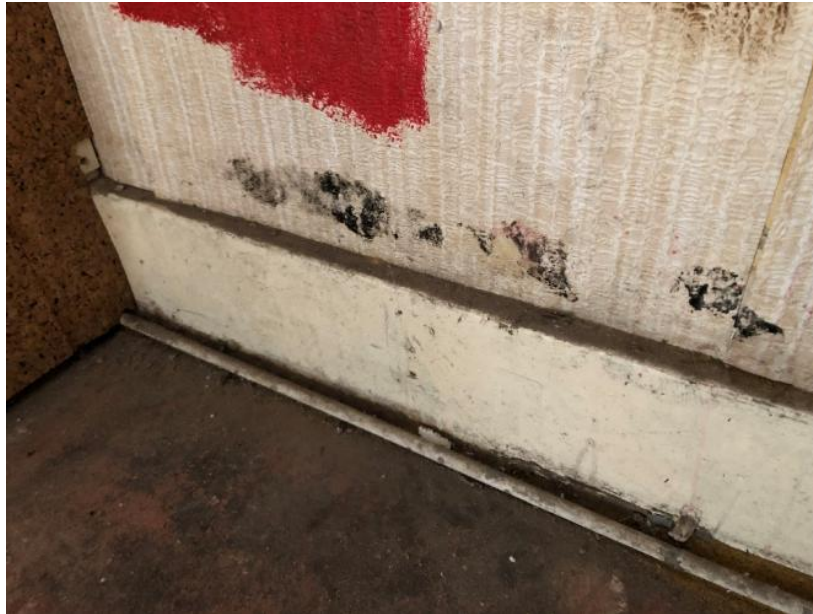
Typical view of Living Room skirting board

The decorated surfaces are discoloured and dirty throughout. The timber skirtings appear generally sound with minor areas of impact damage.

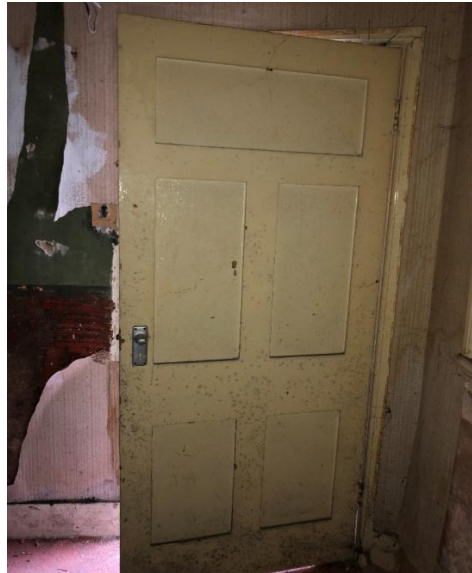
View of Living Room door

All timber surfaces appear sound and in fair condition although the decorations are stained and discoloured throughout. The stainless steel door furniture is damaged as per the image below:

- Remove remaining damaged door furniture and dispose.
- Remove overpanelling and dispose, making good underlying timber surfaces as necessary.
- Thoroughly prepare all timber surfaces and redecorate with brush applied satinwood paint.
- Install new door furniture – details to be confirmed.

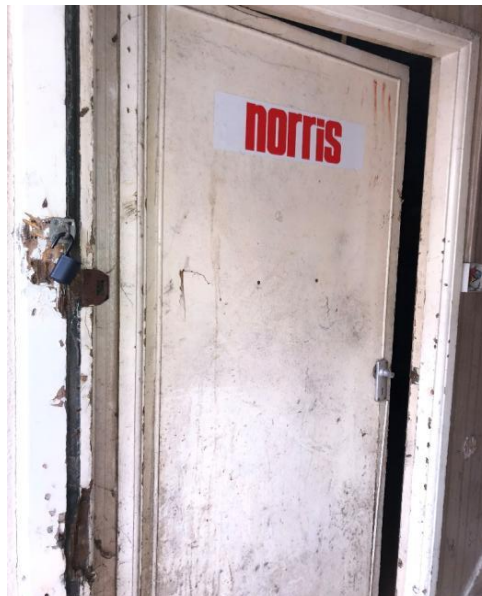
Overboarding to external face of door

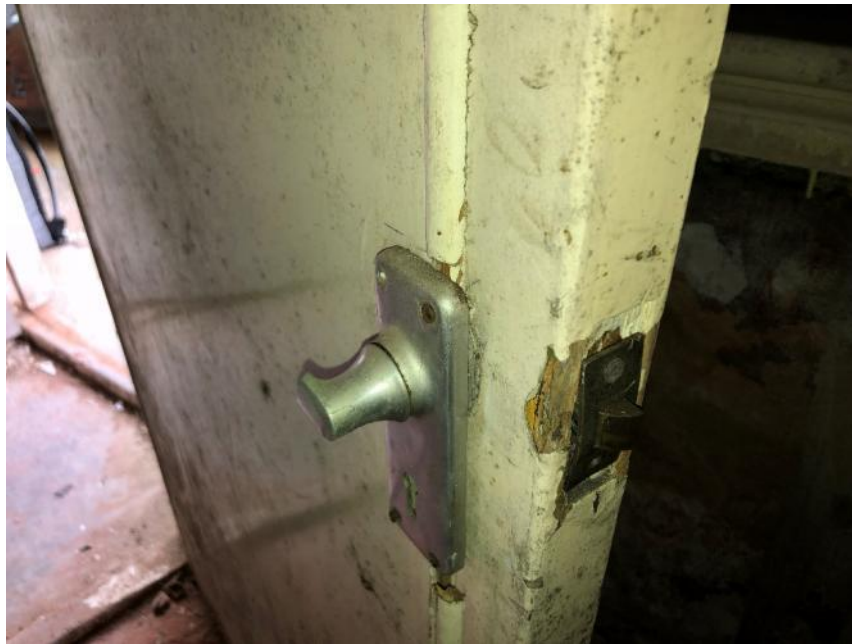
Existing door furniture

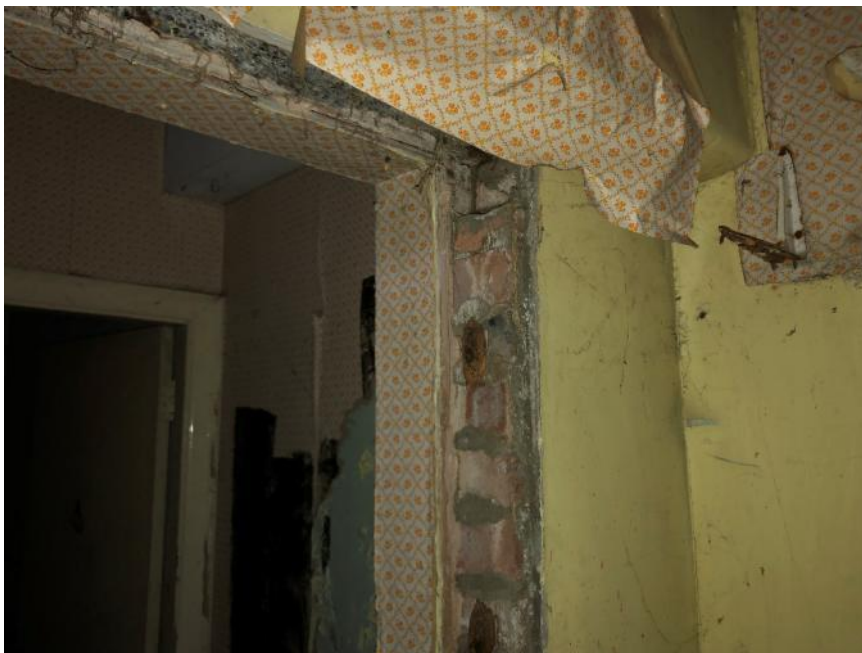
Door lining and architrave to rear entrance lobby removed

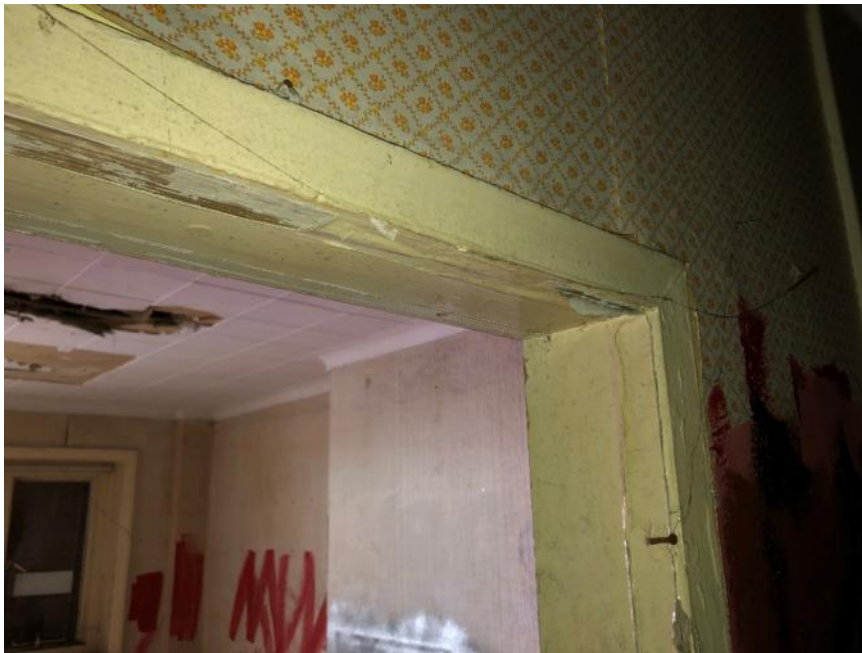
Door lining and architrave to kitchen entrance

The kitchen entrance door linings and architraves have been affected by damp ingress and as such are in poor condition throughout. All timbers are softened and distorted in a manner indicative of fungal decay. This corresponds with the water damage noted to adjacent wall surfaces as per the image below:

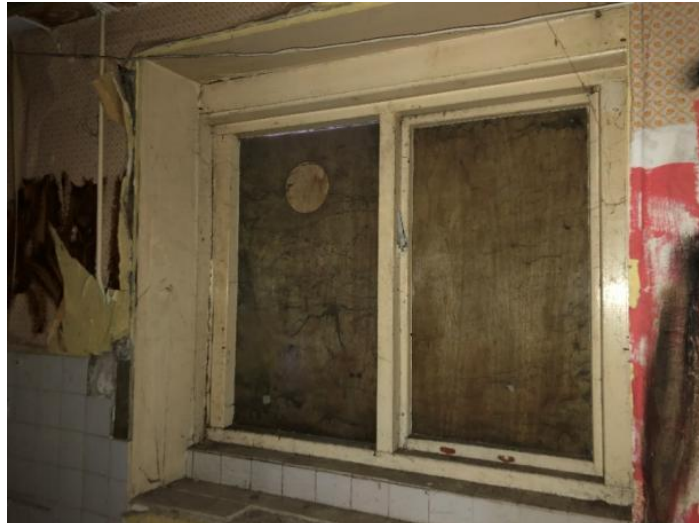
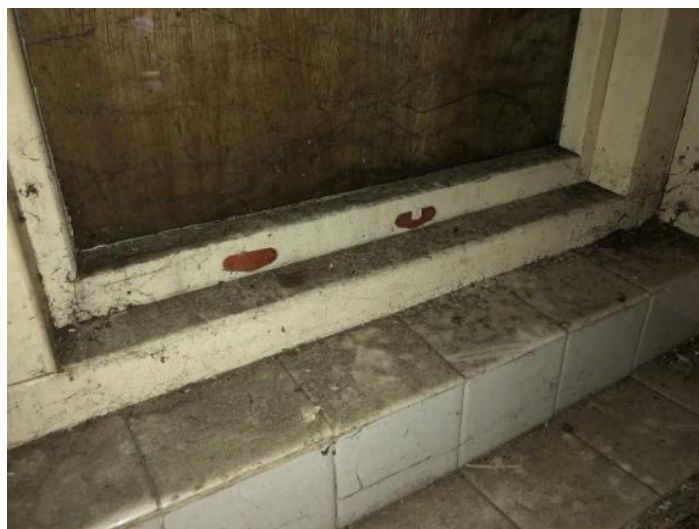
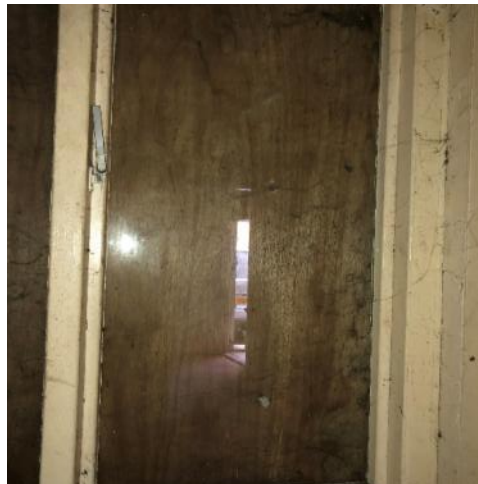
View of existing window

View of opening unit and ceramic tiled cill

View of opening unit

The outer face of the window unit is over-boarded and as such is not visible. The inner surfaces appear to be in fair condition, although close examination reveals a low quality installation of differing size to surrounding window opening. All surfaces are stained and discoloured throughout.

- Remove outer boarding, casement window unit, window reveals and architraves and dispose.
- Install new timber framed, casement unit complete with clear sheet single glazing and applied lead strips. Full details of replacement window unit are included in Appendix A.
- Prepare all surfaces and redecorate with brush applied satinwood paint to internal surfaces and brush applied exterior gloss paint to external surfaces.
- Install new metal framed slimline horizontal sliding secondary glazing units to inner face of windows as detailed in Appendix B.

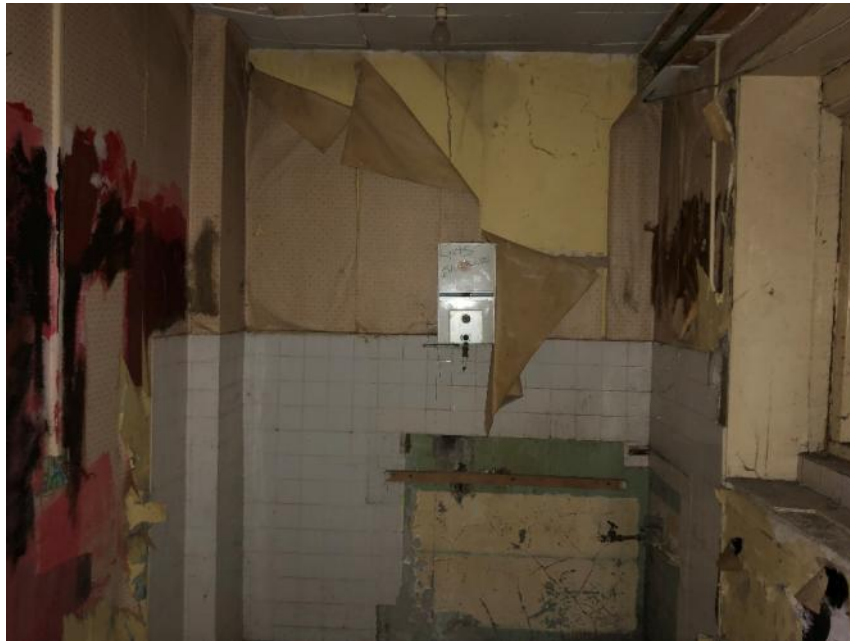
There is no chimney breast in this room. The chimney breast formerly located to the southern aspect of the room has been removed, as per the image below:

View of southern aspect of the room

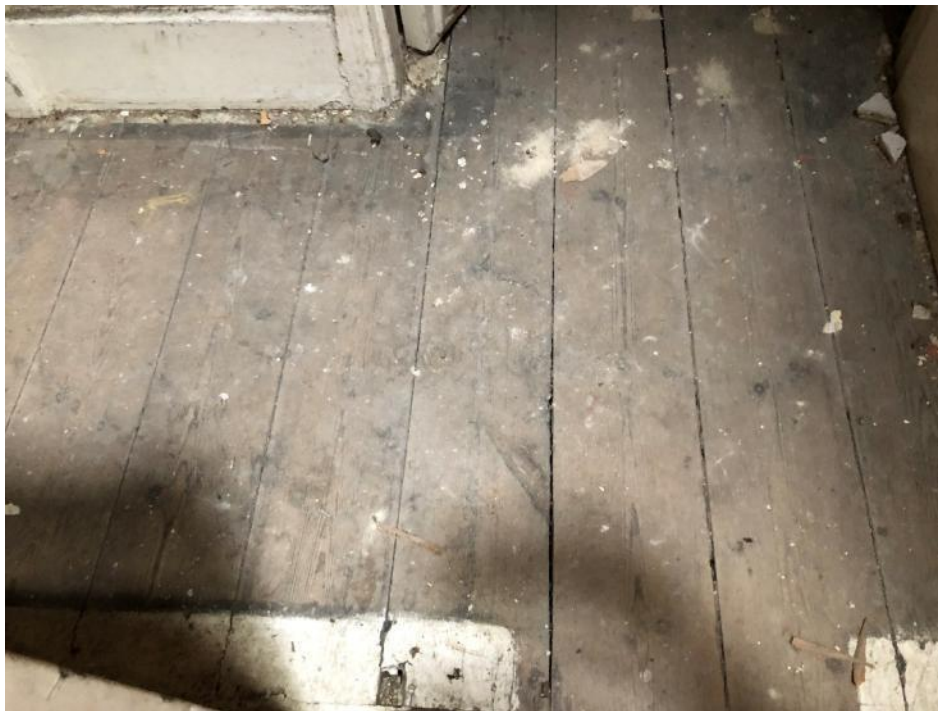
General view of landing floor surfaces

The exposed timber floor surfaces appear to be in fair condition with no visible defects although all surfaces are covered with dirt and debris.

- Clear all surface dirt and debris.
- Retain all existing timber surfaces and re-secure any loose floor boards where necessary,
- Install new edge-fixed carpet floor coverings.

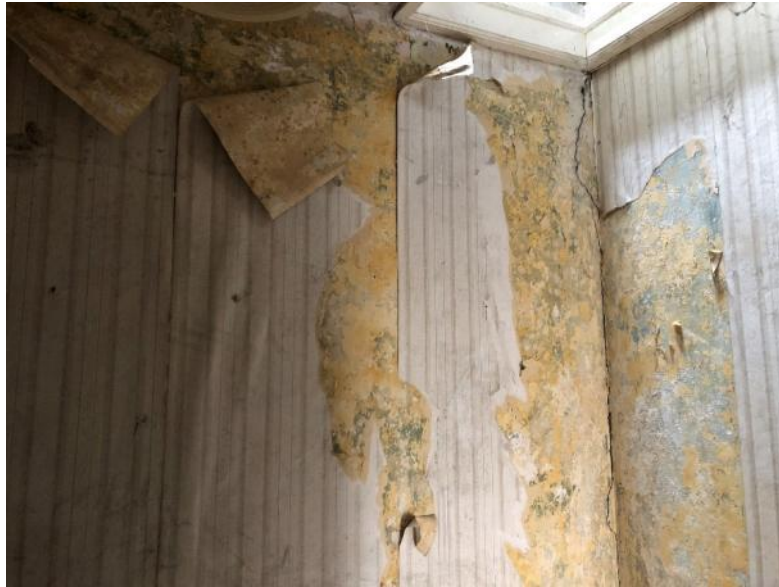
General view of landing walls

Decorative wallpaper and paint finishes are stained, discoloured and de-bonding throughout. The wall surfaces appear generally sound although plaster finishes appear friable in some areas.

- Strip off and dispose of all existing wallpaper coverings,
- All loose, friable or damaged plaster surfaces are to be removed to a stable substrate. (The full extent of defective plasterwork is to be assessed following removal of all decorative wall coverings),
- Where removed, plaster surfaces to be reinstated using non-hydraulic lime-based plaster applied to the level of the existing finishes.,
- All stable and un-damaged plaster wall surfaces will be retained,
- All new and existing plaster wall surfaces to be covered with lining paper and decorated with emulsion paint.

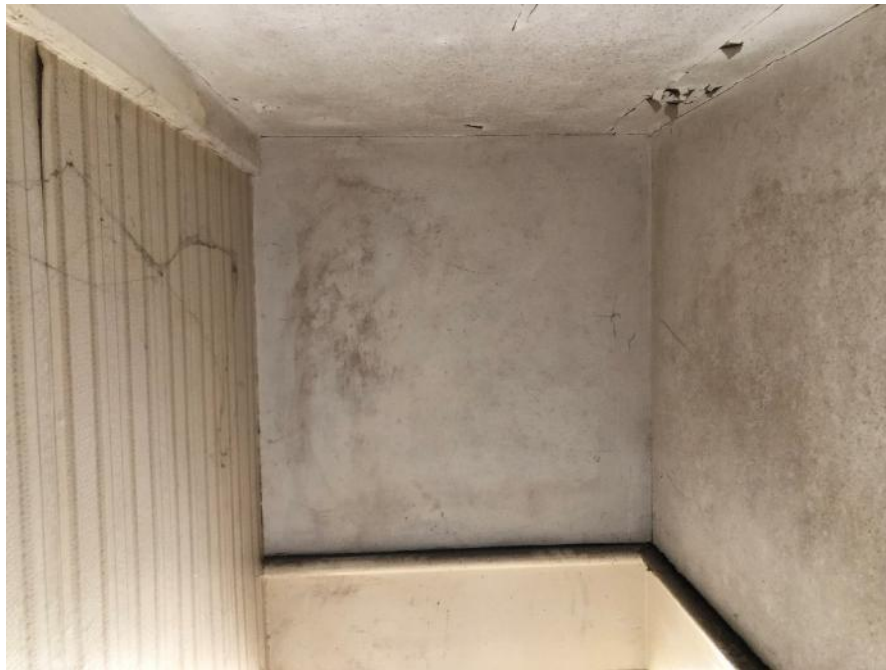
Overboarded timber panelled landing walls

All boarded surfaces appear to be in fair condition and free from any visible defects. All underlying panelled surfaces are concealed and cannot be inspected.

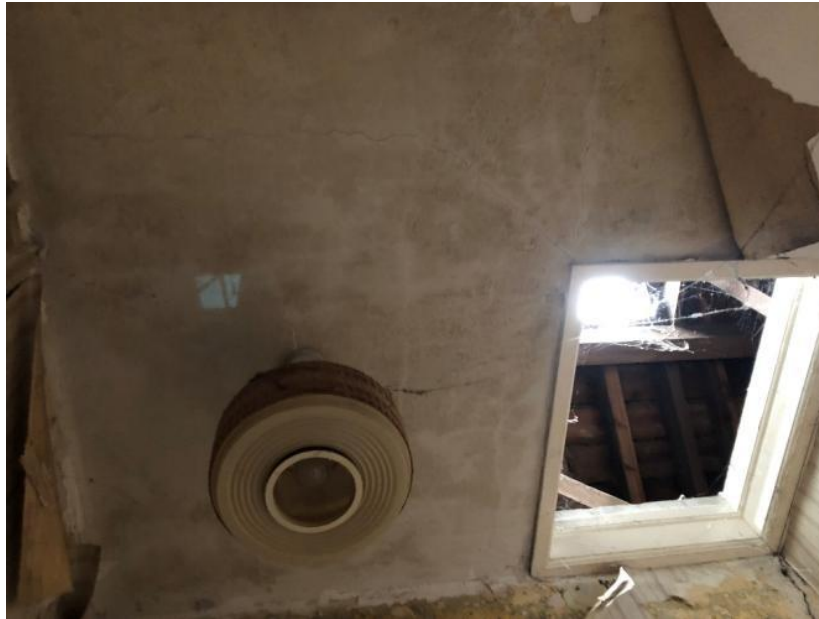
View of landing ceiling

Approximately 80% of the ceiling paper finishes have de-bonded and fallen away, exposing the underlying plaster surfaces. These appear to be in fair condition with no visible defects save localised hairline cracking.

- Retain existing plaster ceiling surfaces and timber access hatch,
- Remove existing pendant light fitting and replace with new,
- Prepare existing plaster surfaces and redecorate with emulsion paint.

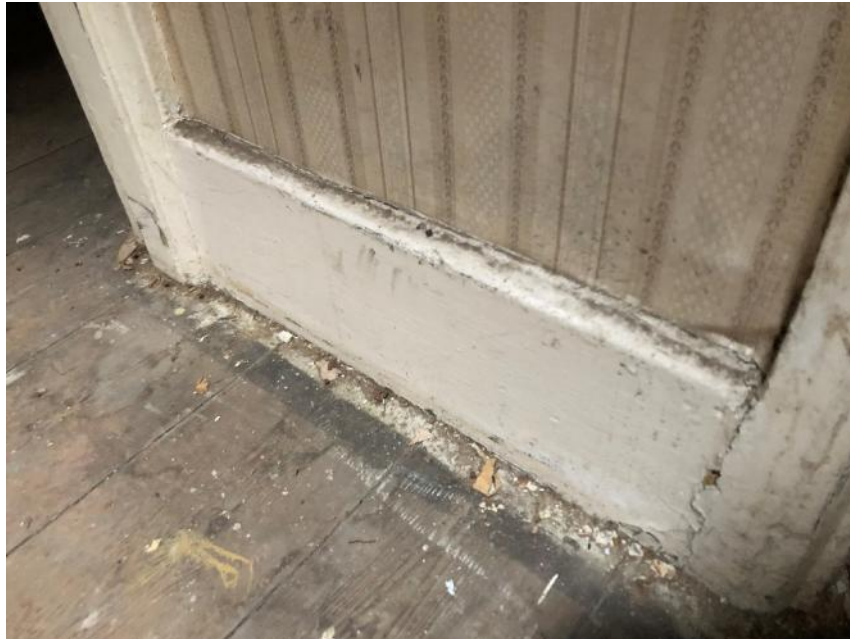
Typical view of landing skirting board

The decorated surfaces are discoloured, dirty and chipped throughout. The timber skirtings appear generally sound with minor areas of impact damage.

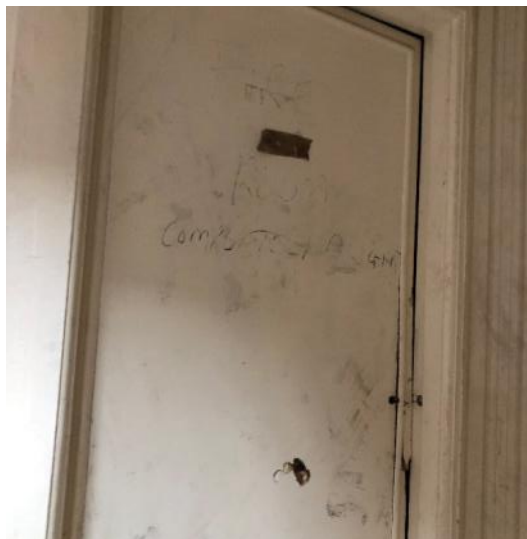
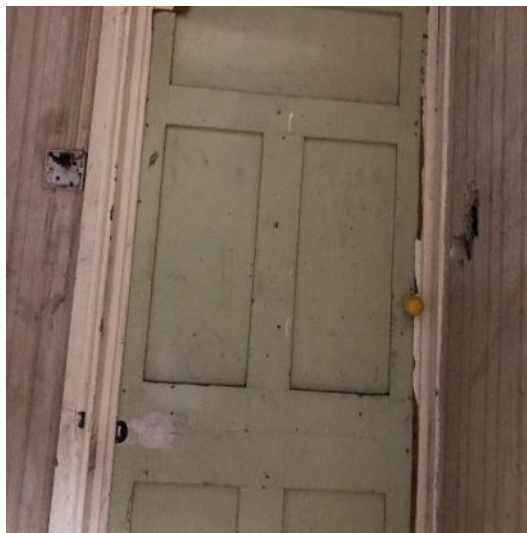
Entrance to Bedroom 1

Entrance to Bedroom 2

The plastic door furniture and cylinder latches fitted to each door are damaged/partially removed, as per the images below:

- Remove plywood boarding and plastic door furniture from existing doors and dispose, making good underlying surfaces as necessary.
- Carry out repairs to damaged timberwork. All repairs/replacement timbers to match the detail and dimensions of the existing.
- Prepare all timber surfaces and redecorate with brush applied satinwood paint.
- Where removed, install replacement door furniture – ironmongery details to be confirmed.

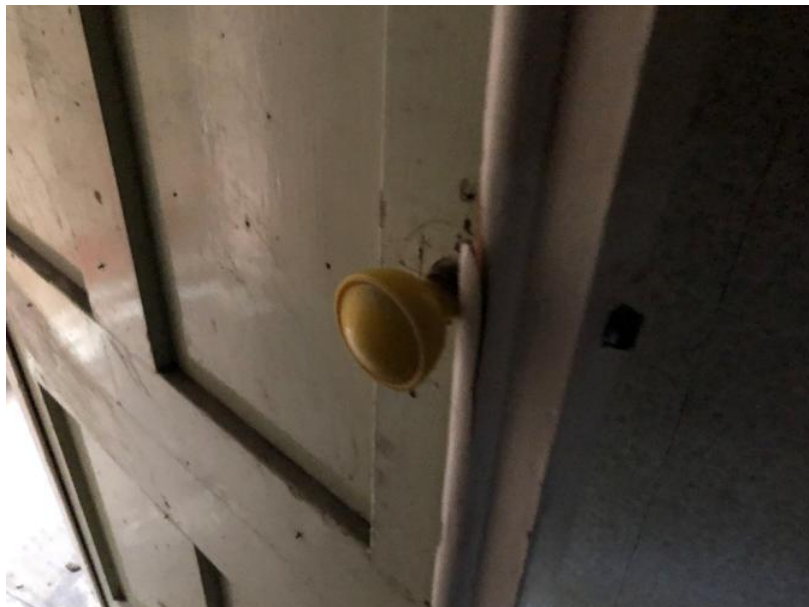
The Bedroom 1 entrance door appears to have been re-hung and the direction of door-swing reversed. Remnants of a plastic door knob and an overpainted metal escutcheon remain on the now hinged side of the door, as shown below:

Plastic door furniture to Bedroom 2

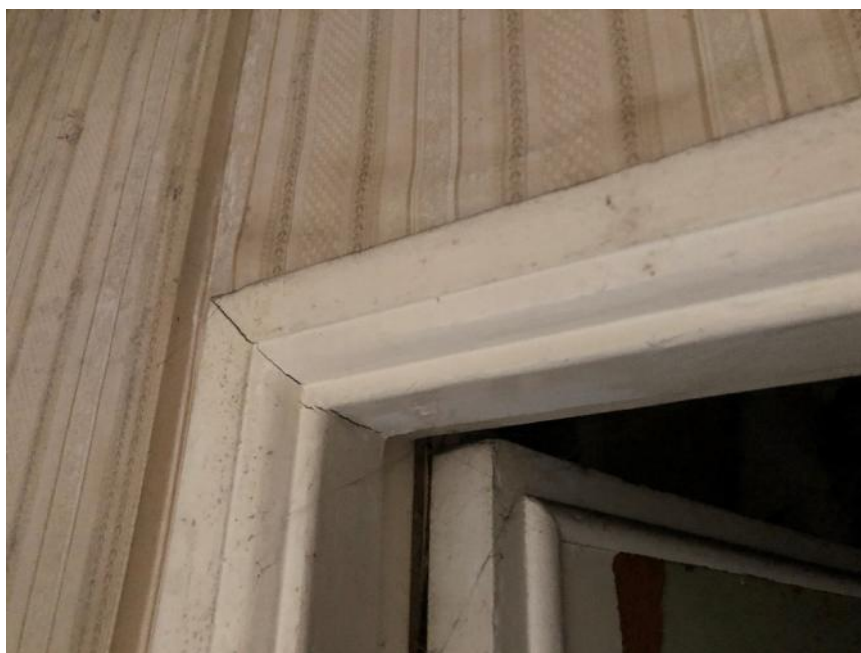
Door architrave detail

All timber surfaces appear to be in fair condition although the decorated surfaces are discoloured throughout.

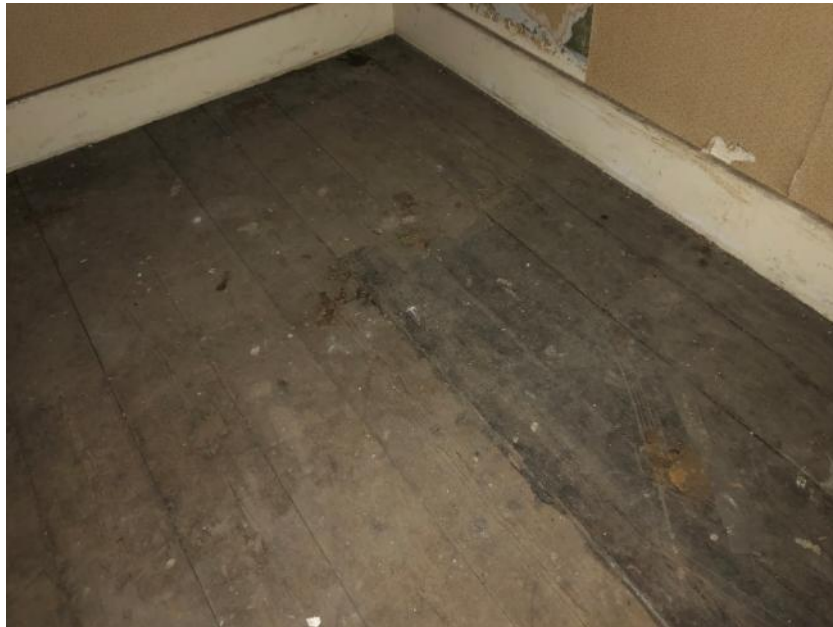
Bedroom floor surface

The exposed timber floor surfaces appear to be in fair condition with no visible defects, although 1 no. floor board to the western aspect of the room has been removed, as per the image below:

- Clear all surface dirt and debris.
- Replace any missing floorboards with new to match the dimensions and levels of the existing,
- Re-fix existing floorboards where loose,
- Retain existing floor coverings and install new edge-fixed carpet floor coverings throughout.

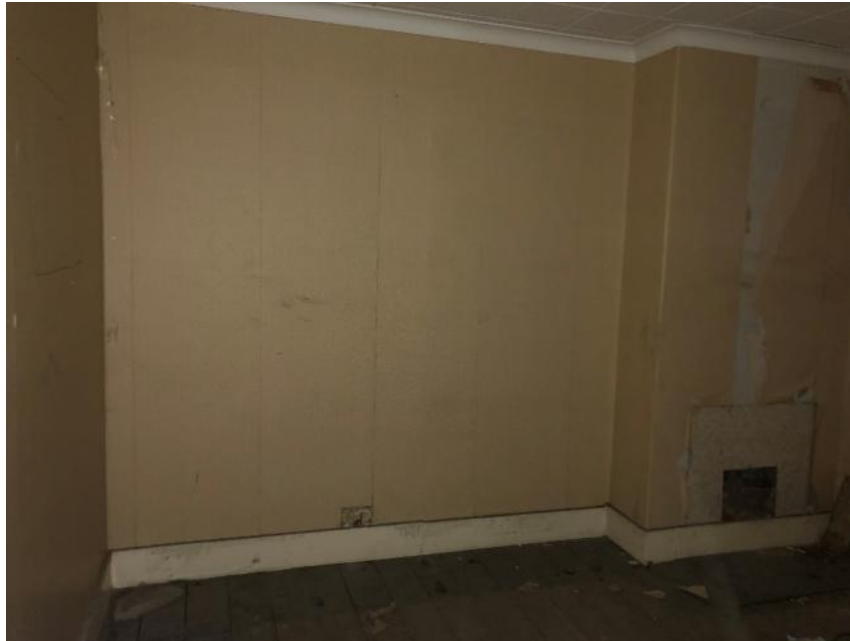
General view of bedroom walls

All decorative finishes are faded and discoloured throughout and the patterned wallpaper is de-bonding in places. The wall surfaces appear generally sound with no visible defects.

- Strip off and dispose of all existing wallpaper coverings.
- All loose, friable or damaged plaster surfaces are to be removed to a stable substrate. (The full extent of defective plasterwork is to be assessed following removal of all decorative wall coverings),
- Where removed, all plaster surfaces to be reinstated using non-hydraulic lime-based plaster applied to the level of the existing finishes,
- All stable and un-damaged plaster wall surfaces will be retained,
- All new and existing plaster wall surfaces to be covered with lining paper and decorated with emulsion paint.

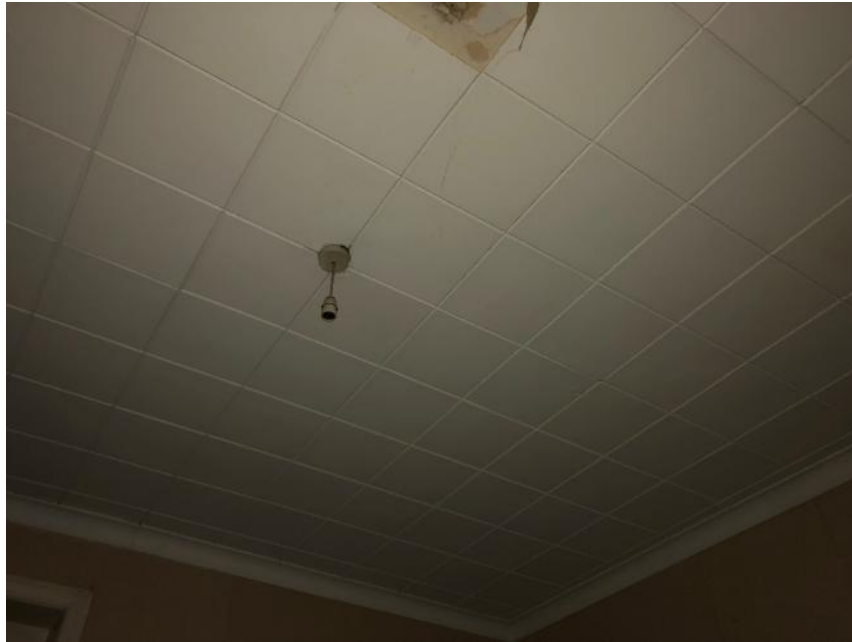
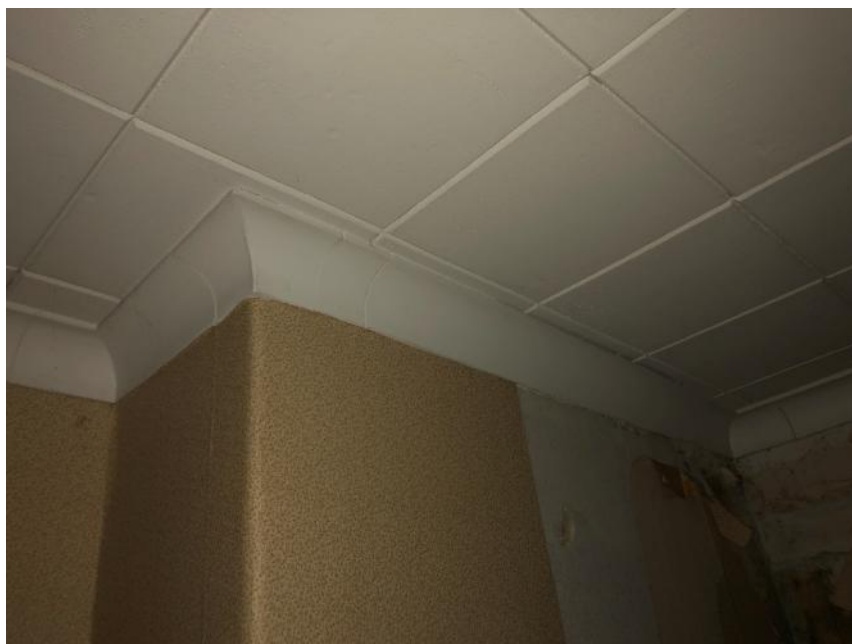
General view of bedroom ceiling

Bedroom ceiling/wall junction

The decorative finishes are generally discoloured throughout. The polystyrene tiles have de-bonded in places, exposing the underlying plaster surfaces. There is 1 no. area of damaged plasterwork to the north-east corner of the room of approximately 0.3 square metres as per the image below:

- Strip off existing polystyrene coverings and surface mounted plaster covings and dispose,
- All loose, friable or damaged plaster surfaces are to be removed to a stable substrate. (The full extent of defective plasterwork is to be assessed following removal of all decorative coverings),
- Where removed, all plaster surfaces to be reinstated using non-hydraulic lime-based plaster applied to the level of the existing finishes,
- All stable and un-damaged plaster wall surfaces will be retained,
- Remove existing pendant light fitting and replace with new.
- Prepare existing and new plaster surfaces and redecorate with emulsion paint.

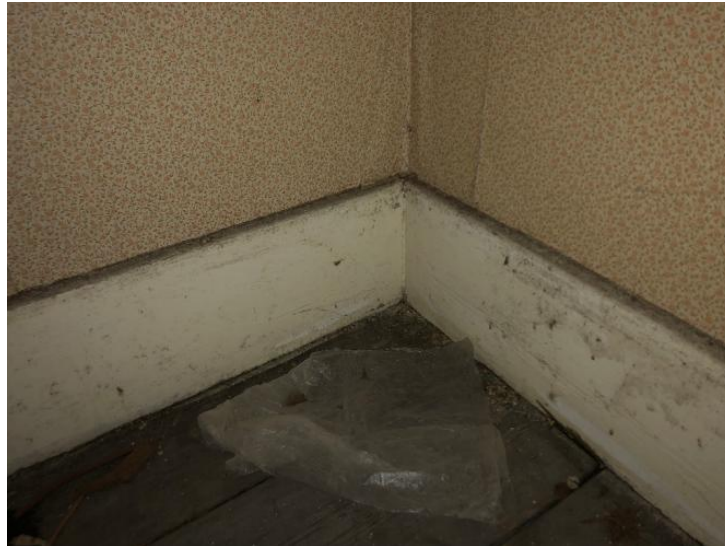
Typical view of bedroom skirting board

The decorated surfaces are discoloured, dirty and chipped throughout. The timber skirtings appear generally sound with minor areas of impact damage.

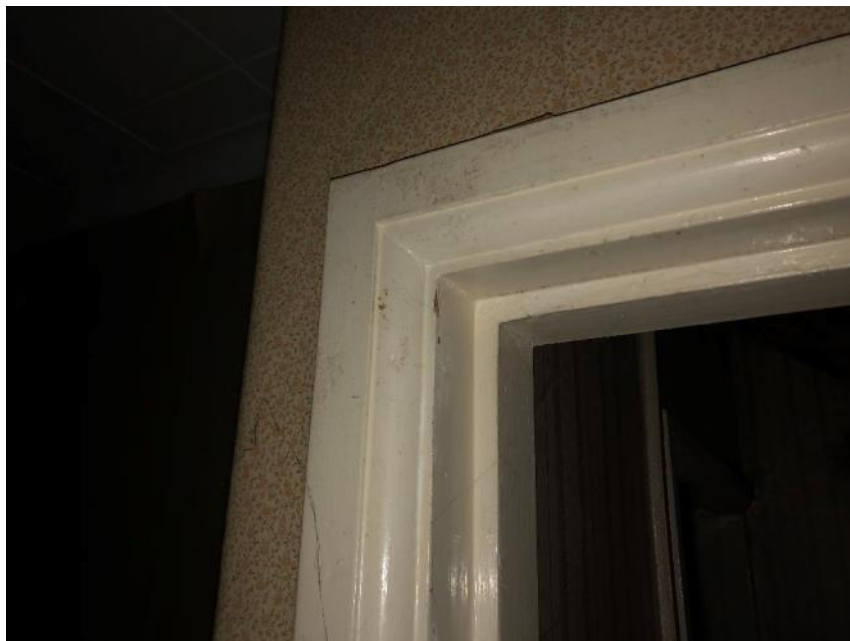
View of entrance door lining and architrave

All timber surfaces appear to be in fair condition although the decorated surfaces are discoloured throughout.

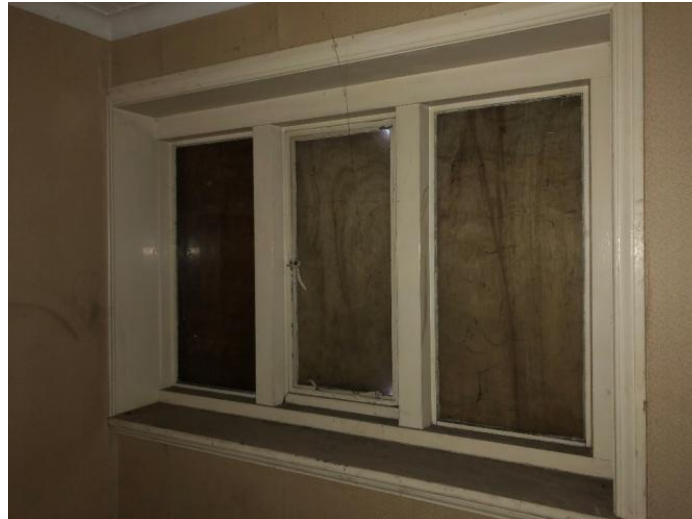
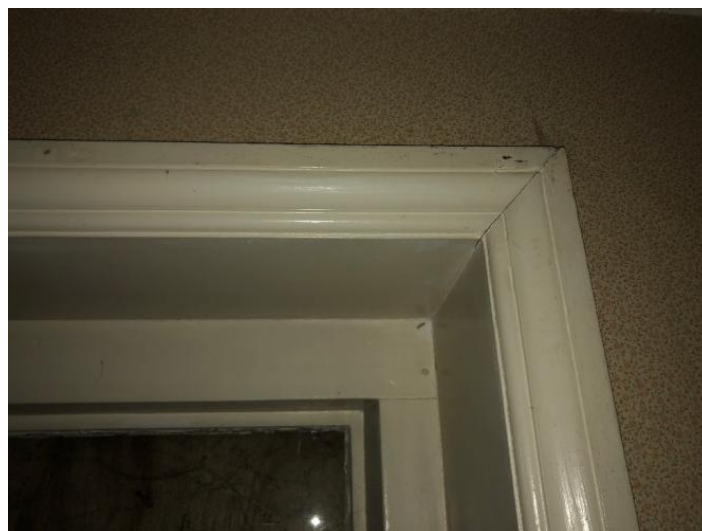
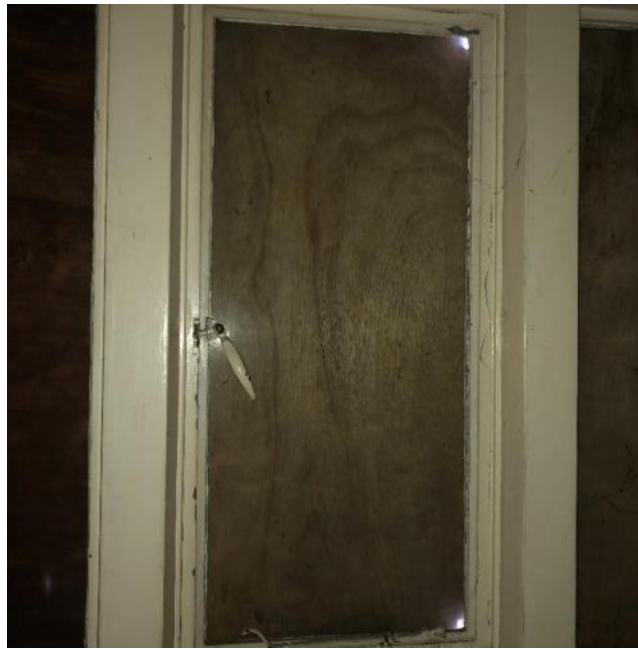
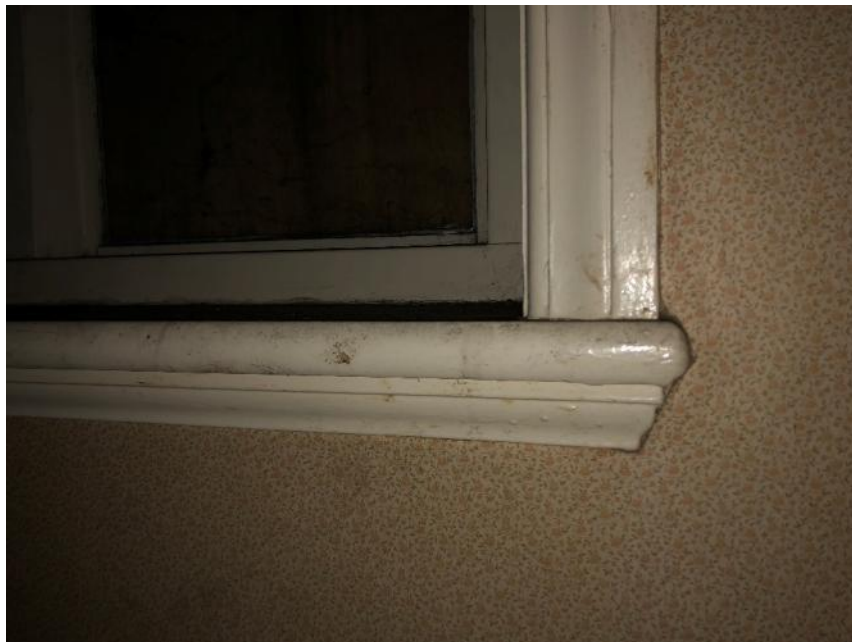
View of existing bedroom 1 window

View of existing bedroom 1 window architrave

View of opening unit

View of existing window board and beading

The outer face of the window unit is over-boarded and as such is not visible. The inner surfaces generally appear to be in sound condition, although all decorations are discoloured and dirty throughout.

- Remove outer boarding and thoroughly inspect window units for damage and deterioration,
- Carry out localised timber repairs to external surfaces as necessary,
- Rake out existing glazing putties, remove existing sheet glazing and replace with single glazed sheet glass with applied leaded strips to outer face. Full details of the proposed installation are included in Appendix A.
- Ease and adjust all hinges, stays and latches to ensure opening units functioning as intended.
- Prepare all timber and metals surfaces and redecorate internal surfaces with brush applied satinwood paint. External surfaces to be redecorated with brush applied exterior gloss paint.
- Install new metal framed slimline horizontal sliding secondary glazing units to inner face of windows as detailed in Appendix B.
