Schedule of Condition and Proposed Works

House No. 3
West Hampstead Cottages
West Hampstead Fire Station
325 West End Lane
London NW6 1RR

Dron & Wright

July 2019

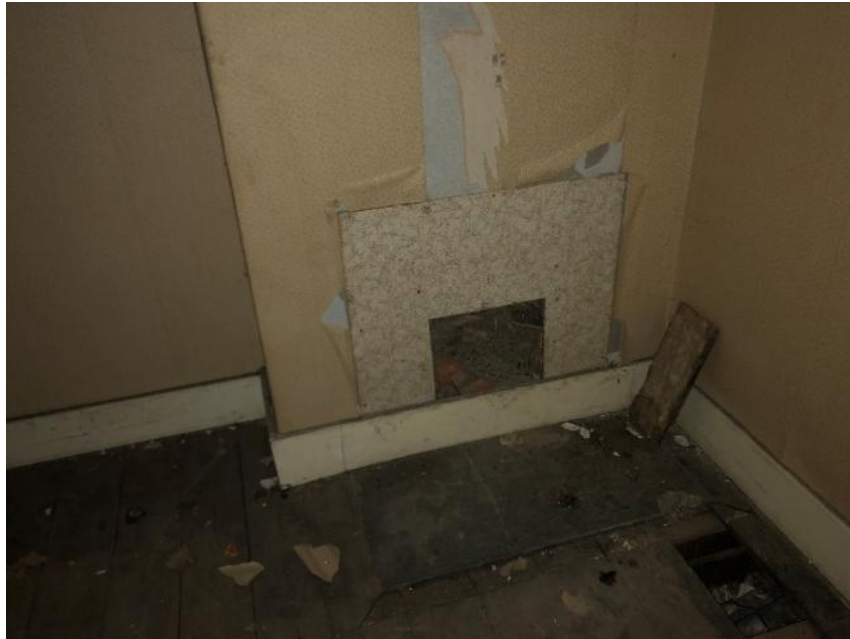
View of former fireplace position

All remaining wall and floor surfaces are in fair condition, although generally dusty and discoloured throughout.

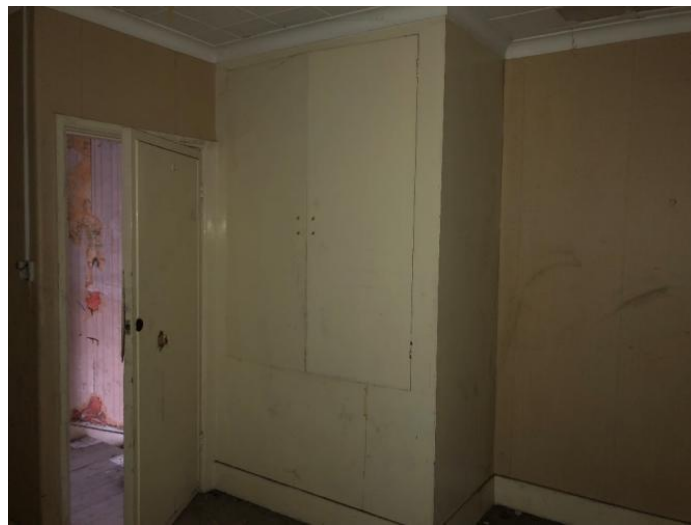
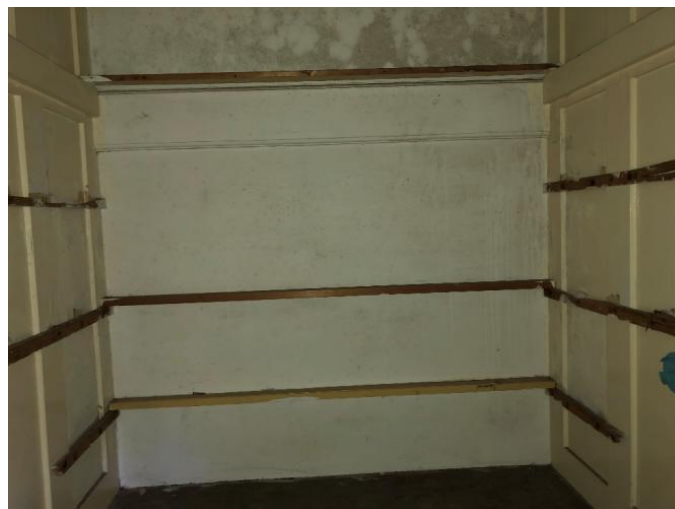
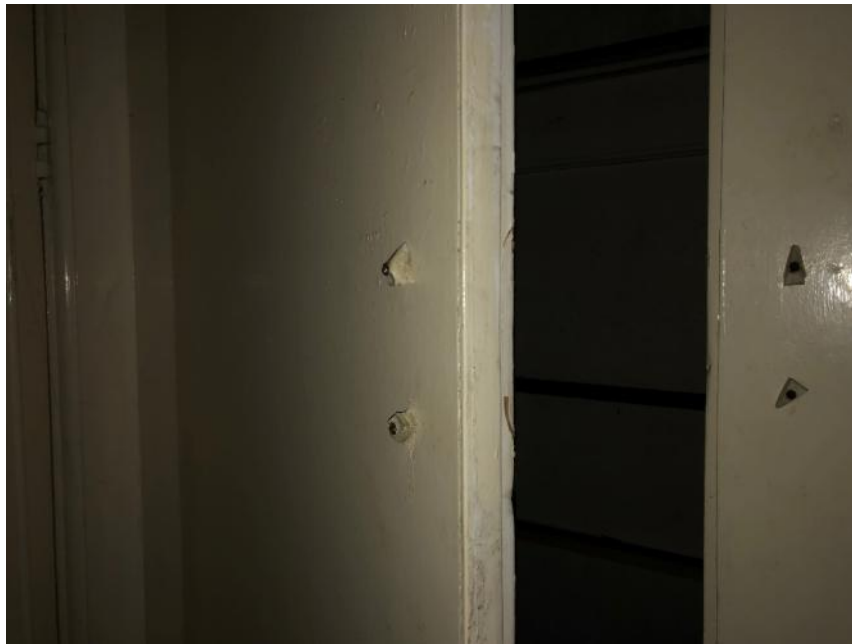
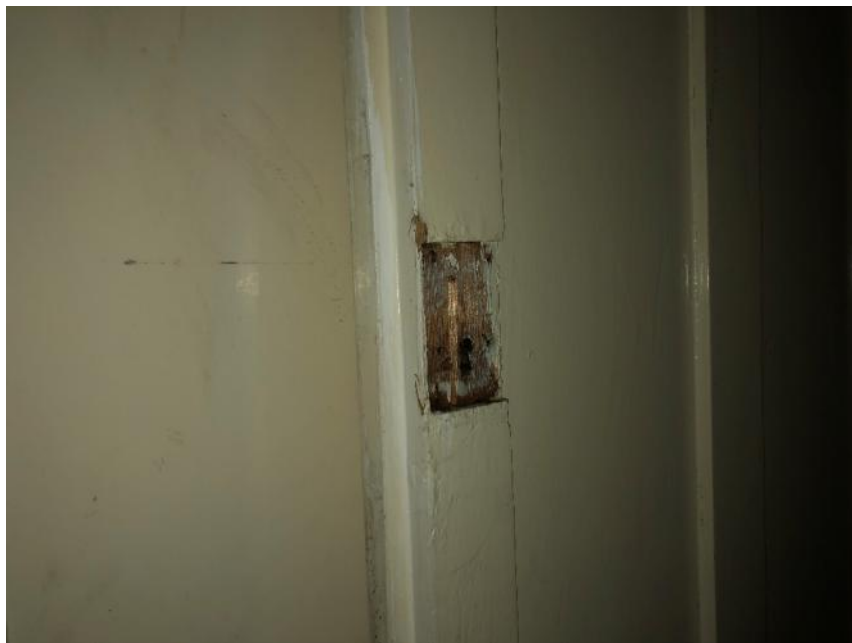
View of over stair storage cupboard

Interior view of over stair storage cupboard

Remnants of former door handles

Position of former locking mechanism

All surfaces generally appear to be in fair condition, although all decorations are dirty discoloured.

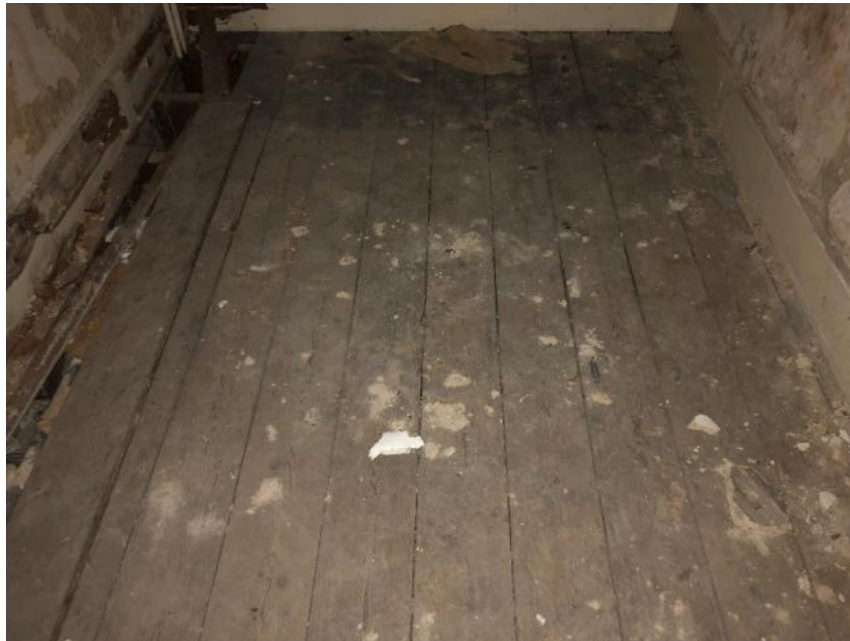
Bedroom floor surface

The majority of exposed timber floor surfaces appear to be in fair condition with no visible defects. However, a series of damaged floorboards to the north-west corner of the room have been removed, exposing the underlying floor structure, as per the image below:

- **Proposed Works**
 - Clear all surface dirt and debris and remove all loose remnants of former carpet floor coverings,
 - Replace damaged floorboards to match dimensions of existing.
 - Secure existing floorboards where loose,
 - Retain existing floor coverings and install new edge-fixed carpet floor coverings throughout.
- **Impact Assessment of Heritage Significance**
 - Clear all surface dirt and debris and remove all loose remnants of former carpet floor coverings - *Significance: Neutral effect on significance*
 - Replace damaged floorboards to match dimensions of existing - *Significance: Neutral effect on significance*
 - Secure existing floorboards where loose - *Significance: Neutral effect on significance*
 - Retain existing floor coverings and install new edge-fixed carpet floor coverings throughout - *Significance: Neutral effect on significance*

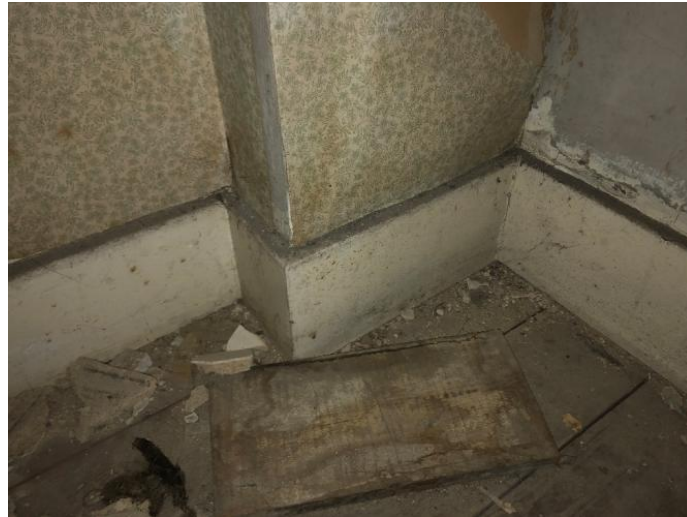
Typical view of bedroom skirting board

The decorated surfaces are discoloured, dirty and damaged throughout.

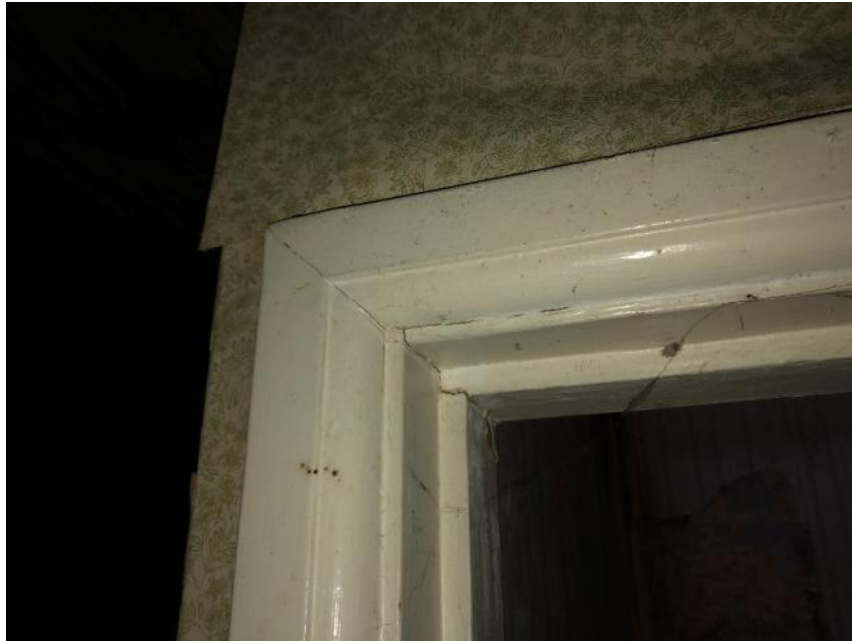
View of entrance door lining and architrave

All timber surfaces appear to be in fair condition although the decorated surfaces are discoloured throughout.

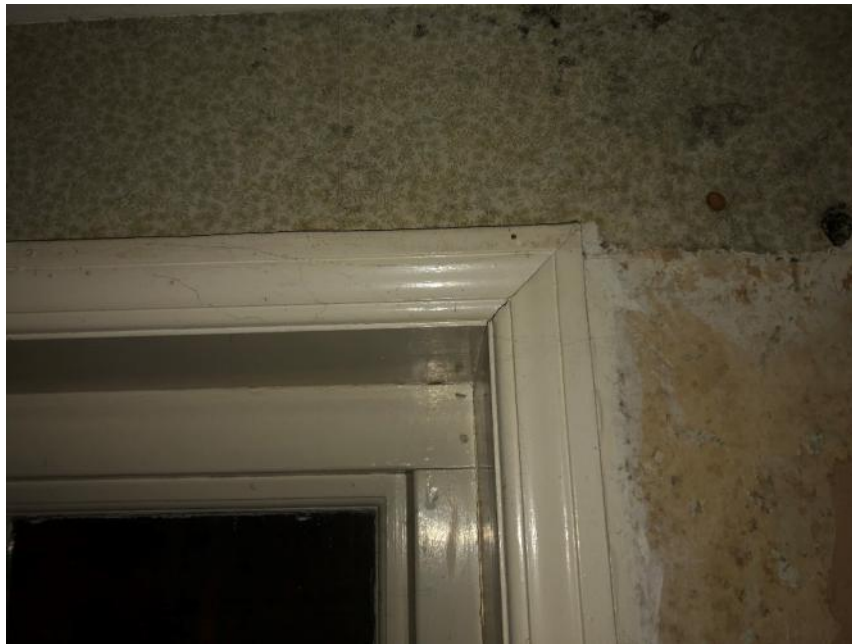
View of existing bedroom window architrave

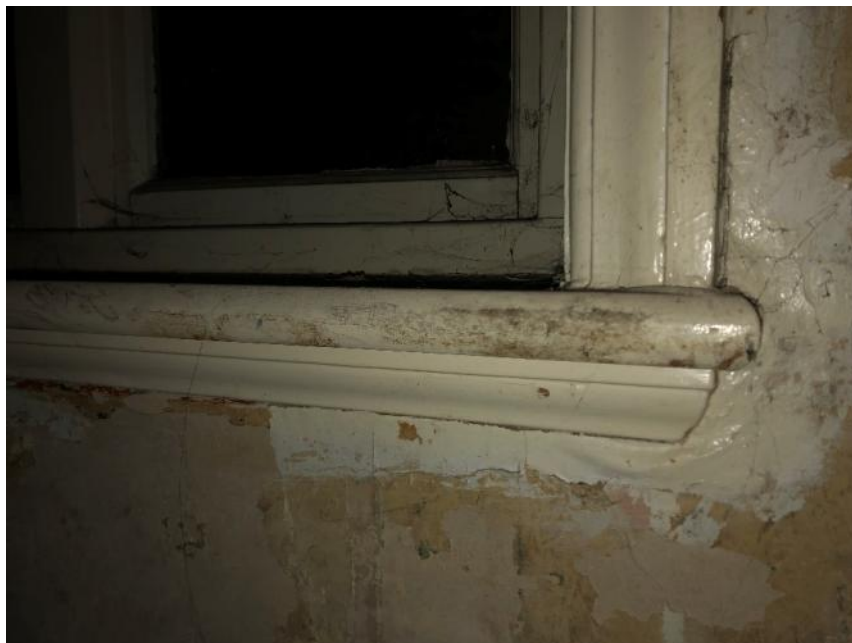
View of existing bedroom window board and moulding

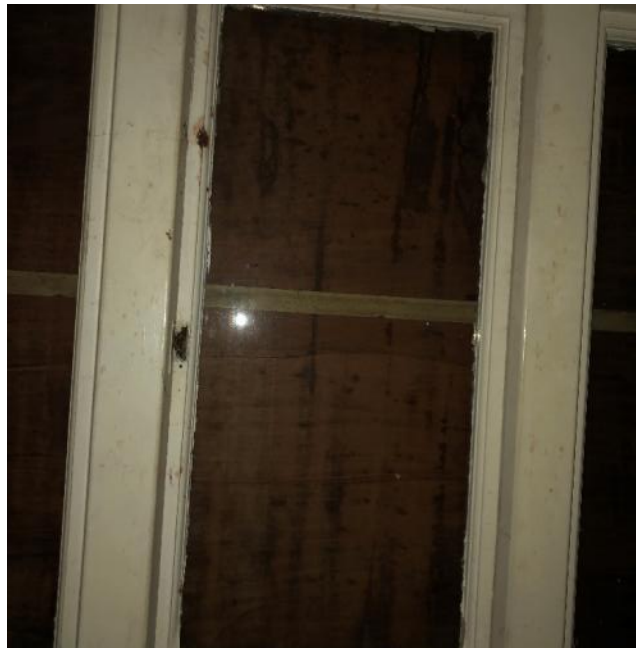
View of opening unit

The outer face of the window unit is over-boarded and as such is not visible. The northern section of the window appears to have suffered timber decay where adjacent to damp affected wall surfaces. The timber window board, reveal and architrave have softened and distorted in this area as per the image below:

- Remove outer boarding and thoroughly inspect window units for damage and deterioration,
- Carry out localised timber repairs to external surfaces as necessary,

- Remove damp affected timbers to inner face of window and replace to match details and dimensions of the existing,
- Rake out existing glazing putties, remove existing sheet glazing and replace with single glazed sheet glass with applied leaded strips to outer face. Full details of the proposed installation are included in Appendix A,

- Replace missing metal latch and ease and adjust all hinges and stays to ensure opening units functioning as intended,
- Prepare all timber and metal surfaces and redecorate internal surfaces with brush applied satinwood paint. External surfaces to be redecorated with brush applied exterior gloss paint,

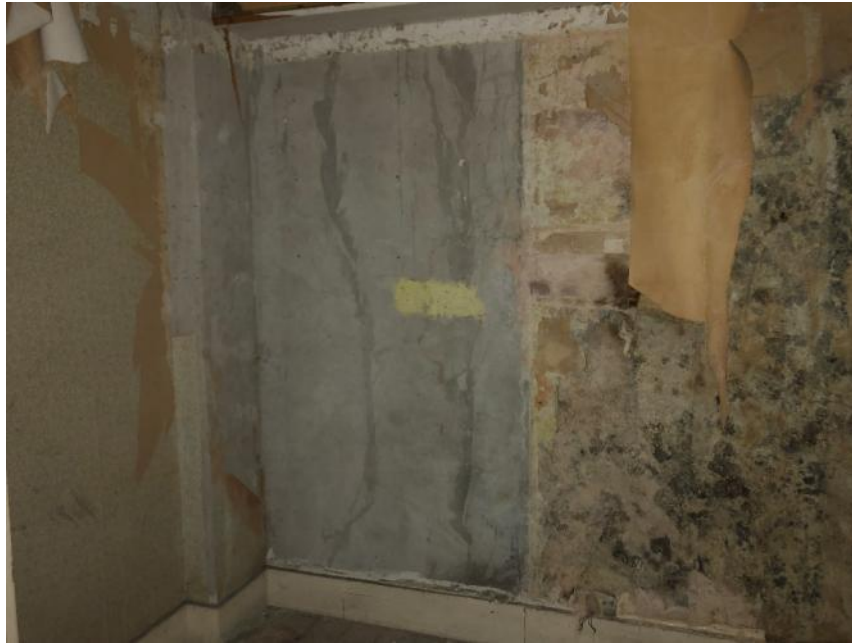
There is no chimney piece in this room. The former chimney breast appears to have been removed and the chimney stack supported by a rolled steel joist, as per the images below:

View of former chimneybreast position

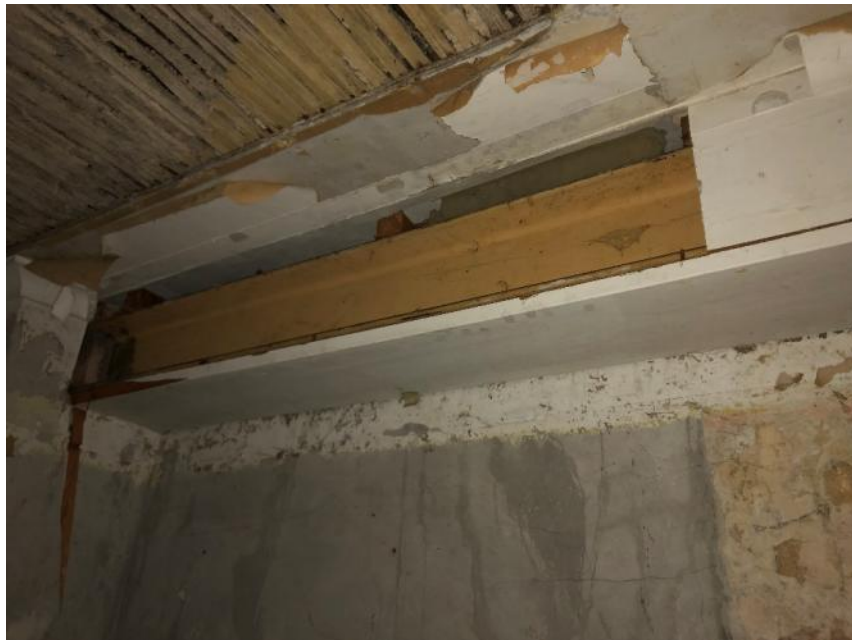
View of rolled steel support joist

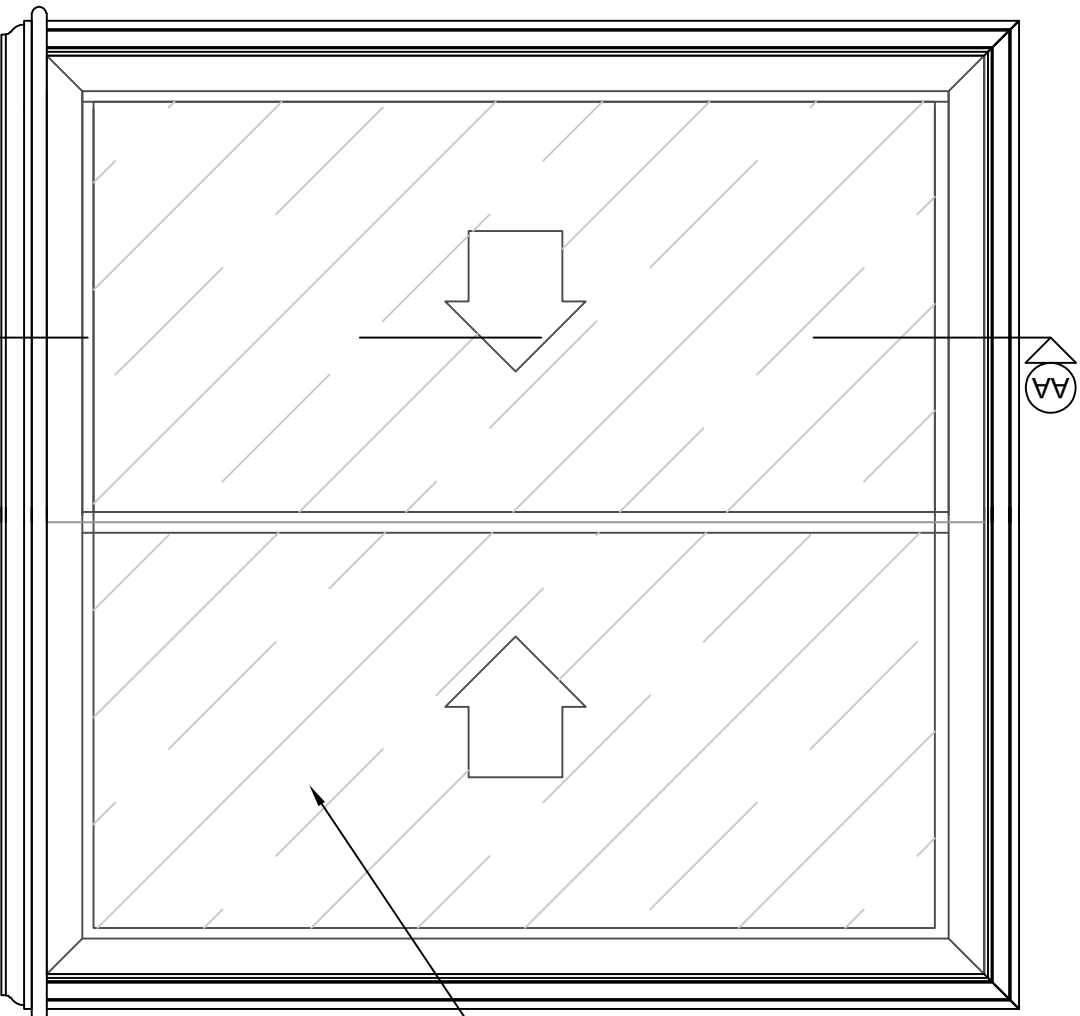
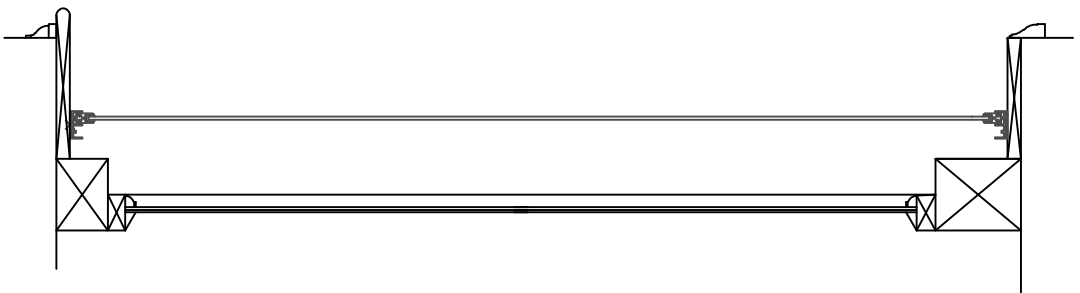
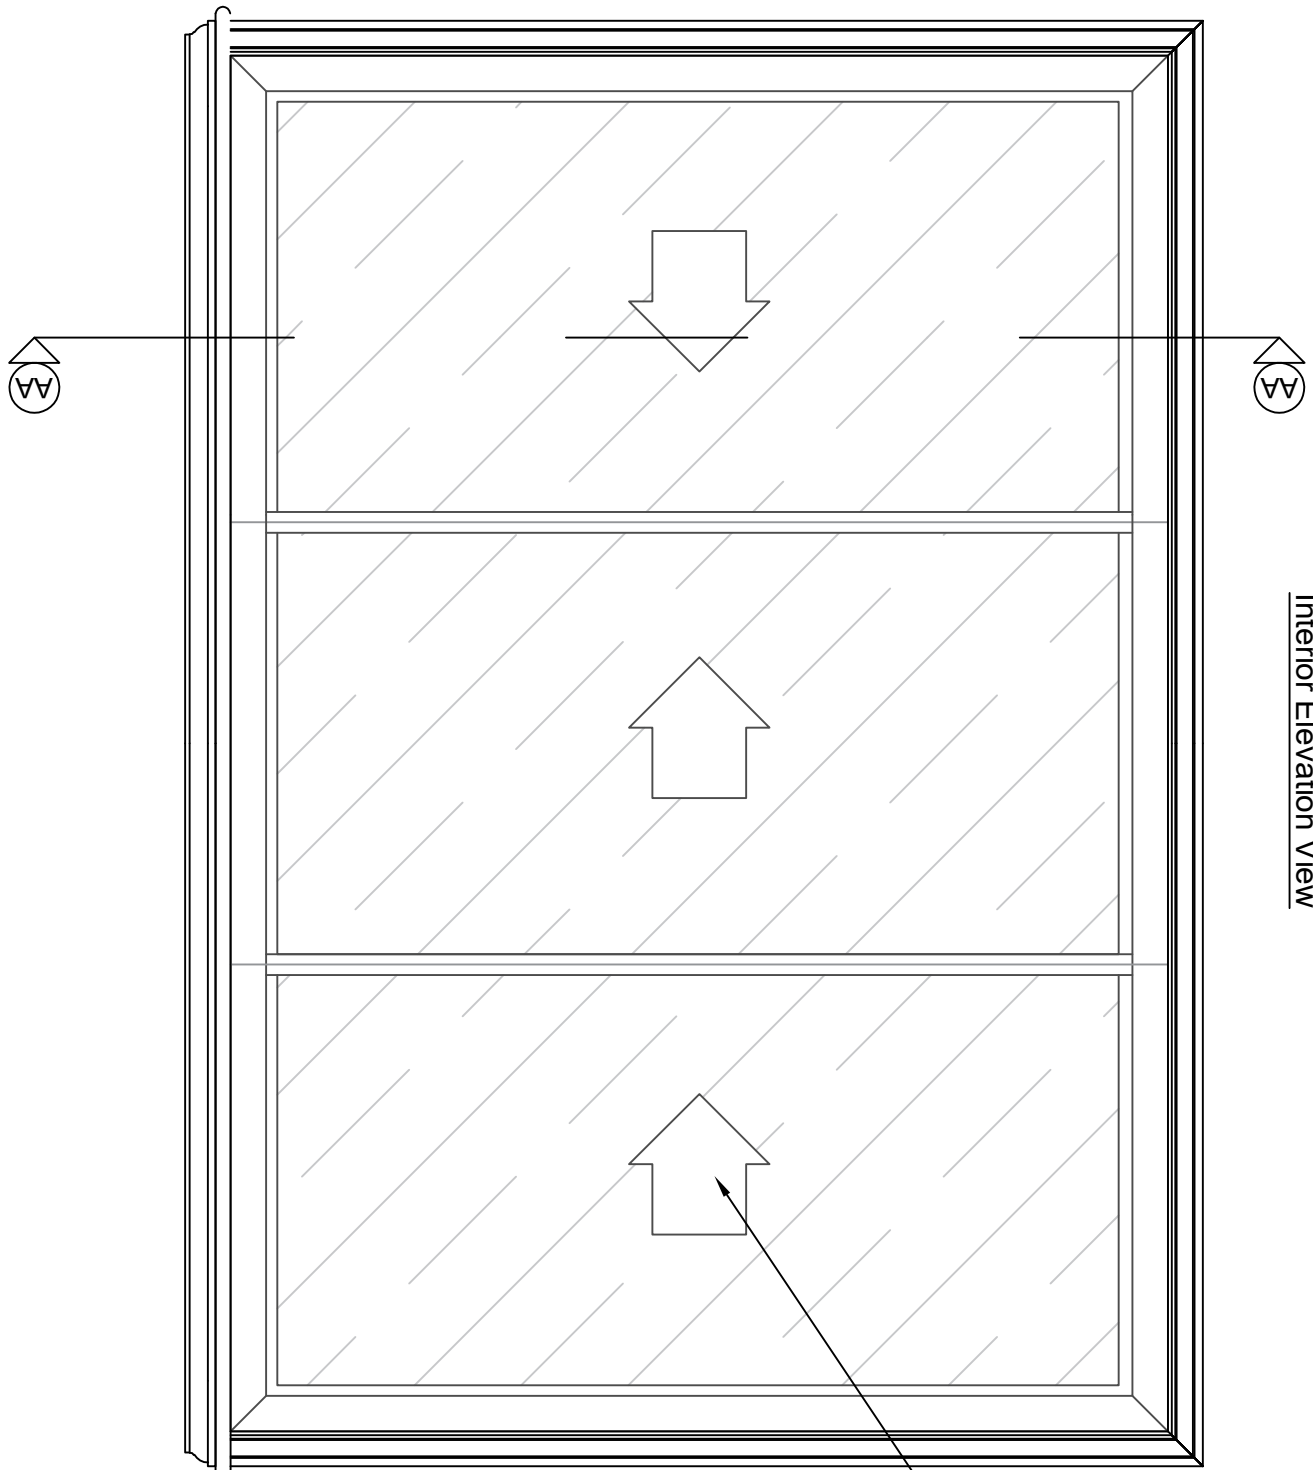
Selectaglaze Series 10 Slimline horizontal sliding secondary glazing unit.
Glazing: Clear Float Glass
Frame: Aluminium with polyester powder coated finish - Colour: White.

New units installed within existing window reveals as per Section AA.
