THE DIOCESE OF LONDON

ST PETERS VICARAGE, 53 BELZISE SQUARE,
LONDON, NW3 4HY

FULL CONSTRUCTION MANAGEMENT PLAN

Asbestos Demolition Survey (with MA only)

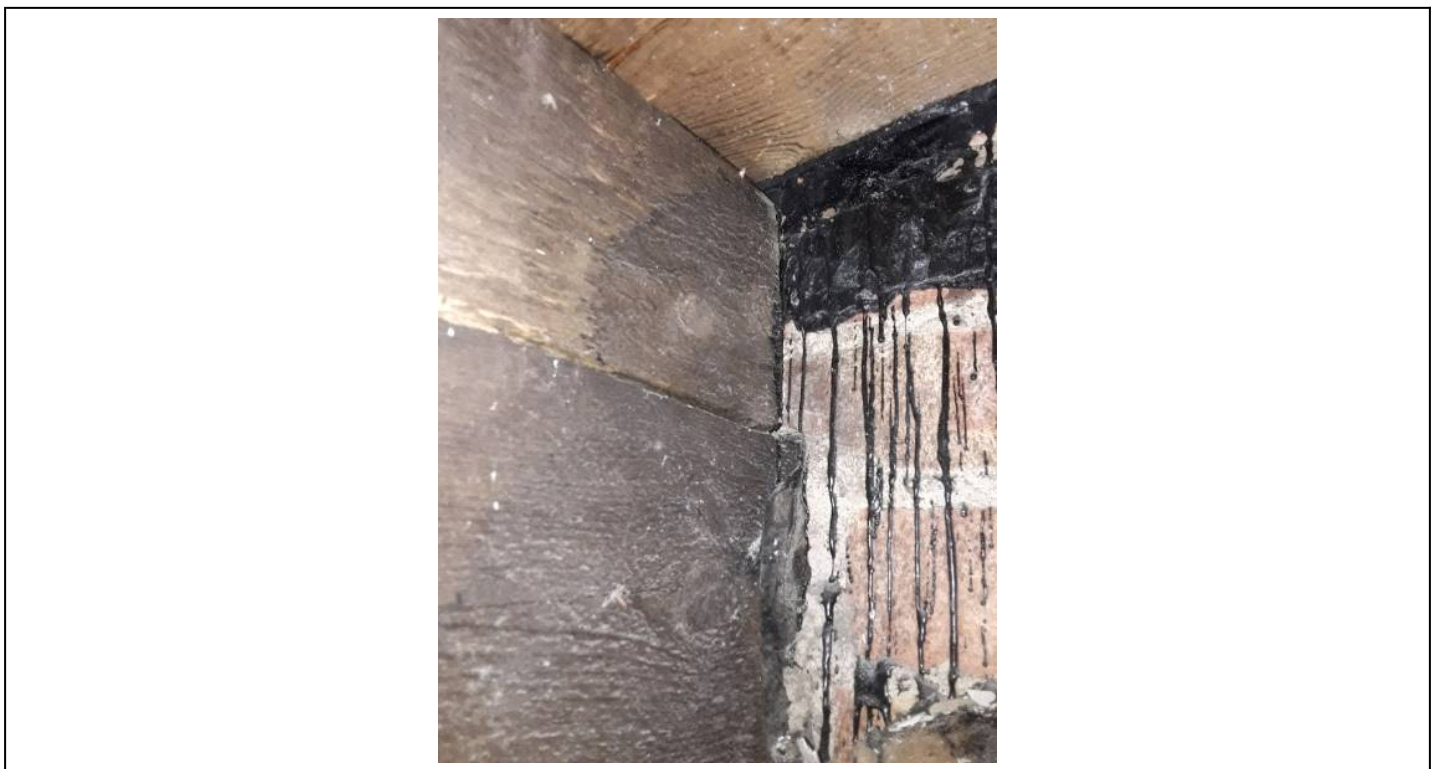
Item Number:	1 Ref Item: N/A	Sample Reference	AM001068
Item Description:	Damp proof course to timber framework passing through the brick walls within the ceiling void	Approx. Quantity:	N/A
Position:	Ceiling void	Identification:	Identified
Item Material:	N/A	Asbestos Present:	No Asbestos Detected

Total Assessment:	N/A	N/A
Sample notes:	N/A	
Comments:	Identified to all timber framework on 1st floor within rooms.	
Recommendation:	No further action required	Timescale: N/A

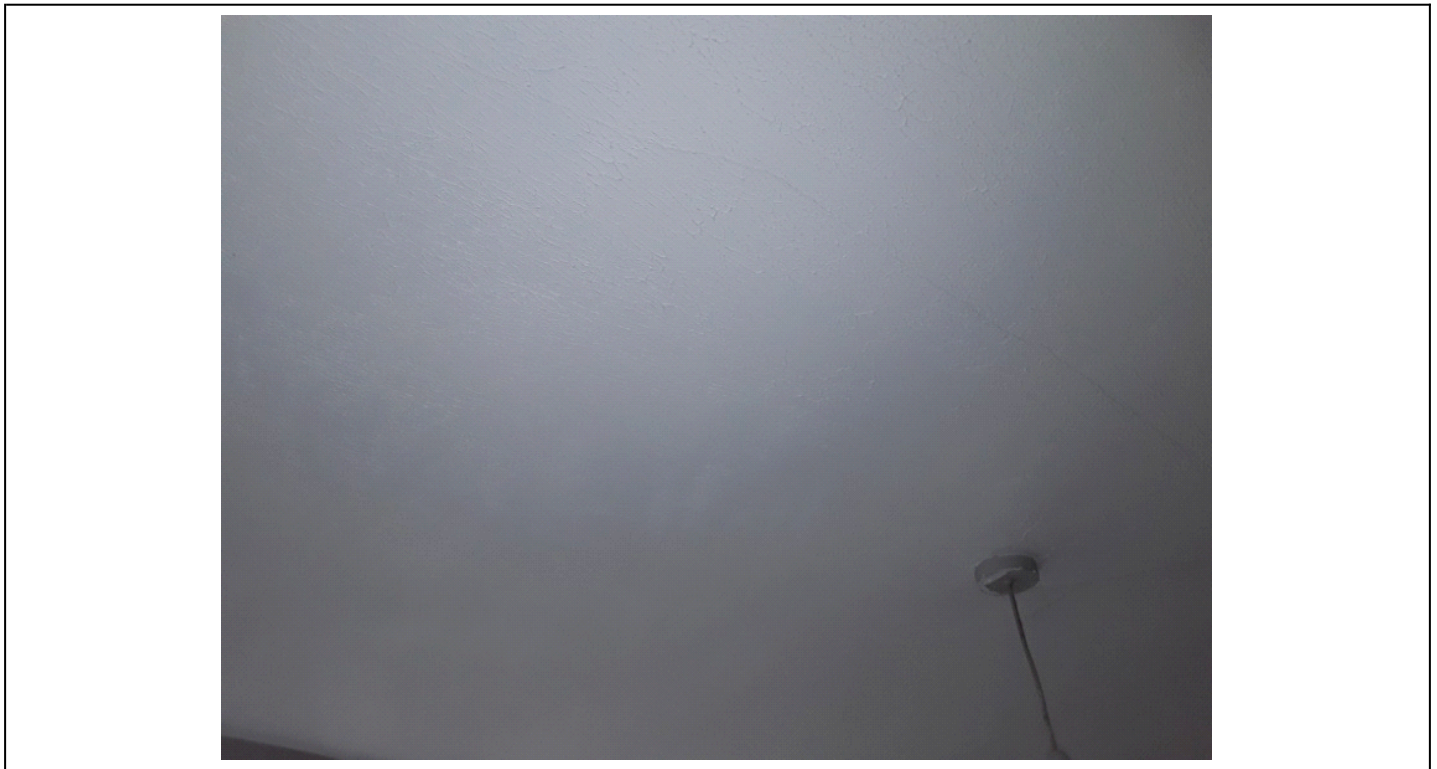
Item Number:	2 Ref Item: N/A	Sample Reference	AM001069
Item Description:	Textured coating to the plasterboard ceiling	Approx. Quantity:	N/A
Position:	Ceiling	Identification:	Identified
Item Material:	N/A	Asbestos Present:	No Asbestos Detected

Total Assessment:	N/A	N/A	
Sample notes:	N/A		
Comments:	No access above due to being sampled.		
Recommendation:	No further action required	Timescale	N/A

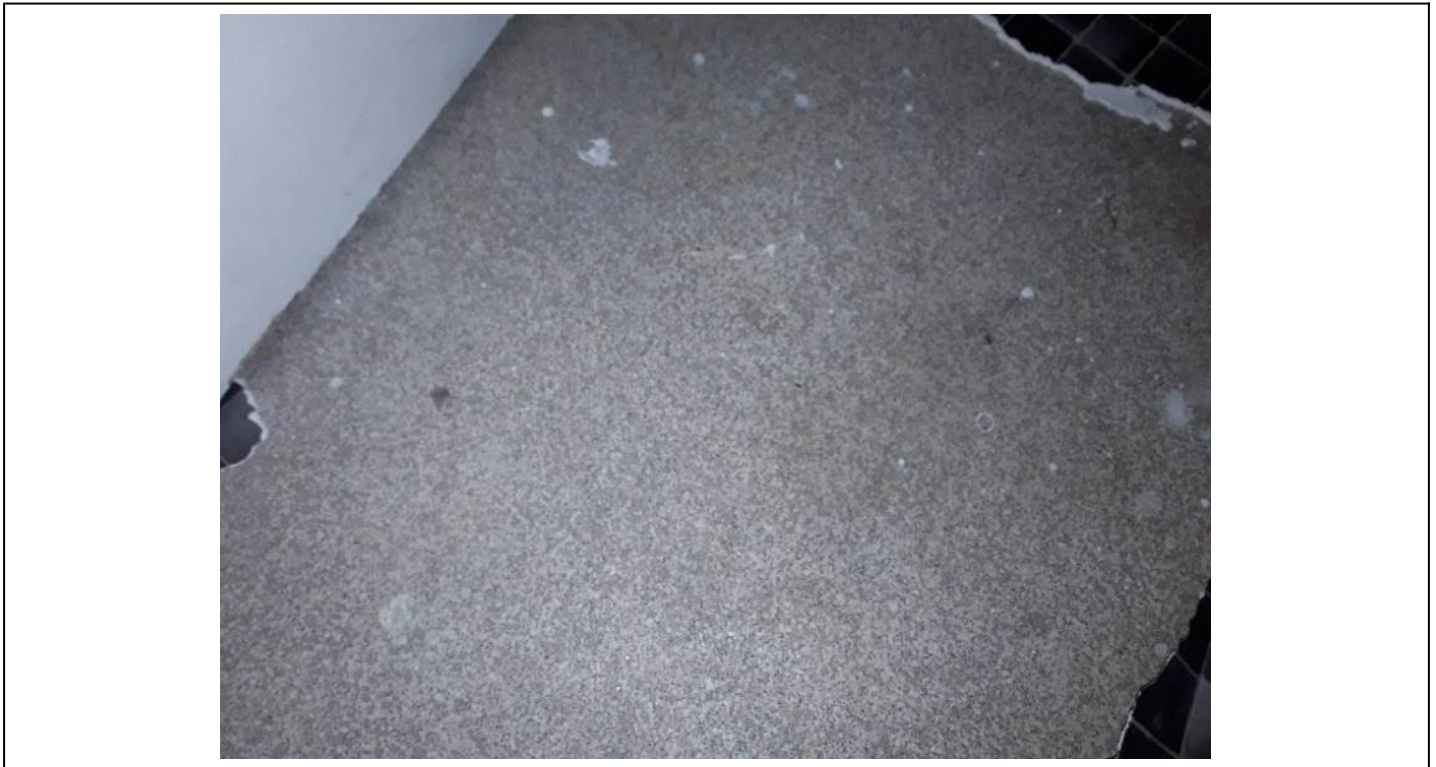
Item Number:	3 Ref Item: N/A	Sample Reference	AM001071
Item Description:	Vinyl to the floor	Approx. Quantity:	N/A
Position:	Ceiling	Identification:	Identified
Item Material:	N/A	Asbestos Present:	No Asbestos Detected

Total Assessment:	N/A	N/A
Sample notes:	N/A	
Comments:	Below the modern non-asbestos vinyl, no access below due to being sampled.	
Recommendation:	No further action required	Timescale N/A

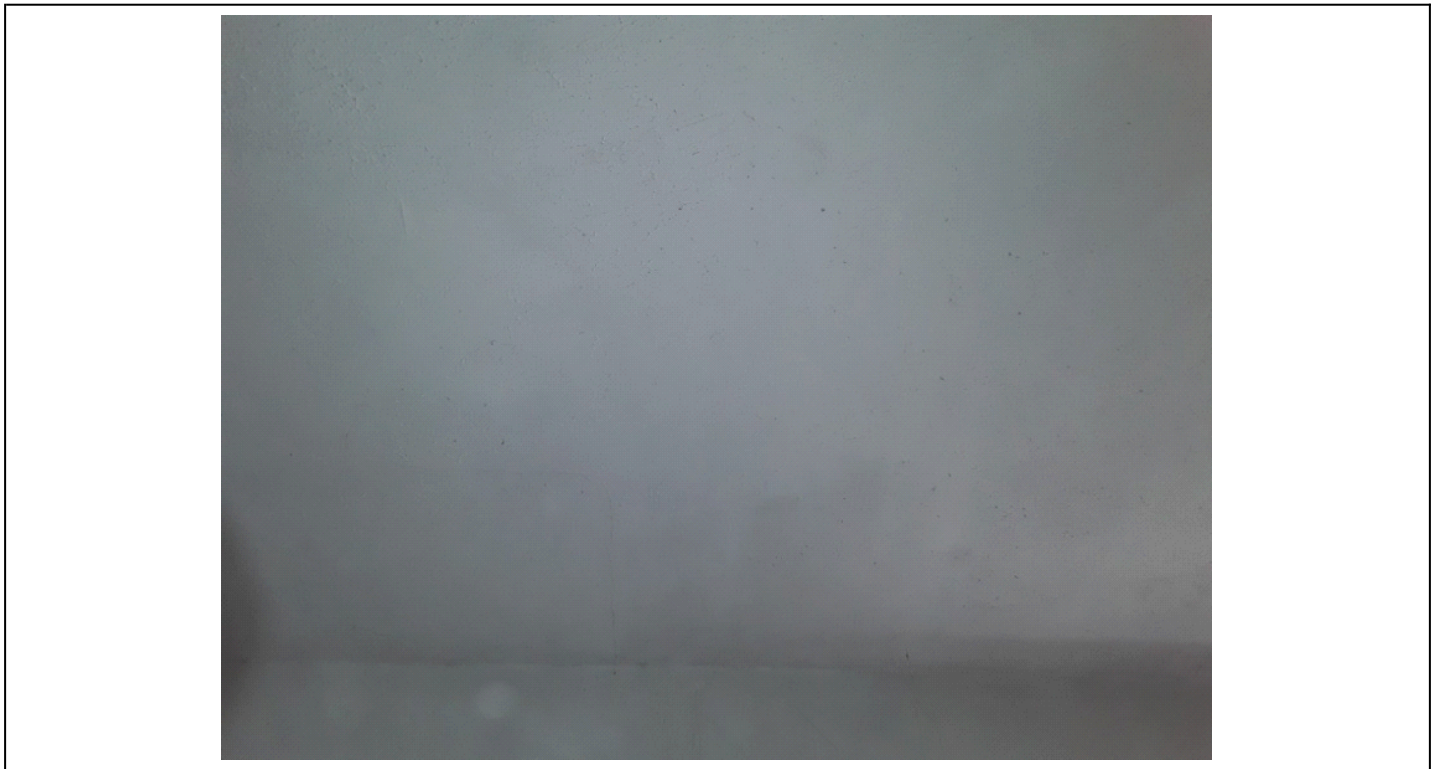
Item Number:	4 Ref Item: N/A	Sample Reference	AM001072
Item Description:	Textured coating to the plasterboard ceiling	Approx. Quantity:	N/A
Position:	Ceiling	Identification:	Identified
Item Material:	N/A	Asbestos Present:	No Asbestos Detected

Total Assessment:	N/A	N/A	
Sample notes:	N/A		
Comments:	No access above due to being sampled.		
Recommendation:	No further action required	Timescale	N/A

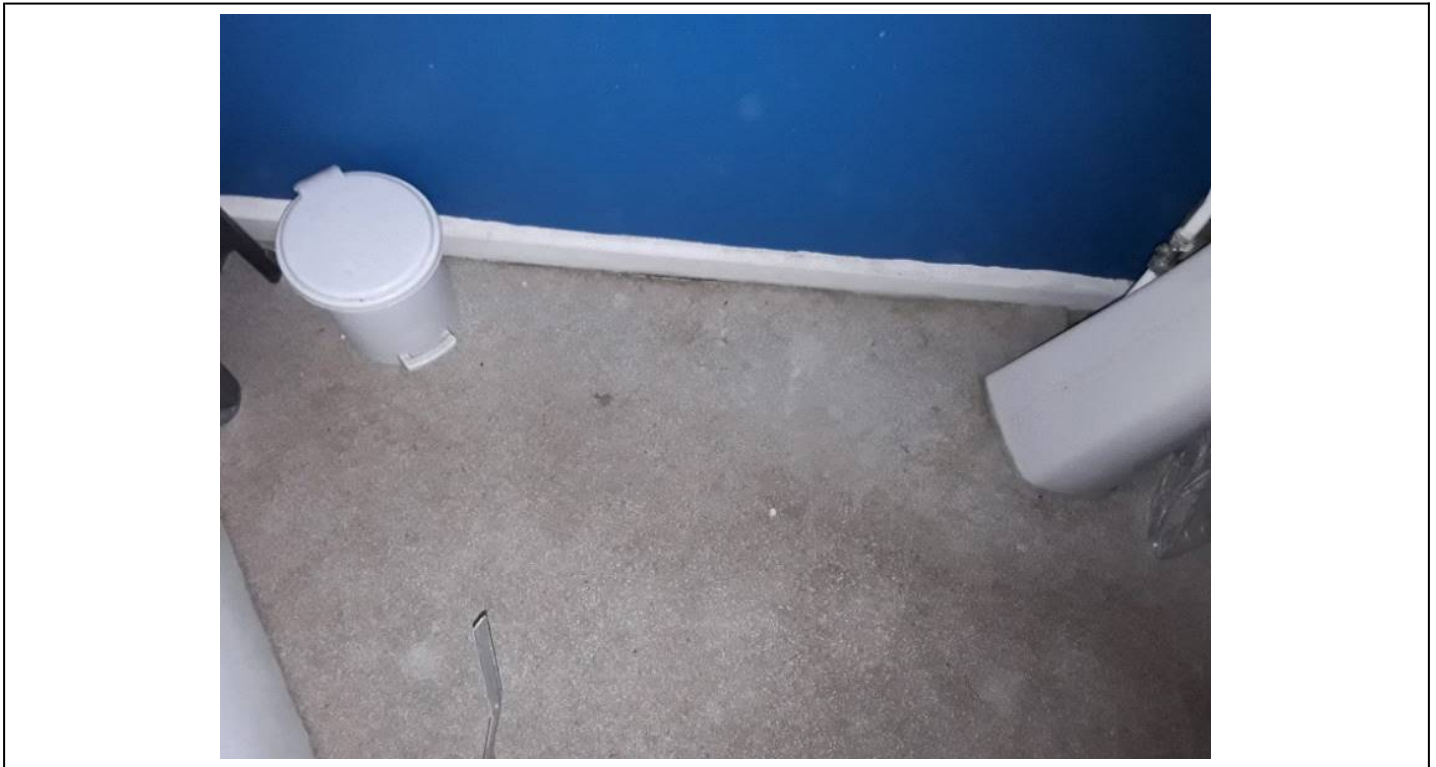
Item Number:	7 Ref Item: 3	Sample Reference	AS/ AM001071
Item Description:	Vinyl to the floor	Approx. Quantity:	N/A
Position:	Ceiling	Identification:	Strongly Presumed
Item Material:	N/A	Asbestos Present:	No Asbestos Detected

Total Assessment:	N/A	N/A
Sample notes:	N/A	
Comments:	No access below due to being sampled.	
Recommendation:	No further action required	Timescale: N/A

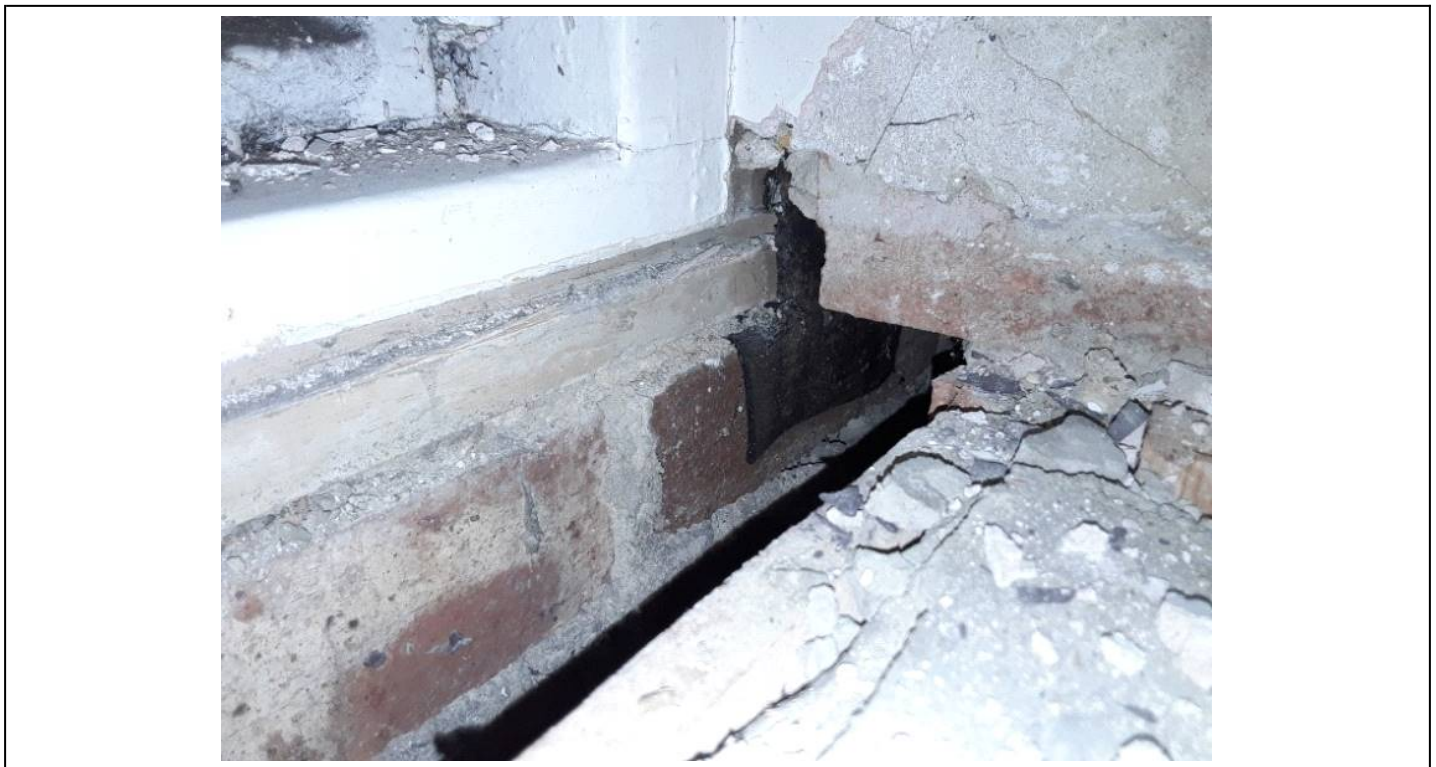
Item Number:	9 Ref Item: 1	Sample Reference	AS/ AM001068
Item Description:	Damp proof course to timber framework passing through the brick walls within the ceiling void	Approx. Quantity:	N/A
Position:	Ceiling void	Identification:	Strongly Presumed
Item Material:	N/A	Asbestos Present:	No Asbestos Detected

Total Assessment:	N/A	N/A	
Sample notes:	N/A		
Comments:	Identified to all timber framework on 1st floor within rooms.		
Recommendation:	No further action required	Timescale	N/A

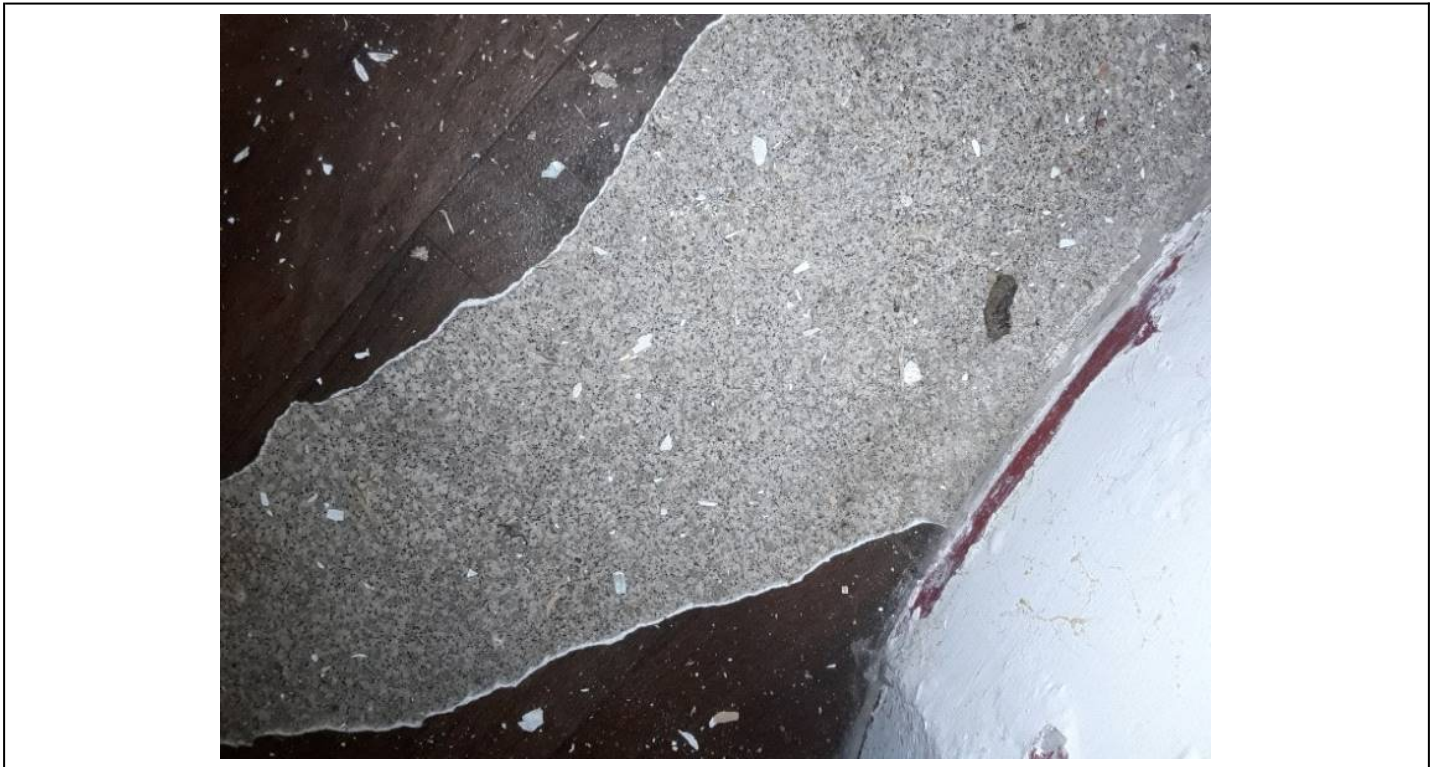
Item Number:	10 Ref Item: N/A	Sample Reference	AM001074
Item Description:	Vinyl to the floor	Approx. Quantity:	N/A
Position:	Floor	Identification:	Identified
Item Material:	N/A	Asbestos Present:	No Asbestos Detected

Total Assessment:	N/A	N/A
Sample notes:	N/A	
Comments:	Below the modern non-asbestos vinyl	
Recommendation:	No further action required	Timescale: N/A

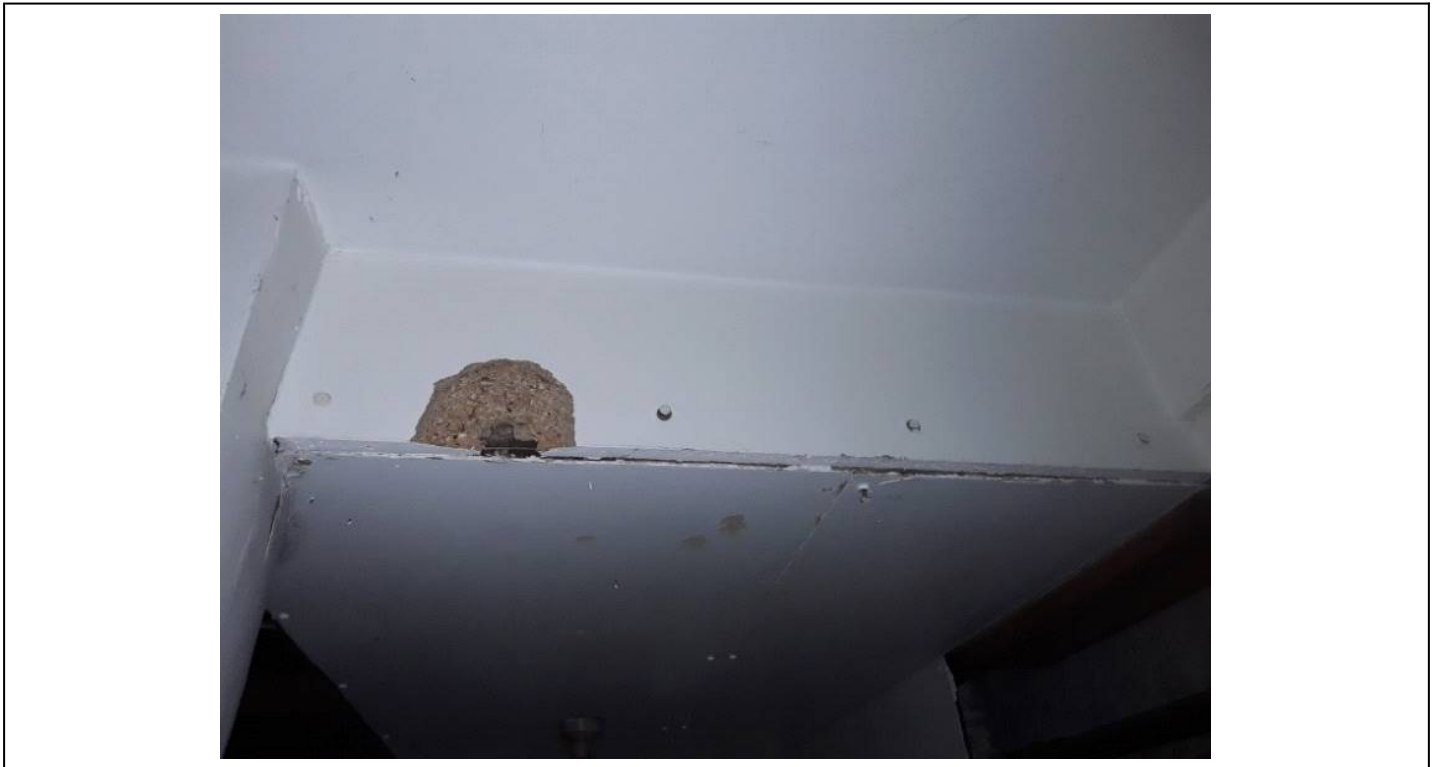
Item Number:	12 Ref Item: N/A	Sample Reference	AM001076
Item Description:	Board upstand	Approx. Quantity:	N/A
Position:	Upstand	Identification:	Identified
Item Material:	N/A	Asbestos Present:	No Asbestos Detected

Total Assessment:	N/A	N/A	
Sample notes:	N/A		
Comments:	Millboard.		
Recommendation:	No further action required	Timescale	N/A

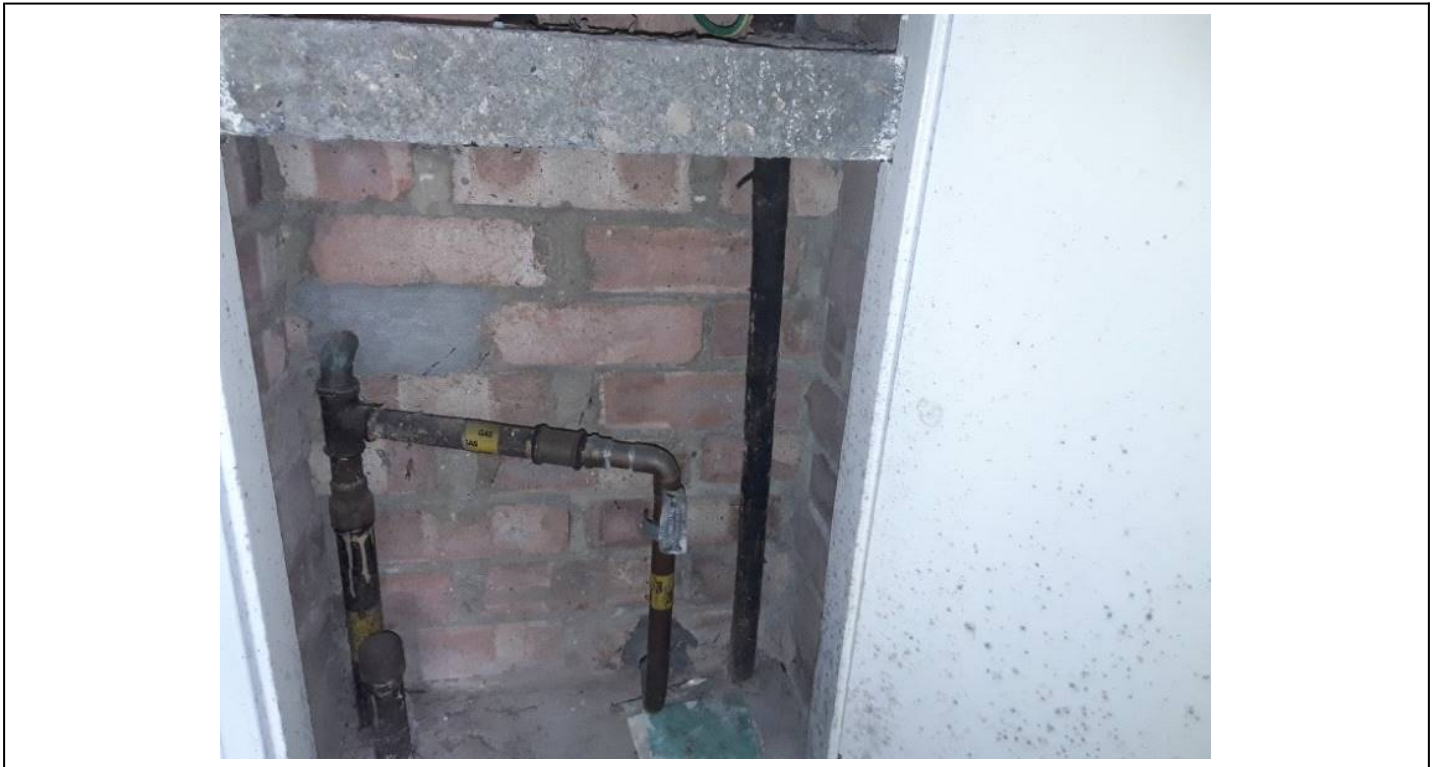
Item Number:	13 Ref Item: N/A	Sample Reference	AM001077
Item Description:	Bitumen wrapped cable	Approx. Quantity:	N/A
Position:	Electrics	Identification:	Identified
Item Material:	N/A	Asbestos Present:	No Asbestos Detected

Total Assessment:	N/A	N/A	
Sample notes:	N/A		
Comments:	No comments.		
Recommendation:	No further action required	Timescale	N/A

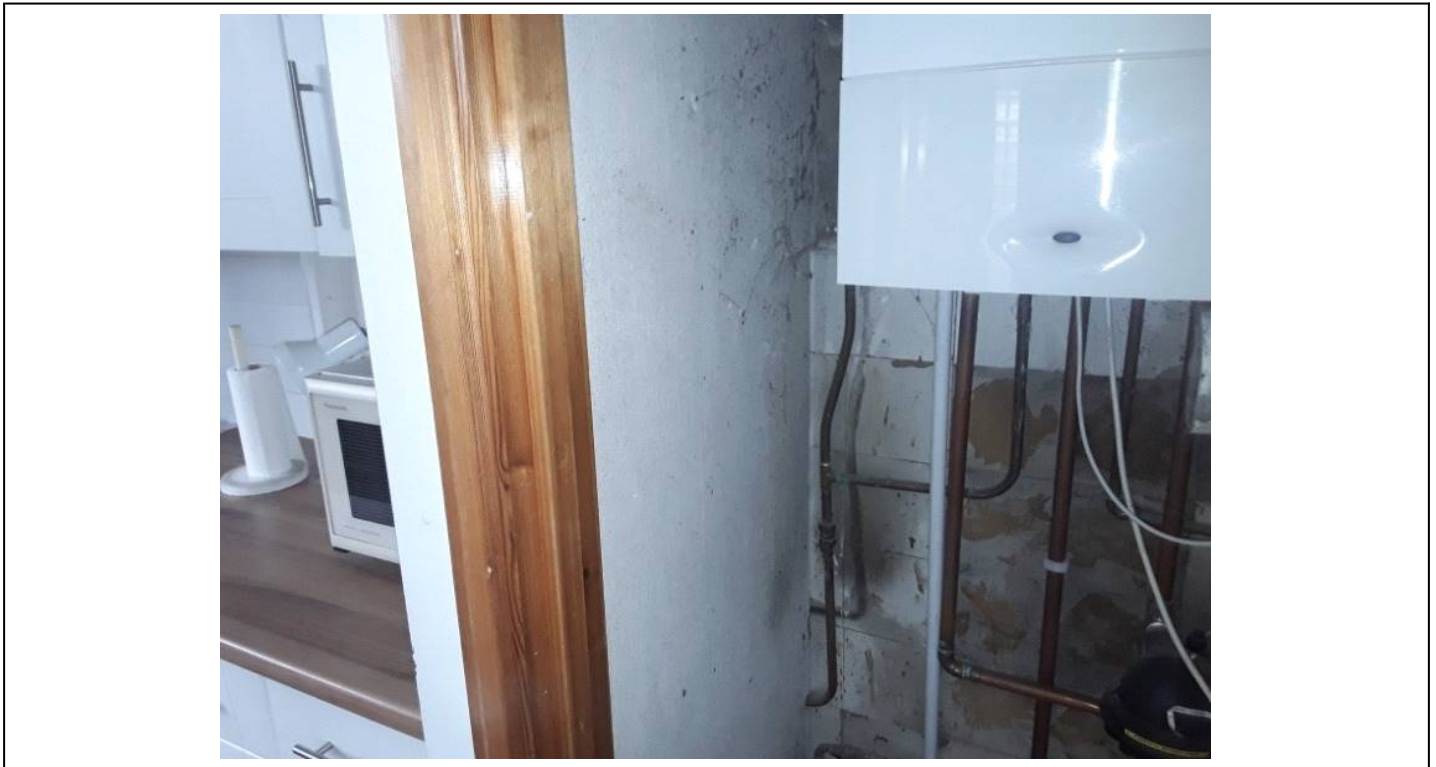
Item Number:	15 Ref Item: N/A	Sample Reference	AM001078
Item Description:	Board wall within cupboard	Approx. Quantity:	N/A
Position:	Wall	Identification:	Identified
Item Material:	N/A	Asbestos Present:	No Asbestos Detected

Total Assessment:	N/A	N/A	
Sample notes:	N/A		
Comments:	No comments		
Recommendation:	No further action required	Timescale	N/A

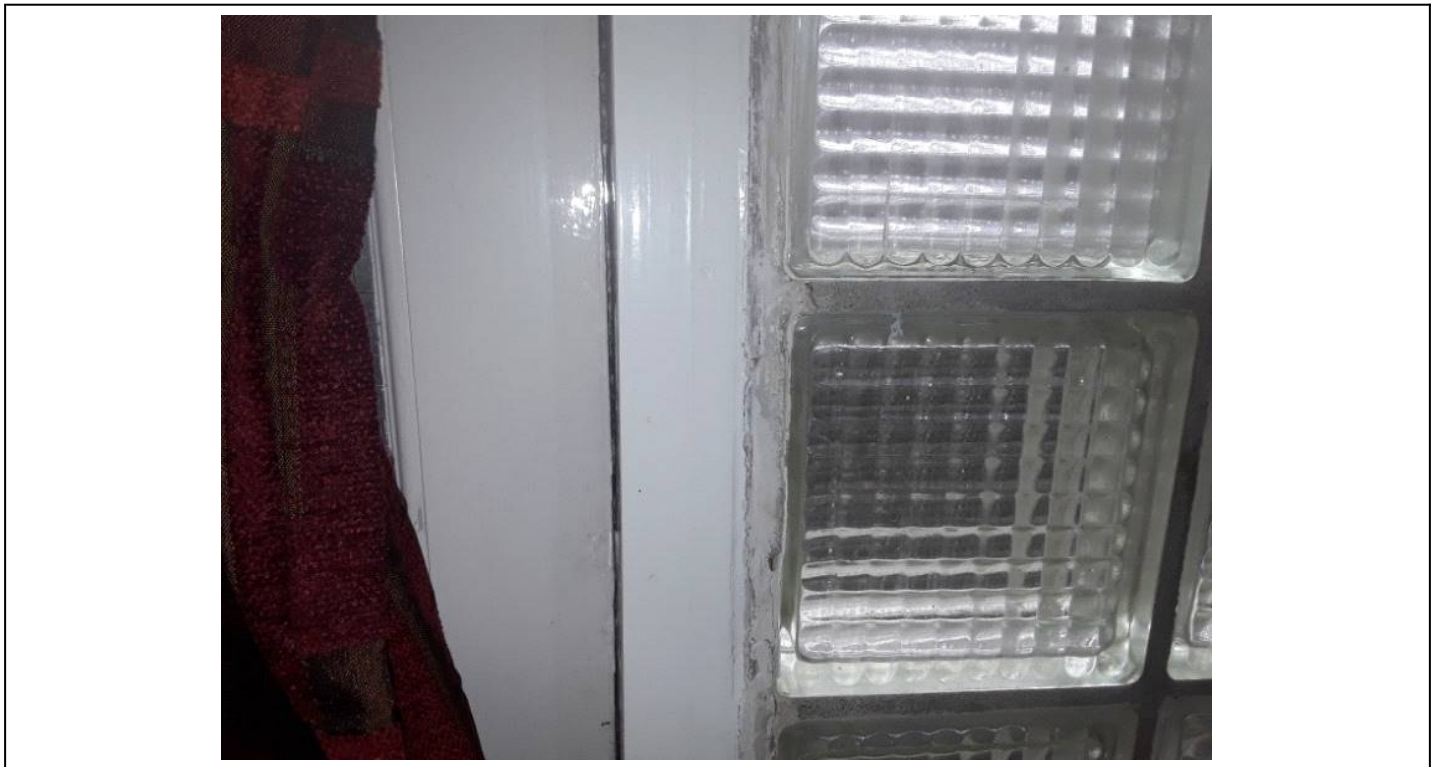
Item Number:	17 Ref Item: N/A	Sample Reference	AM001079
Item Description:	Mastic to glass of rear door surrounds	Approx. Quantity:	N/A
Position:	Glass	Identification:	Identified
Item Material:	N/A	Asbestos Present:	No Asbestos Detected

Total Assessment:	N/A	N/A	
Sample notes:	N/A		
Comments:			
Recommendation:	No further action required	Timescale	N/A

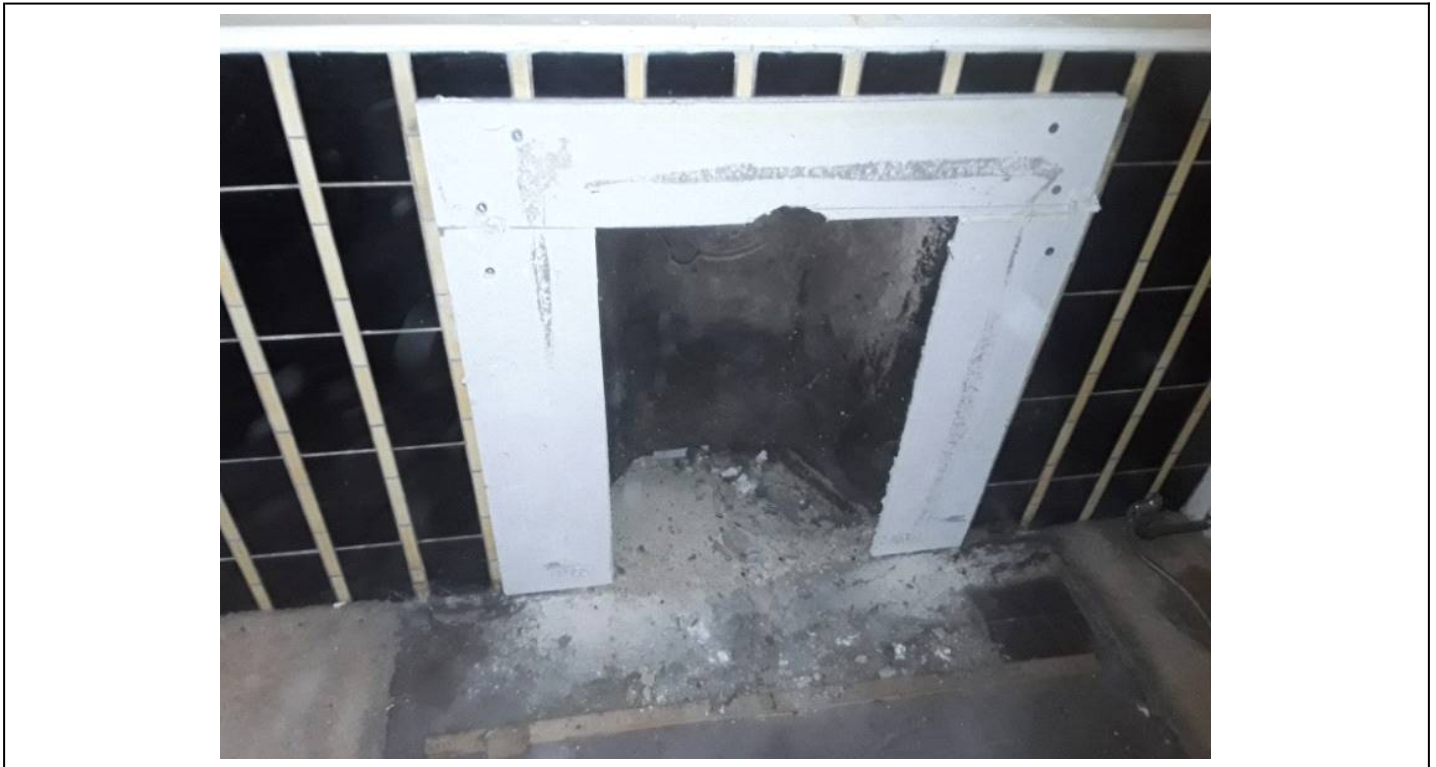
Item Number:	21 Ref Item: N/A	Sample Reference	AM001084
Item Description:	Board infills rear of fireplace	Approx. Quantity:	N/A
Position:	Fireplace	Identification:	Identified
Item Material:	N/A	Asbestos Present:	No Asbestos Detected

Total Assessment:	N/A	N/A	
Sample notes:	N/A		
Comments:	No comments		
Recommendation:	No further action required	Timescale	N/A

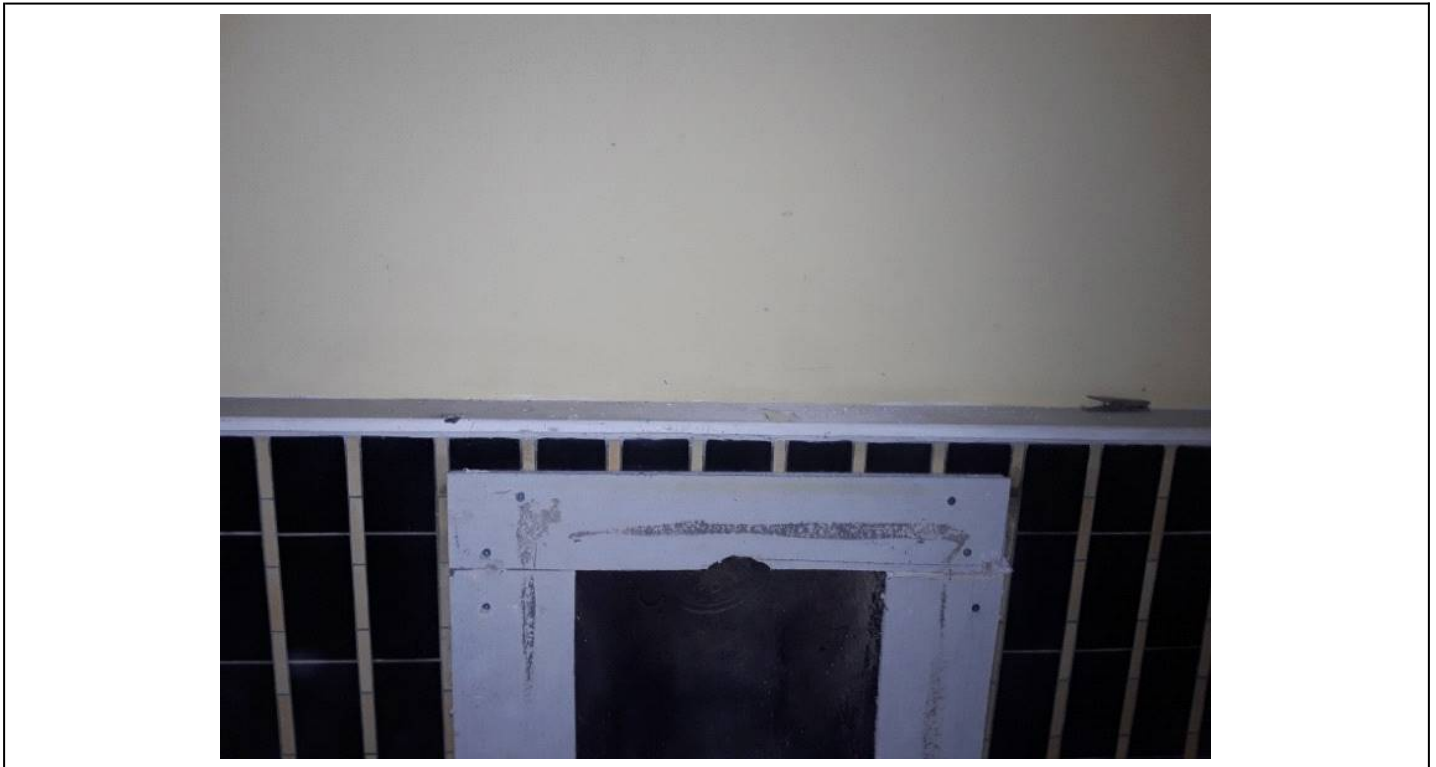
Item Number:	22 Ref Item: N/A	Sample Reference	AM001085
Item Description:	Bakerlite sill to fireplace	Approx. Quantity:	N/A
Position:	Fireplace	Identification:	Identified
Item Material:	N/A	Asbestos Present:	No Asbestos Detected

Total Assessment:	N/A	N/A	
Sample notes:	N/A		
Comments:	No comments		
Recommendation:	No further action required	Timescale	N/A

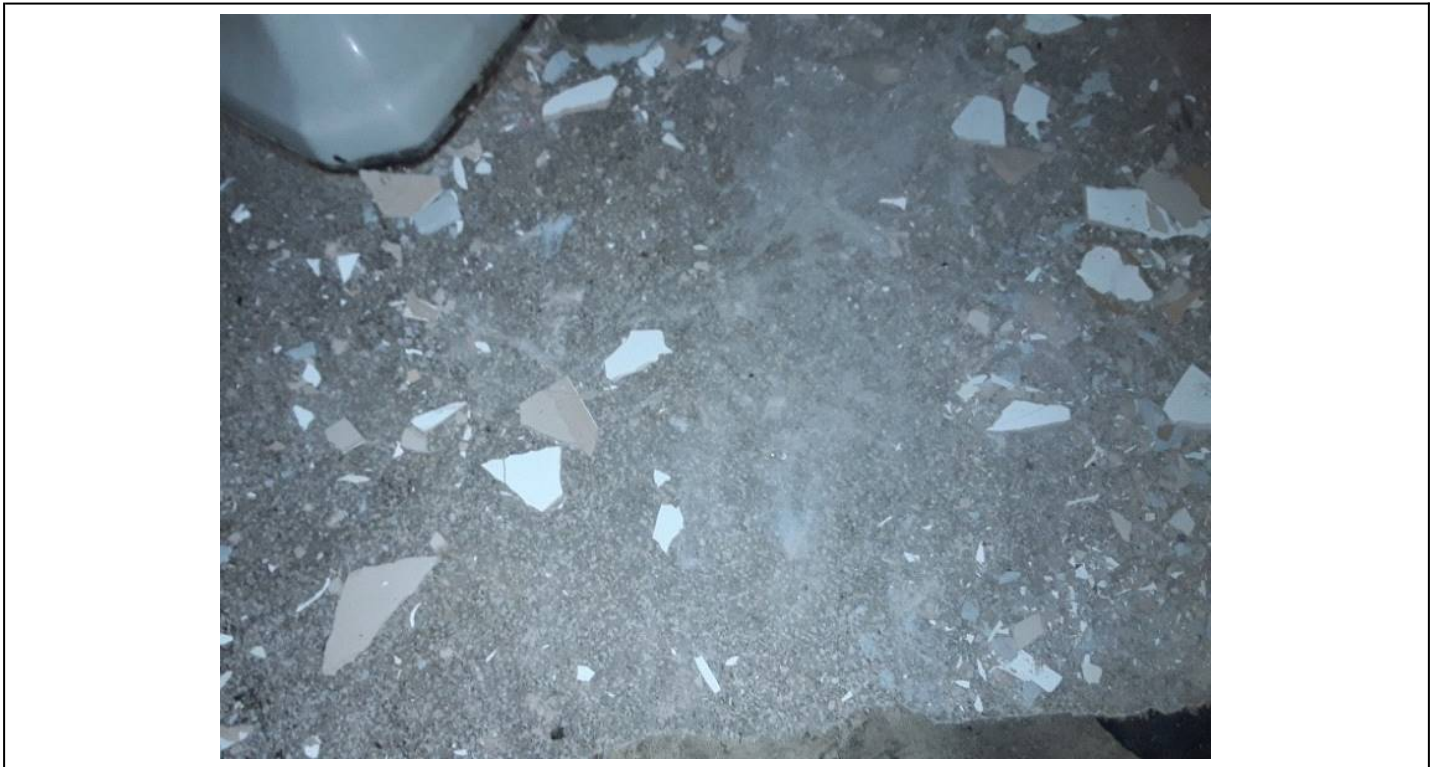
Item Number:	26 Ref Item: 10	Sample Reference	AS/ AM001074
Item Description:	Vinyl to the floor	Approx. Quantity:	N/A
Position:	Floor	Identification:	Strongly Presumed
Item Material:	N/A	Asbestos Present:	No Asbestos Detected

Total Assessment:	N/A	N/A	
Sample notes:	N/A		
Comments:	No comments.		
Recommendation:	No further action required	Timescale	N/A

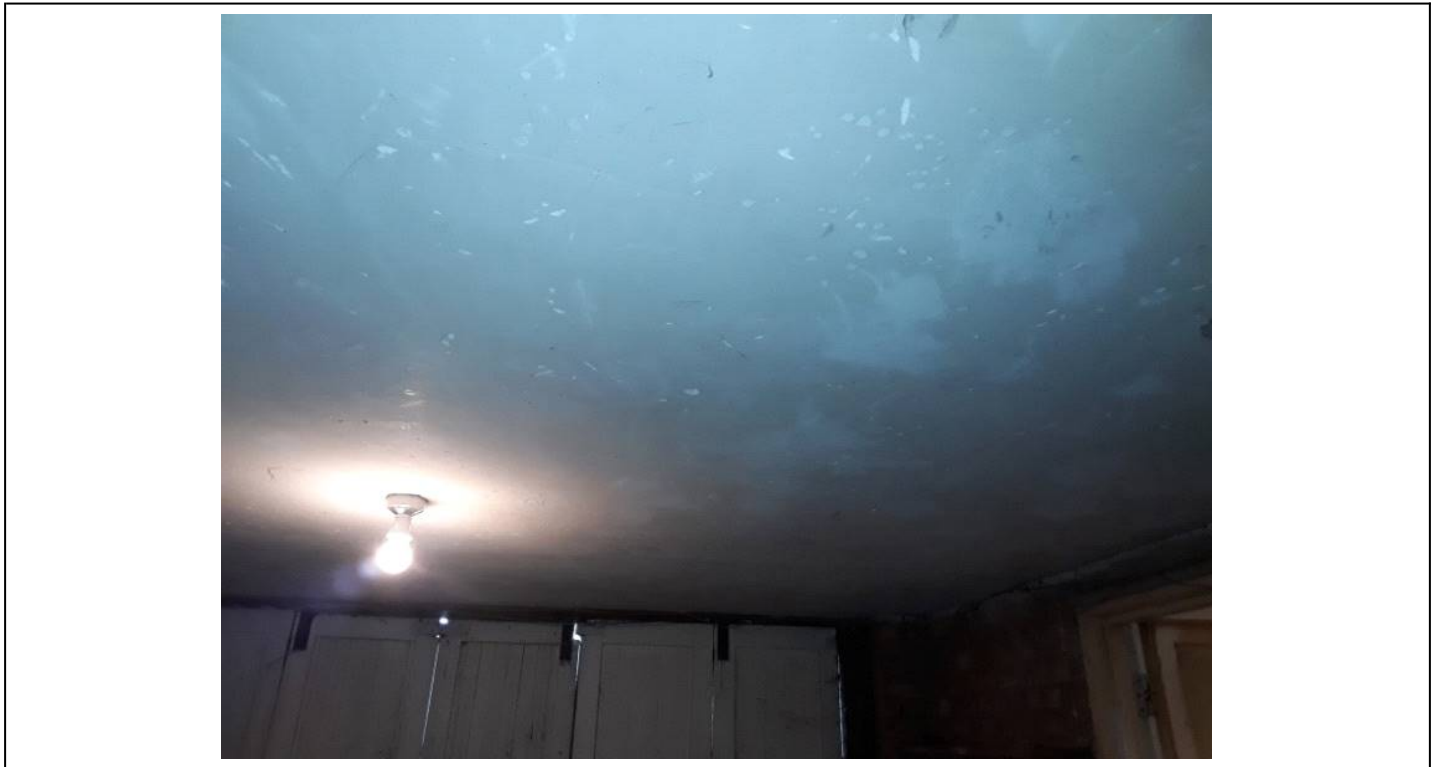
Item Number:	28 Ref Item: N/A	Sample Reference	AM001088
Item Description:	Board ceiling	Approx. Quantity:	N/A
Position:	Ceiling	Identification:	Identified
Item Material:	N/A	Asbestos Present:	No Asbestos Detected

Total Assessment:	N/A	N/A	
Sample notes:	N/A		
Comments:	No comments		
Recommendation:	No further action required	Timescale	N/A

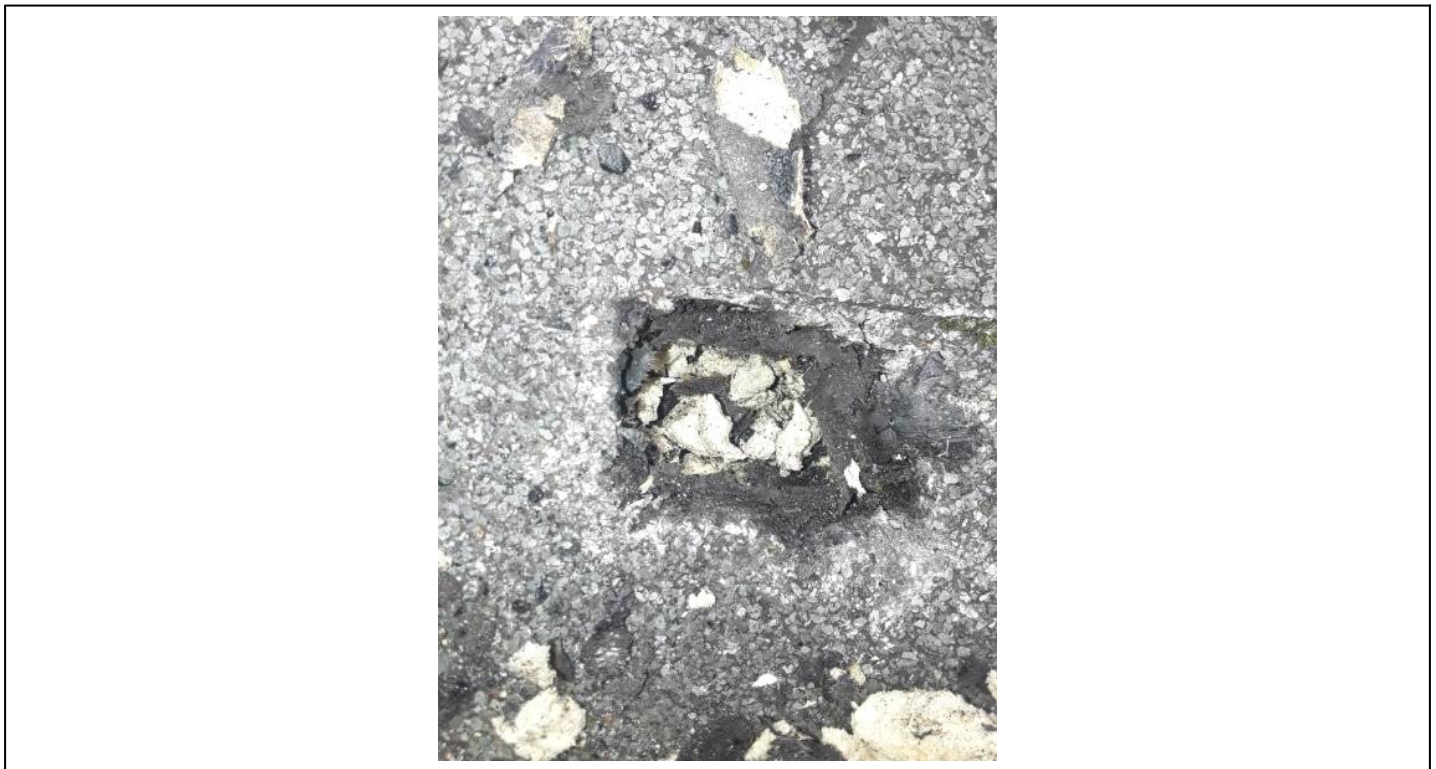
Item Number:	31 Ref Item: N/A	Sample Reference	AM001091
Item Description:	Bitumen felt to the flat roof	Approx. Quantity:	N/A
Position:	Roof area	Identification:	Identified
Item Material:	N/A	Asbestos Present:	No Asbestos Detected

Total Assessment:	N/A	N/A	
Sample notes:	N/A		
Comments:	Below the asphalt.		
Recommendation:	No further action required	Timescale	N/A

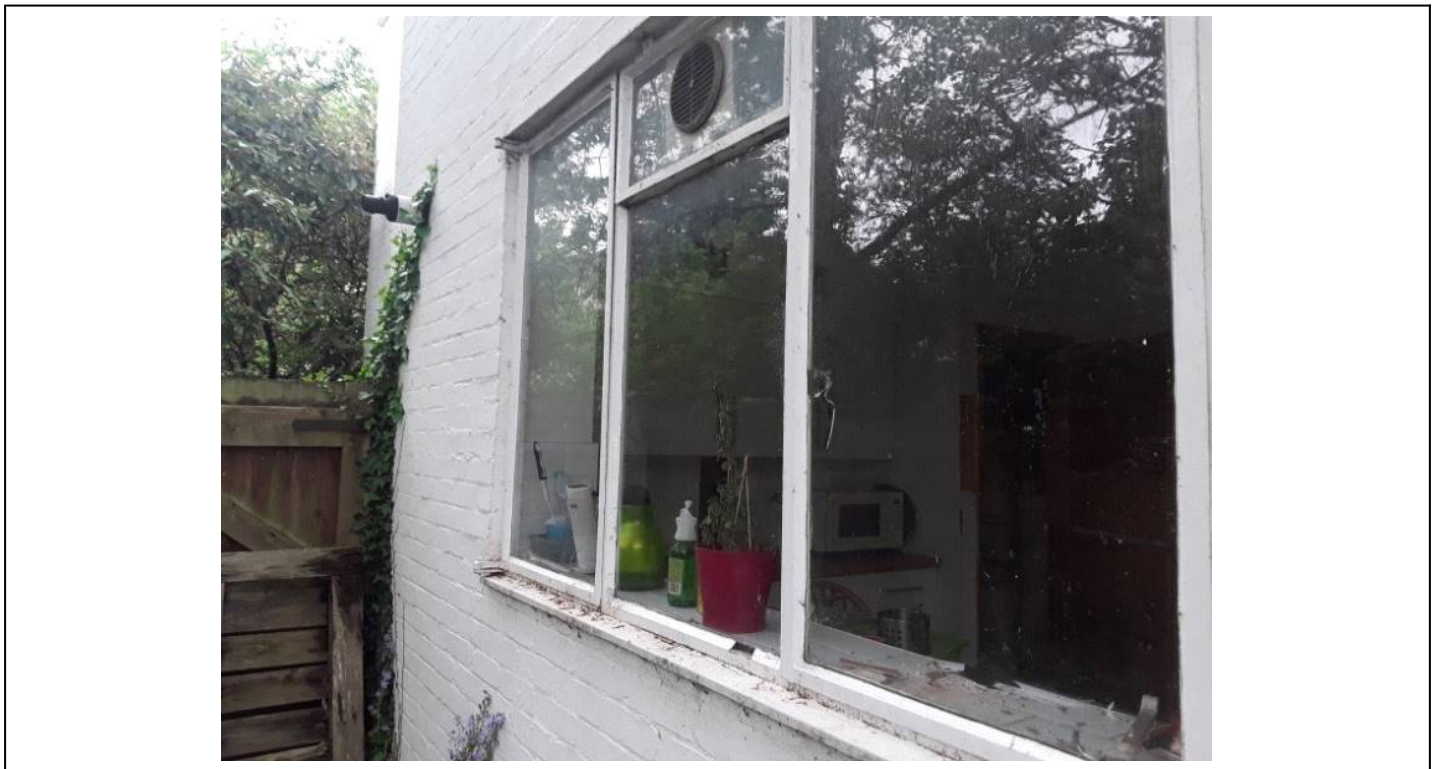
Item Number:	33 Ref Item: N/A	Sample Reference	AM001092
Item Description:	Putty to metal framed windows	Approx. Quantity:	N/A
Position:	Windows	Identification:	Identified
Item Material:	N/A	Asbestos Present:	No Asbestos Detected

Total Assessment:	N/A	N/A	
Sample notes:	N/A		
Comments:	Identified throughout property		
Recommendation:	No further action required	Timescale	N/A

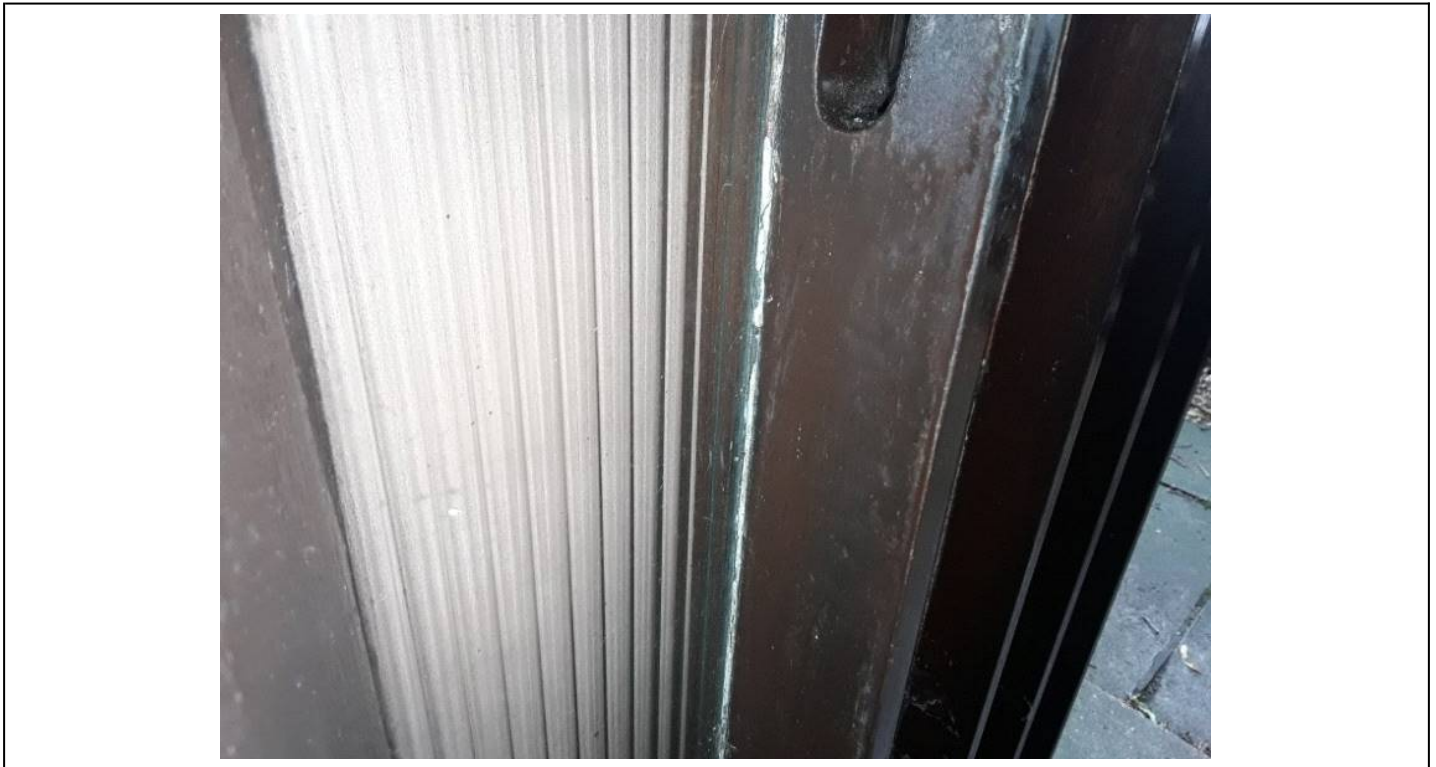
Item Number:	35 Ref Item: N/A	Sample Reference	AM001094
Item Description:	Mastic to front door glass	Approx. Quantity:	N/A
Position:	Door	Identification:	Identified
Item Material:	N/A	Asbestos Present:	No Asbestos Detected

Total Assessment:	N/A	N/A	
Sample notes:	N/A		
Comments:	No comments		
Recommendation:	No further action required	Timescale	N/A
