# Arboricultural Impact Assessment and Method Statement

**Report Reference: 3BACON001/09/19**

3 Bacon Lane, Camden, London

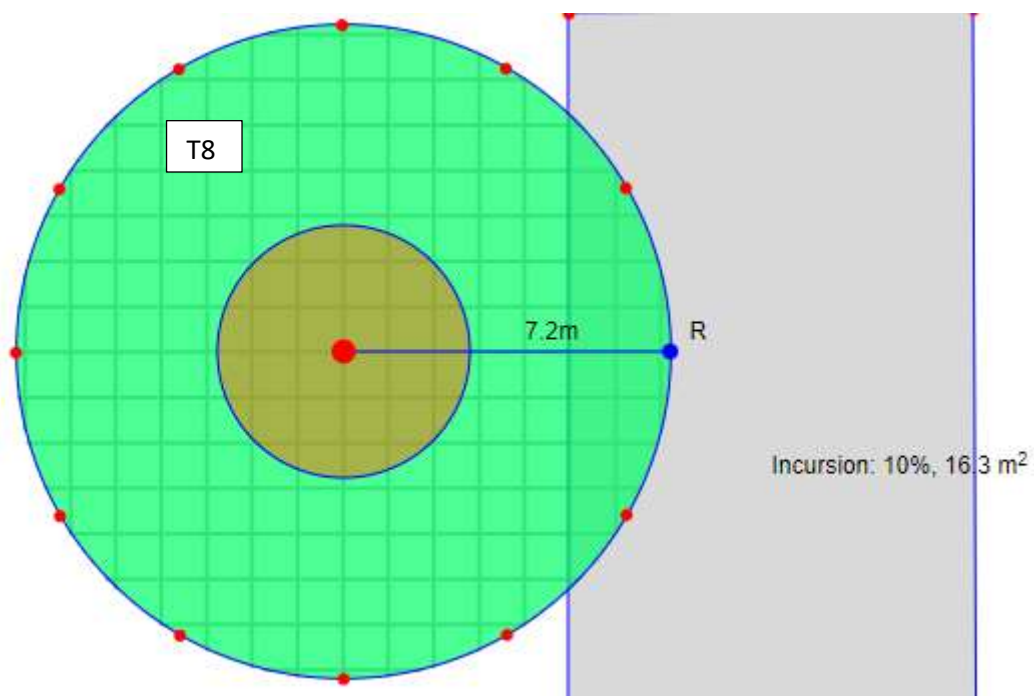
- 6.1 No construction maps have been supplied to Thor's tree. This report has been built on the demarcation of construction lines that have already been partially excavated.
- 6.2 There is no access conflict, as building materials will be brought through the house and side road.
- 6.3 No excavation depths have been provided to Thor's tree to inform this report.
- 6.3 Patio excavation falls within the RPA of T8. The level/depth of excavation should be considerably less than that of the building extension. The cross of the patio into the RPA is 10% by volume as the tree is 4.9m from the stem and the RPA is 7.2m. This level can be off-set by good rhizome management and aftercare.

- 7.1 Hand-dig methodology under arboriculture supervision should be employed for patio excavation into the RPA of T8 (SEE APPENDIX A).
- 7.2 Landscaping should be agreed to off-set tree loss within the rear garden of the property.
- 7.3 Lift T8 to 5m over property boundary to minimize potential for construction plant conflict.
- 7.4 Follow aftercare programme for T8 rhizome (SEE APPENDIX B)
- 7.5 Follow Tree Protection Plan ((TPP) SEE APPENDIX C)
