ARBORICULTURAL IMPACT ASSESSMENT REPORT

& OUTLINE METHOD STATEMENT:

12 Park Village West London NW1 4AE

Ref: CZL/12PVW/AIM/03a

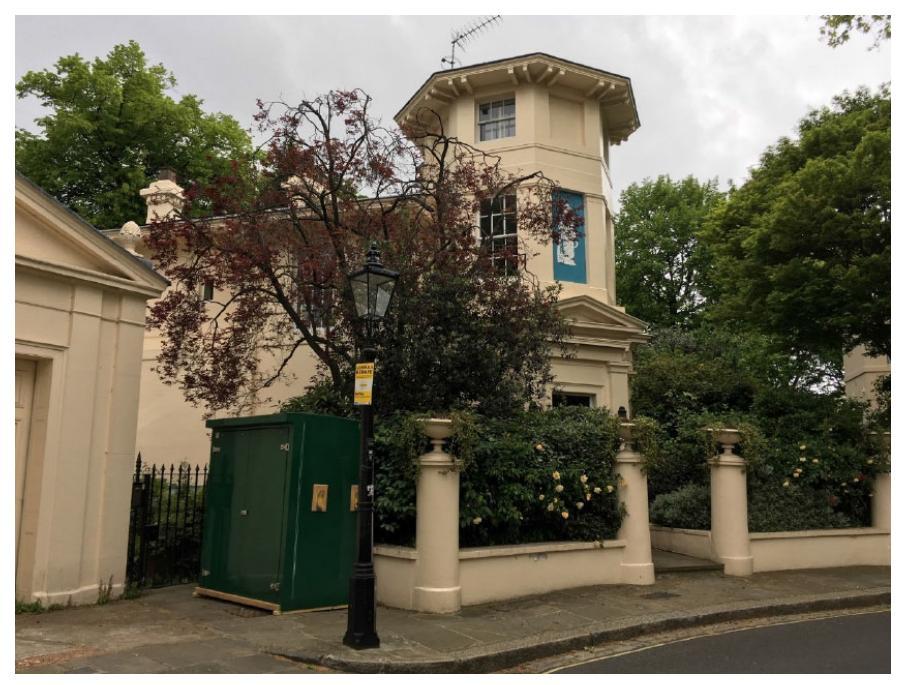
Photograph 1: 12 Park Village West, London NW1 4AE

- 3.1.1 12 Park Village West is an early Victorian 'villa' style property, situated on the northern corner of the Park Village West Road. The house lies within the generally gentle sloped setting toward Regents Canal. Although the areas to either side of no 12 are relatively flat, the site is divided into two levels: the front house and garage levelled with Park Village West road, and a lower ground level toward the garden facing Regents Canal area, with an approximately 3m difference in level.

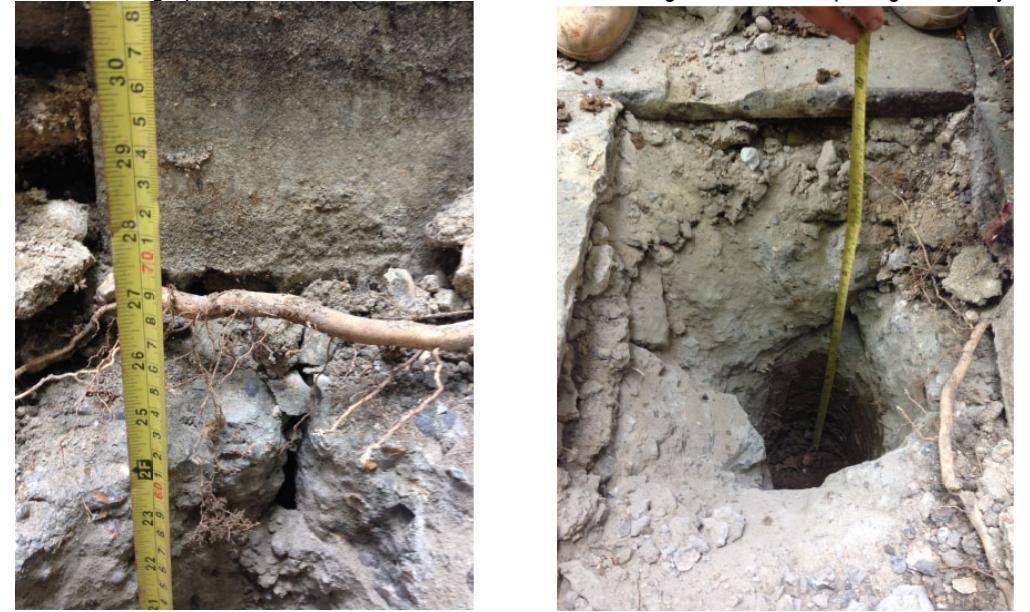
Photographs A4.1 - A4.4: Results from Trial Pit 8 showing one root in the paving slabs only

- A4.2 The roots/rootlets noted in Extract A4.1 above and Table A4 were identified by Richardson's Botanical Identifications (see letter below).
- A4.3 It has been agreed between the Tree Officer Nick Bell and Landmark Trees during the site meeting on the 5th August 2015 and subsequent emails that none of the trial pits contained significant roots. Whilst it was noted TP8 was a 'hole' rather than a trench, it was noted that the 600mm of concrete excavated to provide the trial pit evidence had clearly restricted root colonisation in this area.
