Pinpoint Drainage Services Ltd

17 Branch Hill Hampstead

21 July 2019

Project Name: 17 Branch Hill Hampstead	Project Number: SJC21719	Date: 21/07/2019	Contact: Karl Zadeh
--	------------------------------------	----------------------------	-------------------------------

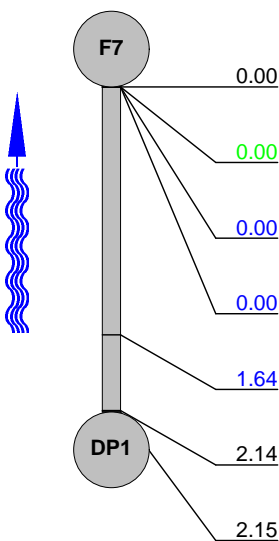
Comment :	No Structural Defects Identified
-----------	---

ST	Start of survey	(Misc) 0
	0.00	MH	Manhole Remarks: F7	(Constr) 0
	0.00	WL	Water level, 5% of sewer height	(Serv) 0
	0.00	LL	Line of sewer deviates left	(Serv) 0
	1.64	LU	Line of sewer deviates up	(Serv) 0
	2.14	GO	General observation Remarks: Drain Point 1 Reached	(Misc) 0
	2.15	FH	Finish survey	(Misc) 0

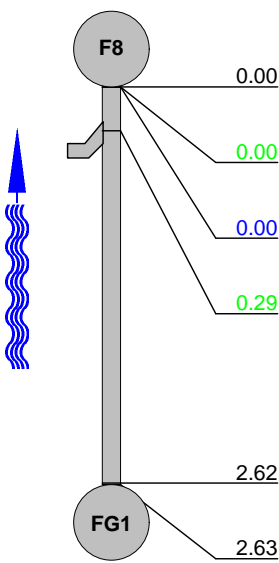
Comment :	No Structural Defects Identified
-----------	---

0.00	ST	Start of survey	(Misc) 0
	0.00	MH	Manhole Remarks: F8	(Constr) 0
	0.00	WL	Water level, 5% of sewer height	(Serv) 0
	0.29	JN	Junction, at 3 o'clock, 100mm diameter	(Constr) 0
	2.62	GO	General observation Remarks: Floor Gully 1 Reached	(Misc) 0
	2.63	FH	Finish survey	(Misc) 0

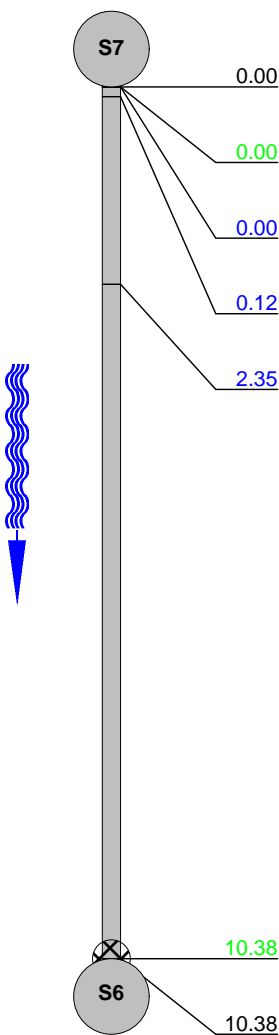
Comment :	No Structural Defects Identified
-----------	---

0.00	ST	Start of survey	(Misc) 0
	0.00	MH	Manhole Remarks: S7	(Constr) 0
	0.00	WL	Water level, 5% of sewer height	(Serv) 0
	0.12	LL	Line of sewer deviates left	(Serv) 0
	2.35	LR	Line of sewer deviates right	(Serv) 0
	10.38	MH	Manhole Remarks: S6 Reached (PS)	(Constr) 0
	10.38	FH	Finish survey	(Misc) 0

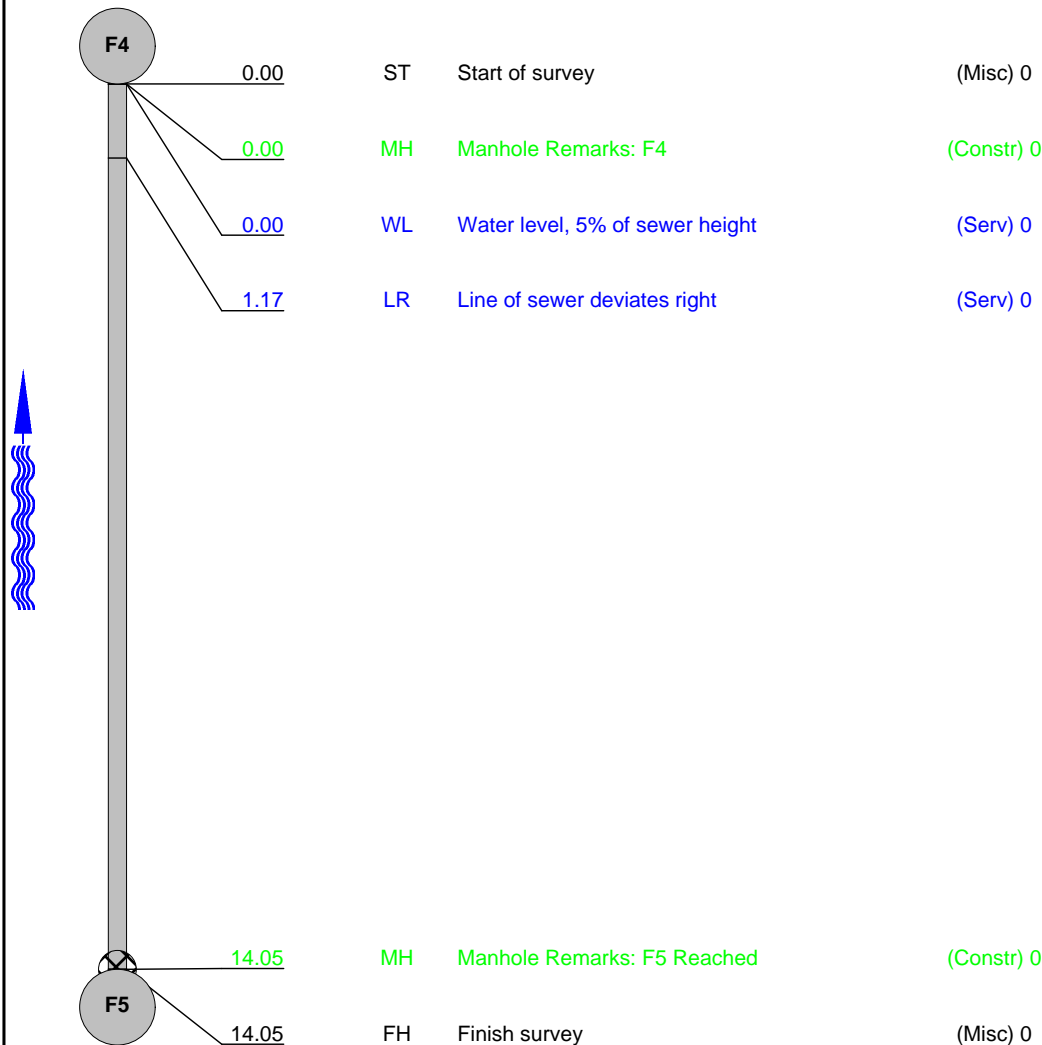
Comment : **No Structural Defects Identified**

1:120 Position Code Observation Grade
Manhole F4 and S1 are one chamber hence combined system

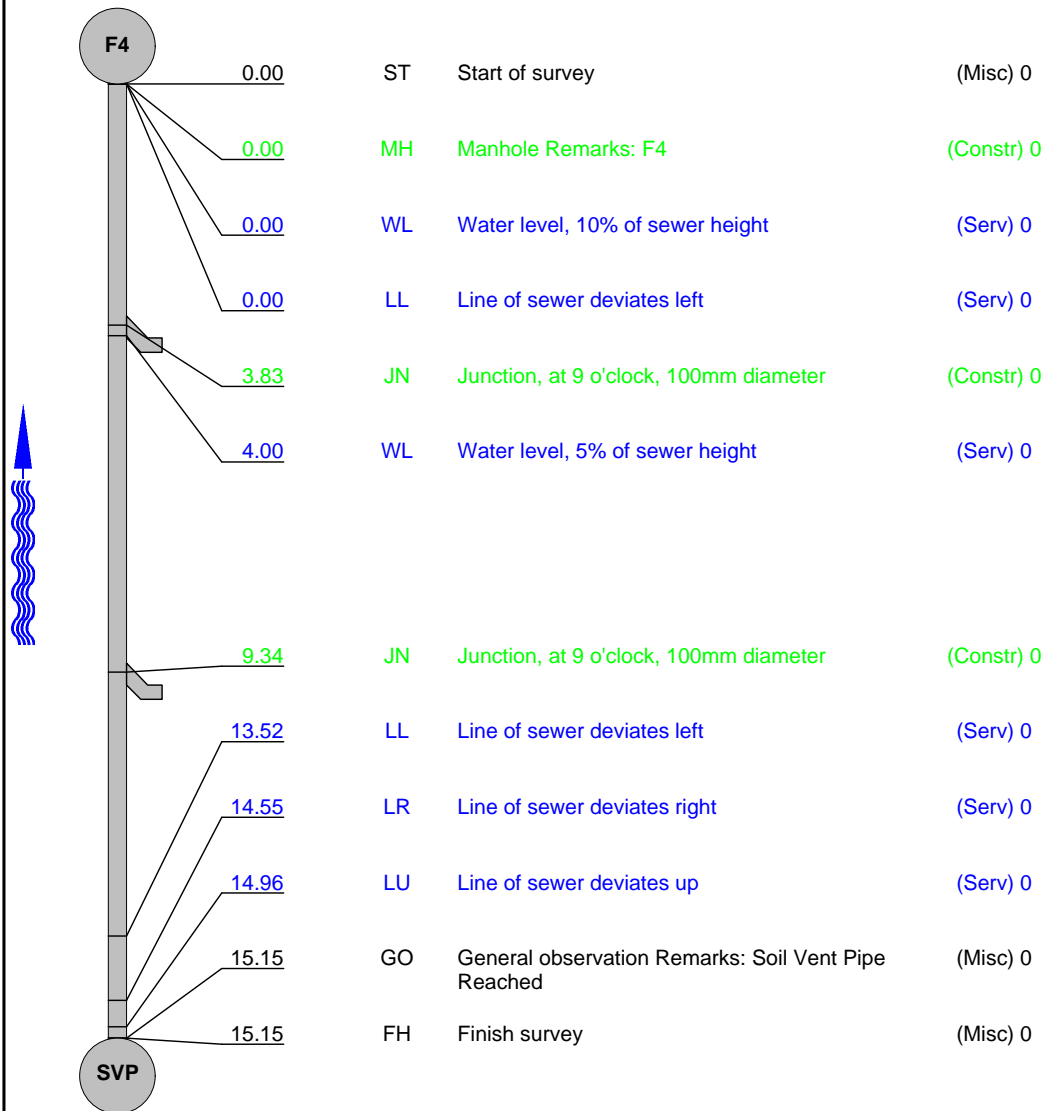
Comment : **No Structural Defects Identified**

1:120 Position Code Observation Grade
Manhole F4 and S1 are one chamber hence combined system
