DR WILLIAMS'S LIBRARY- 14 Gordon Square, London WC1H 0AR

HERITAGE STATEMENT | NOVEMBER 2019

8555-CPM- ZZ-ZZ-RP-A-10001

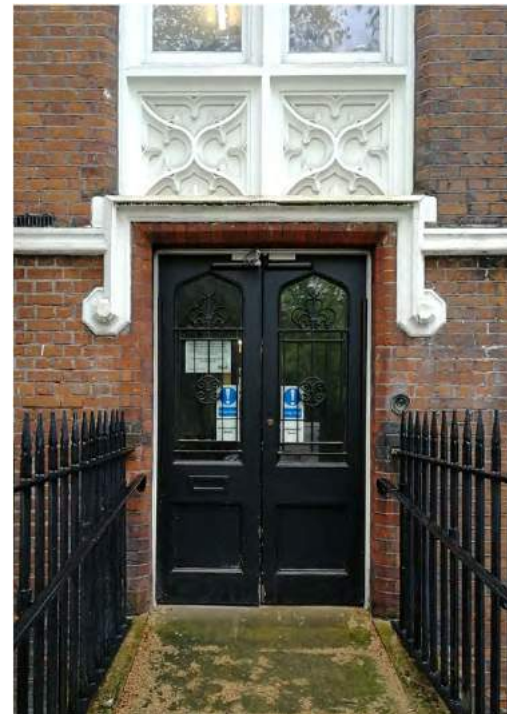
CONDITION SURVEY:
Entrance door to North Wing

It is proposed that the current ramp to the North wing will be removed and two new matching, free floating ramps will be introduced to serve the existing and new entrance doors to the North and South wings. York Stone will finish the ramps and new railings will be installed to match the existing listed railings on a like-for-like basis. Discreet call boxes will be placed on

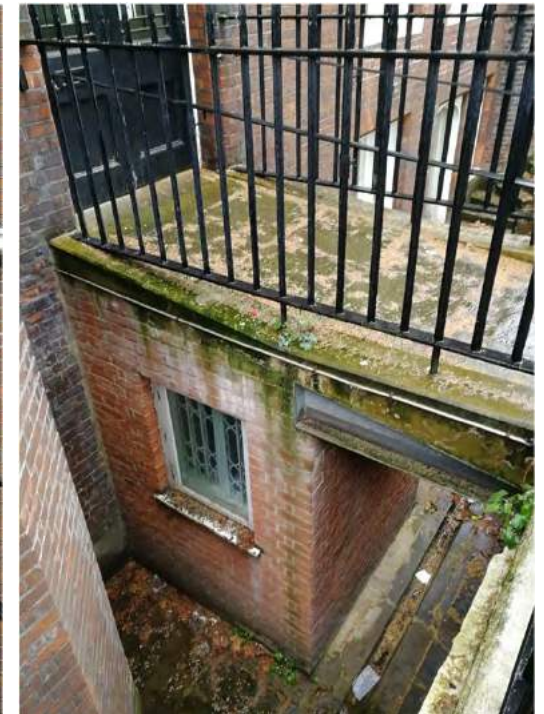
CONDITION SURVEY:
North Wing Extension and Ramp

Below the bridge link serving the North wing at level 2 is a modern brick extension, this is not in character with the existing brick construction of the Gordon Square façade. The proposed works includes the removal of this extension, and restoring the original building line of the front elevation. An external door will provide access to the proposed cycle-user showers.

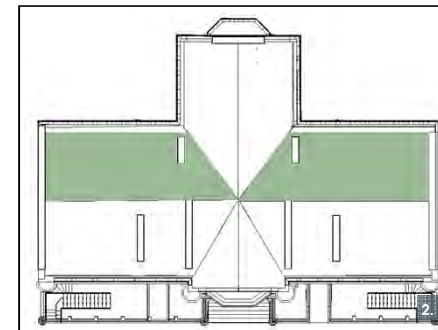
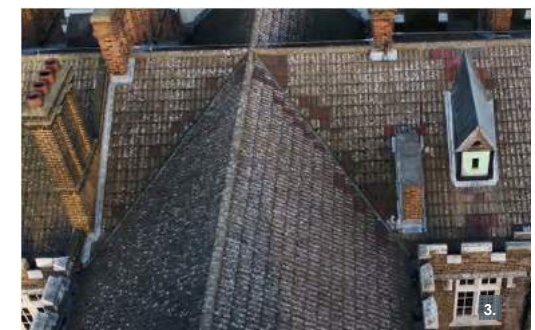
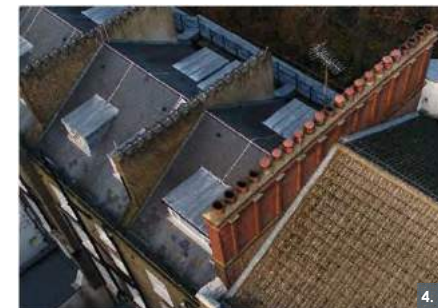
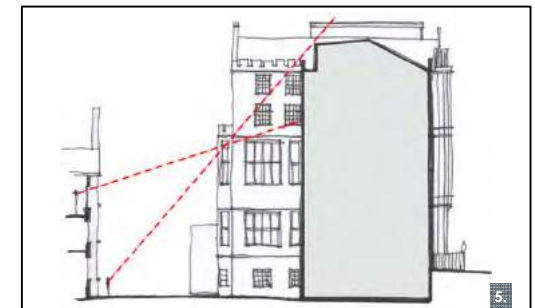
1- Original Donaldson specification extract.
2- Graphic indicating section of roof to be altered
4- Adjoining neighbours dormer's to front & rear

3- Drone Survey indicating chimney lost
5- Indicative Site Lines from courtyard & Morley building

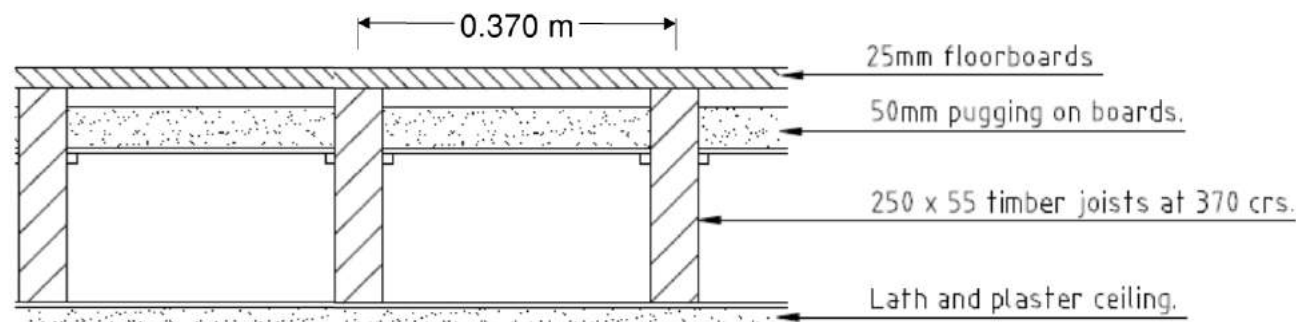
A typical floor build-up is shown in Figure 2, typically 50mm of pugging has been identified below the floorboards. Typically used for acoustic insulation, 50mm of mortar will make up a considerable portion of the permanent load of the floor. The existing floors would benefit greatly from the removal of the pugging and replacing it with lightweight modern acoustic insulation.

Figure 2: Typical single boarded floor build-up from Chamberlain Consulting Engineers' report

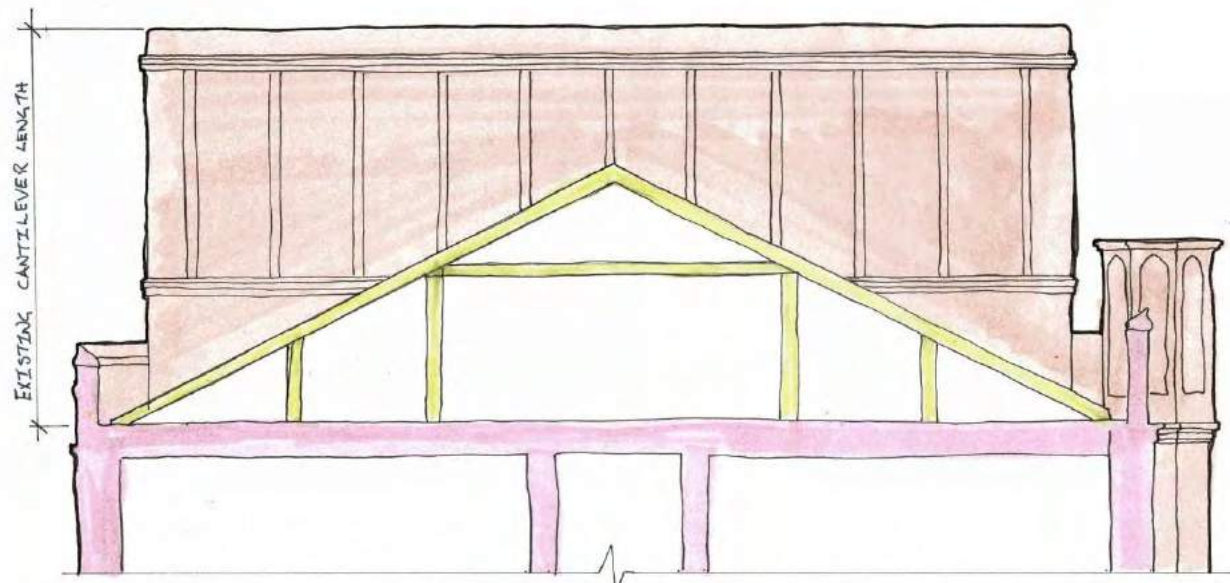
Figure 10: Elevation of north chimney stack showing existing cantilever length

Structural intervention will be required to stabilise the lateral movement of the stacks, and one strategy for this, combined with rebuilding the chimney stacks, is to reduce the length that the chimneys cantilever. This can be achieved by creating a dormer structure at roof level. The diaphragm to the dormer roof would be tied to the existing chimney, providing lateral restraint to the chimney and reducing the length of the cantilever.

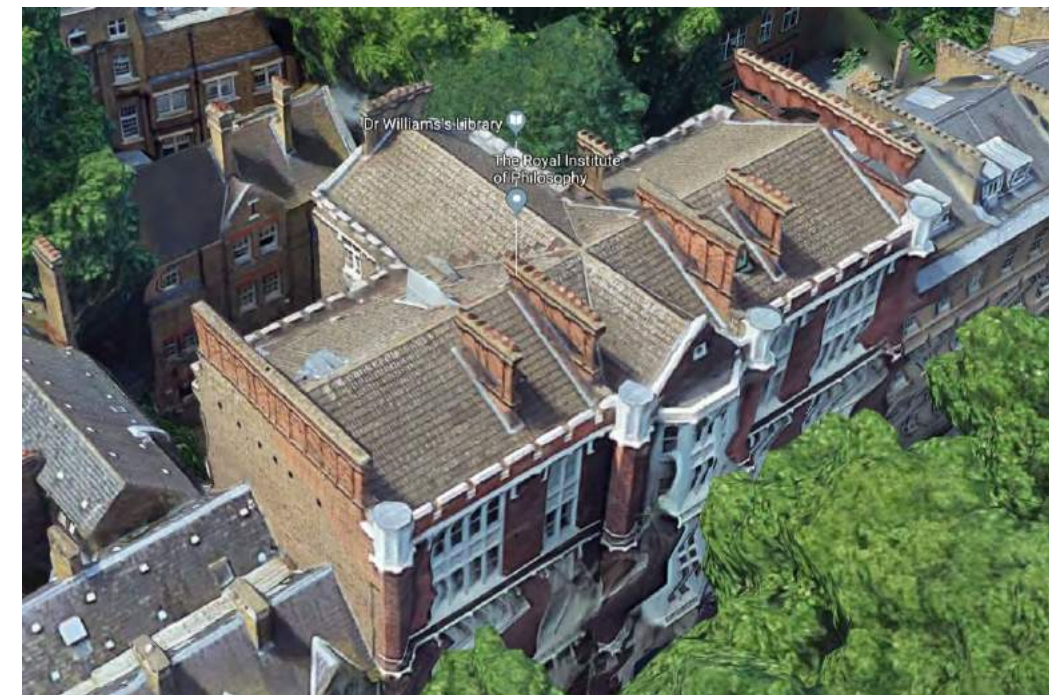
Strengthening and stiffening of the level 8 floor will also help to stabilise the two gable ends; the south gable has had steel discs applied at this level in order to counter lateral movement and will need to be re-connected to a stiffened floor structure. The north gable has not had these discs applied and further exploratory opening up work will be required to confirm that lateral support from a stiffened level 8 floor is also required at this location.

Figure 12: Roof of building from Google Maps. Steel discs visible at south wall

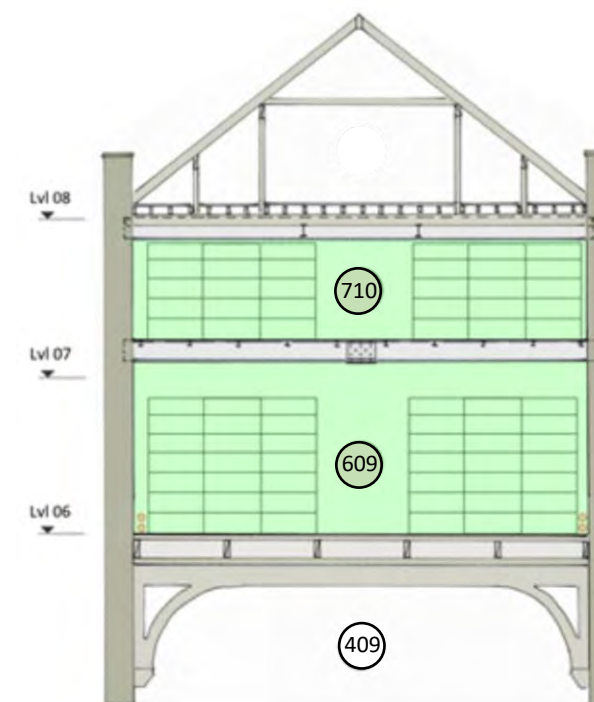
Figure 22: Existing Section through Central Core, existing Static Shelving shown indicatively

The floor structure at room 602 is largely unknown at present due to the decorative ceiling below and the heavy book stacks above, which have limited the ability to view the structure. Further investigation will be required during the proposed Enabling Works contract, however the proposed reduction in loading, coupled with the lack of obvious signs of structural distress, indicates that the proposed use of this floor for offices appears feasible and is structurally beneficial. It should be noted that if strengthening works are required at

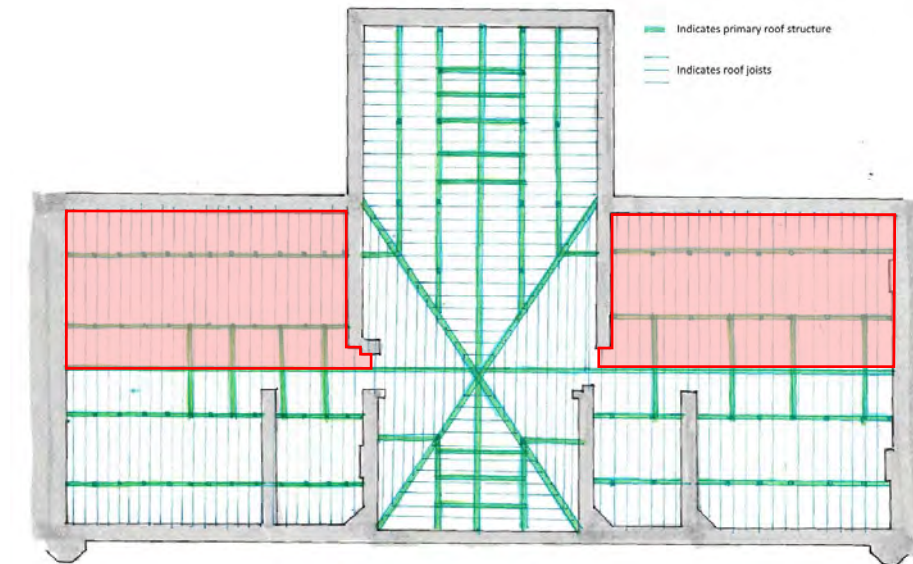
Figure 23: Plan of the existing roof structure showing the structure to be removed in red

- To allow for sufficient headroom to the 8th floor attic space, it is proposed that the existing structural layout be adapted and dormer windows added to the rear elevation. This will require the replacement of the existing timber rafters to the rear elevation of the North and South wings. The rafters to the central core and front elevation will remain untouched.

1. All floor joists will likely require replacement, as the level 8 floor would not likely have been designed for any specific imposed loads beyond those from the internal partition and roof. Replacement of the floor joists would also give the added benefit of allowing a diaphragm and ties to be included in the floor build-up to help restrain the tops of the masonry walls and tie the structure together.

2. The central core floor could be strengthened either by inserting new primary steel beams and/or by restraining the lateral buckling of existing steel members to enhance their capacity. Timber beams may need to be replaced or strengthened with new steel members. Material testing will be used to possibly justify the capacity of some of the existing beams to see if they can be retained.

3. For the north wing, a new structural scheme will be required to eliminate load transfers to lower floor structures. This may involve the replacement of the existing timber beams with new steel members. The south wing has not been opened up, due to possible asbestos, but it is assumed to be similar to the north wing.

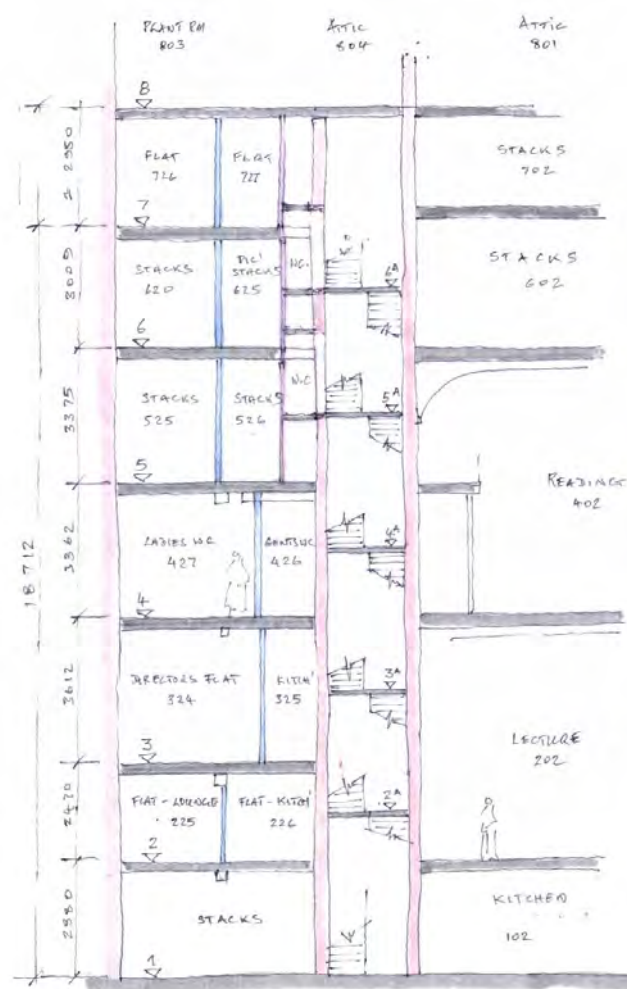
Figure 24: Sections looking east at south wing of building. Image on left shows existing building layout with remaining loadbearing timber stud walls.

Due to the sagging floors and inconsistent reinforcement done at the original lines of loadbearing timber stud walls, it is structurally advisable to remove the remainder of these timber walls and add new steel beams in their places which span between masonry walls. This will increase the robustness of the structure by making each floor self-supporting and minimizing the presence of transfer structures in these areas.

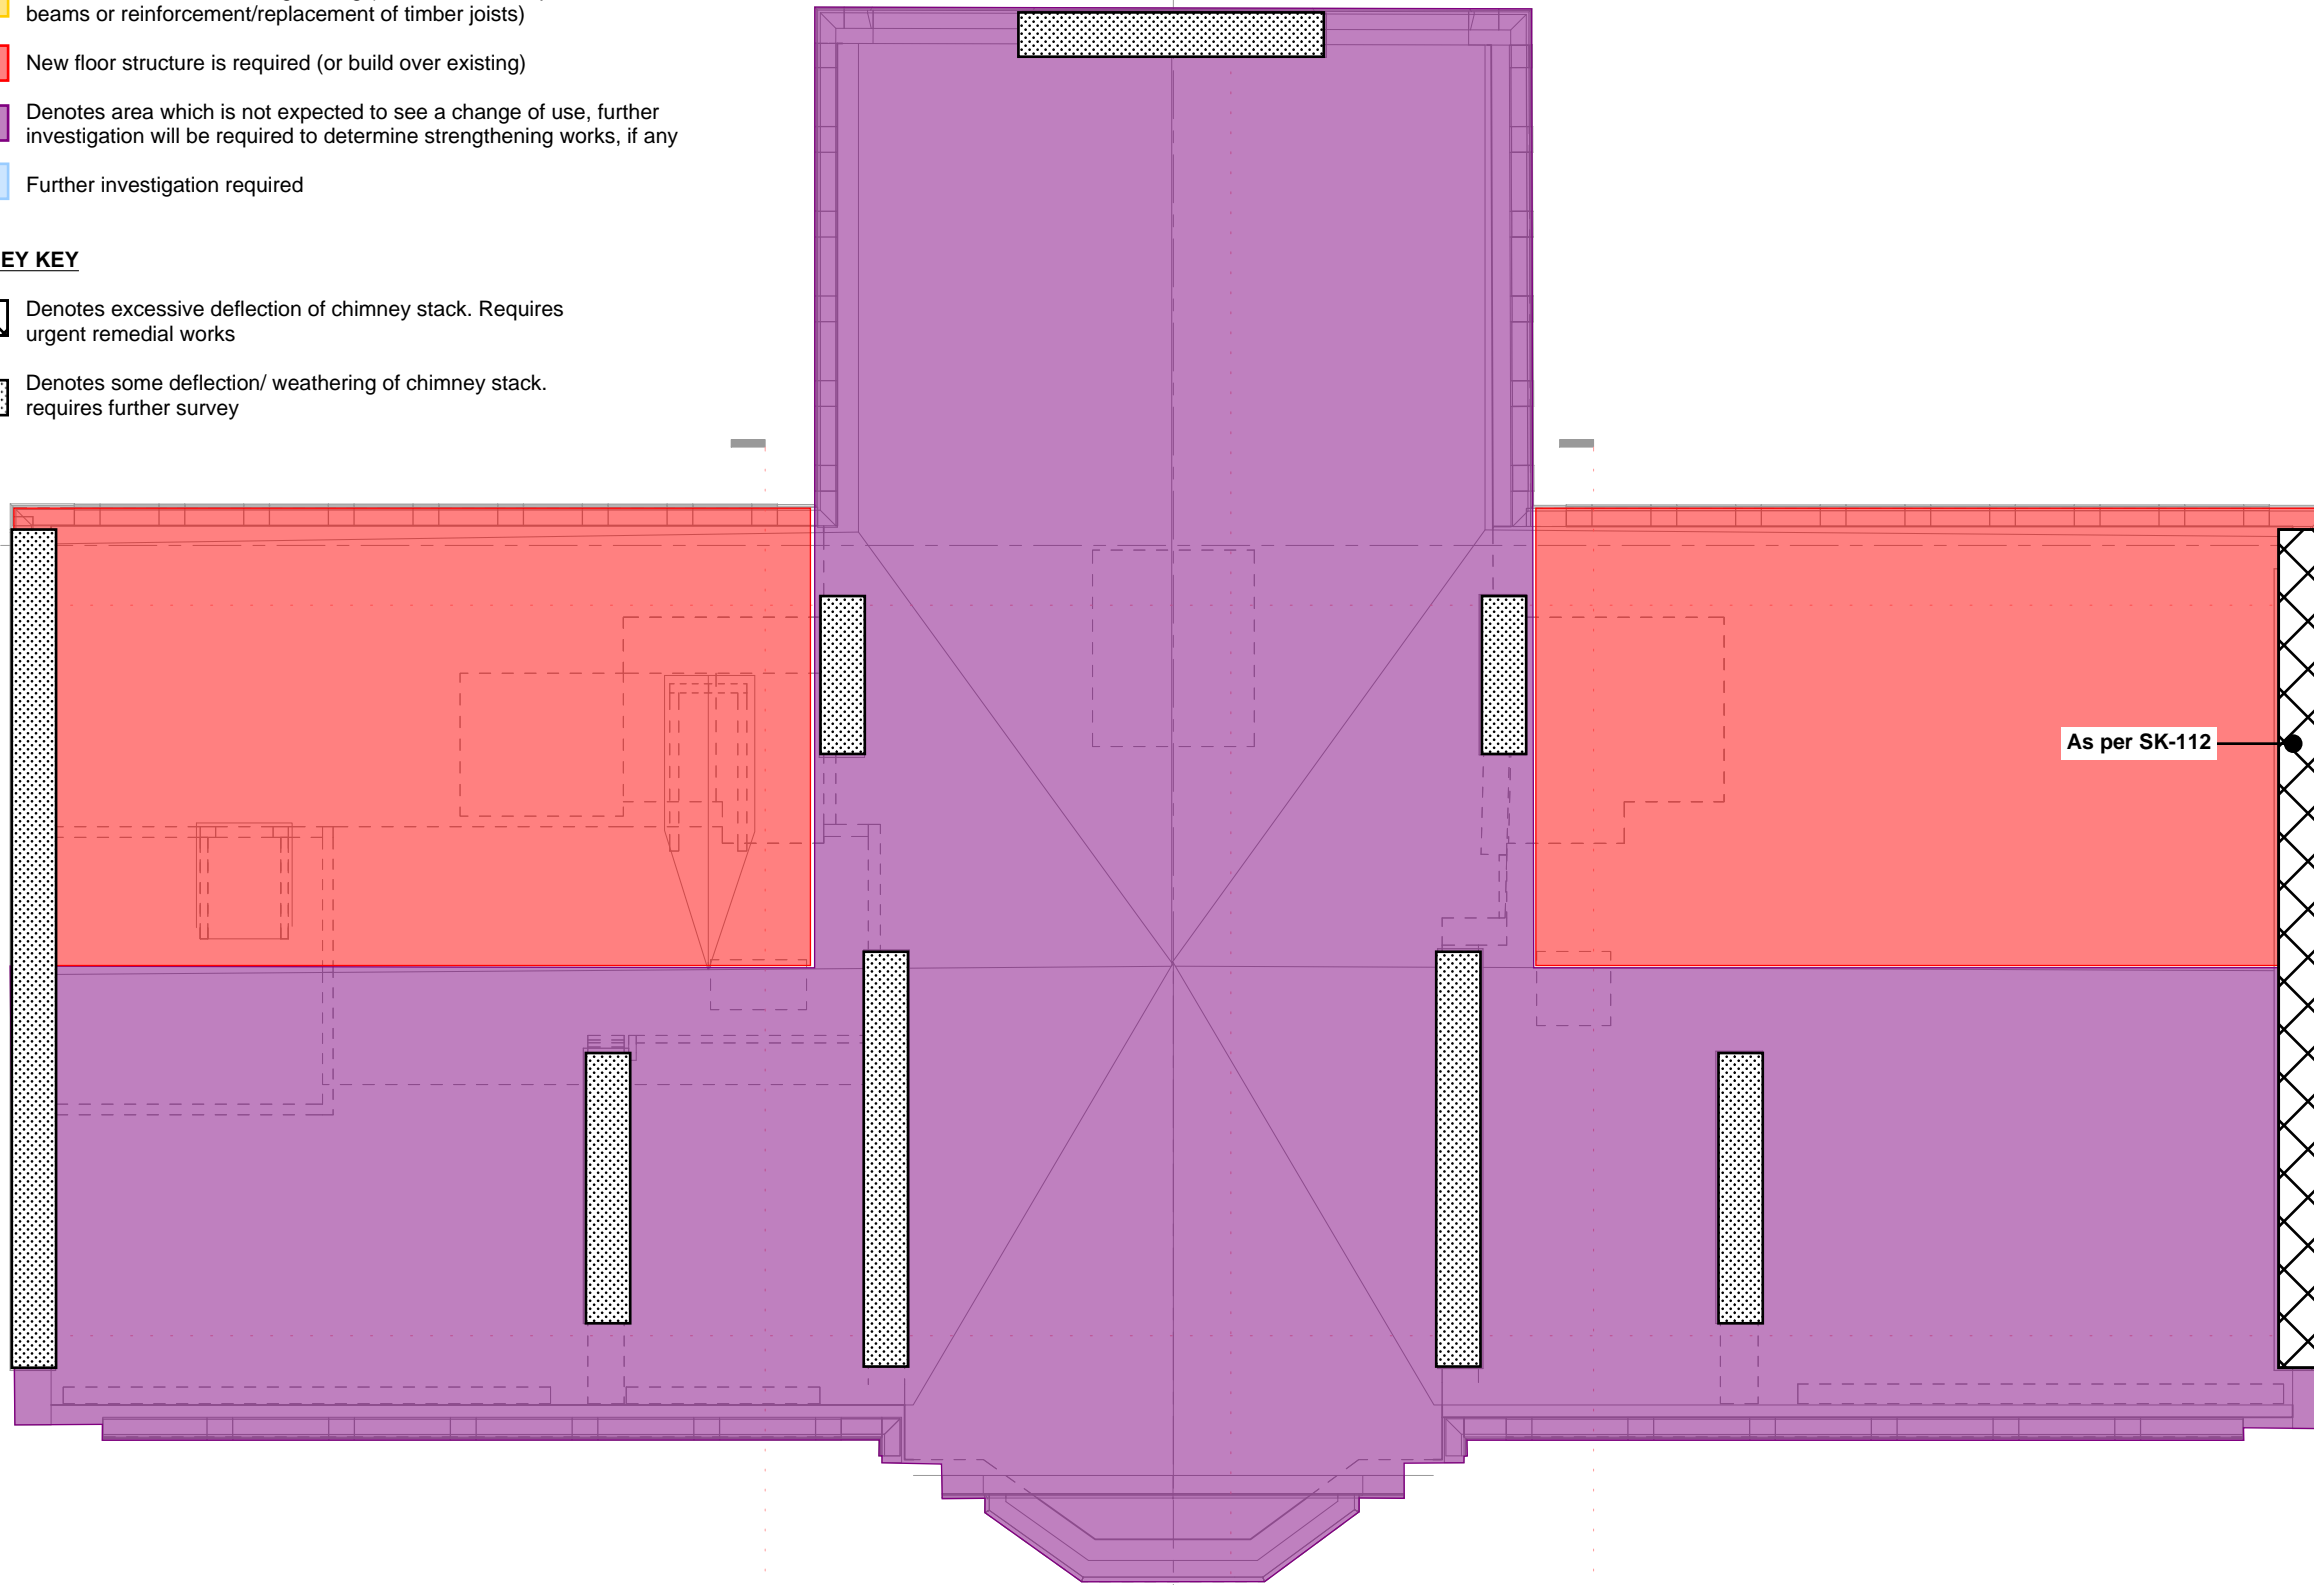
- Denotes excessive deflection of chimney stack. Requires urgent remedial works
- Denotes some deflection/ weathering of chimney stack. requires further survey

15. Two of the chimney stacks have been noted as being out of plum, and two more have been noted visually. More detailed survey work, during an Enabling Works contract, will allow for the construction and the out of plumbness of the chimney stacks to be recorded. The typical strategy to correct out of plum chimneys is to rebuild the chimney.

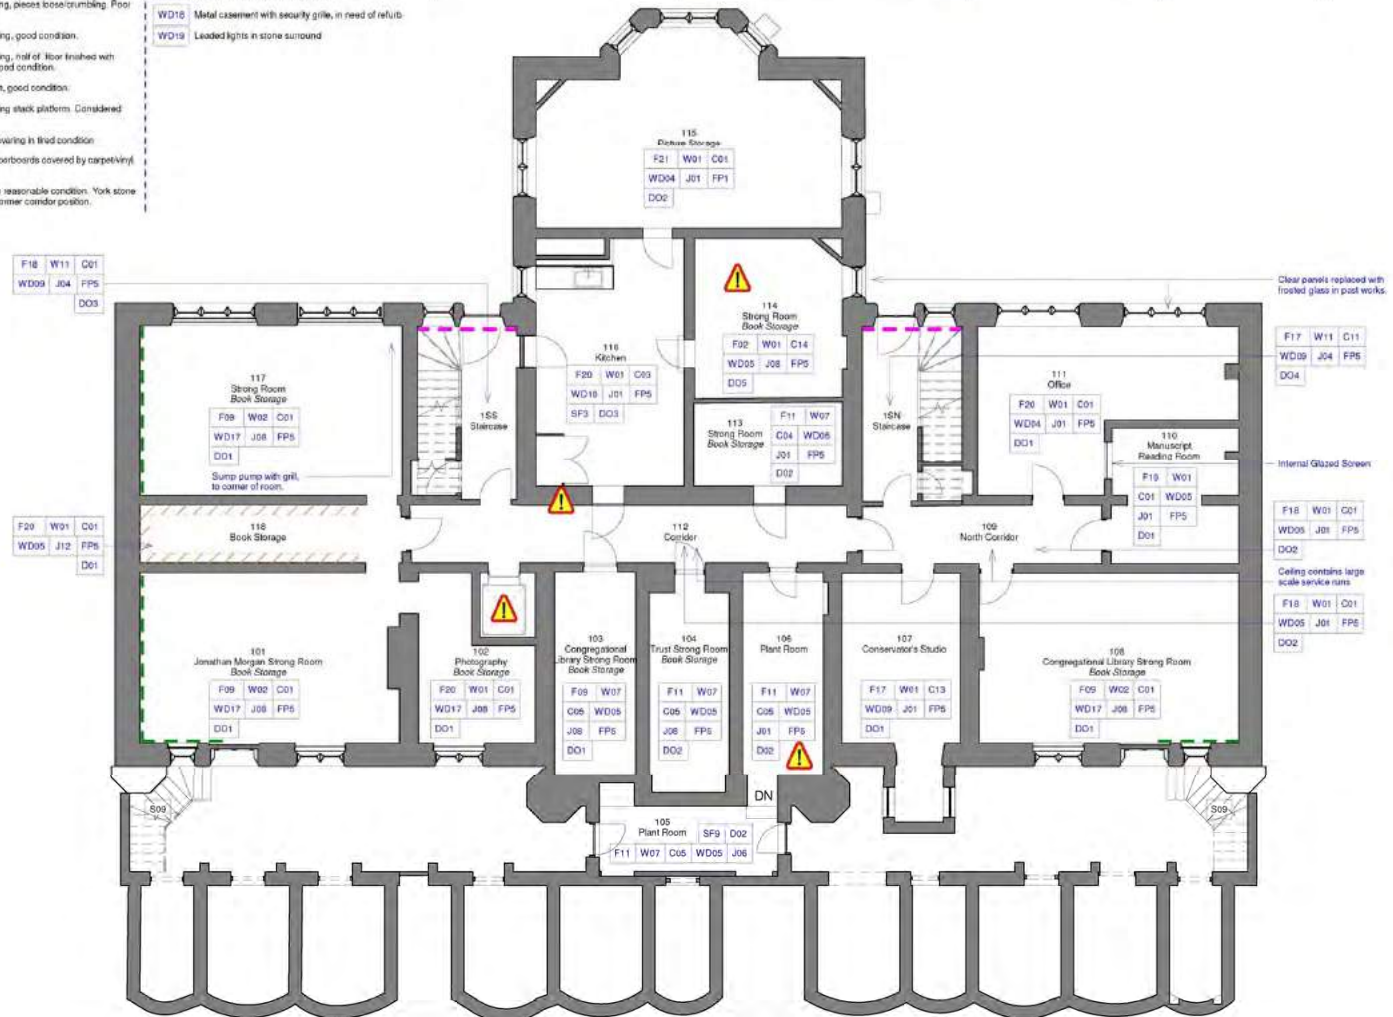
Conditions Survey - Level 01

Floors	Windows	Walls	Ceilings	Joinery	Fireplaces	Stairs	Sanitary / Kitchen Fixings	Decorative Order
F01 No significant deflection noted, floorboards covered by carpet/vinyl. Covering in reasonable condition.	WD01 Metal casement with secondary internal glazing, no damp/mould issues. Good condition.	W01 Painted plaster, considered good condition.	C01 Plain painted plastered ceiling considered good condition.	J01 Door, door frame, architraves and skirting in good condition.	FP1 Fireplace intact. Roman cement decorative legs, cast iron firebox and timber mantle in good condition.	S01 York stone treads in reasonable condition, signs of past repair work to treads.	SF1 Sanitary fittings in good condition. Electric extract fan present, cannot comment on working order.	DD1 General interior condition of room- Good.
F02 No significant deflection noted, floorboards exposed.	WD02 Metal casement with secondary internal glazing, damp/mould issues between glazing.	W02 Significant dampness evident to painted plaster walls, dampness in excess of 20%, as indicated on plan.	C02 Ornate/vaulted painted plastered ceiling, good condition.	J02 Door, door frames, architraves and skirting in poor condition.	FP2 Fireplace intact. Roman cement decorative legs, cast iron firebox and timber mantle in good condition.	S02 York stone treads in reasonable condition, signs of past repair work to treads.	SF2 Sanitary fittings including lavatories, urinals and washbasins considered in poor condition.	DD2 General interior condition of room- Fair.

F03 Significant deflection noted, floorboards covered by carpet/vinyl. Covering in poor condition.	WD03 Metal casement with secondary internal glazing, damp/mould issues between glazing. Dampness measured in excess of 20%.	W03 Moderate cracking to painted plaster walls, as indicated on plan.	C03 Painted plastered ceiling in poor condition, cracking evident.	J03 Timber exterior door with glazed panels and ogee heads, in good condition.	FP3 Fireplace intact. Roman cement decorative legs, cast iron firebox, glazed tile base and timber mantle in good condition.	S03 Roman cement, decorative balustrade present and in good condition.	SF3 Fitted kitchen with sink, believed to be in good condition. Cannot comment on working order.	DD3 General interior condition of room- Tired.
F04 Significant deflection noted, floorboards exposed.	WD04 Metal casement with security grille. Good condition.	W04 Moderate dampness evident to painted plaster walls, as indicated on plan.	C04 No ceiling - Exposed timber floor construction.	J04 Timber exterior door, good condition.	FP4 Fireplace boarded over.	S04 Timber handrail on steel railing balustrade in reasonable condition.	SF4 Sanitary fittings removed, redundant pipes left in place.	DD4 General interior condition of room- Poor.

F05 York stone slab in reasonable order.	WD05 No window within highlighted space.	W05 Plastered masonry wall with wallpaper, general condition considered good.	C05 Fair faced painted brick ogmental vault, good condition.	J05 Timber paneling to perimeter walls with built in integral alcove and book shelving in poor condition.	FP5 No fireplace evident or believed to have been within space highlighted.	S05 Secondary guarding wall used as security measure within stairwell. Guarding known as unoriginal, not suitable for existing stair.	SF5 Self contained gas fired boiler, with balanced flue, extracted through the rear wall provides heating and hot water independently to main systems serving the building.	
F06 Millad timber floor adjoining York stone slab floor, good condition.	WD06 Stained glass in metal casements, reasonable condition. Refurbishment required.	W06 Significant cracking to plastered painted walls, as indicated on plan.	C06 Painted plaster ceiling with decorative cornice at the wall-ceiling junction, not original to building. Considered good condition.	J06 Timber doors with ogee heads considered good condition.	FP6 Fireplace boarded over.	S06 Unoriginal cast-iron spiral staircase, believed in good condition.	SF6 Un-original proprietary laminated toilet cubicles, in good condition.

F07 Long strip hardwood and scribed boarding on cast iron and timber structure beneath. In good condition. Stone slabs at intended fireplace locations to side walls.	WD07 Metal casement window in reasonable condition, extraction fan included in glazing. External oil in need of refurb.	W07 Painted fire faced brickwork, considered good condition.	C07 Painted plaster in poor condition. The timber gas ventilation hood is not believed to be protected.	J07 Modern strong room door (high security and fire properties). Good condition.	FP7 Fireplace boarded over.	S07 Un-original timber stairs believed in reasonable condition.	SF7 Un-original cast-iron toilet cubicles, in good condition.	
F08 York stone slabs, masked by carpet. Covering in good condition.	WD08 Metal casement window in good condition.	W08 Painted plaster walls, walls in tired condition.	C08 Painted plaster ceiling with down stand beams, good condition.	J08 Mass timber door (un-original), door frame, architrave and skirting in good condition.	FP8 Roman cement decorative legs still evident, fireplace boarded over.	S08 External York stone stairs, cause for significant damp issue internally. Currently prepared as deemed unsafe/unusable. Refurbishment required urgently.	SF8 Sanitary fittings including lavatories, urinals and washbasins considered in good condition.

F09 Tanked floor with recessed rolling rack tracks and seamless linoleum flooring. Good condition.	WD09 Metal casement window in good condition.	W09 Painted plaster walls, believed to be in good condition. Exposed steel lintels above windows.	C09 Painted plaster ceiling with down stand beams, good condition.	J09 Soft wood six panel door with decorative glass in good condition.	FP9 Fireplace boarded over.	S09 External York stone stairs, cause for significant damp issue internally. Non original brick structure erected during past works to support this has moved and no longer supports the stair. Stairs deemed unsafe/unusable, intervention required urgently.	SF9 Cleaners sink, believed in poor condition.	
F10 Solid concrete with painted finish. (Good condition).	WD10 Metal casement window in good condition.	W10 Painted plaster walls, Koenig's cement skirting's edges and window reveals. Significant plaster cracking around the window/sill noted, as indicated on plan.	C10 Painted plaster ceiling with timber cased cast iron beams, in need of refurb. Decorative braces and corbels in good condition.	J10 Timber door with ogee heads considered good condition.	FP10 Marble surround left in place, fireplace boarded over.	S10 York stone treads with linoleum nosings. Tired condition.	SF10 Fitted kitchen with sink, in poor condition. Not operational.

F11 Brick Pave, maintained good condition.	WD11 Metal casement window in good condition.	W11 Painted plaster walls, Koenig's cement skirting's edges and window reveals. Significant plaster cracking around the window/sill noted, as indicated on plan.	C11 No ceiling - York stone stairs/landing exposed.	J11 Timber door with ogee heads considered good condition.	FP11 Fireplace boarded over.		SF11 Gas meter on wall, redundant casting evident.	
F12 Long strip oak finish flooring. Considered good condition.	WD12 Metal casement window in good condition.	W12 Painted plaster walls, Koenig's cement skirting's edges and window reveals. Significant damage to plaster from leaks.	C12 Painted underside of metal grillage in poor condition. Number of supporting downward beams.	J12 Built in book shelving, good condition, as indicated on plan.				
F13 Significant deflection noted, floorboards covered by carpet/vinyl. Covering in poor condition.	WD13 Stained glass in metal casements replaced during past works with metal sill panels. Hidden built in book shelving, condition unknown.		C13 Painted plaster ceiling, evidence of dampness from above, poor condition.

F14 Gallery. Two unoriginal cast-iron floors with associated railings, supported on cast-iron columns. Considered good condition.	WD14 Metal casement window in good condition.		C14 No ceiling - Steel shuttered floor above.					
F15 Gallery. Un-original timber gallery with associated timber balustrade, supported below by timber book presses. Good condition.	WD15 Metal casement window in good condition.		C15 Plain painted plastered ceiling considered tired condition.					
F16 Un-original perforated cast-iron gridded floor on supporting cast-iron. Good condition.	WD16 Timber sash window recently refitted, good condition.		C17 Woodchip wallpaper to plaster, in good condition.					
F17 Solid floor with York stone covering, pieces loose/crumbling. Poor condition.	WD17 Environmental structure to window. Openings behind shutters have not been inspected.							
F18 Solid floor with York Stone covering, good condition.	WD18 Metal casement with security grille, in need of refurb.

F19 Solid floor with York Stone covering, half of floor finished with seamless linoleum, considered good condition.	WD19 Leaded lights in stone surround.							
F20 Solid floor with seamless linoleum, good condition.								
F21 Solid floor, painted finish with rolling stack platform. Considered good condition.								
F22 York stone slabs with linoleum covering in tired condition.								
F23 No significant deflection noted, floorboards covered by carpet/vinyl. Covering in poor condition.								
F24 Double suspended timber floor in reasonable condition. York stone slabs in reasonable condition in former carport position.

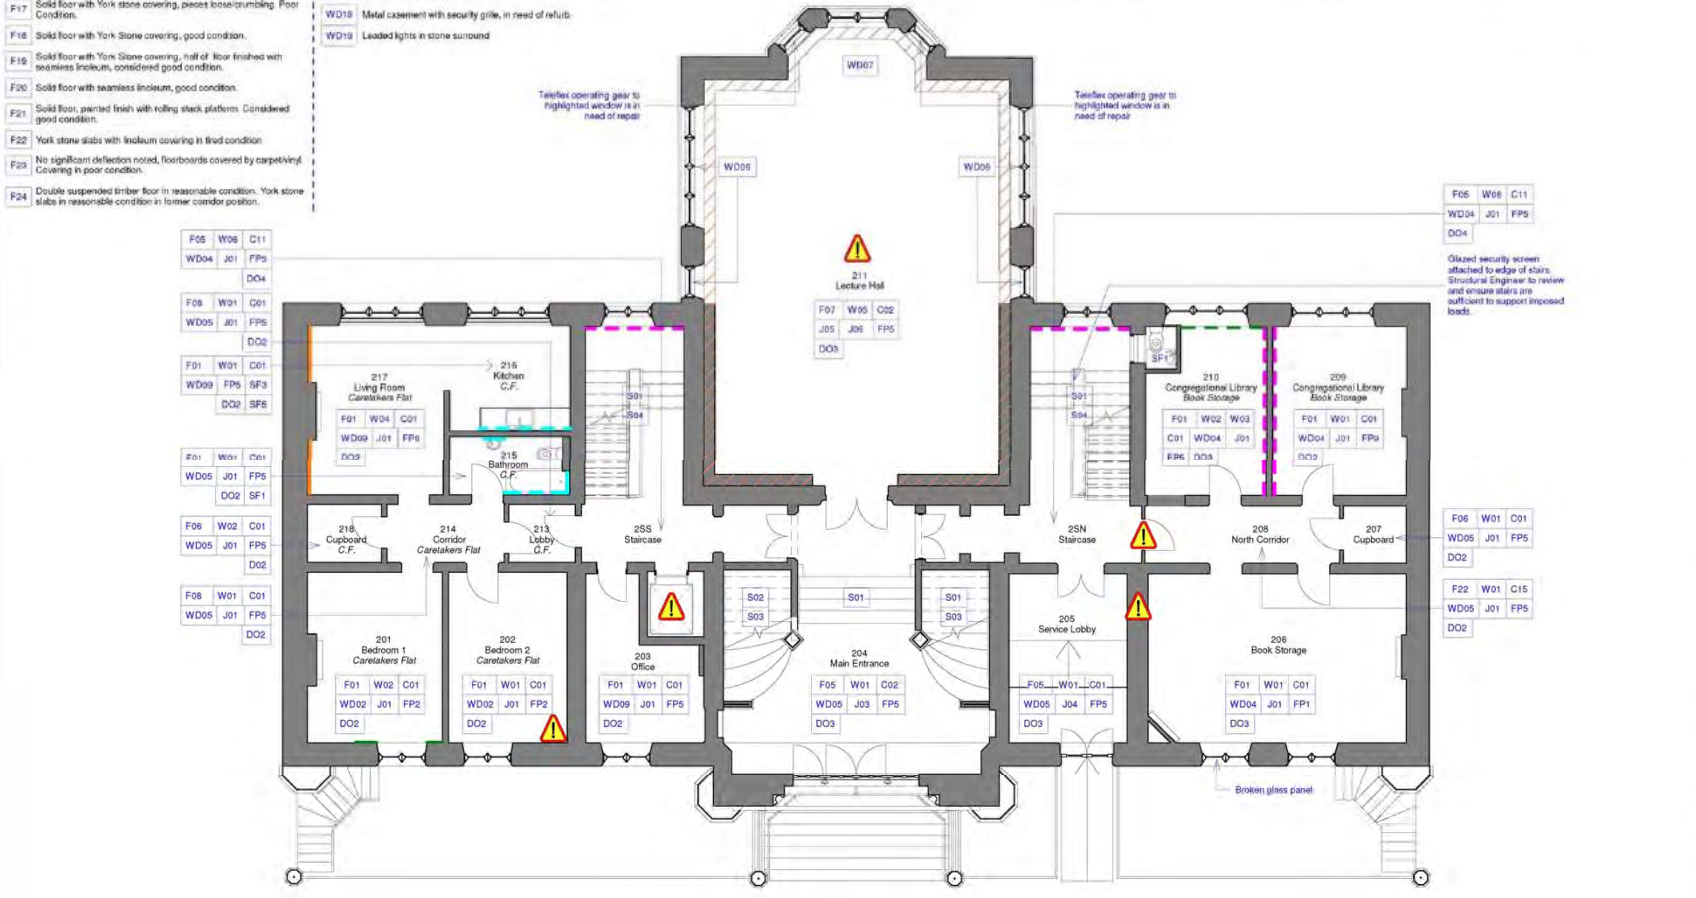
Condition Survey - L02

Floors	Windows	Walls	Ceilings	Joinery	Fireplaces	Stairs	Sanitary / Kitchen Fixings	Decorative Order
F01 No significant deflection noted, floorboards covered by carpet/vinyl. Covering in reasonable condition.	WD01 Metal casement with secondary internal glazing, no damp-mould issues. Good condition.	W01 Painted plaster, considered good condition.	C01 Plain painted plastered ceiling considered good condition.	J01 Door, door frame, architraves and skirting in good condition.	FP1 Fireplace intact. Roman cement decorative legs, cast iron firebox and timber mantle in good condition.	S01 York stone treads in reasonable condition.	SF1 Sanitary fittings in good condition. Electric extract fan present, cannot comment on working order.	DD1 General interior condition of room- Good.
F02 No significant deflection noted, floorboards exposed.	WD02 Metal casement with secondary internal glazing, damp-mould issues between glazing.	W02 Significant dampness evident to painted plaster walls. Dampness in excess of 20%, as indicated on plan.	C02 Ornate/vaulted painted plastered ceiling, good condition.	J02 Door, door frames, architraves and skirting in poor condition.	FP2 Fireplace intact. Roman cement decorative legs, cast iron firebox, glazed tile base and timber mantle in good condition.	S02 York stone treads in reasonable condition, signs of past repair work to treads.	SF2 Sanitary fittings including lavatories, urinals and washbasins considered in poor condition.	DD2 General interior condition of room- Fair.

F03 Significant deflection noted, floorboards covered by carpet/vinyl. Covering in poor condition.	WD03 Metal casement with secondary internal glazing, damp-mould issues between glazing. Dampness measured in excess of 20%.	W03 Moderate cracking to painted plaster walls, as indicated on plan.	C03 Painted plastered ceiling in poor condition, cracking evident.	J03 Timber exterior door with glazed panels and eave heads, in good condition.	FP3 Fireplace intact. Roman cement decorative legs, cast iron firebox, glazed tile base and timber mantle in good condition.	S03 Roman cement, decorative balustrade present and in good condition.	SF3 Fitted kitchen with sink, believed to be in good condition. Cannot comment on working order.	DD3 General interior condition of room- Tired.
F04 Significant deflection noted, floorboards exposed.	WD04 Metal casement with security grille. Good condition.	W04 Moderate dampness evident to painted plaster walls, as indicated on plan.	C04 No ceiling- Exposed timber floor construction.	J04 Timber exterior door, good condition.	FP4 Fireplace boarded over.	S04 Timber handrail on steel railing balustrade in reasonable condition.	SF4 Sanitary fittings removed, redundant pipes left in place.	DD4 General interior condition of room- Poor.

F05 York stone slabs in reasonable order.	WD05 No window within highlighted space.	W05 Plastered masonry wall with wallpaper, general condition considered good.	C05 Plaster in poor condition. The timber gas ventilation hood is not believed fire protected.	J05 Timber panelling to perimeter walls, with built in integral subcabinets and book shelving as indicated on plan.	FP5 No fireplace evident or believed to have been within space highlighted.	S05 Secondary guarding wall used as security measure within stairwell. Guarding known as unoriginal, not suitable for existing stair.	SF5 Self contained gas fired boiler, with balanced flue, extracted through the rear wall provides heating and hot water independently to main systems serving the building.	
F06 Millad timber floor adjoining York stone slab floor, good condition.	WD06 Stained glass in metal casements, reasonable condition. Refurbishment required.	W06 Significant cracking to plastered painted walls, as indicated on plan.	C06 Plaster timber board with timber battens, good condition.	J06 Timber doors with eave heads considered good condition.	FP6 Roman cement decorative legs still evident, fireplace boarded over.	S06 Unoriginal cast-iron spiral staircase, believed in good condition.	SF6 Un-original proprietary laminated toilet cubicles, in good condition.

F07 Lamg slip hardwood and scribed boarding on cast iron and timber structure beneath. In good condition. Stone slabs at intended fireplace locations to side walls.	WD07 Metal casement in reasonable condition, extraction fan included in glazing. External oil in need of refurb.	W07 Painted fire faced brickwork, considered good condition.	C07 Painted plaster in poor condition. The timber gas ventilation hood is not believed fire protected.	J07 Modern strong room door (high security and fire properties). Good condition.	FP7 Marble surround left in place, fireplace boarded over.	S07 Un-original timber stairs believed in reasonable condition.	SF7 Sanitary fittings including lavatories, urinals and washbasins considered in good condition.	
F08 York stone slabs, masked by carpet. Covering in good condition.	WD08 Metal casement window in good condition.	W08 Painted plaster walls, walls in tired condition.	C08 Painted plaster ceiling with down stand beams, good condition.	J08 Mass timber door (un-original), door frame, architrave and skirting in good condition.	FP8 External York stone stairs, cause for significant damp issues internally. Currently prepped as deemed unsafe/unusable. Refurbishment required urgently.	S08 External York stone stairs, cause for significant damp issues internally. Currently prepped as deemed unsafe/unusable. Refurbishment required urgently.	SF8 Cleaners sink, believed in poor condition.

F09 Tanked floor with recessed rolling rack tracks and seamless linoleum flooring. Good condition.	WD09 Metal casement window in good condition.	W09 Painted plaster walls, believed to be in good condition. Exposed steel lintels above windows.	C09 Painted plaster ceiling with down stand beams, good condition.	J09 Soft wood six panel door with original Koen's cement reveal, considered good.	FP9 Fireplace clearly removed.	S09 External York stone stairs, cause for significant damp issues internally. Non original brick structure erected during past works to support this has moved and no longer supports the stair. Stairs deemed unsafe/unusable, intervention required urgently.	SF9 Fitted kitchen with sink, in poor condition. Not operational.	
F10 Solid concrete with painted finish. (Good condition).	WD10 Metal casement window in poor condition.	W10 Painted plaster walls, Koen's cement skirting's, edges and window reveals. Significant plaster cracking around the window/door noted, as indicated on plan.	C10 No ceiling- York stone stairs/landing exposed.	J10 Timber glazed screen and mashing associated feature double doors are considered good in condition.		S10 Gas meter on wall, redundant casting evident.	SF10 Gas meter on wall, redundant casting evident.

F11 Brick Paves, maintained good condition.	WD11 Metal casement window in good condition.	W11 Painted plaster walls, Koen's cement skirting's, edges and window reveals. Significant plaster cracking around the window/door noted, as indicated on plan.	C11 No ceiling- York stone stairs/landing exposed.	J11 Built in book shelving, good condition, as indicated on plan.				
F12 Long slip oak finish flooring. Considered good condition.	WD12 Metal casement window in poor condition.	W12 Painted plaster walls, Koen's cement skirting's, edges and window reveals. Significant plaster cracking around the window/door noted, as indicated on plan.	C12 Painted underside of metal grillage in poor condition. Number of supporting downward beams.					
F13 Significant deflection noted, floorboards covered by carpet/vinyl. Covering in poor condition.	WD13 Stained glass in metal casements replaced during past works with metal infill panels, hidden behind built in book shelving, condition unknown.	W13 Painted plaster walls, Koen's cement skirting's, edges and window reveals. Significant plaster cracking around the window/door noted, as indicated on plan.	C13 Painted plaster ceiling, evidence of dampness from above, poor condition.

F14 Gallery. Two unoriginal cast-iron floors with associated railings, supported on cast-iron columns. Considered good condition.	WD14 Metal casement window in good condition.	W14 Textiles operation believed to be in need of replacement. Metal casement window in good condition.	C14 No ceiling- Steel shuttered floor above.					
F15 Gallery. Un-original timber gallery with associated timber balustrade, supported below by timber book presses. Good condition.	WD15 Metal casement window in good condition.	W15 Textiles operation believed to be in need of replacement. Metal casement window in good condition.	C15 Plain painted plastered ceiling considered tired condition.					
F16 Un-original perforated cast-iron gridded floor on supporting steelwork. Good condition.	WD16 Timber sash window recently refitted/shed, good condition.	W16 Textiles operation believed to be in need of replacement. Metal casement window in good condition.	C16 Plain painted plastered ceiling considered tired condition.

F17 Solid floor with York Stone covering, pieces loose/crumbling. Poor Condition.	WD17 Environmental shutters to window. Openings behind shutters have not been inspected.	W17 Textiles operation believed to be in need of replacement. Metal casement window in good condition.	C17 Woodchip wallpaper to plaster, in good condition.					
F18 Solid floor with York Stone covering, good condition.	WD18 Metal casement with security grille, in need of refurb.	W18 Textiles operation believed to be in need of replacement. Metal casement window in good condition.						
F19 Solid floor with York Stone covering, half of floor finished with seamless linoleum, considered good condition.	WD19 Leaded lights in stone surround.	W19 Textiles operation believed to be in need of replacement. Metal casement window in good condition.						
F20 Solid floor with seamless linoleum, good condition.								
F21 Solid floor, painted finish with rolling stack platform. Considered good condition.

F22 York stone slabs with linoleum covering in tired condition.								
F23 No significant deflection noted, floorboards covered by carpet/vinyl. Covering in poor condition.								
F24 Double suspended timber floor in reasonable condition. York stone slabs in reasonable condition in former corridor position.

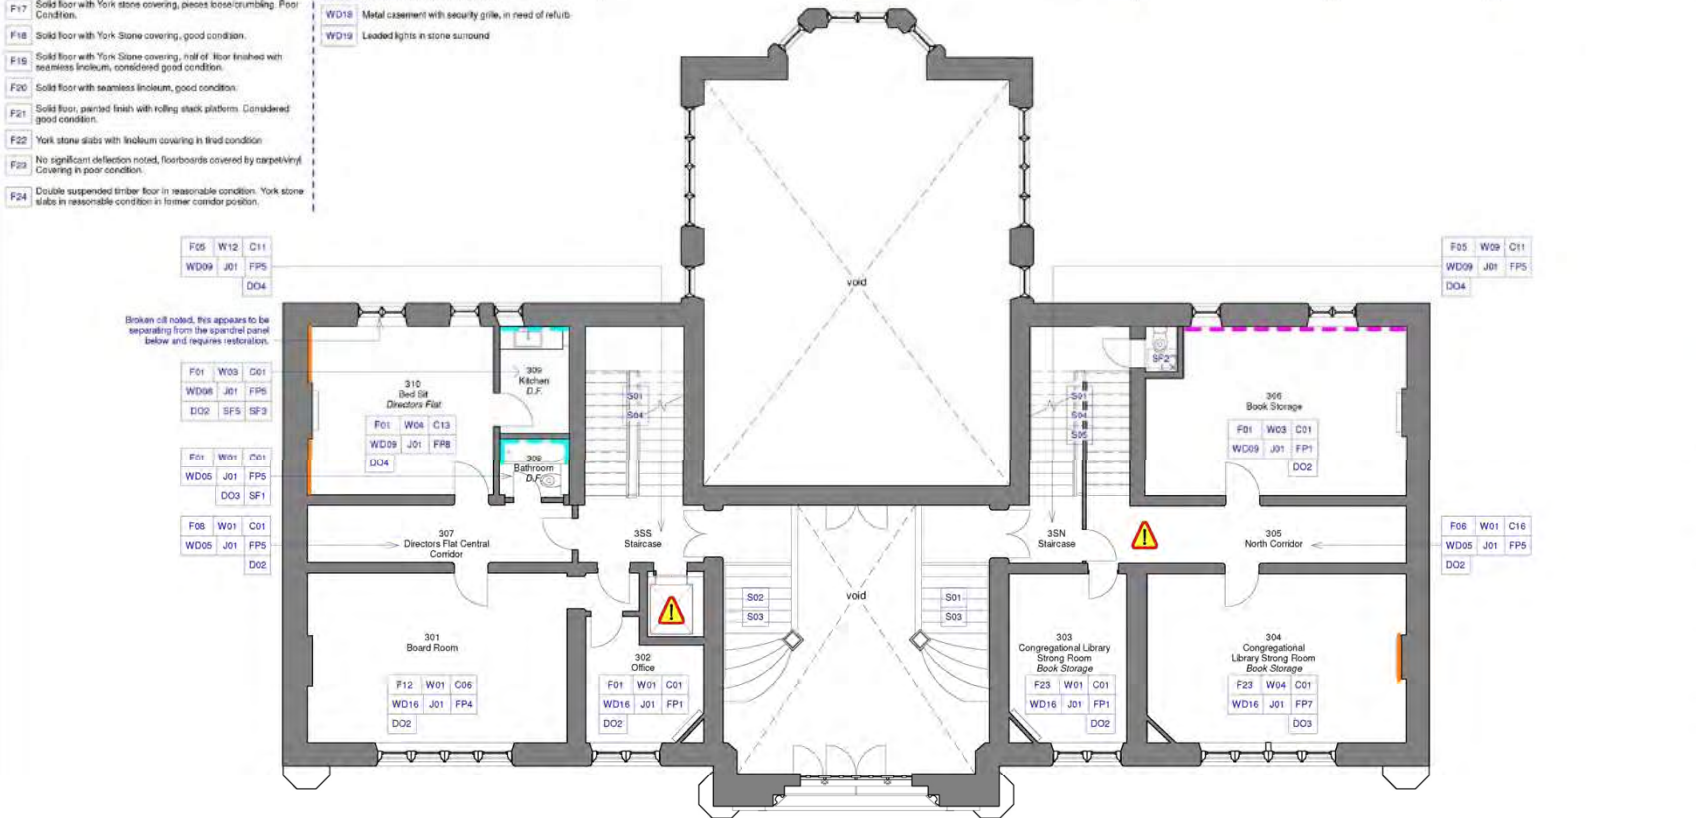
FLOOR PLANS
Condition Survey - L03

Floors	Windows	Walls	Ceilings	Joinery	Fireplaces	Stairs	Sanitary / Kitchen Fixings	Decorative Order
F01 No significant deflection noted, floorboards covered by carpet/vinyl. Covering in reasonable condition.	WD01 Metal casement with secondary internal glazing, no damp/mould issues. Good condition.	W01 Painted plaster, considered good condition.	C01 Plain painted plastered ceiling considered good condition.	J01 Door, door frame, architraves and skirting in good condition.	FP1 Fireplace intact. Roman cement decorative legs, cast iron firebox and timber mantle in good condition.	S01 York stone treads in reasonable condition, signs of past repair work to treads.	SF1 Sanitary fittings in good condition. Electric extract fan present, cannot comment on working order.	DD1 General interior condition of room- Good.
F02 No significant deflection noted, floorboards exposed.	WD02 Metal casement with secondary internal glazing, damp/mould issues between glazing.	W02 Significant dampness evident to painted plaster walls, dampness in excess of 20%, as indicated on plan.	C02 Ornate/vaulted painted plastered ceiling, good condition.	J02 Door, door frames, architraves and skirting in poor condition.	FP2 Fireplace intact. Roman cement decorative legs, cast iron firebox, glazed tile base and timber mantle in good condition.	S02 Roman cement, decorative balustrade present and in good condition.	SF2 Sanitary fittings including lavatories, urinals and washbasins considered in poor condition.	DD2 General interior condition of room- Fair.

F03 Significant deflection noted, floorboards covered by carpet/vinyl.	WD03 Metal casement with secondary internal glazing, damp/mould issues between glazing. Dampness measured in excess of 20%.	W03 Moderate cracking to painted plaster walls, as indicated on plan.	C03 No ceiling - Exposed timber floor construction.	J03 Timber exterior door with glazed panels and ogee heads, in good condition.	FP3 Fireplace intact. Timber surround and tile in poor condition.	S03 Secondary guarding wall used as security measure within stairwell. Guarding known as unoriginal, not suitable for existing stair.	SF3 Fitted kitchen with sink, believed to be in good condition. Cannot comment on working order.	DD3 General interior condition of room- Tired.
F04 Significant deflection noted, floorboards exposed.	WD04 Metal casement with security grille. Good condition.	W04 Moderate dampness evident to painted plaster walls, as indicated on plan.	C04 Plaster ceiling in poor condition. The timber gas ventilation hood is not believed to be protected.	J04 Timber exterior door, good condition.	FP4 Fireplace boarded over.	S04 Timber handrail on steel railing balustrade in reasonable condition.	SF4 Sanitary fittings removed, redundant pipes left in place.	DD4 General interior condition of room- Poor.

F05 York stone slab in reasonable order.	WD05 No window within highlighted space.	W05 Plastered masonry wall with wallpaper, general condition considered good.	C05 Painted plaster board with timber battens, good condition.	J05 Timber panelling to perimeter walls, with built in integral bookshelves and book shelving as indicated on plan.	FP5 No fireplace evident or believed to have been within space highlighted.	S05 Unoriginal cast-iron spiral staircase, believed in good condition.	SF5 Self contained gas fired boiler, with balanced flue, extracted through the rear wall provides heating and hot water independently to main systems serving the building.	
F06 Millred timber floor adjoining York stone slab floor, good condition.	WD06 Stained glass in metal casements, reasonable condition. Refurbishment required.	W06 Significant cracking to plastered painted walls, as indicated on plan.	C06 Painted plaster ceiling with down stand beams, good condition.	J06 Timber doors with ogee heads considered good condition.	FP6 Roman cement decorative legs still evident, fireplace boarded over.	S06 External York stone stairs, cause for significant damp issues internally. Currently prepped as deemed unsafe/unusable. Refurbishment required urgently.	SF6 Sanitary fittings including lavatories, urinals and washbasins considered in good condition.

F07 Long strip hardwood and scribed boarding on cast iron and timber structure beneath. In good condition. Stone slabs at intended fireplace locations to side walls.	WD07 Metal casement in reasonable condition, extraction fan included in glazing. External oil in need of refurb.	W07 Painted fire faced brickwork, considered good condition.	C07 Painted plaster ceiling with timber cased cast-iron beams, in need of refurb. Decorative braces and corbels in good condition.	J07 Modern strong room door (high security and fire properties). Good condition.	FP7 Embellished timber surround with cast iron firebox, in reasonable condition.	S07 Unoriginal timber stairs believed in reasonable condition.	SF7 Unoriginal proprietary laminated toilet cubicle, in good condition.	
F08 York stone slabs, masked by carpet. Covering in good condition.	WD08 Metal casement window in good condition.	W08 Painted plaster walls, walls in tired condition.	C08 No ceiling - York stone stairs landing exposed.	J08 Timber door (in original) door frame, architrave and skirting in good condition.	FP8 Marble surround left in place, fireplace boarded over.	S08 External York stone stairs, cause for significant damp issues internally. Non original brick structure erected during past works to support this has moved and no longer supports the stair. Stairs deemed unsafe/unusable, intervention required urgently.	SF8 Sanitary fittings including lavatories, urinals and washbasins considered in good condition.

F09 Tanked floor with recessed rolling rack tracks and seamless linoleum flooring. Good condition.	WD09 Metal casement window in good condition.	W09 Painted plaster walls, Kewee's cement skirting's edges and window reveals. Significant plaster cracking around the window/sill noted, as indicated on plan.	C09 Painted plaster ceiling with down stand beams, good condition.	J09 Soft wood six panel door with original Kewee's cement reveal, considered good.	FP9 Fireplace boarded over.	S09 External York stone stairs, cause for significant damp issues internally. Non original brick structure erected during past works to support this has moved and no longer supports the stair. Stairs deemed unsafe/unusable, intervention required urgently.	SF9 Cleaners sink, believed in poor condition.	
F10 Solid concrete with painted finish. (Good condition).	WD10 Metal casement window in good condition.	W10 Painted plaster walls, Kewee's cement skirting's edges and window reveals. Significant plaster cracking around the window/sill noted, as indicated on plan.	C10 No ceiling - Steel shuttered floor above.	J10 Timber door (in original) door frame, architrave and skirting in good condition.			SF10 Fitted kitchen with sink, in poor condition. Not operational.
