DR WILLIAMS'S LIBRARY- 14 Gordon Square, London WC1H 0AR

HERITAGE STATEMENT | NOVEMBER 2019

8555-CPM- ZZ-ZZ-RP-A-10001

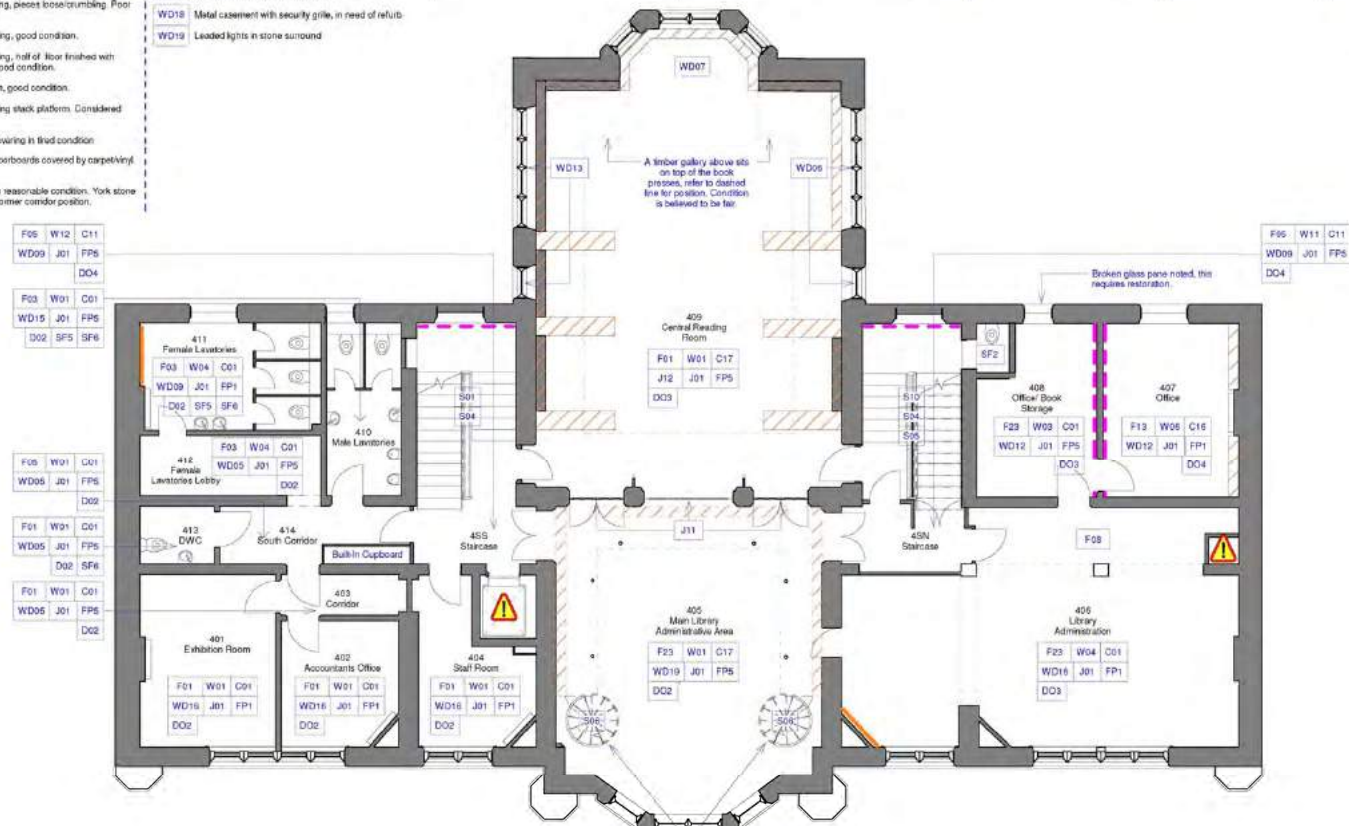
FLOOR PLANS
Condition Survey - L04

F13 Significant deflection noted, floorboards covered by carpet/vinyl. Covering in poor condition.	WD13 Textiles operation believed to be in need of replacement. Metal casement window in good condition.		C13 Painted plaster ceiling, evidence of dampness from above, poor condition.					
F14 Gallery. Two unoriginal cast-iron floors with associated railings, supported on cast-iron columns. Considered good condition.	WD14 Metal casement window in good condition.		C14 No ceiling- Steel shutters floor above.					
F15 Gallery. Un-original timber gallery with associated timber balustrade, supported below by timber book presses. Good condition.	WD15 Metal casement window in good condition.		C15 Plain painted plastered ceiling considered tired condition.					
F16 Un-original perforated cast-iron gridded floor on supporting cast-iron. Good condition.	WD16 Timber sash window recently refurbished, good condition.		C16 Plain painted plastered ceiling considered tired condition.

F17 Solid floor with York stone covering, pieces loose/crumbling. Poor condition.	WD17 Environmental shutters to window. Openings behind shutters have not been inspected.		C17 Woodchip wallpaper to plaster, in good condition.					
F18 Solid floor with York Stone covering, good condition.	WD18 Metal casement with security grille, in need of refurb.							
F19 Solid floor with York Stone covering, half of floor finished with seamless linoleum, considered good condition.	WD19 Leaded lights in stone surround.							
F20 Solid floor with seamless linoleum, good condition.								
F21 Solid floor, painted finish with rolling stack platform. Considered good condition.								
F22 York stone slabs with linoleum covering in tired condition.								
F23 No significant deflection noted, floorboards covered by carpet/vinyl. Covering in poor condition.								
F24 Double suspended timber floor in reasonable condition. York stone slabs in reasonable condition in former carport position.

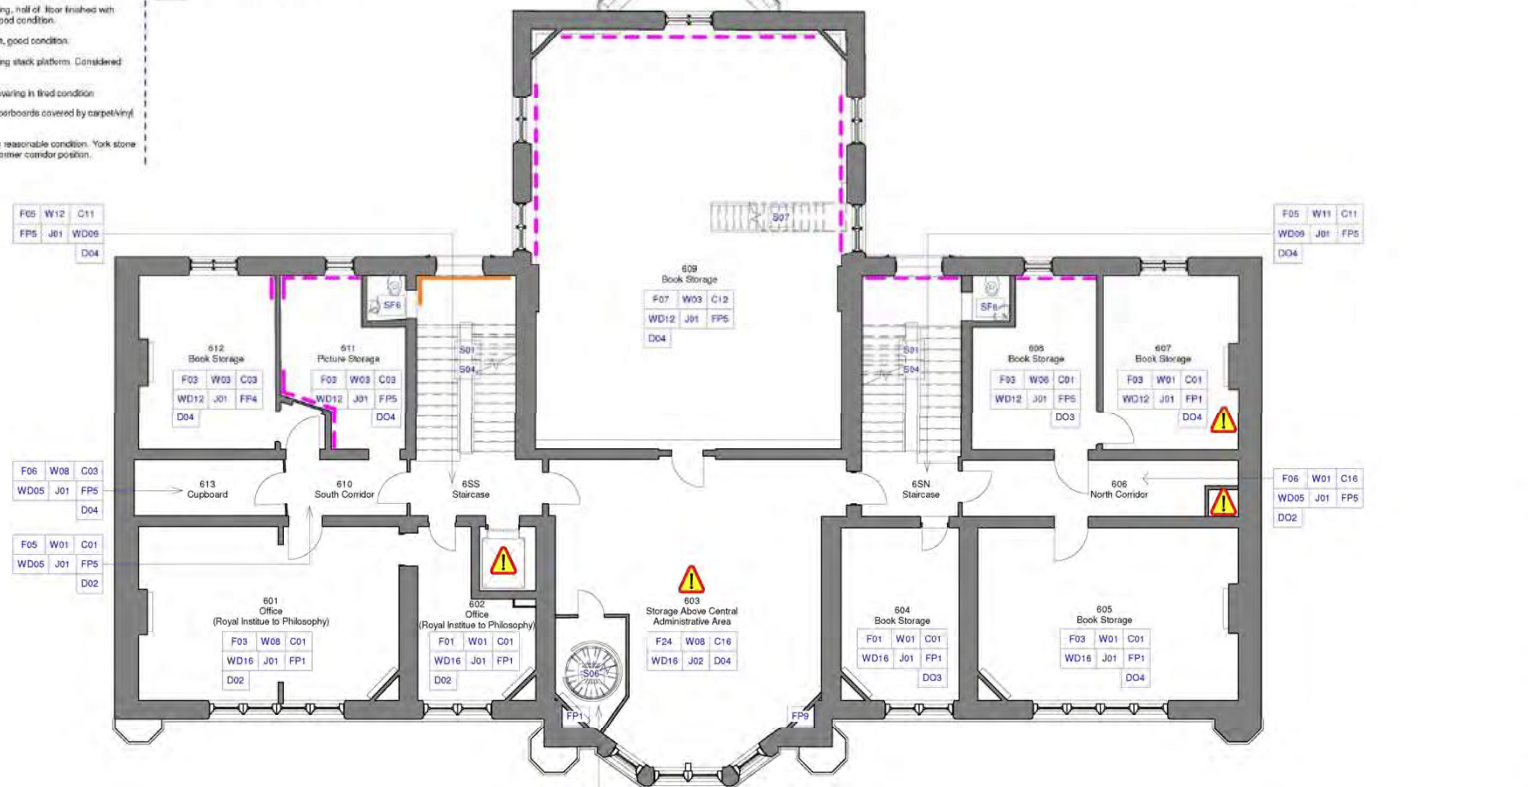
FLOOR PLANS Condition Survey - L06

Timber enclosed spiral staircase with glazed panels. Appears to be in reasonable condition.

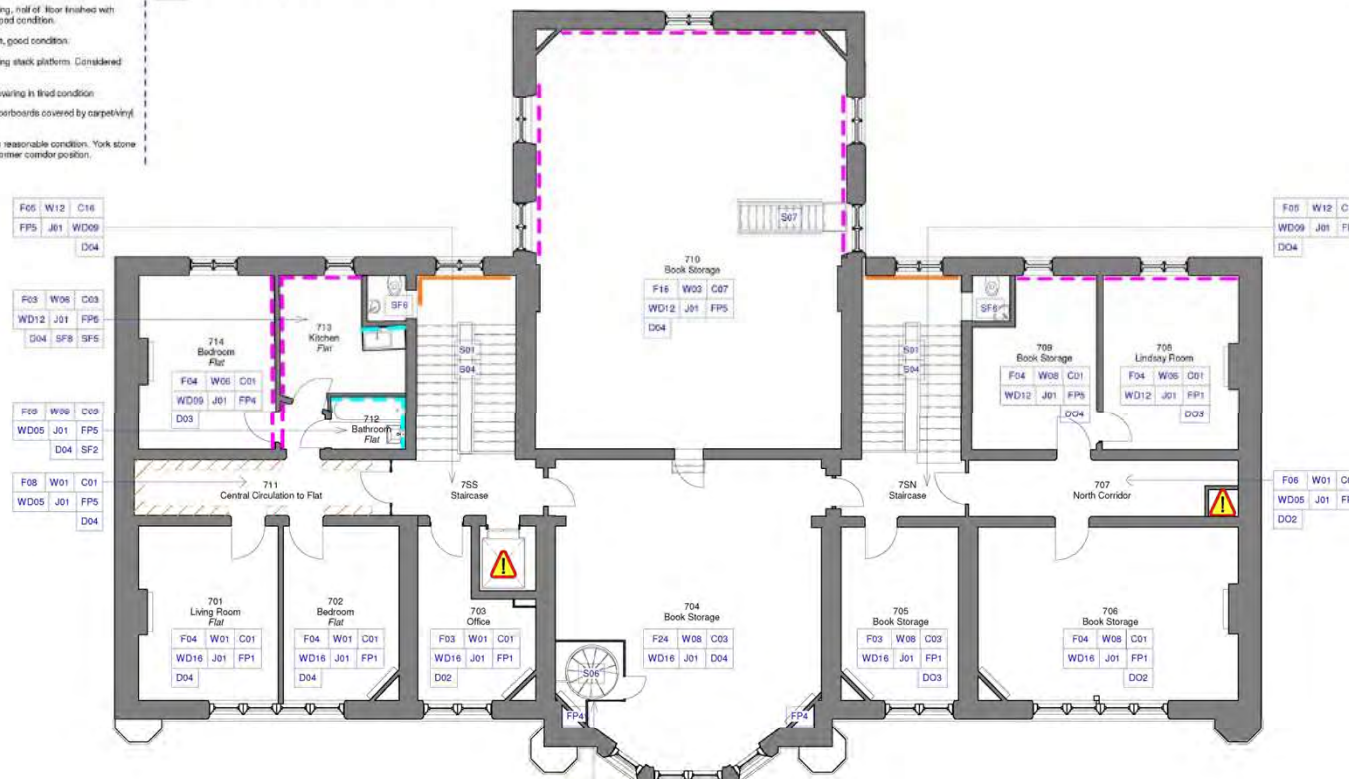
FLOOR PLANS
Condition Survey - L07

F13 Significant deflection noted, floorboards covered by carpet/vinyl. Covered in poor condition.	WD13 Textiles operation believed to be in need of replacement. Metal casement window in good condition.		C13 No ceiling- Steel shutters floor above.				SF13	
F14 Gallery. Two unoriginal cast-iron floors with associated railings, supported on cast-iron columns. Considered good condition.	WD14 Metal casement window in good condition.		C14 Plain painted plastered ceiling considered tired condition.				SF14	
F15 Gallery. Un-original timber gallery with associated timber balustrade, supported below by timber book presses. Good condition.	WD15 Timber sash window recently refurbished, good condition.		C17 Woodchip wallpaper to plaster, in good condition.				SF15	
F16 Un-original perforated cast-iron gridded floor on supporting steelwork. Good condition.	WD17 Metal casement with security grille, in need of refurb.

F17 Solid floor with York stone covering, pieces loose/crumbling. Poor condition.	WD18 Metal casement with security grille, in need of refurb.							
F18 Solid floor with York Stone covering, good condition.	WD19 Leaded lights in stone surround.							
F19 Solid floor with York Stone covering, half of floor finished with seamless linoleum, considered good condition.								
F20 Solid floor with seamless linoleum, good condition.								
F21 Solid floor, painted finish with rolling stack platform. Considered good condition.								
F22 York stone slabs with linoleum covering in tired condition.								
F23 No significant deflection noted, floorboards covered by carpet/vinyl. Covering in poor condition.								
F24 Double suspended timber floor in reasonable condition. York stone slabs in reasonable condition in former car position.

Timber enclosed spiral staircase with glazed panels. This appears to be in reasonable condition.

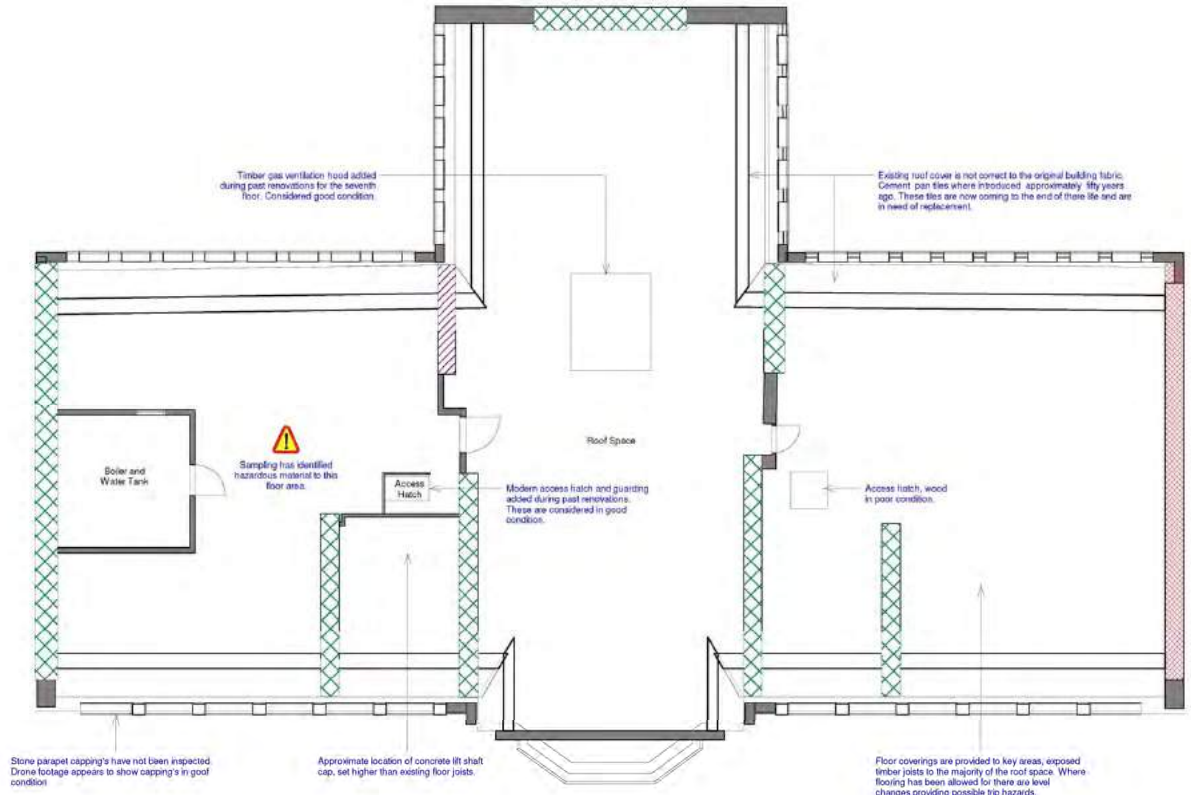
Timber gas ventilation hood added during past renovations for the seventh floor. Considered good condition.

Existing roof cover is not correct to the original building fabric. Cement pan tiles were introduced approximately 10 years ago. These tiles are now coming to the end of their life and are in need of replacement.
