DR WILLIAMS'S LIBRARY- 14 Gordon Square, London WC1H 0AR

CONDITION SURVEY | OCTOBER 2019

8555-CPM- ZZ-ZZ-RP-A-10004_P01

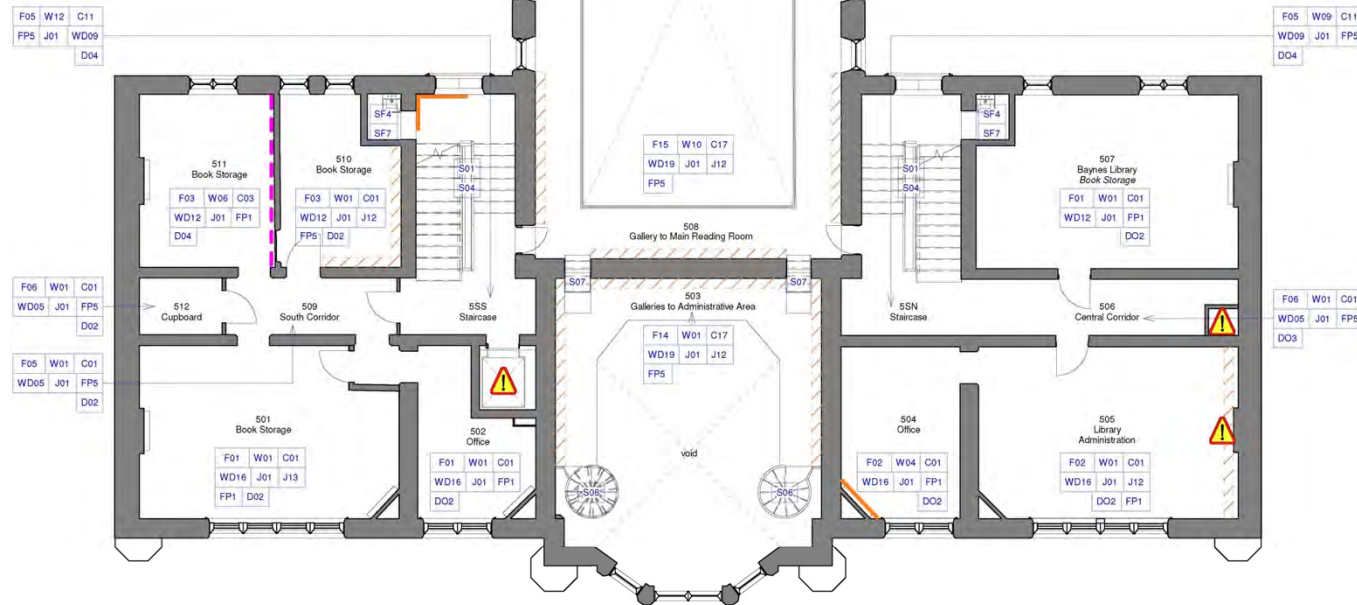
Indicative locations of tile splashback, conditioned considered good.

Timber panelling / built in book shelving to perimeter walls, including Library book presses.

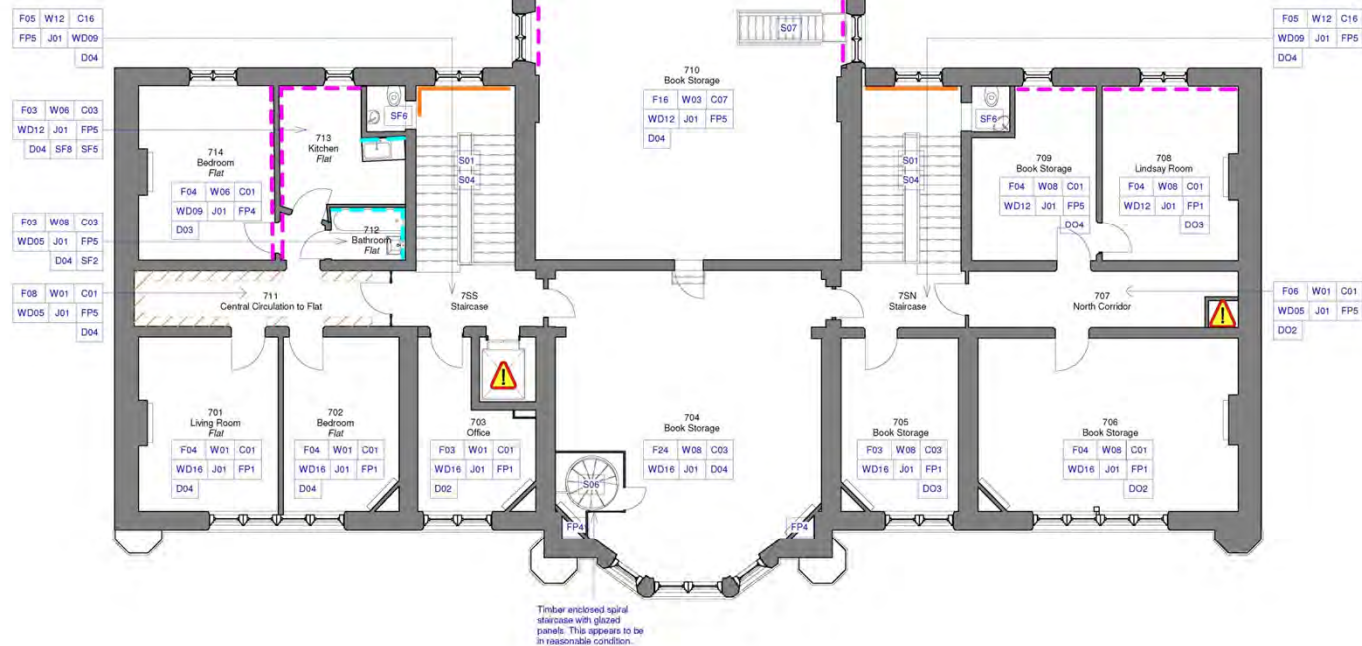
Indicative locations of tile splashback, conditioned considered good.

Timber panelling / built in book shelving to perimeter walls, including library book presses.
