Re-inspection (Material Only) Asbestos Survey

**Dr. Williams's Library
14 Gordon Square
London
WC1H 0AR**

Report Ref: HLA153017/003R

June 2017

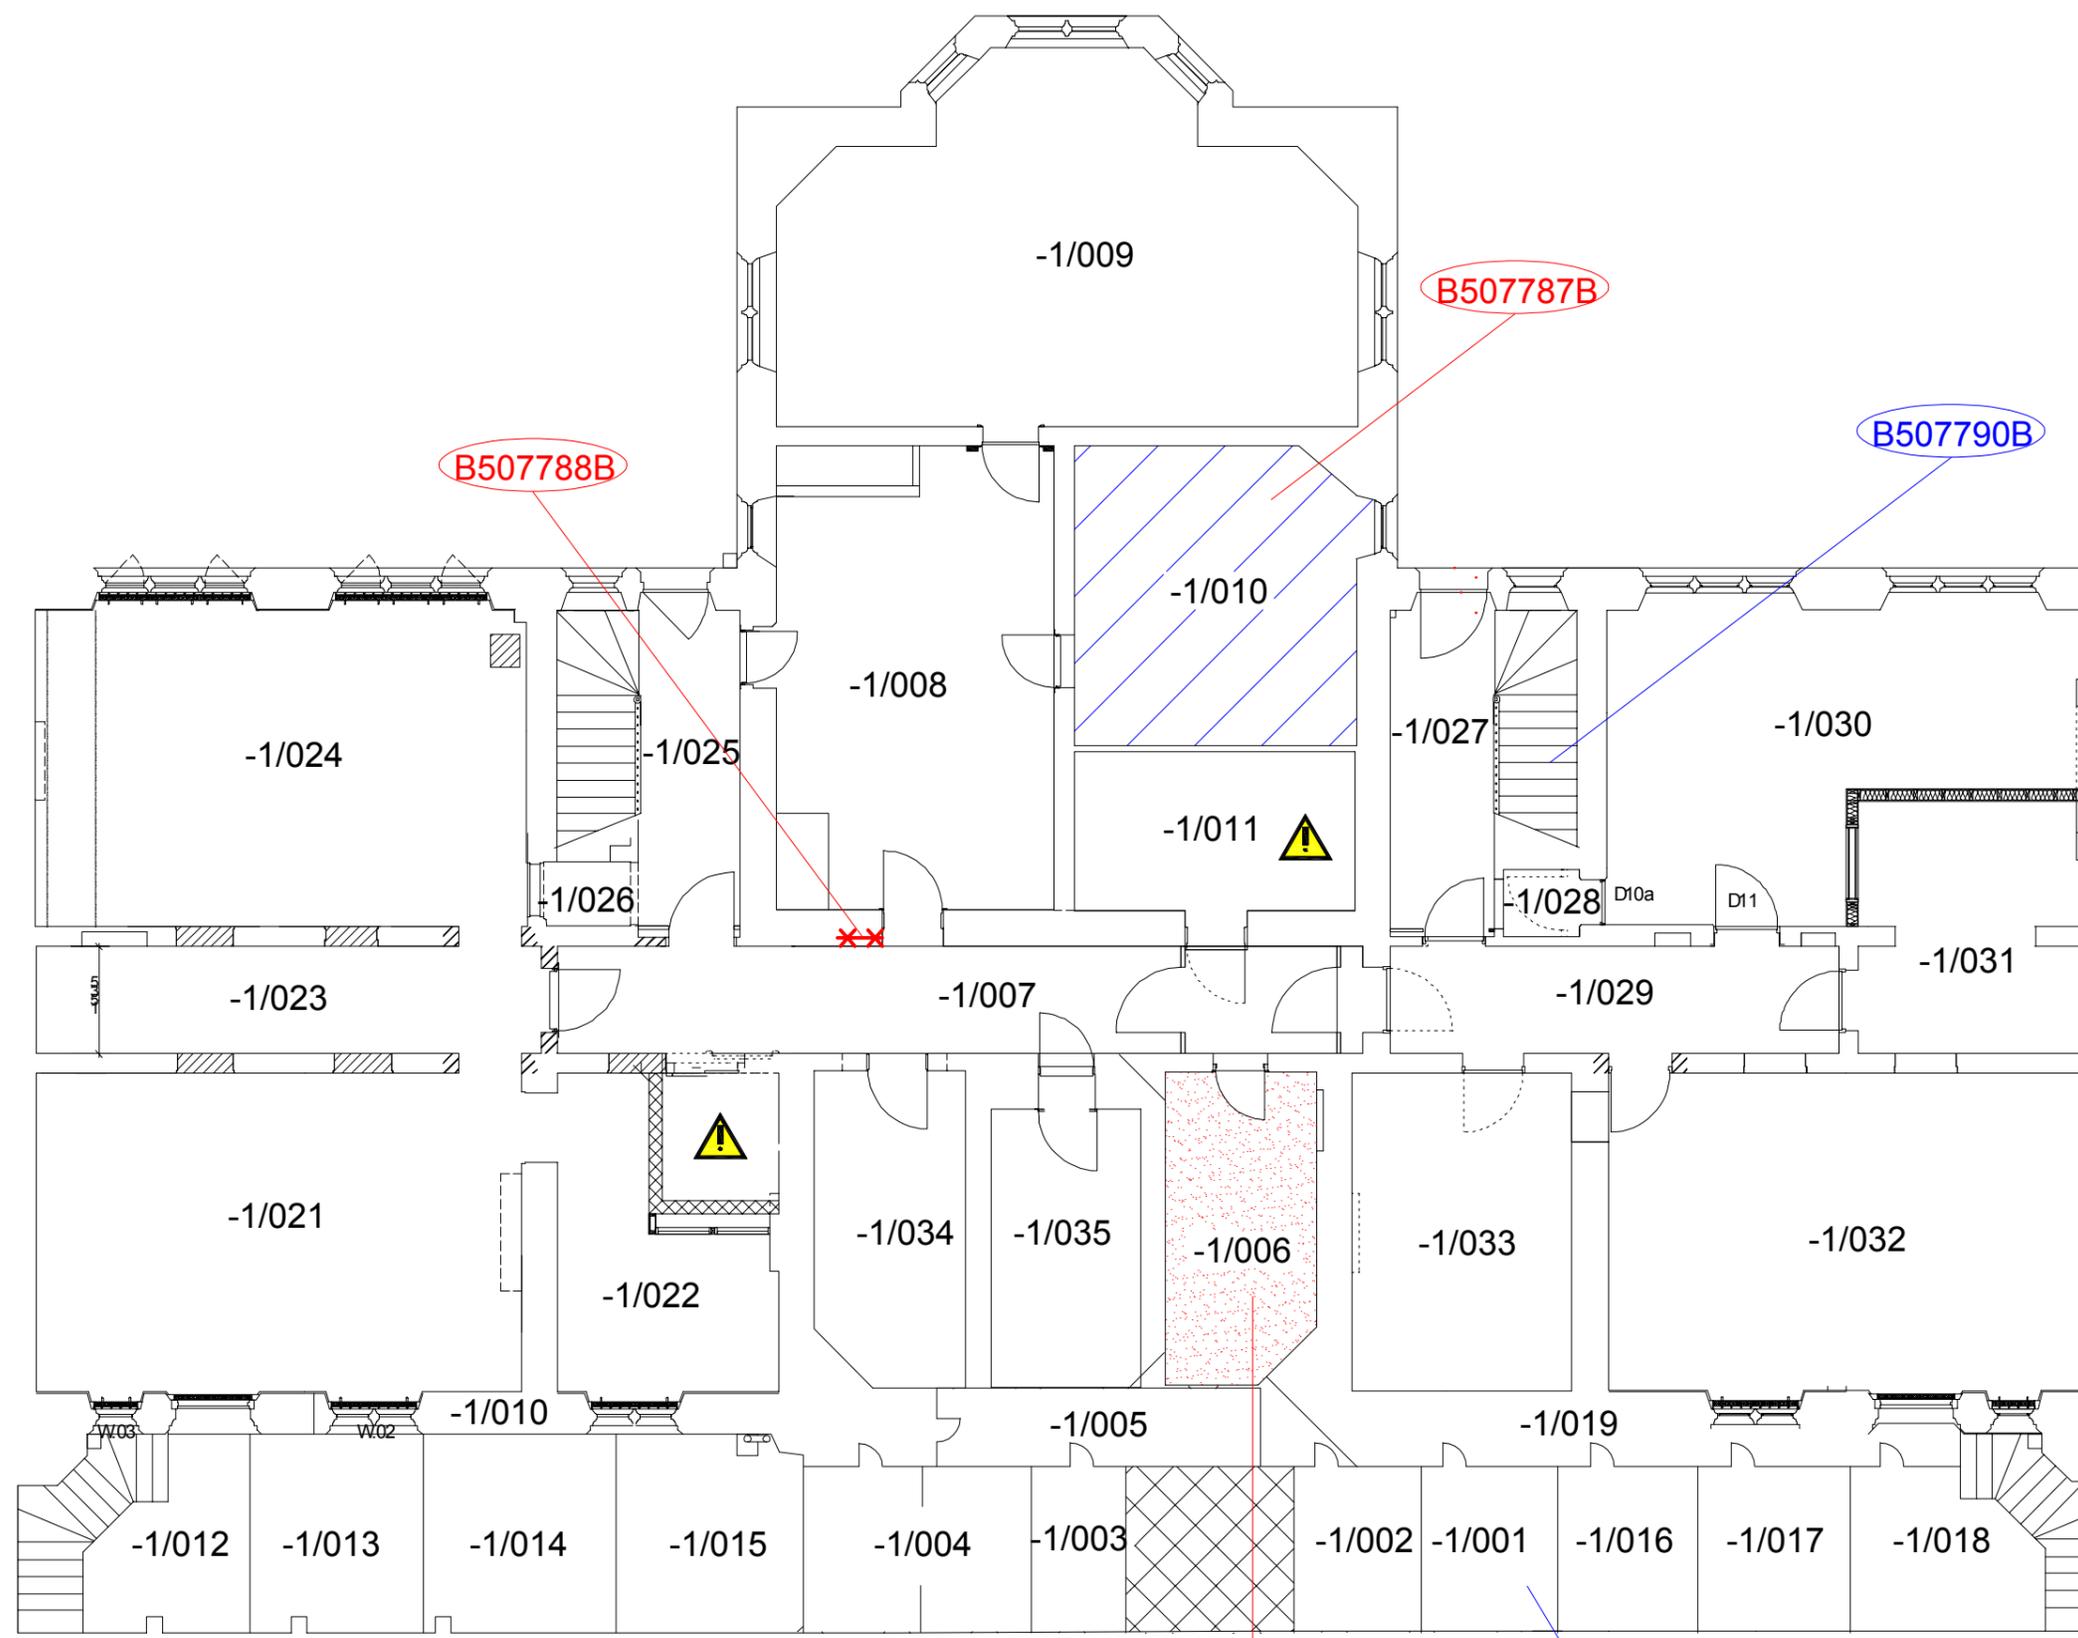
CLIENT: Dr William's Library
SITE: Dr William's Library
LOCATION: Basement
SURVEY DATE: 17th May 2017
RPS DOC NUMBER: HLA153017 / 006D
DRAWING REV:
RPS SURVEYORS: MP
DRAWN BY / DATE: MP / 19th May 2017
CHECKED BY: DR

- B506196B
- B506197B
- B506198B
- B506199B

B506194B

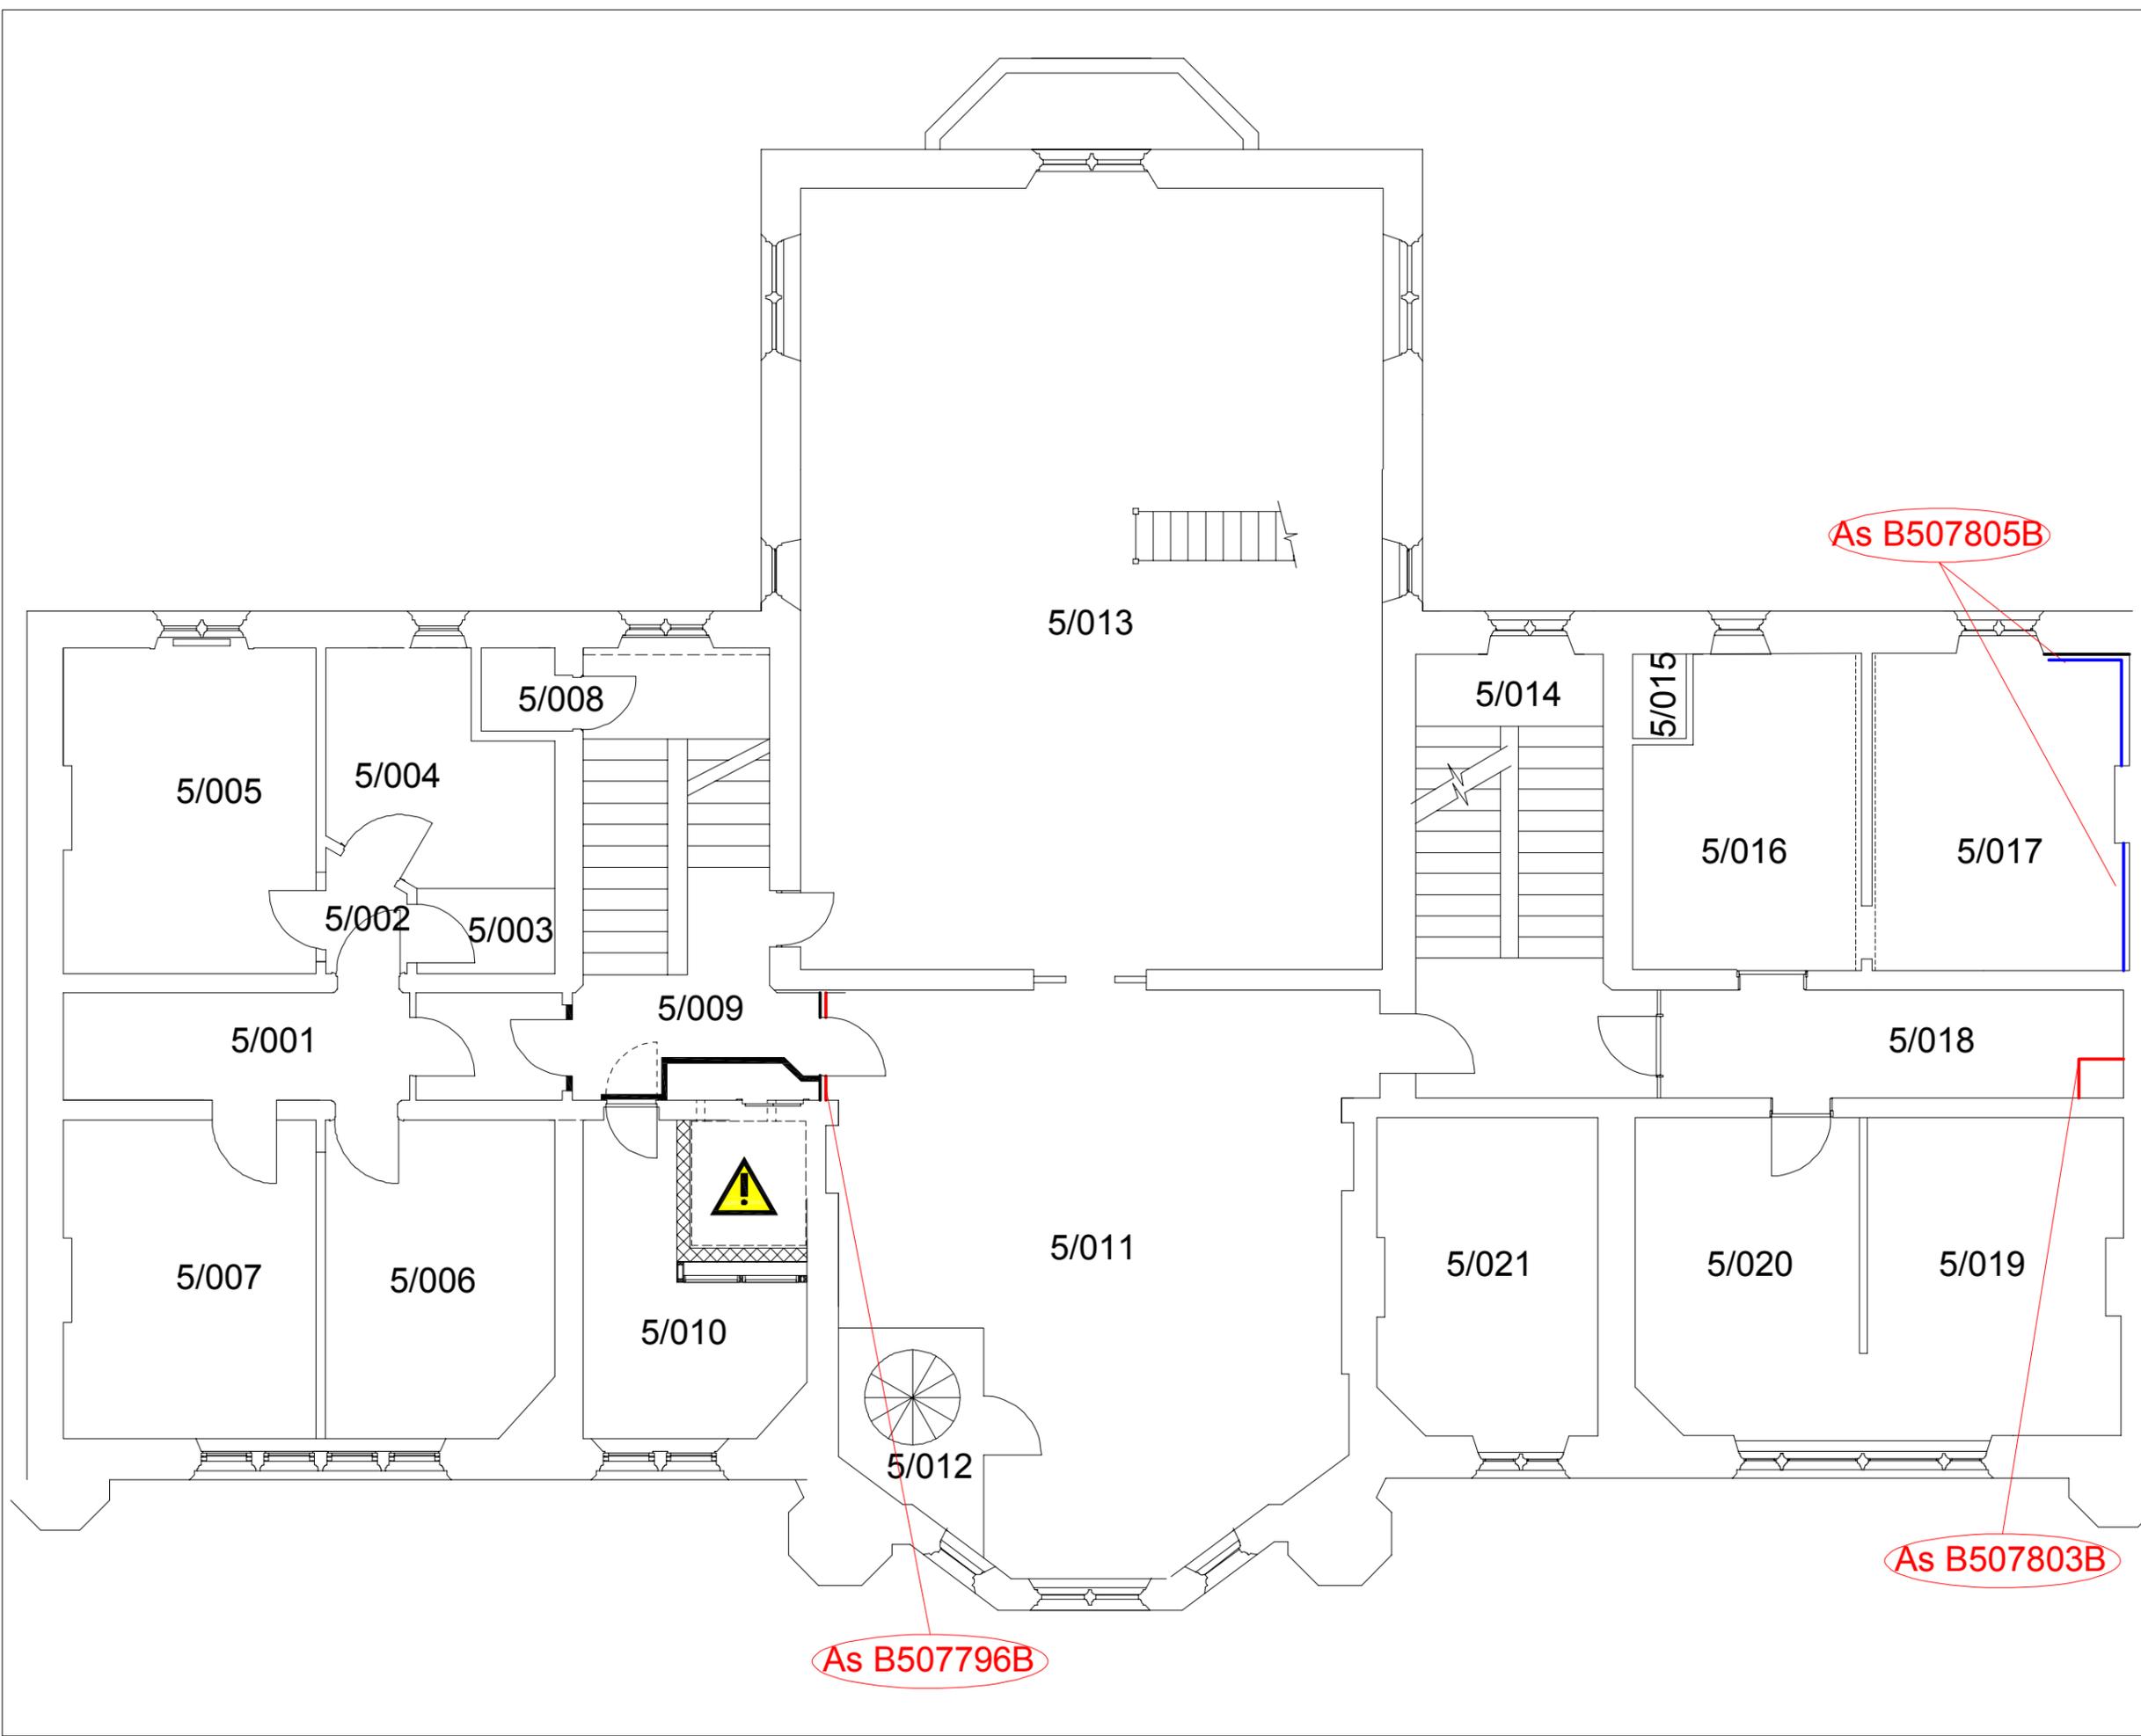
CLIENT: Dr William's Library
SITE: Dr William's Library
LOCATION: Fifth Floor
SURVEY DATE: 17th May 2017
RPS DOC NUMBER: HLA153017 / 012D
DRAWING REV:
RPS SURVEYORS: MP
DRAWN BY / DATE: MP 19th May 2017
CHECKED BY: DR

As B507796B

As B507805B
