**Tree Survey, Arboricultural Impact Assessment
Arboricultural Method Statement & Tree Protection Plan
In Accordance with BS 5837:2012**

| Proj. No 7757 | 16 Downshire Hill, Hampstead, London, NW3 1NT | | |
| Date of Report: | 05/11/2019 | Revision: | A |

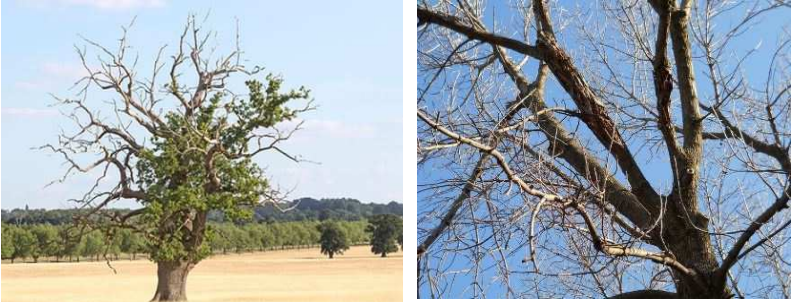
| Symptoms/damage type and cause: | This relates to dead branches in the crown of the tree. In the majority of cases, this is caused by the natural ageing process of the tree or shading due to its close proximity to neighbouring trees. However, in some situations, it may be related to fungal, bacterial or viral infection. |
| Consequence: | Depending upon the location and mass of dead wood removal of the affected tissue may be necessary to prevent harm to persons or property as the wood will become unstable as it decays and in some circumstances is likely to fall from the tree with little or no warning. |

| Control: | Detailed monitoring should be undertaken on those trees showing signs of excessive deadwood production to identify the underlying cause. |
