# 1EW02 Enabling Works – Area South

## Heritage Agreement Method Statement

### Alteration and Temporary Protection Methods for Party Wall between Royal College of General Practitioner’s Building and Walkden House

Document number: 1EW02-CSJ-HS-MST-S003-000625

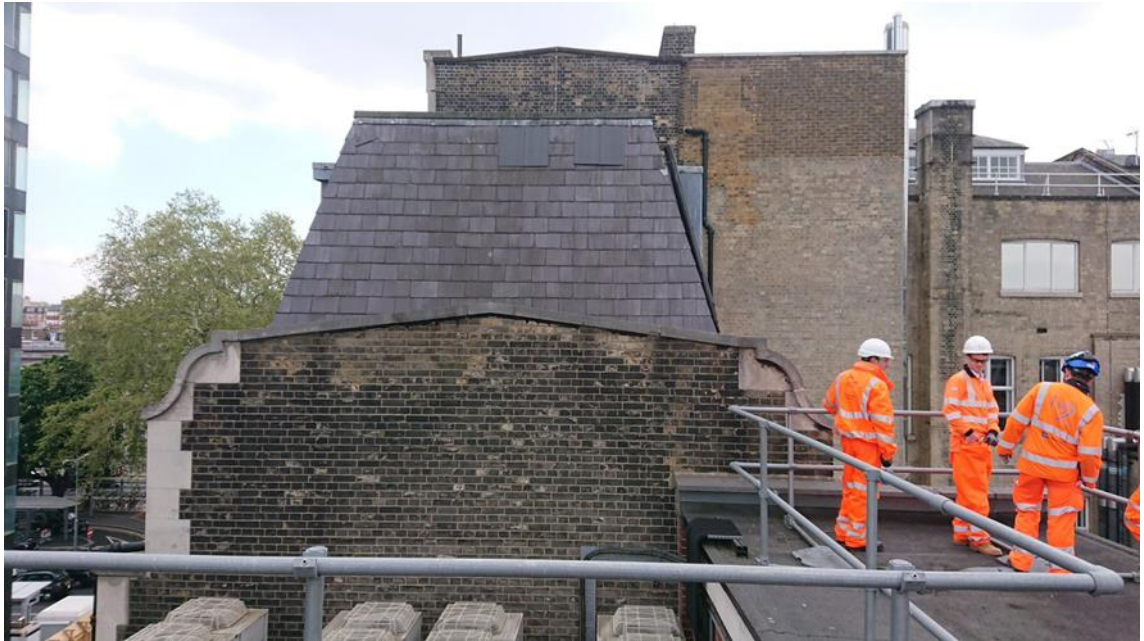
*Figure 5. RCGP party wall with Walkden House, viewed from the north from the roof of Walkden House (Mott Macdonald, 2019)*

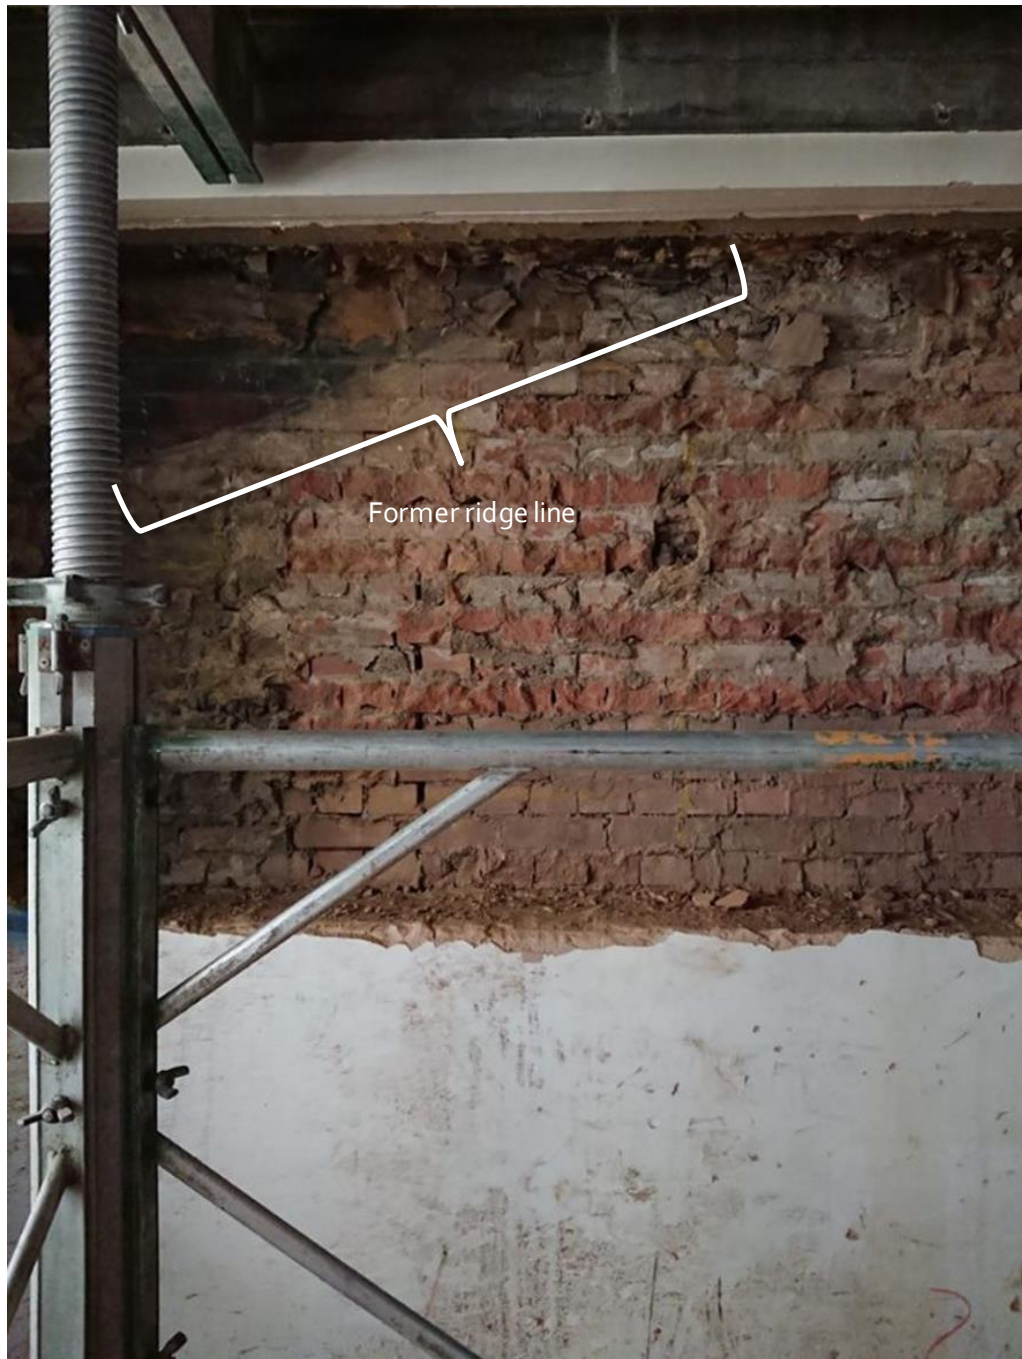
Figure 8. The ridge line of former 19th century terraces visible on the RCGP northern elevation, revealed behind the second storey brick infill of Walkden House (Mott MacDonald, 2019)

6. First floor level – Similar condition to the ground floor level.
7. Second floor level – Brickwork is irregular and appears poorly laid, as in the two lower storeys. A layer of scabbled 19th century red brick adheres mainly to the right side of the RCGP wall. The ridge lines of the 19th century terrace is apparent with brick laid to a better standard approaching and above the ridge height (Figure 8). In this storey brickwork is red, above and below the terrace ridge height. A recess in in the RCGP brickwork in the centre of the elevation presumably relates to the form of the 19th century terraces.

- 3.3.2 The remains of earlier brickwork (thought to belong to the 19<sup>th</sup> century terrace) overlying the RCGP wall face (in a thin layer) will be carefully removed by hand by a mason suitably experienced and skilled in historic brickwork. Removal will permit inspection of the underlying RCGP brickwork, to verify brick bond and condition and to facilitate installation of protection to the exposed RCGP party wall.

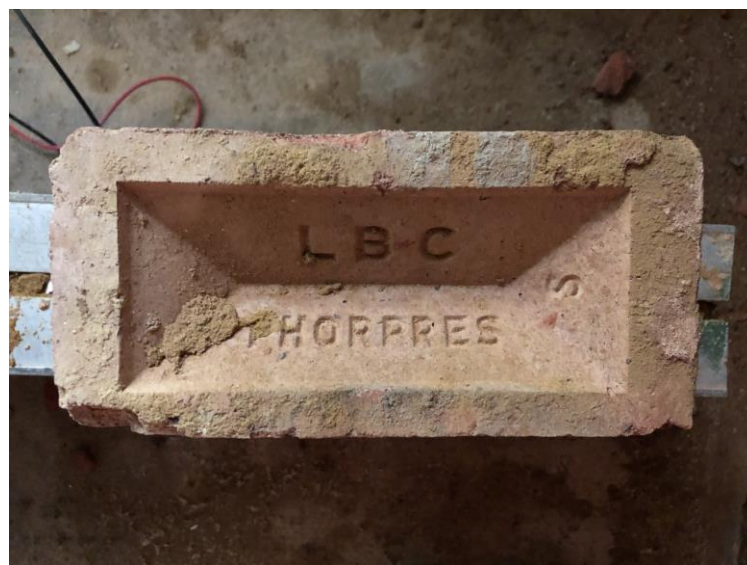
- 2.3.3 While the northern elevation of Pite’s 1923 extension is of lesser aesthetic value than the eastern elevation, the varied use of brick types indicates an intentional application of more aesthetically pleasing materials in areas where they may still be visible. Yellow stock brick, now black from soiling and exposure, (Figure 5) has been employed in the areas of the elevation above the ridge height of former terraces north of the building. This is coursed in English bond and begins several courses above the ridge height of the terraces, only where there is a chance it will be visible. Brick lower down the elevation where the RCGP had a party wall with 19th century terraced houses is red brick rather than yellow stock with little concern for the aesthetic qualities of the wall. The red brick appears to be of the Phorpres type, introduced by the London Brick Company, a leading manufacturer of bricks incorporated in the 1900s – refer to figure 10. This ‘four-pressed’ type of brick with a deep frog and stamp was also found in brickwork of Walkden House. These are imperial pressed bricks of dimensions approx. 8 1/2 inches x 4" x 2 5/8 inches.

*Figure 10 – Phorpres type brick with deep frog and stamp, found in the Walkden House Wall*

- 3.3.20 There are two known void features in the RCGP northern elevation (See Brick Infill Repair, in Appendix D – Remedial Detail Figure). These are located at ground and second floor (Walkden House levels). The largest is located at second floor.
- 3.3.21 At second floor level (Walkden House), void feature is partly infilled with rubble, approximately 1300mm high, as shown in Figure 16. This shall be removed. A single skin of new brickwork shall be installed within the void, where available, existing phorpres bricks will be re-used.

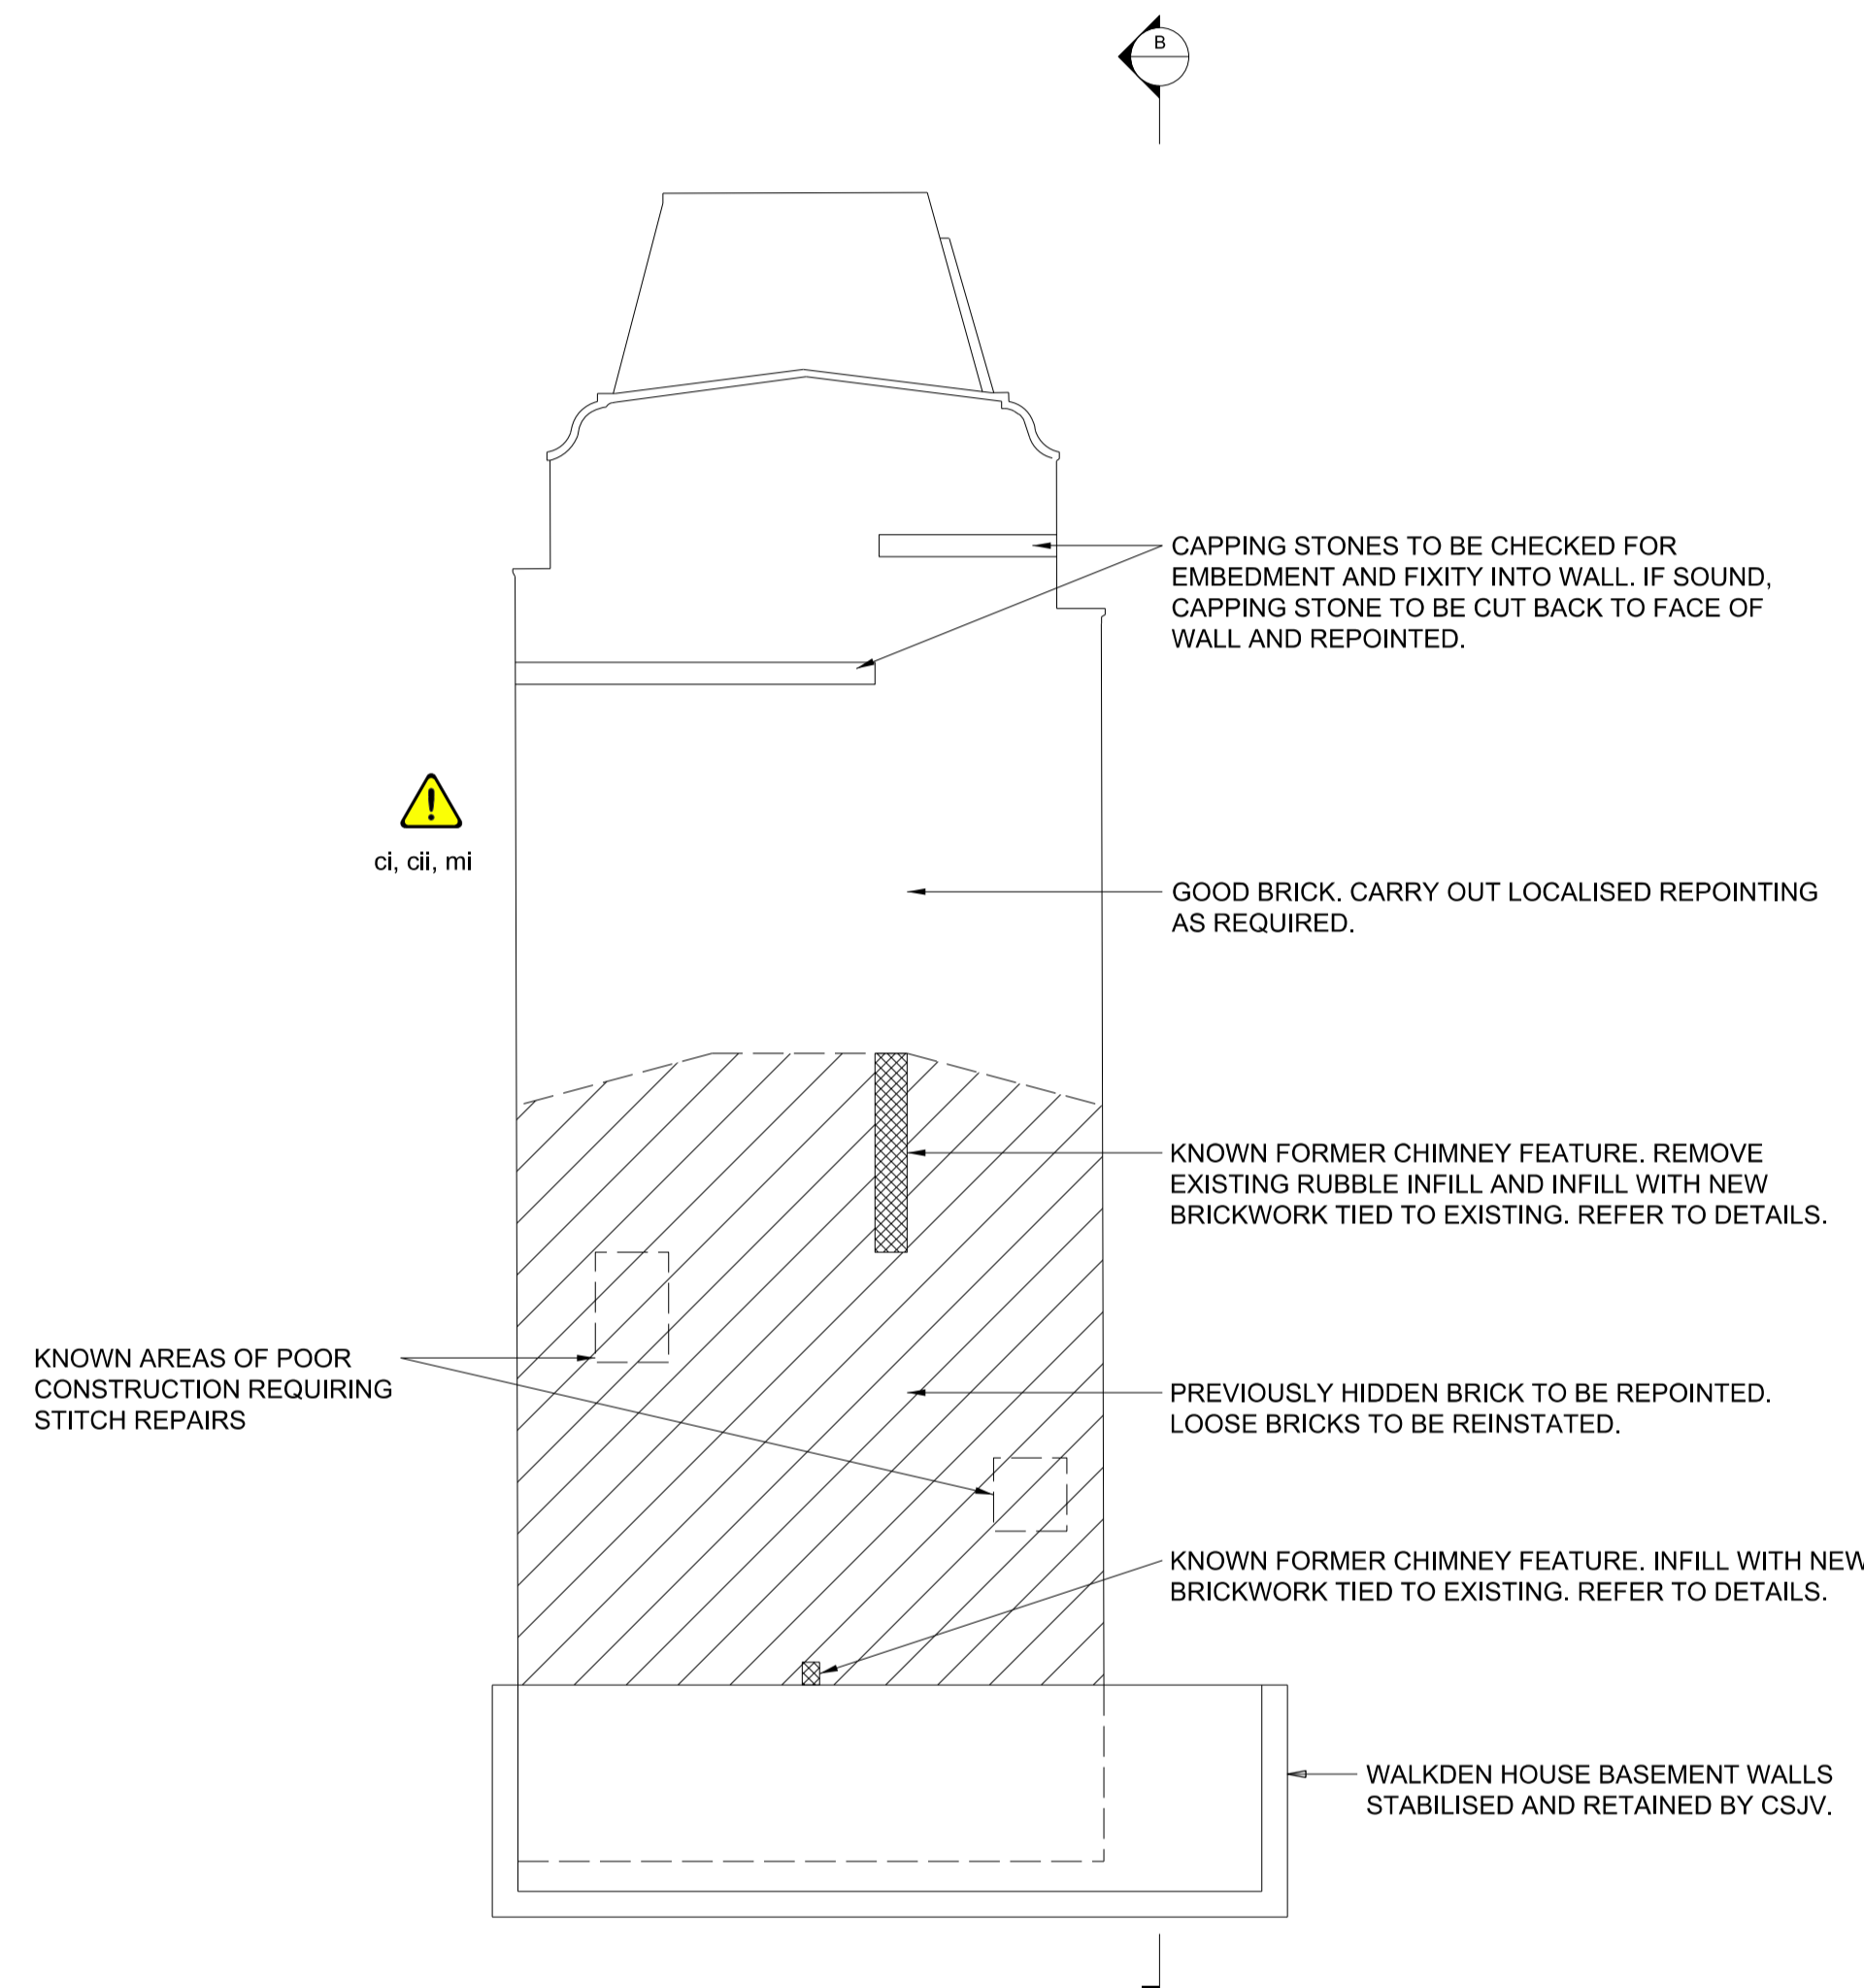
Elevation A-A - Approximate Elevational View of RCGP Wall  
Not to Scale

- 2.4.3 The condition of the RCGP northern elevation below the ridge height of 19th century terraces is generally assessed as poor.
- 2.4.4 Areas of red brick and yellow stock above the ridge height of 19th century terraces and above the roof height of Walkden House, have been assessed as of good quality. The same blackening from air pollution is apparent on both.

- 3.3.1 A number of repairs are to be undertaken to the RCGP northern elevation, prior to the installation of weatherproofing. Repair work, consisting of repointing and localised re-building of missing or defective facing brickwork is necessary to provide structural stability and to permit installation of temporary protection (as it would not be possible to securely fix felt and batten protection to defective brickwork with open joints and loose bricks).

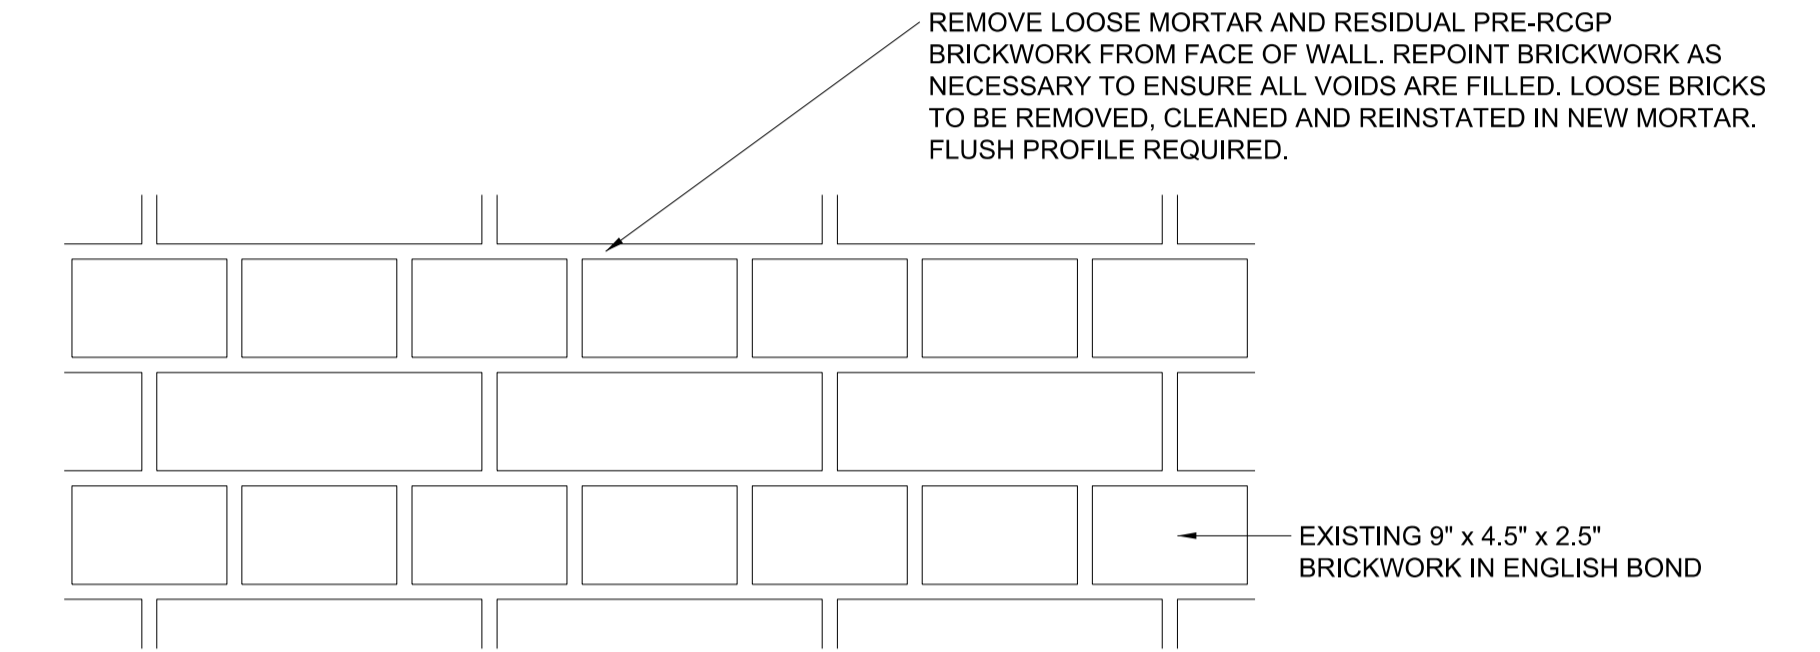
**Brick Repointing Detail In Previously Hidden Brick Area**  
Scale 1:5 @ A1

5. Ground floor level – RCGP brickwork had been covered with a thin building paper membrane prior to construction of the Walkden House wall. This membrane is in a deteriorated condition. The RCGP brick face at this level is irregular and roughly finished red brick, with a scabbled layer of 19th century brick red brick adhering to a large area of the northern elevation of the RCGP. This is in contrast to the upper levels (3rd floor and roof) which were neatly finished as they were originally exposed.

- 3.3.10 Where mortar is present and in good condition, bonded to the brickwork, there is no requirement to remove this. Repointing of the wall is only required where either no mortar is currently present or where existing mortar is loose.

- 3.3.12 Loose mortar is to be raked out and the affected area repointed.
- 3.3.13 There may be small and isolated areas of the exposed wall at third floor and above requiring repointing.
