DRIVING STATUS	PLANNING
DRIVING TITLE	UNDERPINNING SEQUENCE AND SECTIONS A_A & B_B THROUGH BUILDING AND ADJOINING PROPERTIES
PROJECT	20A FERNCROFT AVENUE, LONDON, NW3 7PH,
Project Number	P19-461
3, Dufferin Avenue London EC1Y 8PQ T.020 7253 2626	
Drawn	Checked
GB	NTS
Purpose of Issue	29.10.19
BASEMENT IMPACT ASSESSMENT	
Drawing Number	Revision
P19-461_SK08

## **BS 5837:2012 Tree Survey Arboricultural Impact Assessment**

20A Ferncroft Avenue, Hampstead, London, NW3 7PH

**November 2019**

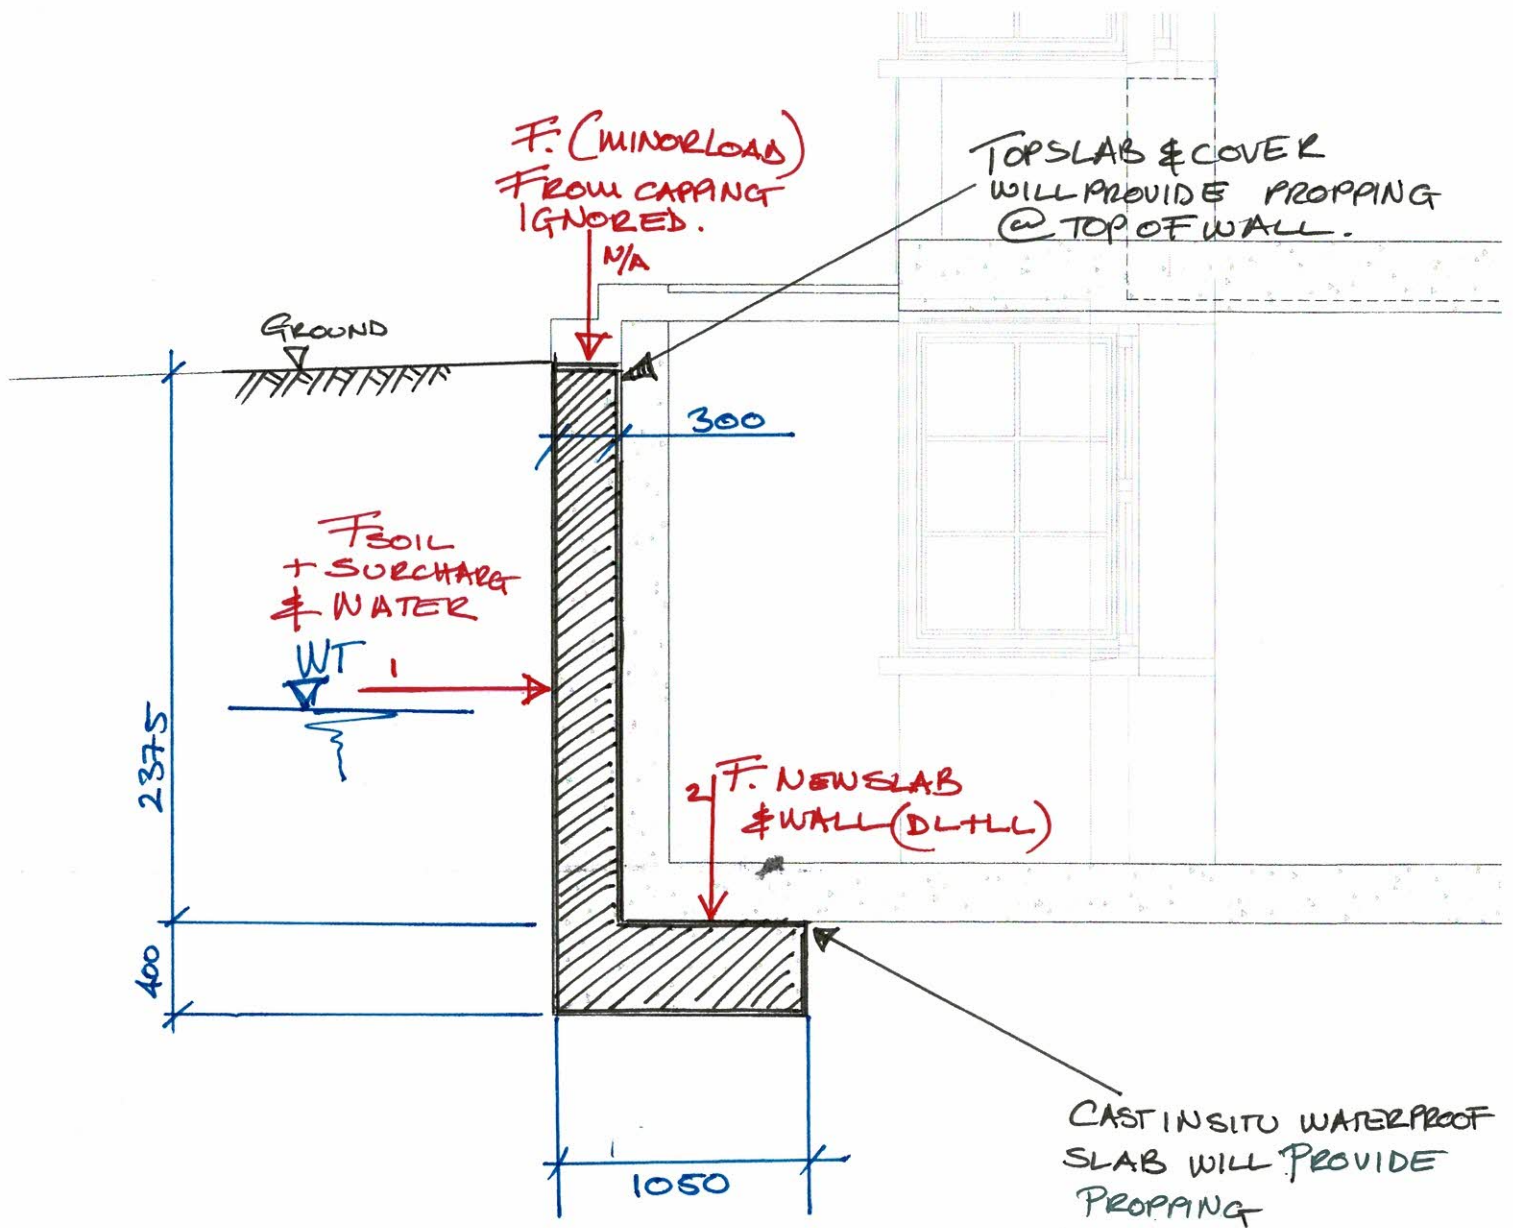
RETAINING WALL SECTION 1

PERMANENT STAGE  
SOIL WILL BE UNDRAINED DURING PERMANENT STAGE

NOTE: GROUND IS TAKEN AS "SILTY CLAY" ALL AROUND.  
& SOIL PRESSURE COEFFICIENT TAKEN AT REST

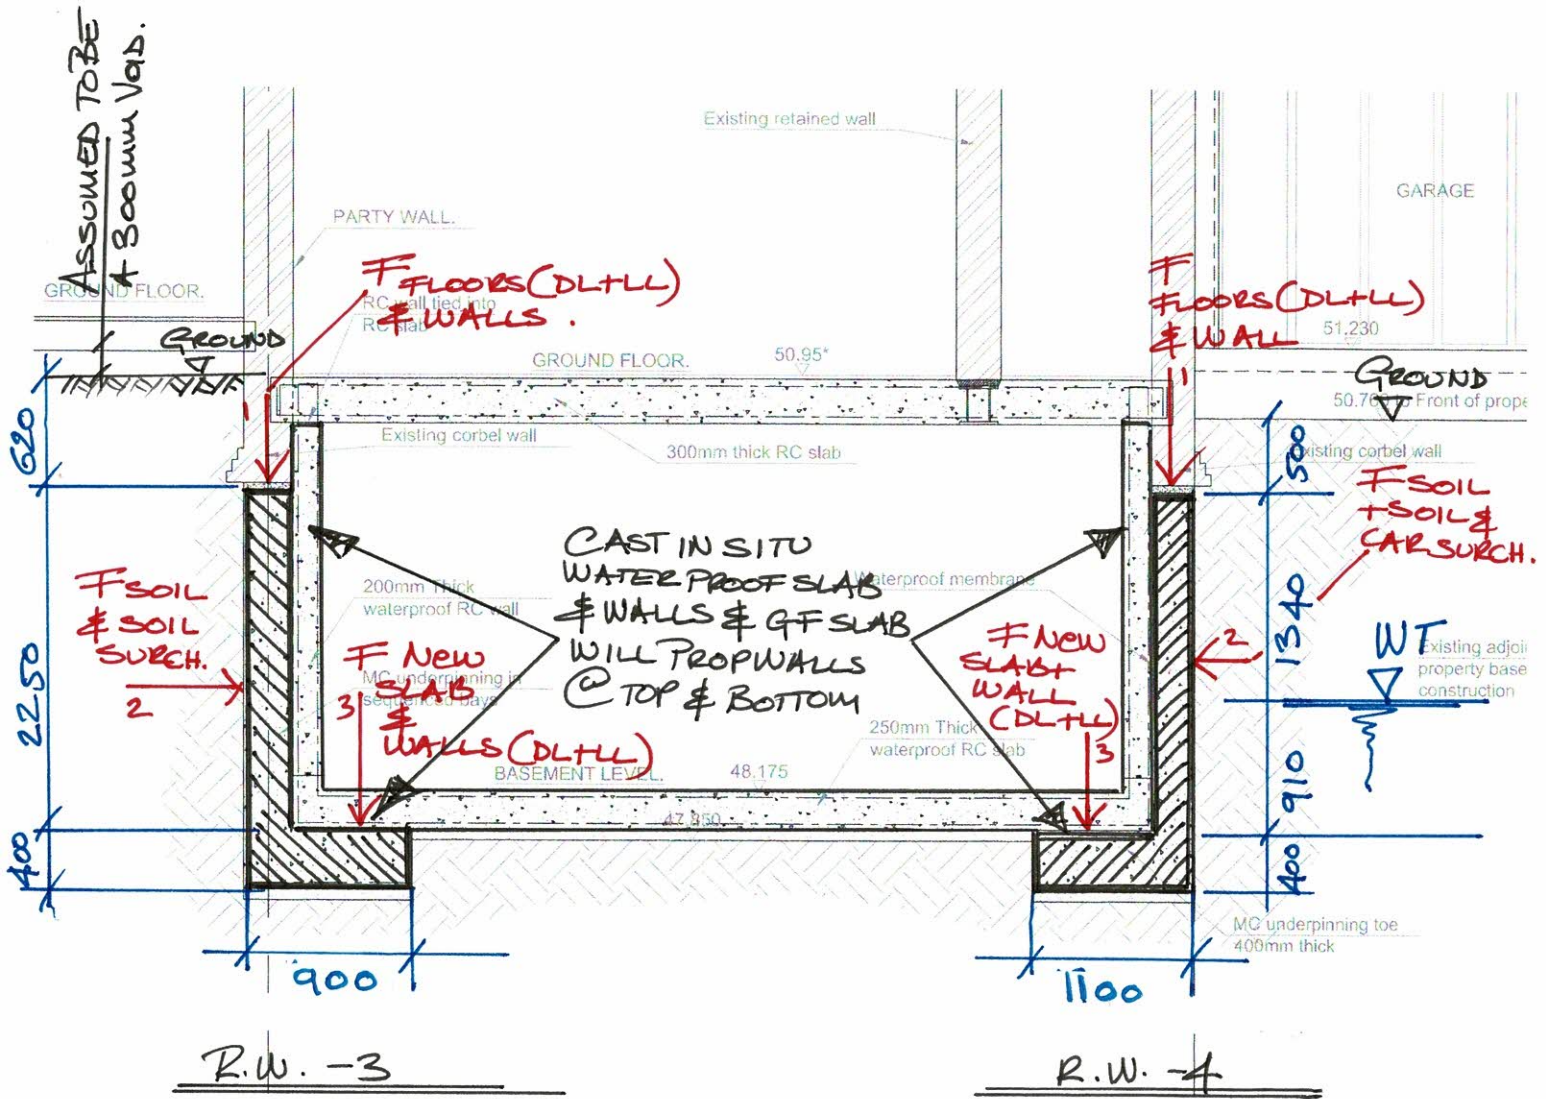
RETAINING WALLS. SECTIONS 3 & 4

SOIL WILL BE UNDRAINED DURING PERMANENT STAGE.

NOTE: GROUND TAKEN AS "SILTY CLAY" ALL AROUND.  
& SOIL PRESSURE COEFFICIENT TAKEN AT REST.

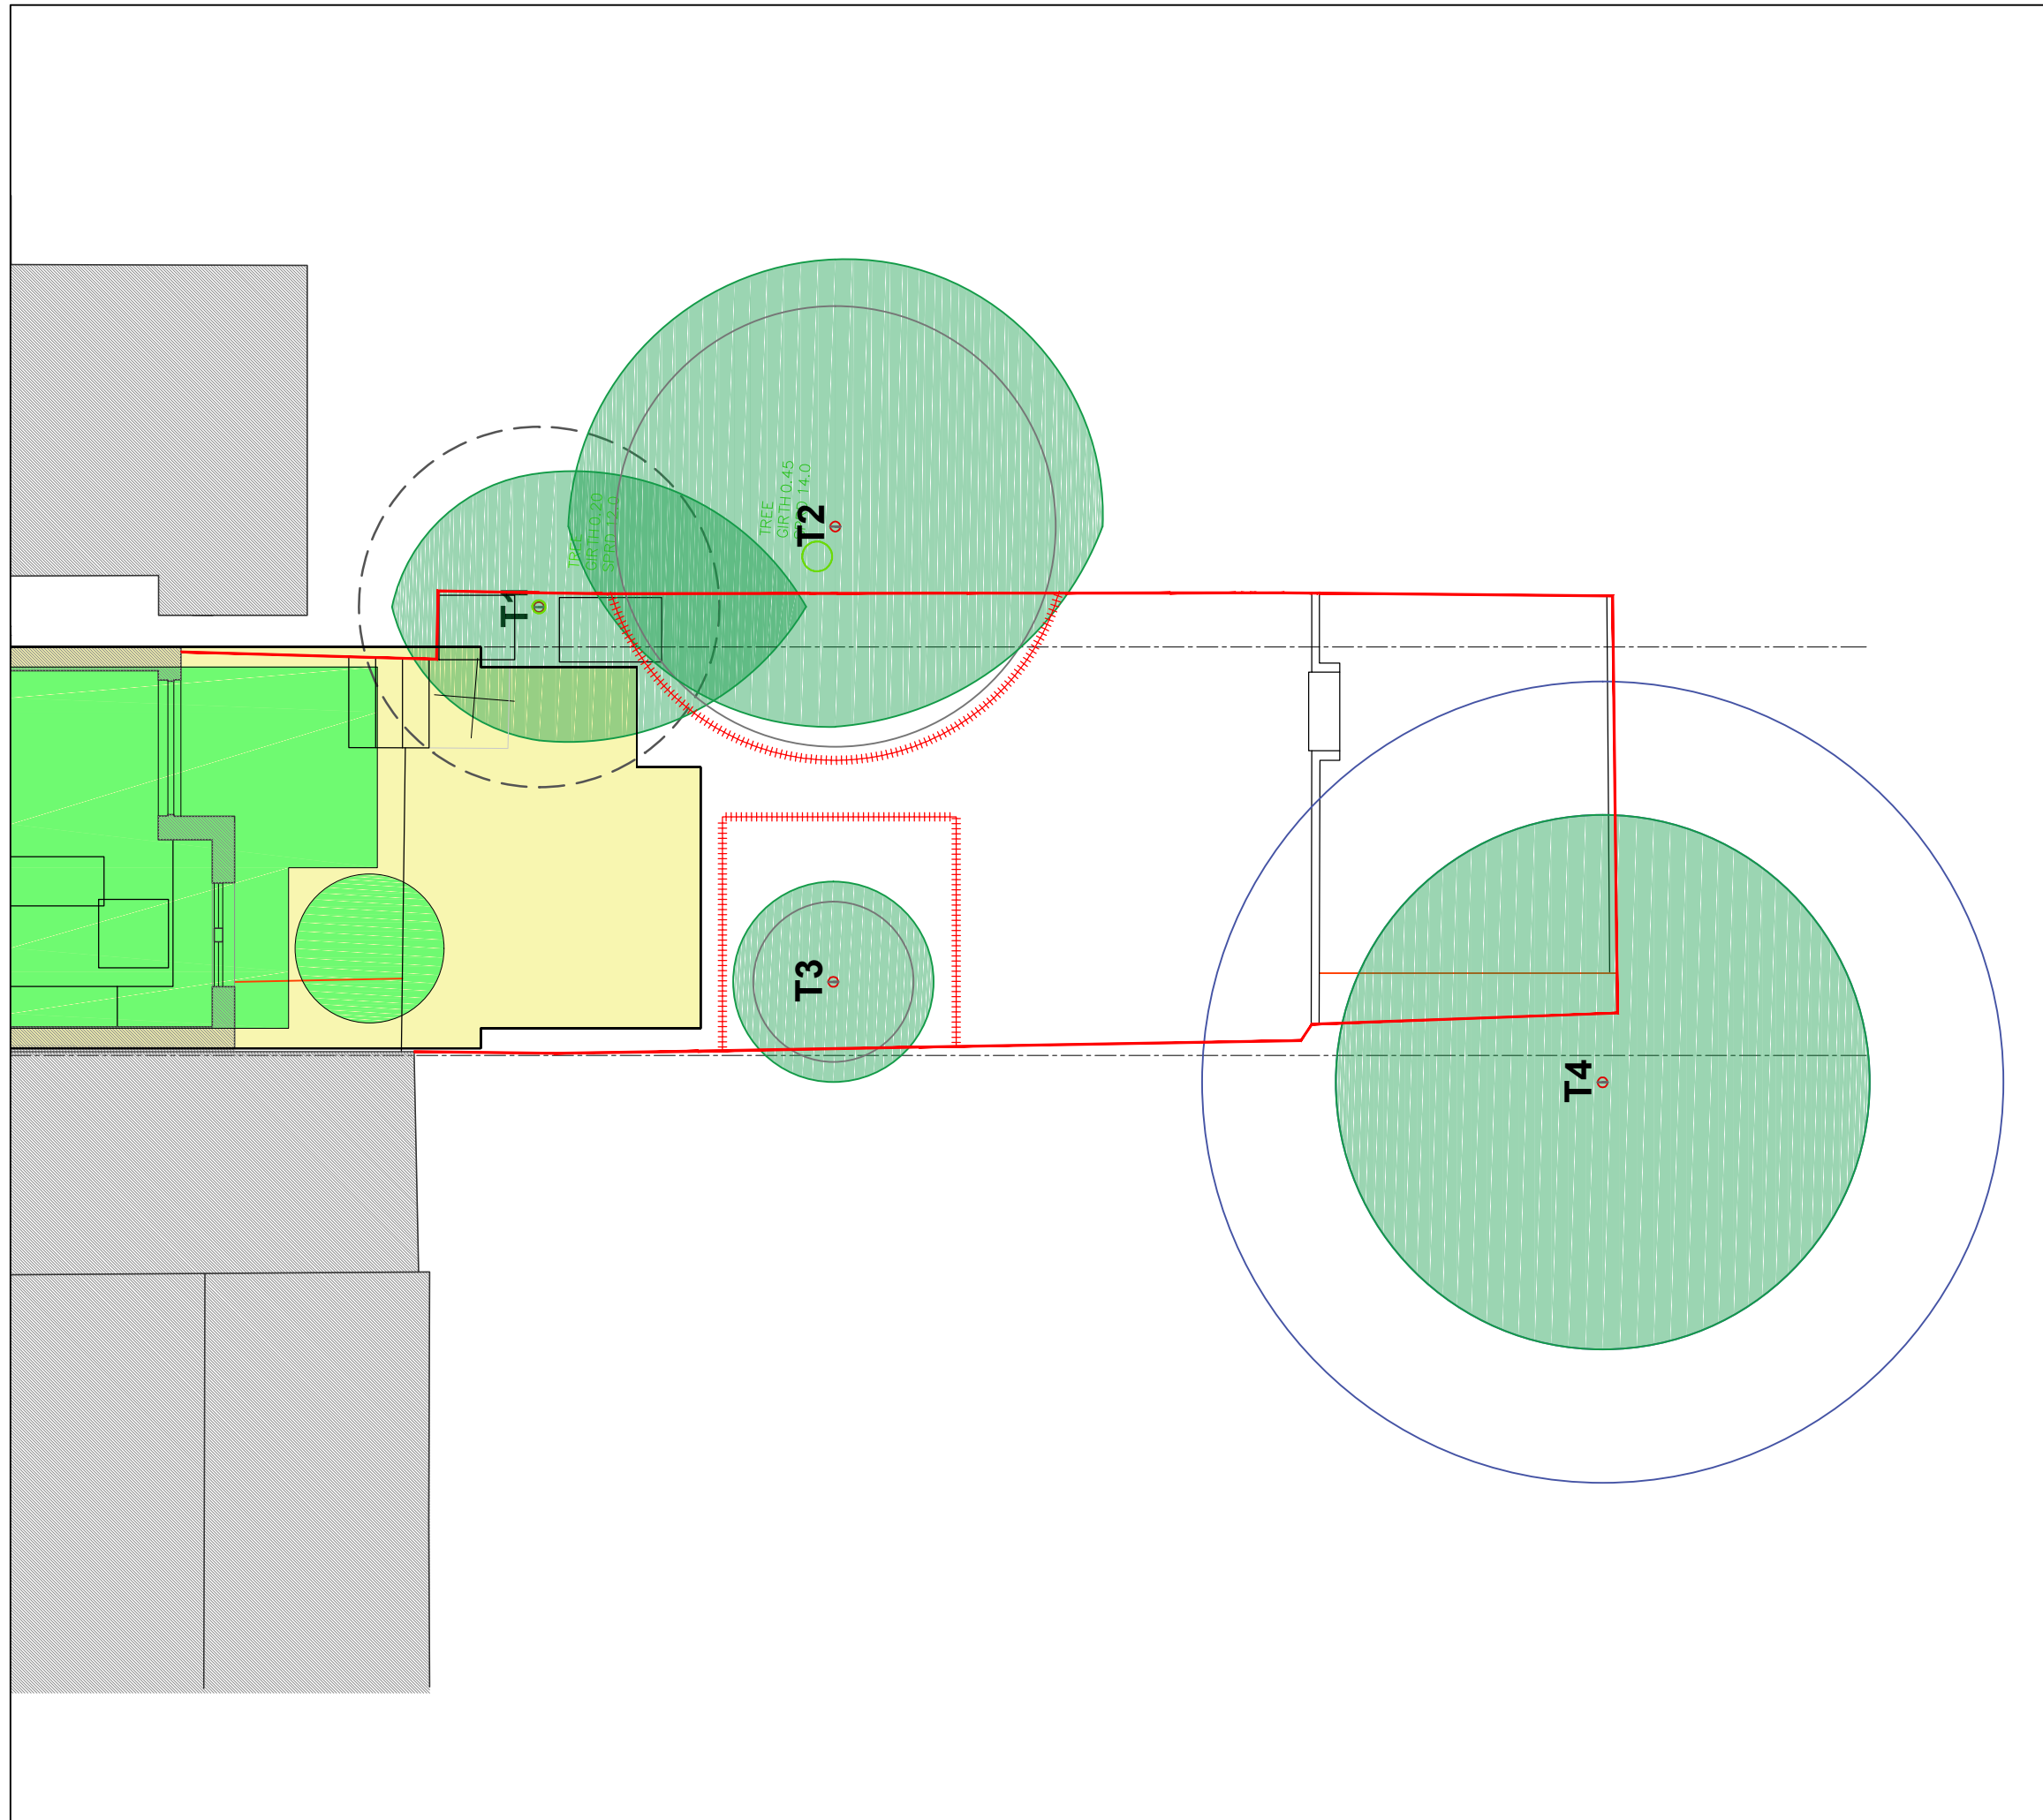
Crown spreads are represented as coloured lines that reflect the crown spread measurements indicated in the tree schedule and accord with BS 5837/2012.

Tree numbers are preceded with a "T" for individual trees, a "G" for groups.
