ARBORICULTURAL IMPACT ASSESSMENT REPORT  
BS 5837:2012 'Trees in relation to design, demolition and construction. Recommendations'

SITE

Branch Hill,

**DATE: 6 December 2019**

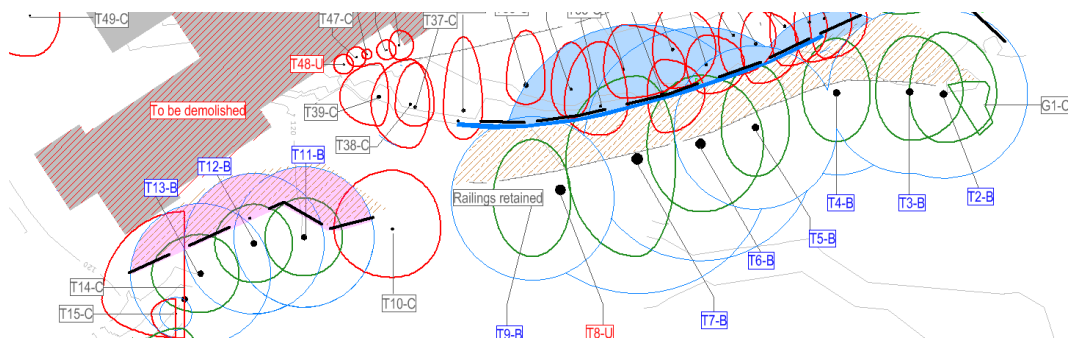
*Plan 1 – extract from SHA 681 TPP1 for demolition. Do not scale. North is vertical. For information on the key, see the drawing at appendix 3.*

As previously discussed, the calculated root protection area of the lime trees, in particular T4 to T7, is not representative of actual rooting due to the presence of holly trees which will be removed. This is shown shaded blue on the plan extract below. Therefore, I am comfortable with the proximity of the proposed building to the trees and have agreed this with the Arboricultural Officer during site meetings. The piling mat to the south of the building normally requires a 600mm excavation. As this space is occupied by the roots of the holly trees, this will not be a concern. This is not the case with T11 – T13, but there is a change in level and hard surfacing, which minimises risk of tree roots being damaged.

The wall to the north of T2 – T9 will be removed with care under arboricultural supervision.

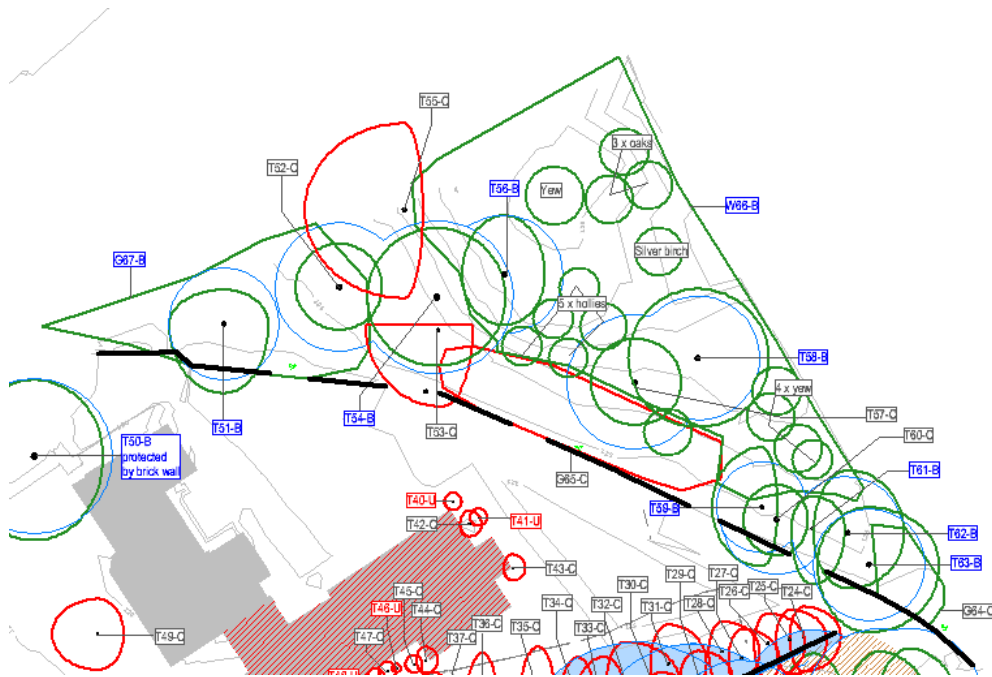
Plan 3 – extract from SHA 681 TPP1 for demolition. Do not scale. North is vertical. For information on the key, see the drawing at appendix 3.

- 6.8.4 The levels around trees to be retained will be unaltered. Works near trees (such as the levelling at the front between trees) will take place under arboricultural supervision and the area will be temporarily fenced as shown at *SHA 681 TPP3*.

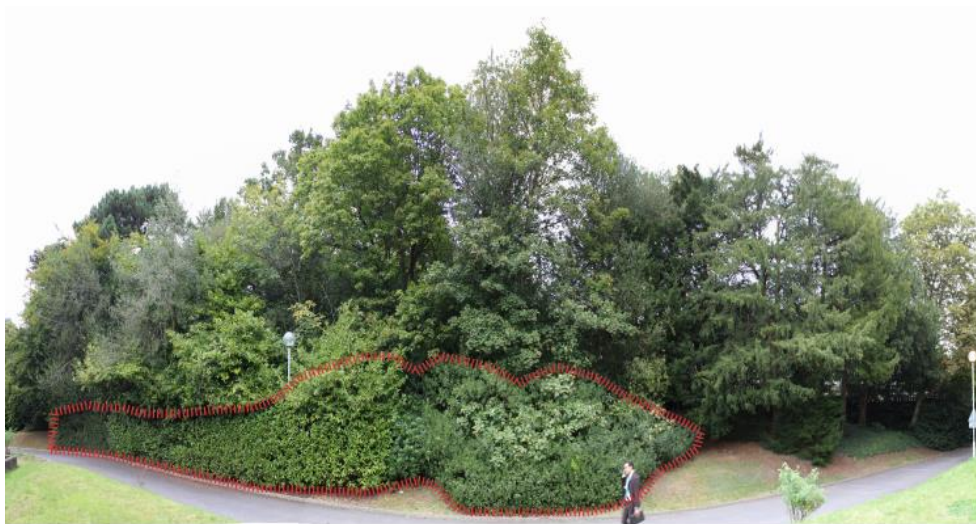
Extract from Planit E Landscape Pre-App presentation document showing the removal of G65 outlined in red.

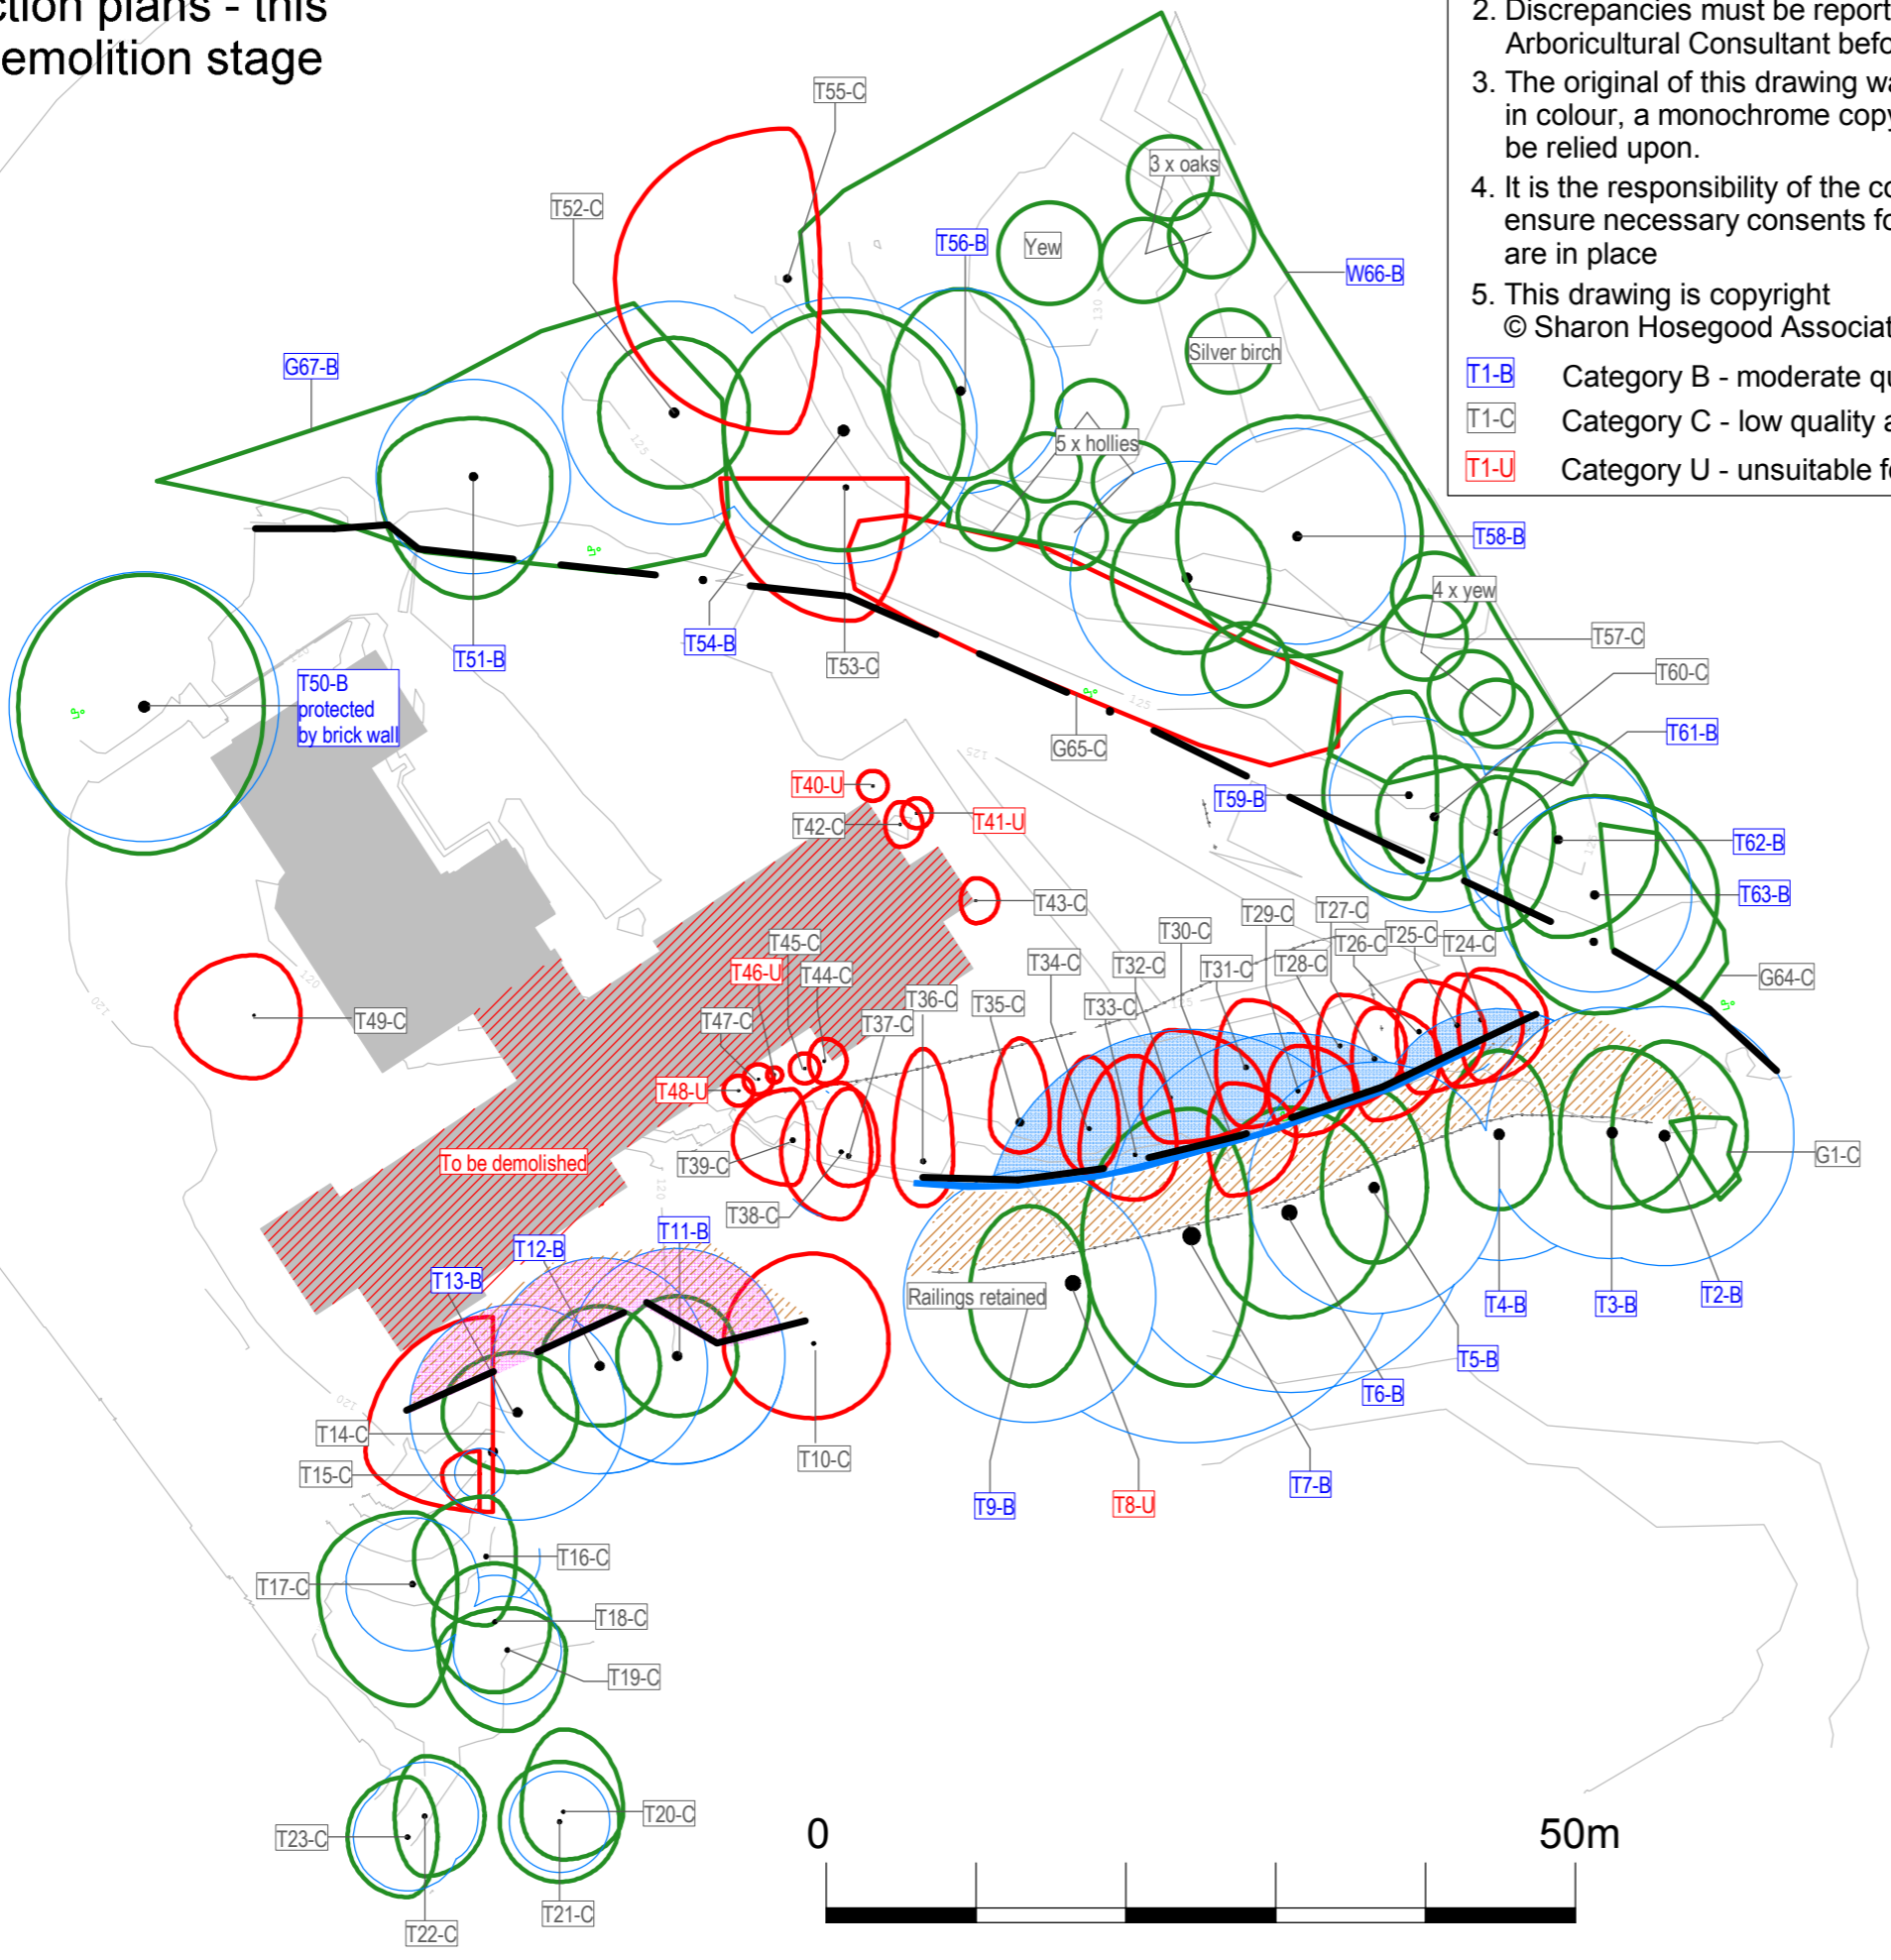
- Wall to be demolished in accordance with the arboricultural method statement
- Area of lime trees RPA in which will not have any roots in the top 600mm due to presence of holly trees and the retaining wall. Low possibility of deeper roots below this, but more likely to be rooting south and along path. Spread woodchip from hollies as ground protection.

- Area of trees RPA below wall's foundations and under tarmac path. Tree roots likely to be deep and low density.
- Area of tarmac which might be used for demolition traffic. If this is the case an assessment will be made by a structural engineer on the loading capacity. If necessary, the tarmac will be reinforced with a method to be agreed.
