TECHNICAL REPORT ON A SUBSIDENCE CLAIM

14 Lindfield Gardens Management Co Ltd  
14 Lindfield Gardens  
London  
NW3 6PU

TECHNICAL REPORT

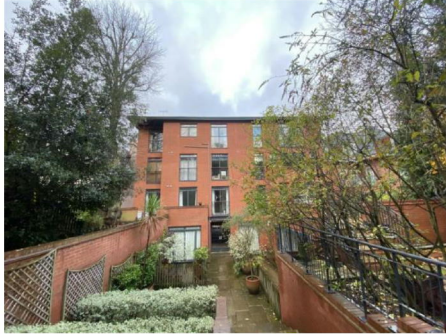
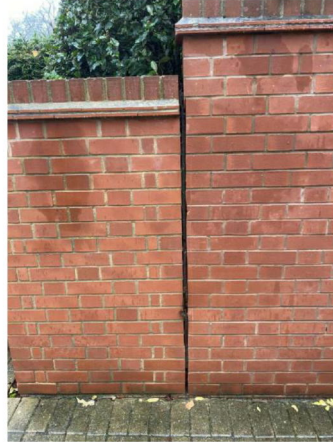
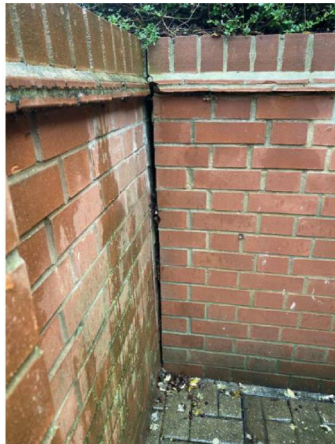
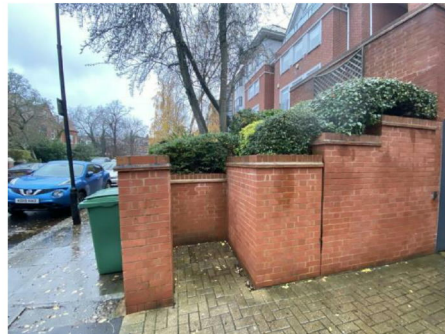
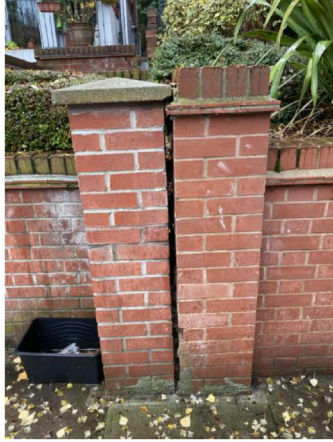
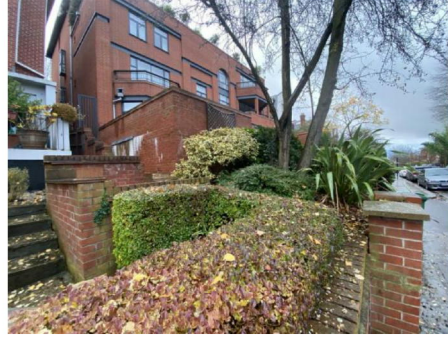
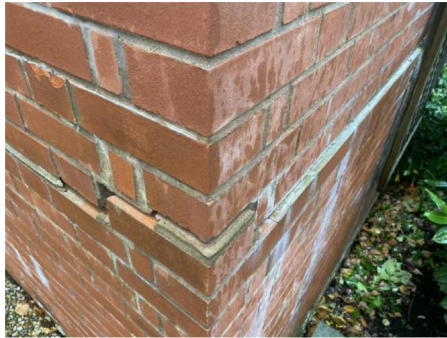
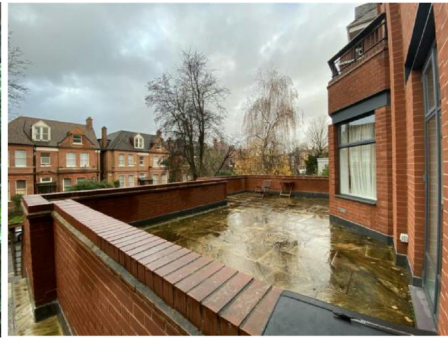
### PHOTOGRAPHS

In structural terms the damage falls into Category 4 of Table 1, Building Research Establishment<sup>6</sup> Digest 251, which describes it as “severe”.

The pattern and nature of the cracks is indicative of an episode of subsidence. The cause of movement appears to be clay shrinkage.

The timing of the event, the presence of shrinkable clay beneath the foundations and the proximity of vegetation where there is damage indicates the shrinkage to be root induced. This is a commonly encountered problem and probably accounts for around 70% of subsidence claims notified to insurers.

The cause of the movement needs to be dealt with first. We have completed a Soil Risk Analysis (VISCAT Assessment) and we are satisfied that your Hawthorn Tree can be removed.

We will obtain a quotation for the recommended tree works. Whilst the trees are not subject of a Tree Preservation Order, they are located in a Conservation Area and therefore an application to the Council will be required.

Provided the tree management works are completed expeditiously, consideration may then be given to carrying out the appropriate repairs to the property.
