75 Lawn Road

Structural Survey

March 2019

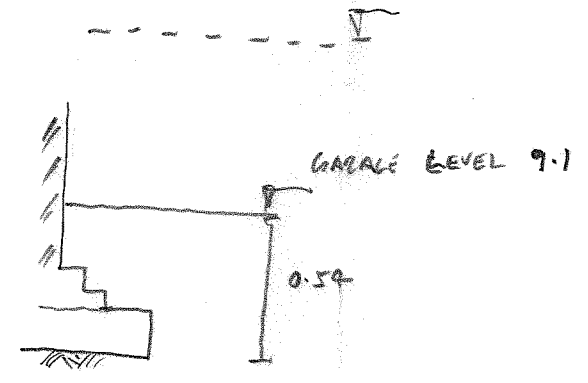
SECTION A-A AT PARTY WALL

ASH	HEIGHT	23m	MODERATE WATER DEMAND
BROAD LEAFED	(35m)	Ø 14m	1.35m DEEP
		19m	1m DEEP
SWAMP CYPRESS	20m	HIGH WATER DEMAND	
CONIFEROUS	(30m)	Ø 13m	1m DEEP
