London School of Hygiene & Tropical Medicine

Structural survey report - Phase 2b

Project number: 60562862

13 September 2019

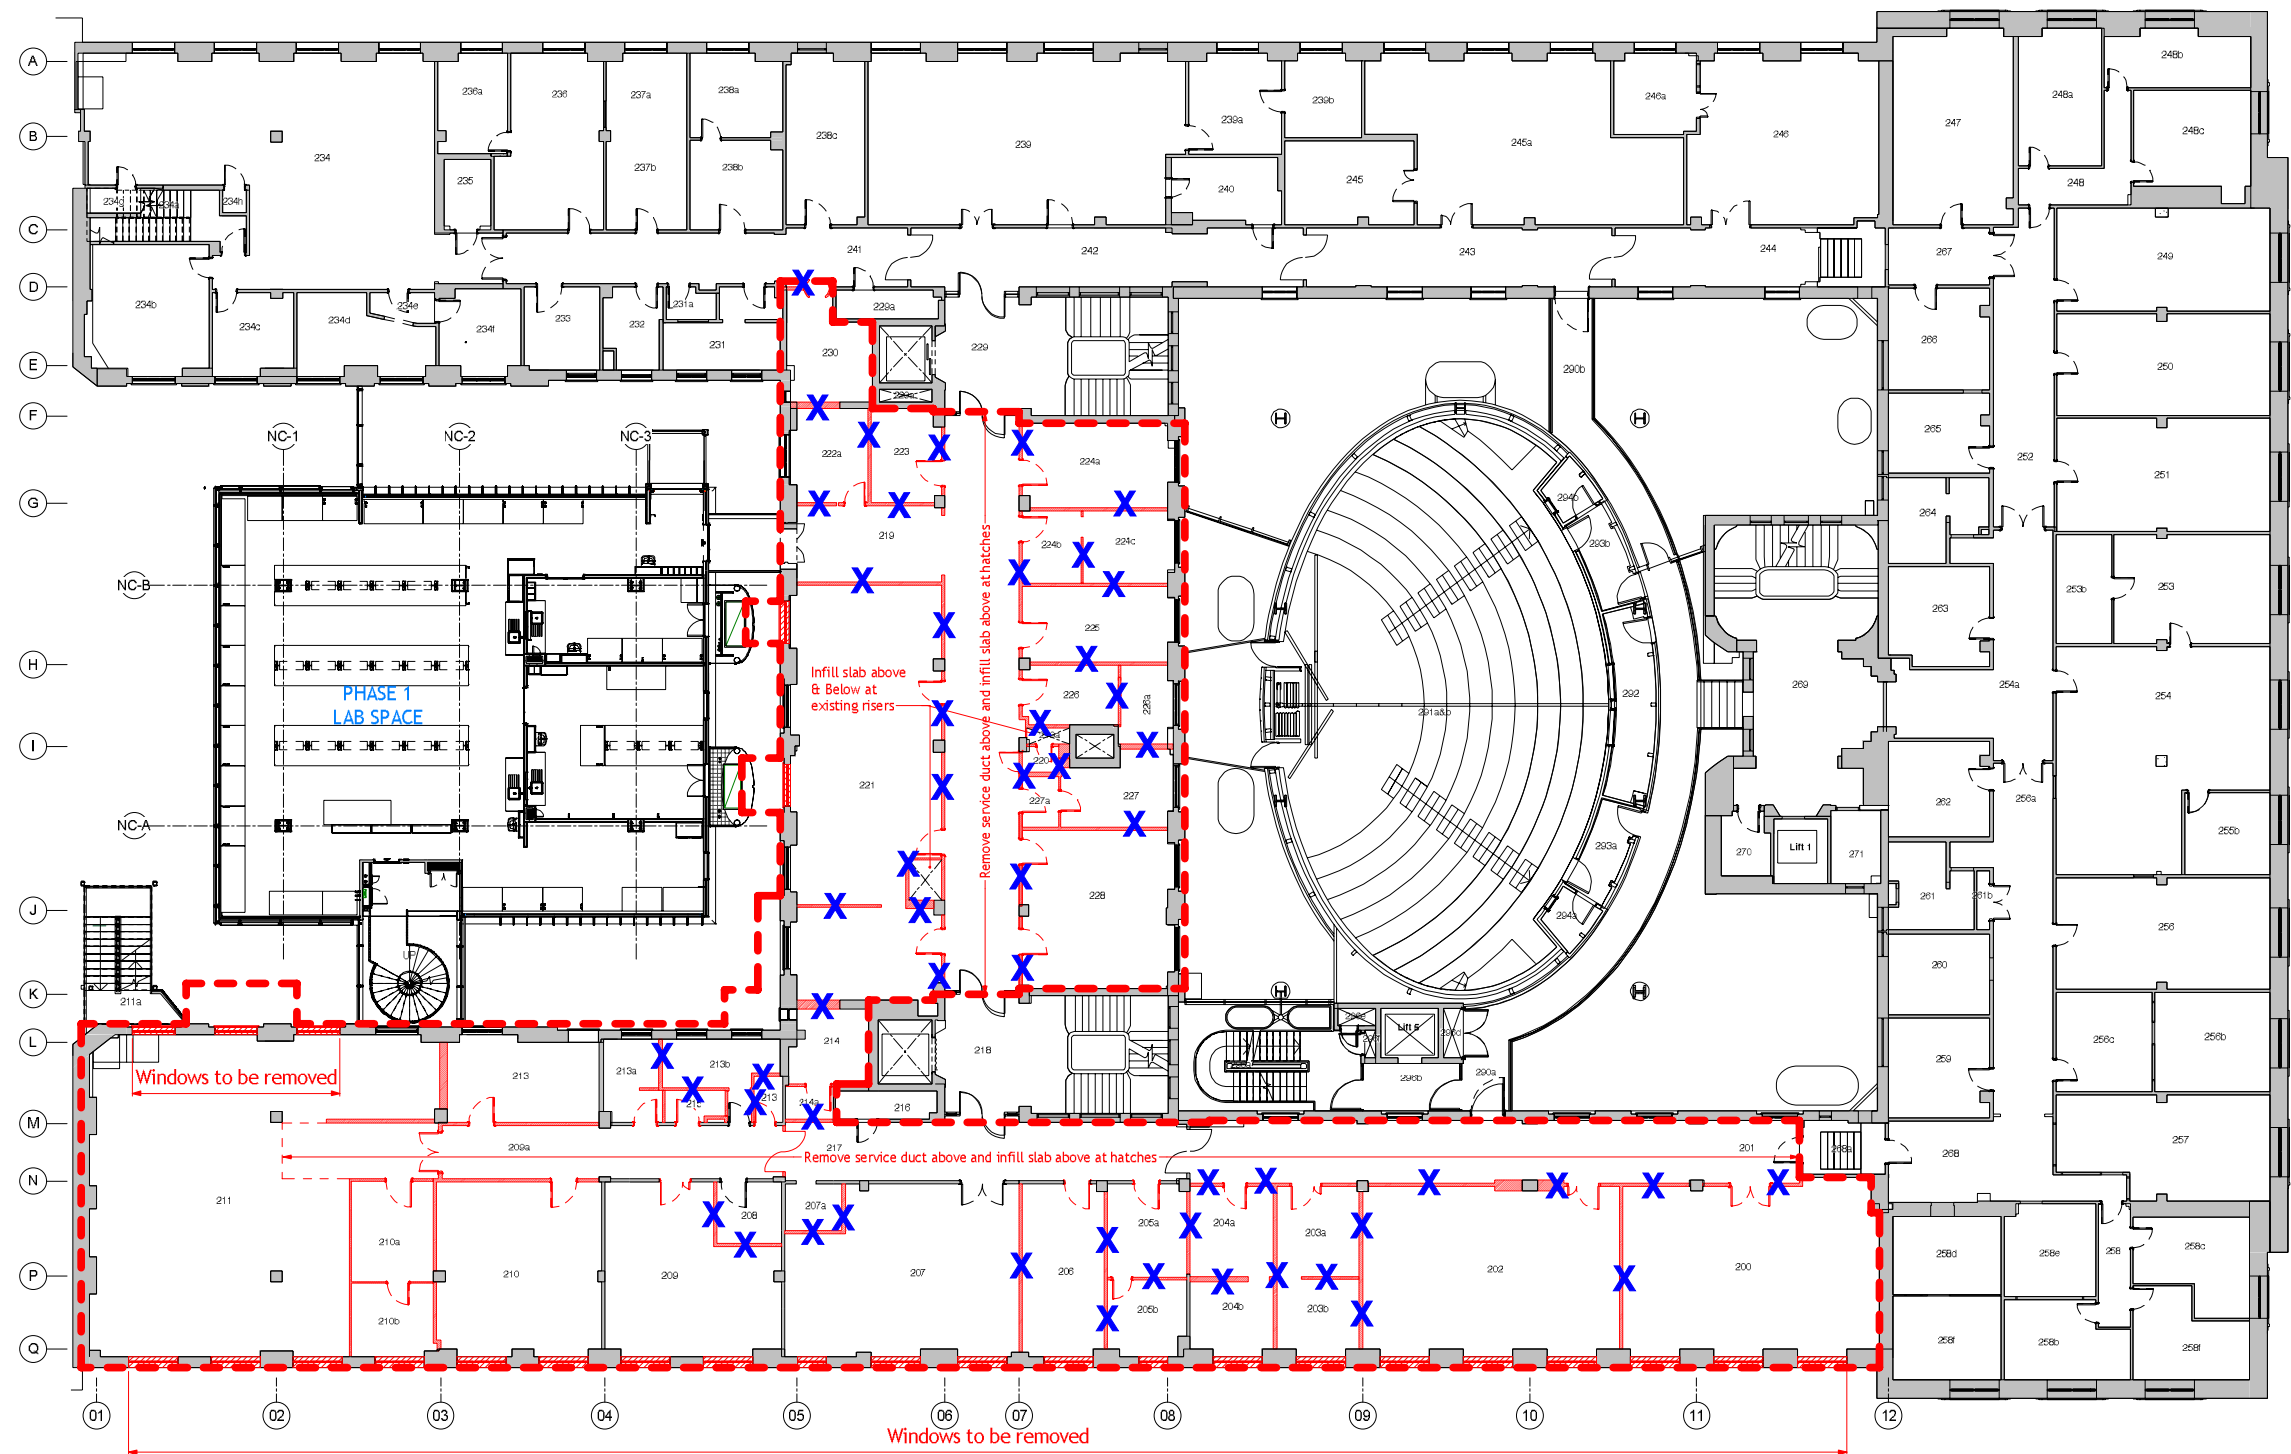
Appendix A – Intrusive Survey Location Plan

X Walls to have 50mm diameter hole created through full wall thickness

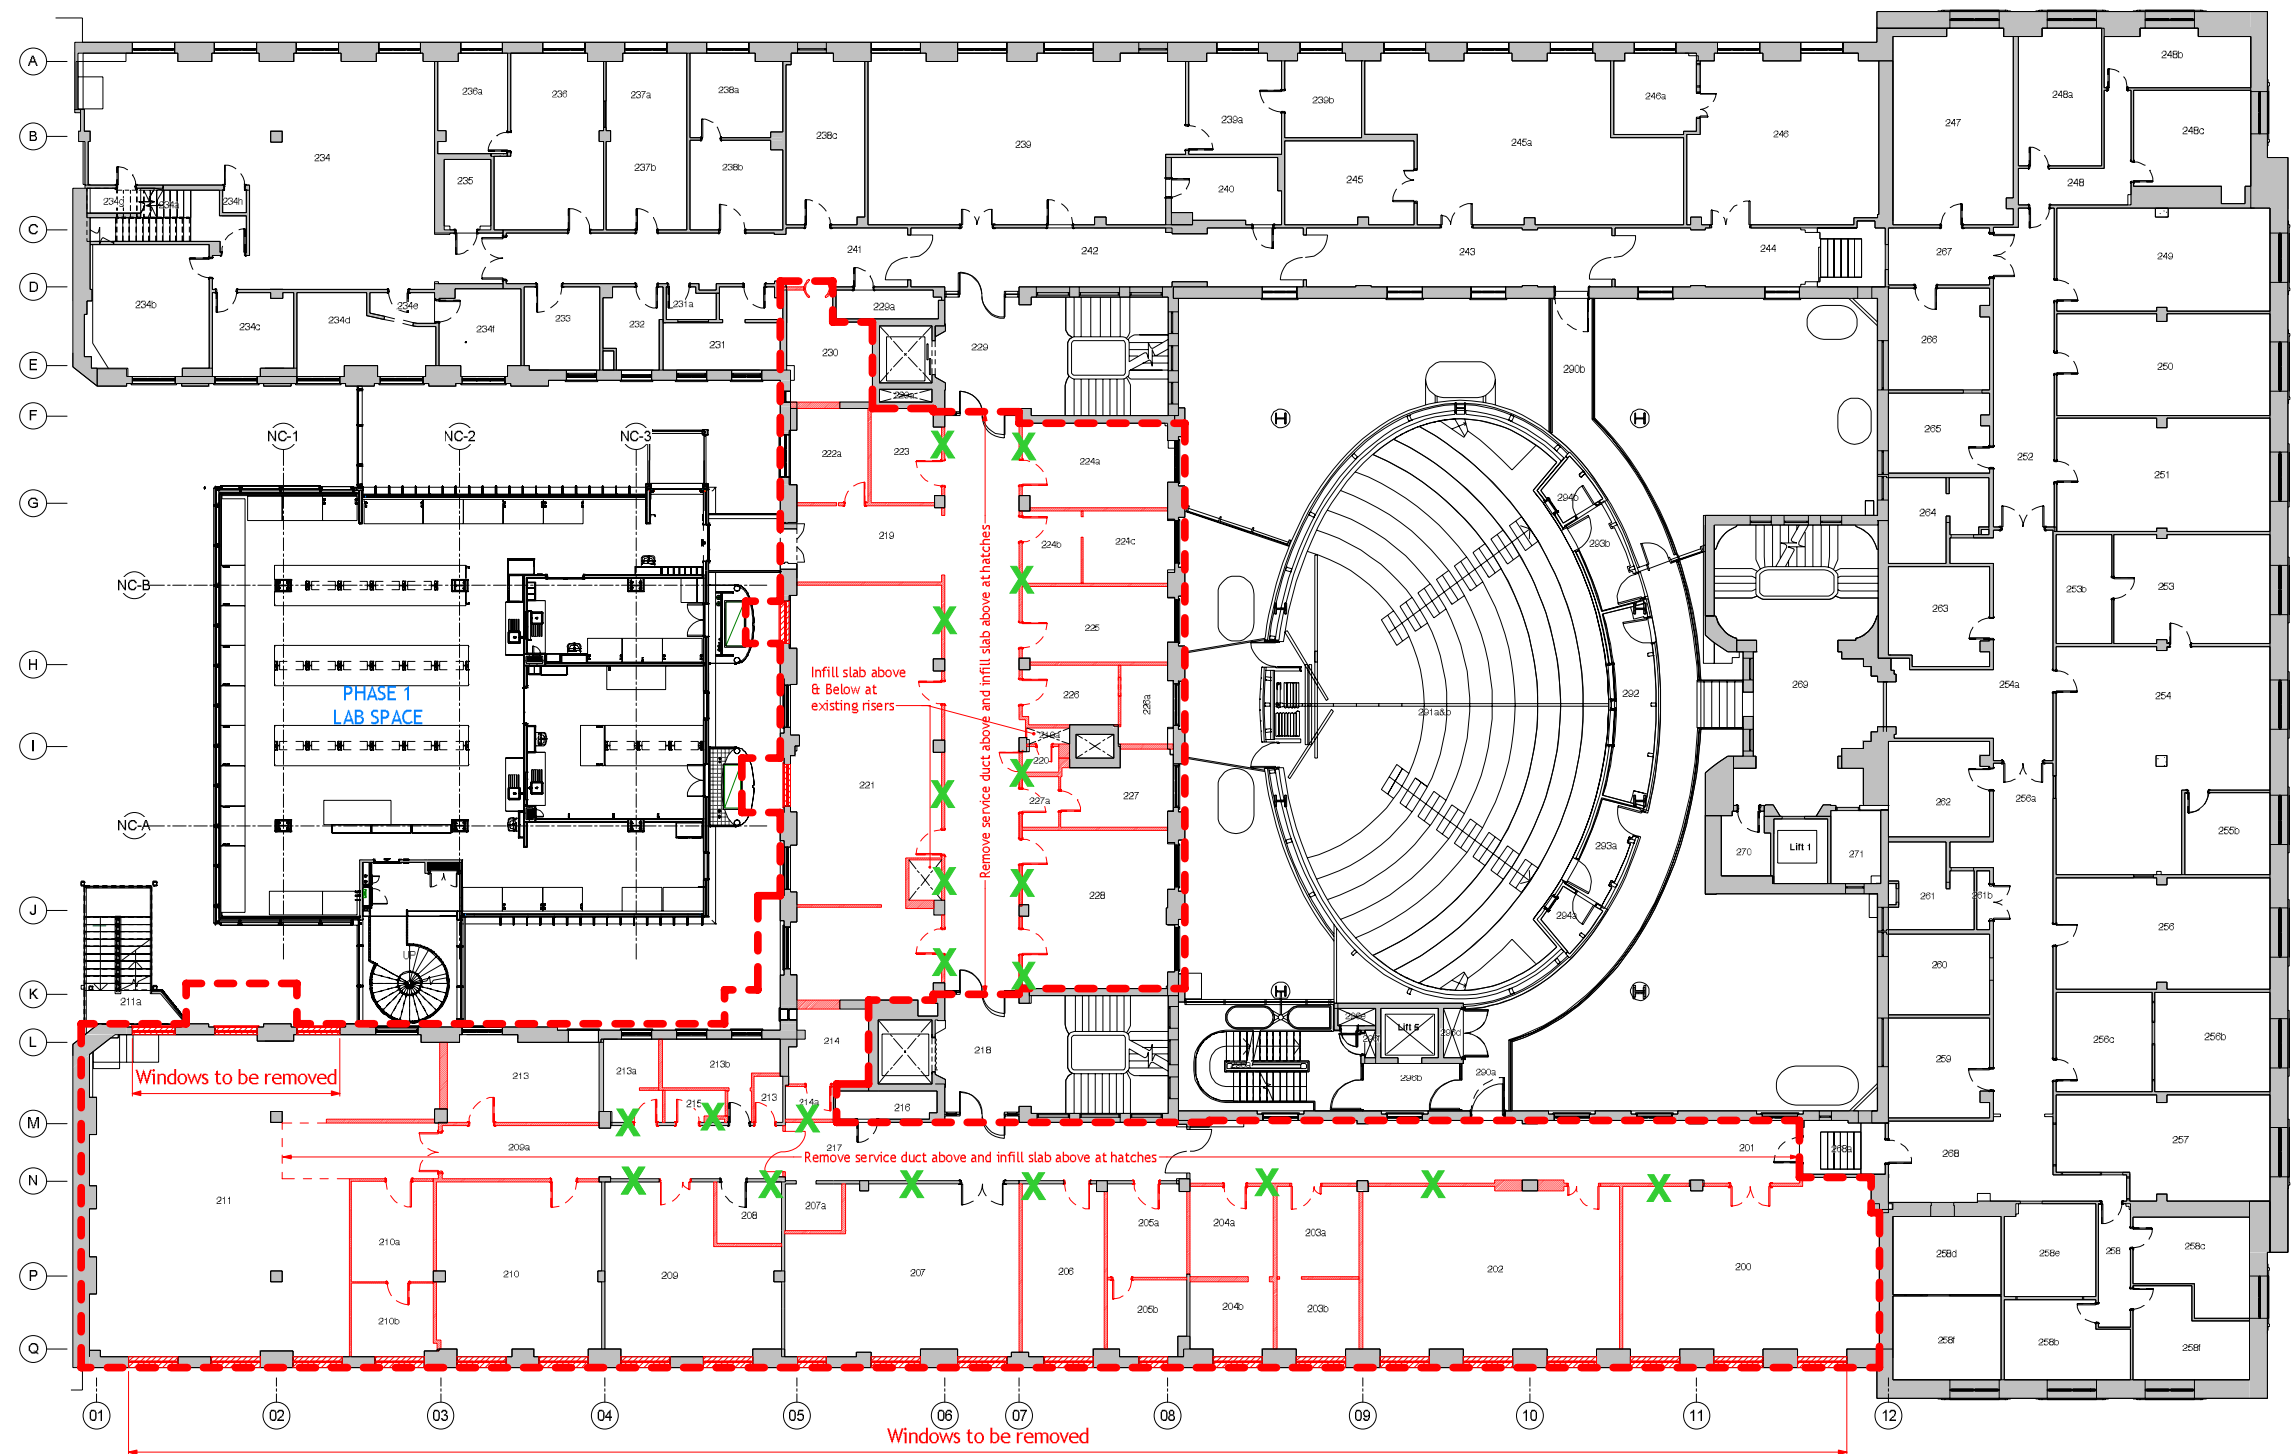
Appendix B – Trench Survey Location Plan

X Walls to have 100mm plaster chased from floor to slab soffit or structural beam
