TECHNICAL REPORT ON A SUBSIDENCE CLAIM

[REDACTED]
114 Highgate Road Management Limited
114 Highgate Road
London
NW5 1PB

SUBSIDENCE CLAIM

16th December 2019

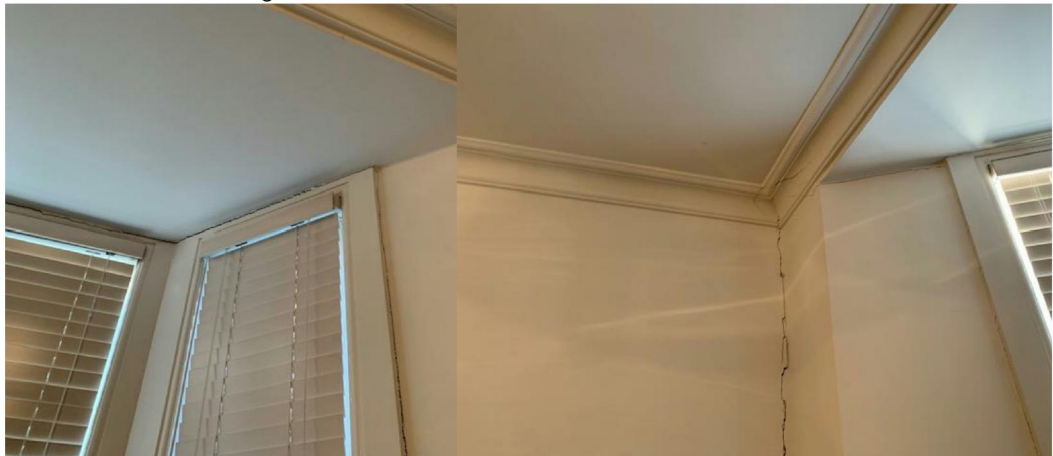
The timing of the event, the presence of shrinkable clay beneath the foundations and the proximity of vegetation where there is damage indicates the shrinkage to be root induced. This is a commonly encountered problem and probably accounts for around 70% of subsidence claims notified to insurers.

Vegetation in the Insureds and neighbours front gardens

The cause of the movement needs to be dealt with first. We have completed a Soil Risk Analysis (VISCAT Assessment) and we are satisfied that your trees can be removed.

We will obtain an Arborists report and quotation for the recommended tree works and undertake statutory checks for Preservation Orders or whether the tree(s) are in a Conservation Area.
