REPORT
Refurbishment/Pre-Demolition
Asbestos Survey
carried out at
Fortress Grove

Issue N°:	1
Survey N°:	2596
Survey Author	Stuart Makemson
Issuing Office	Braintree
Date Issued	20 January 2020

Located at: Fortress Grove Kentish Town London NW5

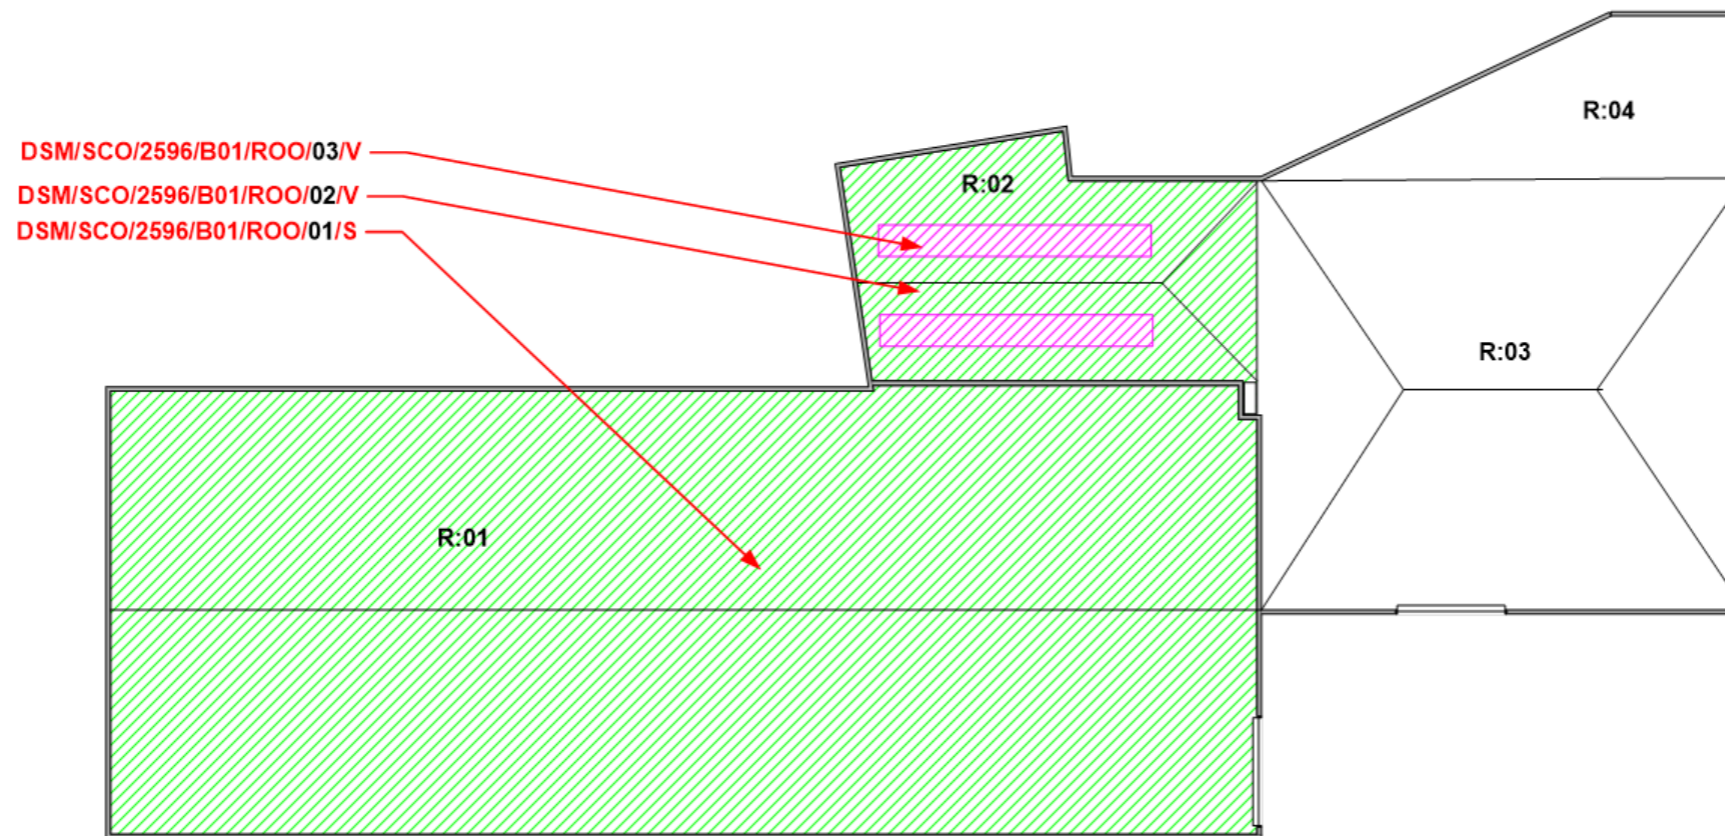
Building name - Building 1. Drawing Title :Roof.

Known or noted risk areas: Roofs R:01 and R:02 are asbestos cement, rooflights to roof R:02 are presumed to contain asbestos rope gaskets to the Georgian glass.

Sample No	Location & Description	Priority Rating	Recommended Action	Comments
DSM/SCO/2596/B01/ROO/01/S	Cement profiled sheeting forming roof.	C	Manage in situ.	In the event of removal the material must be removed by a competent contractor and the waste disposed of to a licensed tip under consignment.

Sample No	Location & Description	Priority Rating	Recommended Action	Comments
DSM/SCO/2596/B01/ROO/02/V	Cement profiled sheeting forming outer skin to roof.	C	Manage in situ.	In the event of removal the material must be removed by a competent contractor and the waste disposed of to a licensed tip under consignment.
DSM/SCO/2596/B01/ROO/03/V	woven gaskets to glass skylights.	C	Manage in situ.	In the event of removal the material must be removed by a competent contractor and the waste disposed of to a licensed tip under consignment.

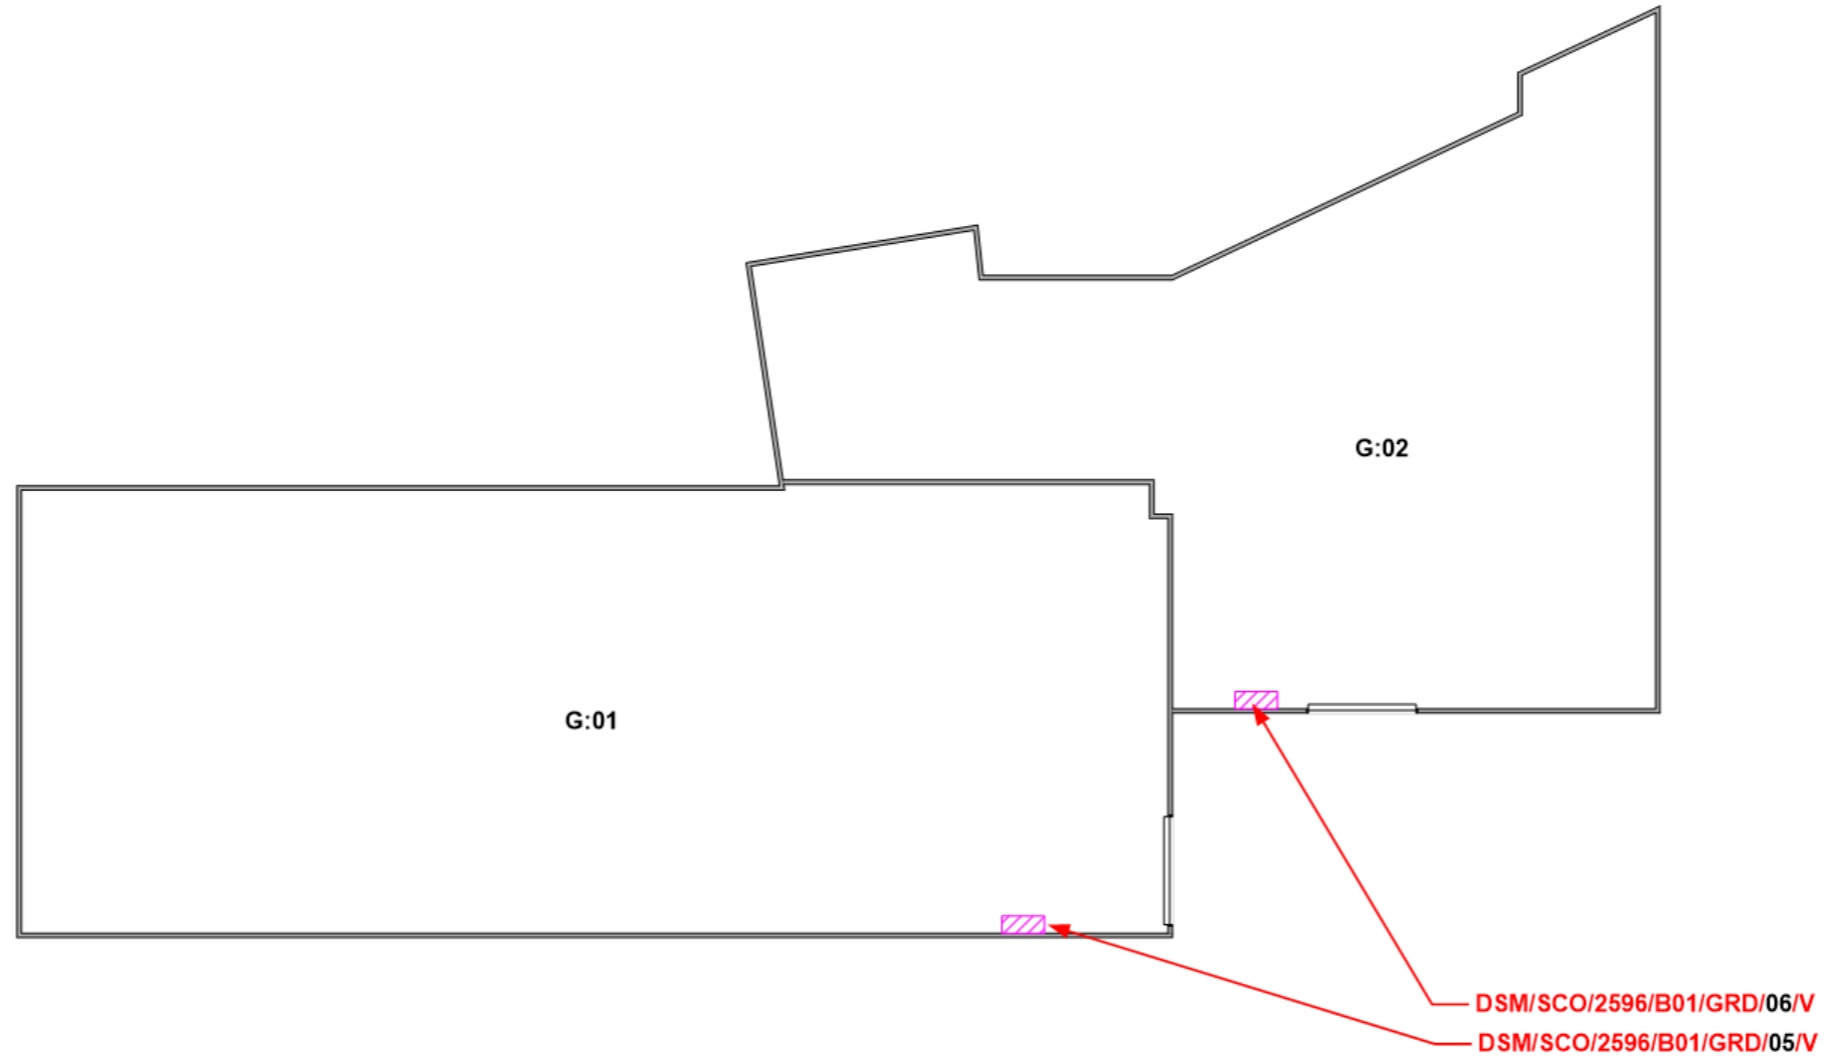
Building name - Building 1. Drawing Title :Ground.

Sample No	Location & Description	Priority Rating	Recommended Action	Comments
DSM/SCO/2596/B01/GRD/05/V	Flash guards / gaskets to electrical boxes.	B	Remove due to proposed demolition / refurbishment	In the event of removal the material must be removed by a competent contractor and disposed of to a licensed tip / transfer station under consignment.
