Barton Hyett Associates
Arboricultural Consultants

66 PARKHILL ROAD, CAMDEN, LONDON

TREE INSPECTION REPORT

Date: 13th February 2020

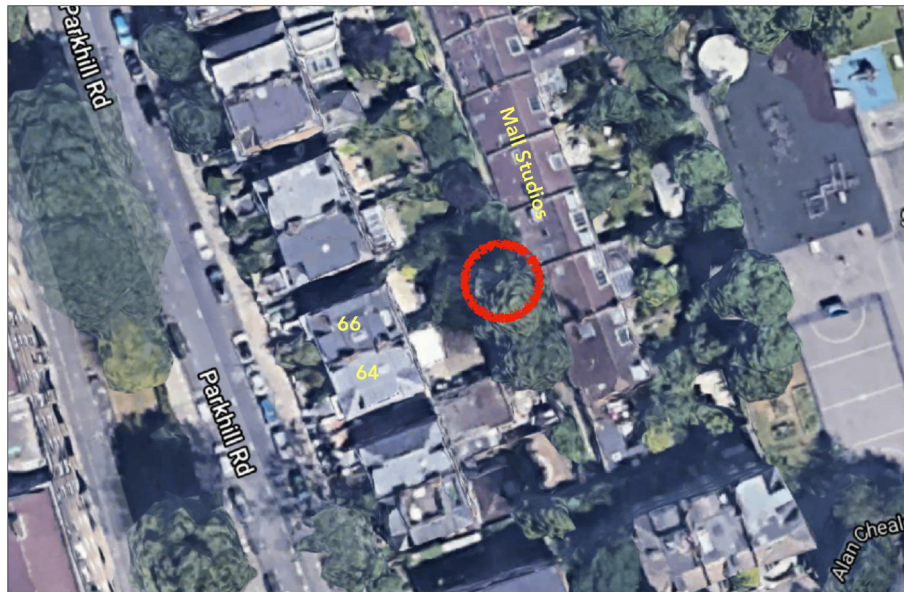
Figure 1: snapshot of aerial photograph showing the context of the tree, circled in red. Image copyright of Google Maps.
