CCTV Inspection Report

12-14 Maresfield Gardens
London
NW3 5SU

Reference: 40814

Date: February 2020

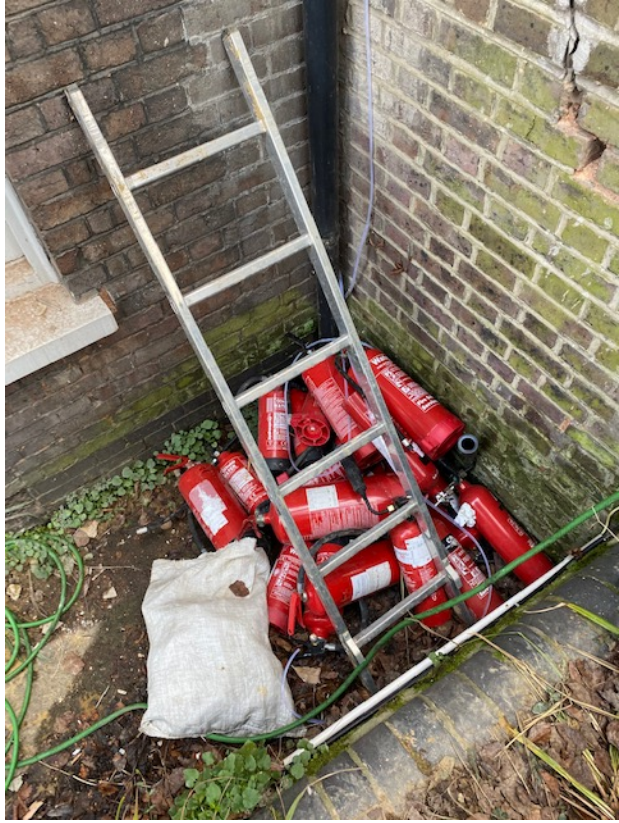
RWP 10

Rainwater downpipes 3,4,5,6,7 & 10: No camera access.
