ADDENDUM TECHNICAL REPORT

[REDACTED]  
**94 Greencroft Gardens Freehold Ltd**  
**94 Greencroft Gardens**  
**London**  
**NW6 3PH**

**Allianz Commercial**  
**SUBSIDENCE CLAIM**

DATE 26 February 2020

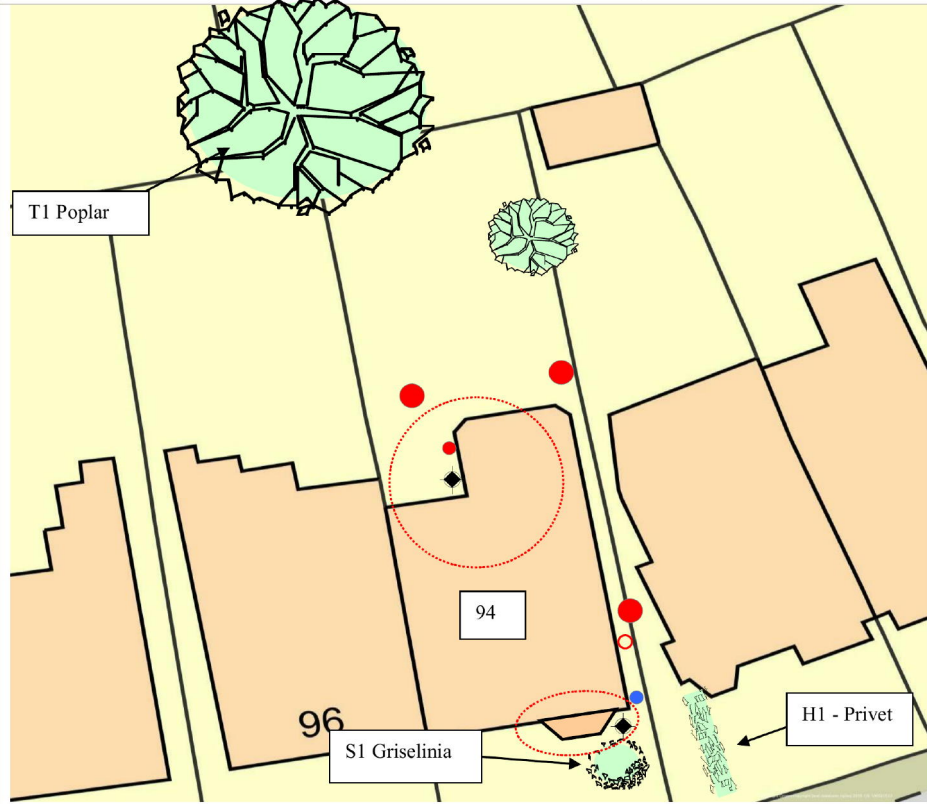
**Site Plan**

Trial holes were excavated to expose the foundations - see site plan for location and the diagram below for details. Trial Hole 1 to the front of the property revealed a brick corbel on a concrete strip footing founded at a depth of 1.3m below ground level which bears onto stiff, mid brown / orange silty CLAY.

Trial Hole 2 to the rear of the property revealed a brick corbel on a concrete strip footing founded at a depth of 1.3m below ground level which bears onto very stiff, mid brown / orange silty CLAY.

Independent arboricultural experts at MWA Arboriculture provided a report and identified T1, S1 and H1 as the principle causes of movement and damage.

The cause of the movement needs to be dealt with first. From the results of the site investigation, the arborist has recommended removal of the T1, S1 and H1. Based on our analysis, we are satisfied there is no adverse heave risk to the property.
