Asbestos Refurbishment Survey Roof to 12th Floor(Tower)

**Space House
1 Kemble Street
London
WC2B 4AN**

Project Reference: P-358038A

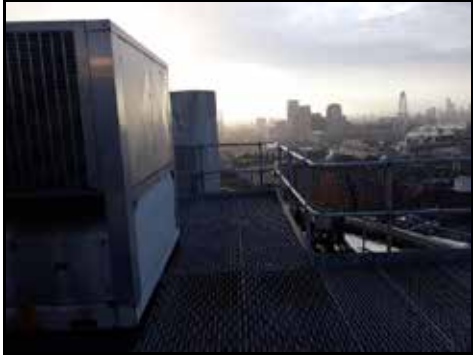
Building Name:	Space House (Tower)	Floor Level:	Sixteenth Floor
Location Number:	001	Location Description:	Roof
Surveyor:	Martin Quigley	Survey Date:	06/01/2020
Room Data / Observations:

General Comments:	
		<p>MMMF insulation to metal ducting and uninsulated metal ducting with modern rubber seals, MMMF insulated metal pipework, metal walkways, metal windows with UPVC sliding doors, timber doors and frames to walkway, concrete ceiling with solid brick walls and a concrete floor to walkway.</p> <p>No inspection was made within the air cooling units due to being live and operational. Access to the roof was limited to areas where walkways and edge protection are present.</p>

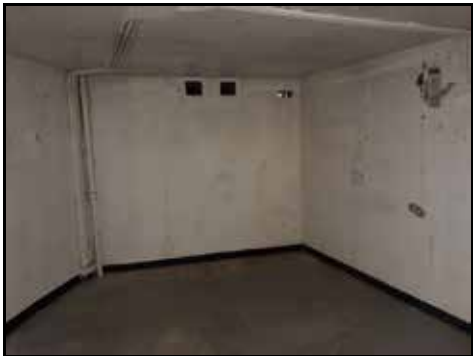
Building Name:	Space House (Tower)	Floor Level:	Sixteenth Floor
Location Number:	002	Location Description:	Store
Surveyor:	Martin Quigley	Survey Date:	06/01/2020
Room Data / Observations:

General Comments:	
		<p>Concrete ceiling with solid brick walls and a raised timber floor with concrete beneath, timber door and frame, metal waste pipes with lead packing to joints, timber surround to 2x wall vents, metal electrical conduit to walls.</p>

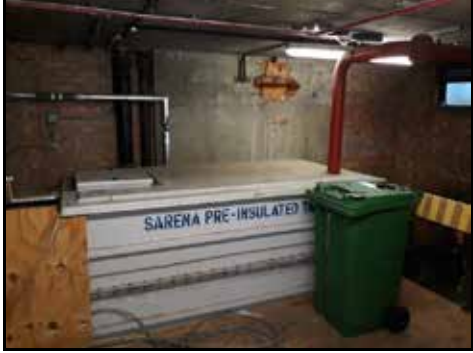
Building Name:	Space House (Tower)	Floor Level:	Sixteenth Floor
Location Number:	003	Location Description:	Water tank room
Surveyor:	Martin Quigley	Survey Date:	06/01/2020

General Comments:
	Concrete ceiling with solid brick walls and a concrete floor, raised timber flooring to entrance, timber door and frame, metal waste pipes with lead packing to joints, fibreglass water tank with plastic pipework, MMMF insulated metal pipework, uninsulated metal pipework.

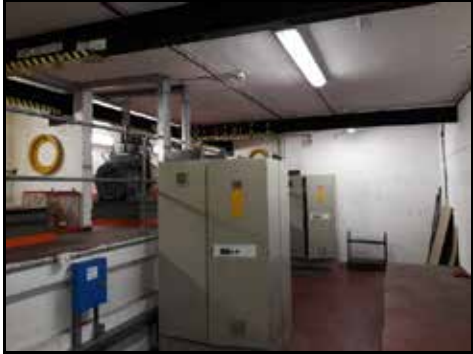
Building Name:	Space House (Tower)	Floor Level:	Sixteenth Floor
Location Number:	004	Location Description:	Lift motor room
Surveyor:	Martin Quigley	Survey Date:	06/01/2020

General Comments:
	Concrete ceiling with solid brick walls and a concrete floor, timber door and frame, metal window, 4x modern electrical control units for lifts, metal trunking, modern MEM switch boxes to walls, modern consumer units to wall, RSJ'S to ceiling.

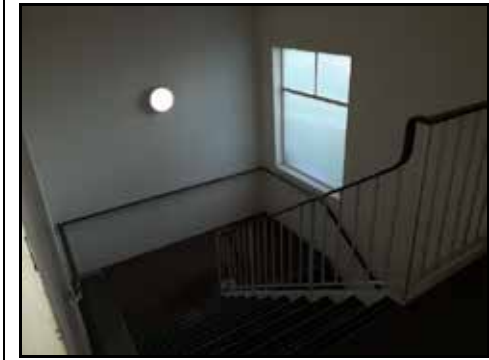
Building Name:	Space House (Tower)	Floor Level:	Sixteenth Floor
Location Number:	005	Location Description:	Stairwell 1
Surveyor:	Martin Quigley	Survey Date:	06/01/2020

Concrete ceiling with solid walls and a concrete floor beneath carpet tiles, timber doors and frames, solid concrete staircase with modern stair nosing, plastic trunking to wall, metal window.

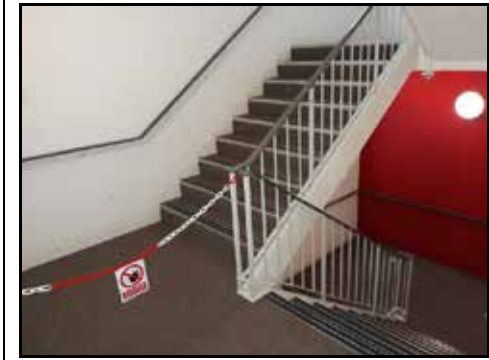
Building Name:	Space House (Tower)	Floor Level:	Sixteenth Floor
Location Number:	006	Location Description:	Stairwell 2
Surveyor:	Martin Quigley	Survey Date:	06/01/2020

Concrete ceiling with solid walls and a concrete floor beneath carpet tiles, timber doors and frames, solid concrete staircase with modern stair nosing, metal radiator to wall, metal window, plastic trunking to wall.

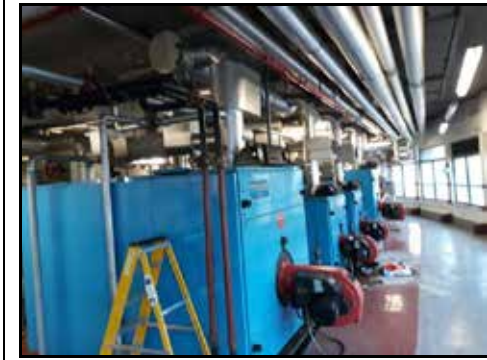
Building Name:	Space House (Tower)	Floor Level:	Fifteenth Floor
Location Number:	007	Location Description:	Plant Room
Surveyor:	Martin Quigley	Survey Date:	08/01/2020

Concrete ceiling with solid walls and a concrete floor, timber doors and frames with metal windows and a quarry tile sill, ceramic tiles to concrete base of boiler units, MMMF insulation to pipework with armour cladding, modern electrical control units modern MEM electrical units to wall, metal trunking, MMMF insulation to metal water tanks with armour cladding, 4x Hartley and Sugden boilers with modern MMMF insulation within.

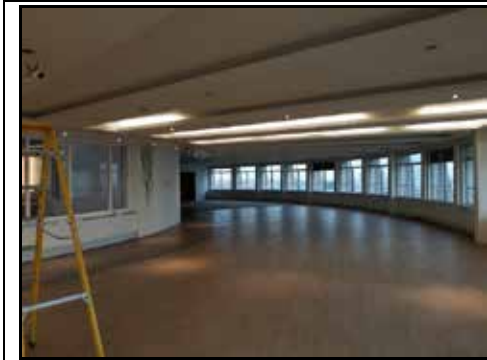
Building Name:	Space House (Tower)	Floor Level:	Fifteenth Floor
Location Number:	008	Location Description:	Open office
Surveyor:	Martin Quigley	Survey Date:	08/01/2020

Concrete ceiling above suspended ceiling with modern ducting and services to void, solid brick walls/plasterboard boost walls to areas containing MMMF insulation cavity and MMMF insulated metal pipework, concrete floor beneath modern vinyl tiles, timber doors and frames with 2x metal glazing, uninsulated metal pipework within heaters to walls mounted upon timber boxing, modern electrical units within riser cupboard, plasterboard panels above windows to wall and ceiling, plasterboard ceiling between lighting strips, modern pipework and gaskets with MMMF insulation within metal boxing to outer window divides.

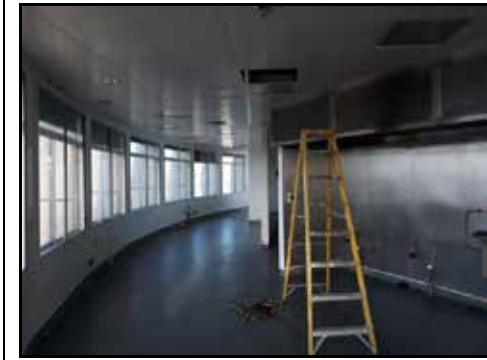
Building Name:	Space House (Tower)	Floor Level:	Fifteenth Floor
Location Number:	009	Location Description:	Kitchen
Surveyor:	Martin Quigley	Survey Date:	09/01/2020

Concrete ceiling above metal suspended ceiling tiles with modern ducting and MMMF insulated metal pipework above, solid/plasterboard walls with plastic cladding to areas and a concrete floor beneath modern vinyl, timber doors and frames, metal windows, modern consumer unit to wall with metal trunking, built in freezer unit.

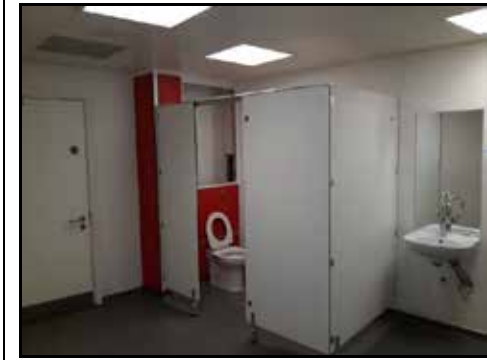
Building Name:	Space House (Tower)	Floor Level:	Fifteenth Floor
Location Number:	010	Location Description:	Toilet
Surveyor:	Martin Quigley	Survey Date:	08/01/2020

Concrete ceiling above metal suspended ceiling tiles with MMMF insulated metal pipework and modern services, plasterboard walls and a timber floor beneath modern vinyl, timber doors and frames, timber boxing containing plastic toilet cistern and waste pipe, uninsulated metal/plastic pipework, plastic trunking.

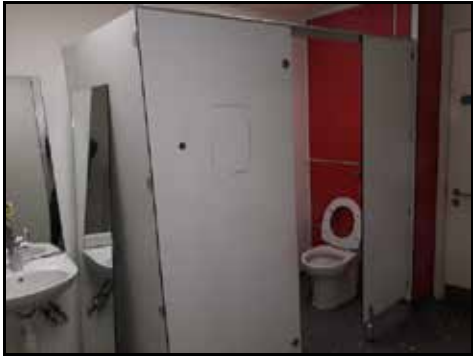
Building Name:	Space House (Tower)	Floor Level:	Fifteenth Floor
Location Number:	011	Location Description:	Toilet
Surveyor:	Martin Quigley	Survey Date:	08/01/2020

General Comments:
	Concrete ceiling above metal suspended ceiling tiles with MMMF insulated metal pipework and modern services, plasterboard walls and a timber floor beneath modern vinyl, timber doors and frames, timber boxing containing plastic toilet cistern and waste pipe, uninsulated metal/plastic pipework, plastic trunking.

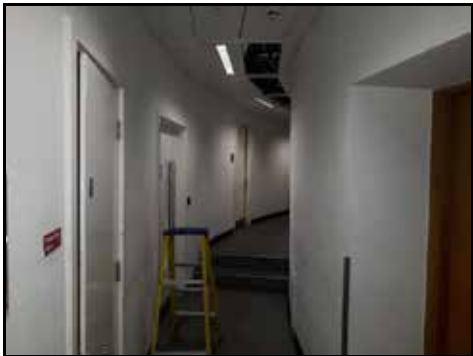
Building Name:	Space House (Tower)	Floor Level:	Fifteenth Floor
Location Number:	012	Location Description:	Corridor
Surveyor:	Martin Quigley	Survey Date:	09/01/2020

General Comments:
	Concrete ceiling above metal suspended ceiling tiles with MMMF insulated metal pipework and modern services, solid/plasterboard walls and a concrete floor beneath modern vinyl, timber doors and frames, modern stair nosing to raised timber section of floor, MMMF and plasterboard fire breaks.

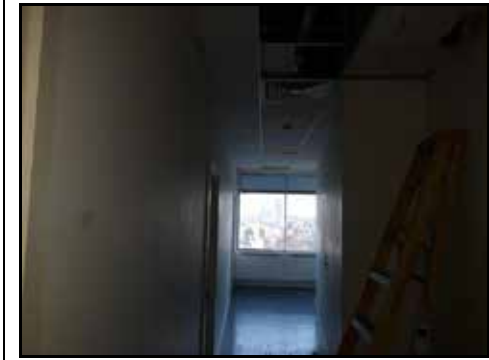
Building Name:	Space House (Tower)	Floor Level:	Fifteenth Floor
Location Number:	013	Location Description:	Offices
Surveyor:	Martin Quigley	Survey Date:	08/01/2020

Concrete ceiling above MMMF suspended ceiling tiles with MMMF insulated metal pipework and uninsulated metal ducting, MMMF fire breaks above suspended ceiling, solid brick walls with plasterboard cladding and a concrete floor beneath carpet tiles, metal stair nosing, timber doors and frames, metal windows, modern sink pads.

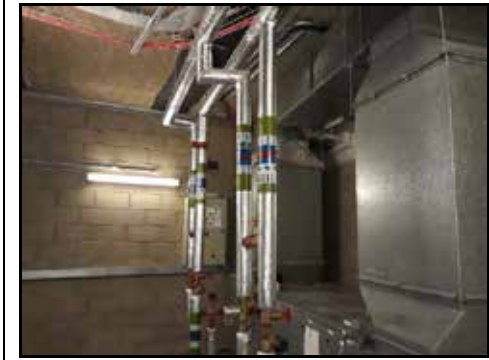
Building Name:	Space House (Tower)	Floor Level:	Fifteenth Floor
Location Number:	014	Location Description:	Plant room
Surveyor:	Martin Quigley	Survey Date:	08/01/2020

Concrete ceiling with solid brick walls and a concrete floor, timber door and frame, metal ducting and MMMF insulated metal pipework, modern consumer unit to wall with metal trunking, modern electrical control unit to wall, MMMF fire breaks to walls, metal electrical conduit to walls.

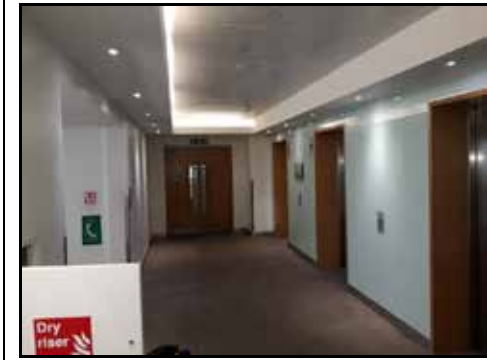
Building Name:	Space House (Tower)	Floor Level:	Fifteenth Floor
Location Number:	015	Location Description:	Lift lobby
Surveyor:	Martin Quigley	Survey Date:	08/01/2020

Concrete ceiling above metal suspended ceiling tiles, solid/plasterboard walls with solid walls behind the plasterboard and a timber/concrete floor to lobby, timber doors and frames, timber/plasterboard boxing with strip lighting inset.
 Concrete ceiling with solid brick walls and a concrete floor to electrical riser cupboard, modern electrical units mounted onto metal frame, metal trunking.
 Riser cupboard with water shut off valve and uninsulated metal pipework with concrete ceiling and floor and solid brick walls.
 2x cupboards with metal windows inside and solid ceilings, walls and floors.

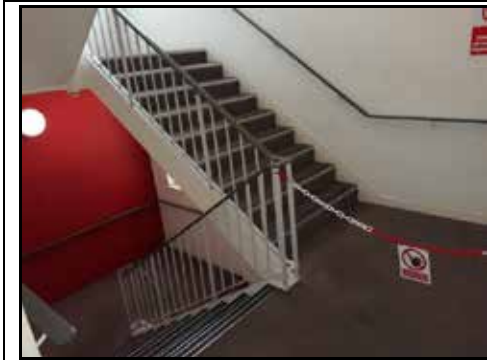
Building Name:	Space House (Tower)	Floor Level:	Fifteenth Floor
Location Number:	016	Location Description:	Stairwell 1
Surveyor:	Martin Quigley	Survey Date:	06/01/2020

Concrete ceiling with solid walls and a concrete floor beneath carpet tiles, timber doors and frames, solid concrete staircase with modern stair nosing, plastic trunking to wall, metal window.

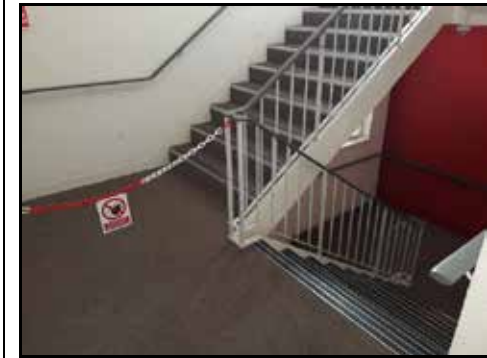
Building Name:	Space House (Tower)	Floor Level:	Fifteenth Floor
Location Number:	017	Location Description:	Stairwell 2
Surveyor:	Martin Quigley	Survey Date:	06/01/2020

Concrete ceiling with solid walls and a concrete floor beneath carpet tiles, timber doors and frames, solid concrete staircase with modern stair nosing, metal radiator to wall, metal window, plastic trunking to wall.

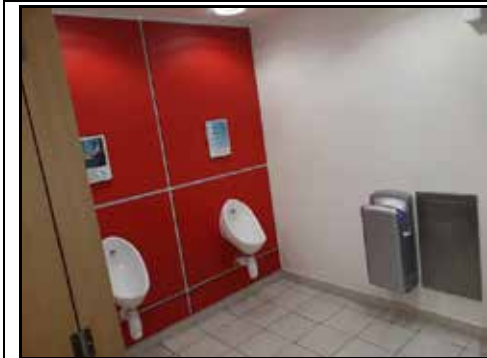
Building Name:	Space House (Tower)	Floor Level:	Fifteenth Floor
Location Number:	018	Location Description:	Male WC
Surveyor:	Martin Quigley	Survey Date:	06/01/2020

Concrete ceiling above plasterboard with modern uninsulated ducting and MMMF insulated metal pipework with solid/plasterboard walls and a concrete floor beneath ceramic tiles, timber door and frame, timber boxing to wall containing plastic toilet cisterns and waste pipes to toilets and urinals, timber partitions to cubicles, 2x riser cupboards with MMMF insulated metal pipework and electrical units to wall with plastic pipework.

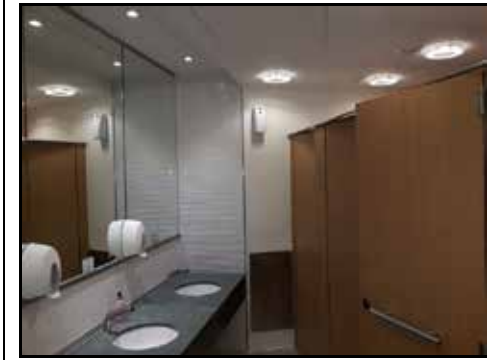
Building Name:	Space House (Tower)	Floor Level:	Fifteenth Floor
Location Number:	019	Location Description:	Female WC
Surveyor:	Martin Quigley	Survey Date:	06/01/2020

Concrete ceiling above plasterboard with modern uninsulated ducting and MMMF insulated metal pipework with solid/plasterboard walls and a concrete floor beneath ceramic tiles, timber door and frame, timber boxing to wall containing plastic toilet cisterns and waste pipes to toilets and urinals, timber partitions to cubicles, 2x riser cupboards with MMMF insulated metal pipework and electrical units to wall with plastic pipework.

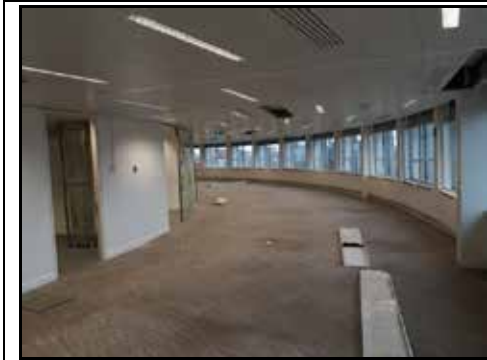
Building Name:	Space House (Tower)	Floor Level:	Fourteenth Floor
Location Number:	020	Location Description:	Open plan offices
Surveyor:	Martin Quigley	Survey Date:	08/01/2020

Concrete ceiling above suspended metal ceiling with modern ducting with MMMF insulation and modern services to void, solid brick/plasterboard walls to areas containing MMMF insulation to cavity, concrete floor beneath modern vinyl/carpet tiles, timber doors and frames with 2x metal glazing to windows, uninsulated/MMMF insulated metal pipework within heaters to walls, modern electrical units within riser cupboards, modern sink pads to sinks, plasterboard partition walls with MMMF insulation within cavity to built in offices with glass fronts to some, modern pipework and gaskets with MMMF insulation within metal boxing to outer window divides.

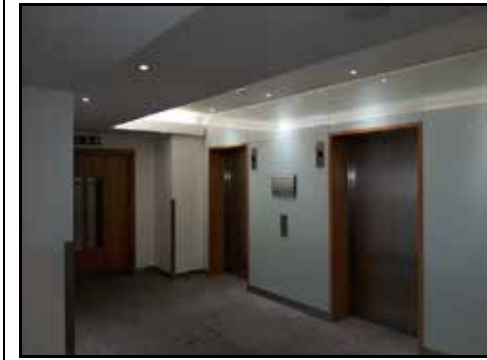
Building Name:	Space House (Tower)	Floor Level:	Fourteenth Floor
Location Number:	021	Location Description:	Lift lobby
Surveyor:	Martin Quigley	Survey Date:	08/01/2020

Concrete ceiling above metal suspended ceiling tiles, solid/plasterboard walls with solid walls behind the plasterboard and a timber/concrete floor to lobby, timber doors and frames, timber/plasterboard boxing with strip lighting inset.
 Concrete ceiling with solid brick walls and a concrete floor to electrical riser cupboard, modern electrical units mounted onto metal frame, metal trunking.
 Riser cupboard with water shut off valve and uninsulated metal pipework with concrete ceiling and floor and solid brick walls.
 2x cupboards with metal windows inside and solid ceilings, walls and floors.

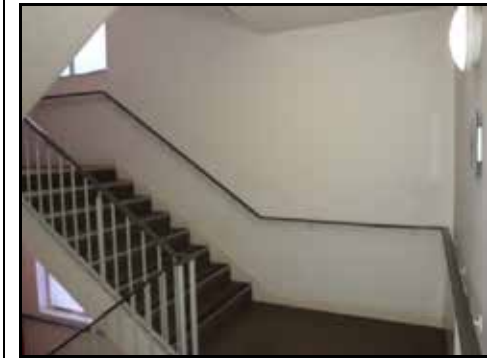
Building Name:	Space House (Tower)	Floor Level:	Fourteenth Floor
Location Number:	022	Location Description:	Stairwell 1
Surveyor:	Martin Quigley	Survey Date:	06/01/2020

Concrete ceiling with solid walls and a concrete floor beneath carpet tiles, timber doors and frames, solid concrete staircase with modern stair nosing, plastic trunking to wall, metal window.

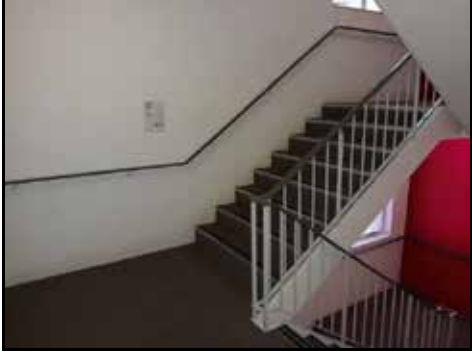
Building Name:	Space House (Tower)	Floor Level:	Fourteenth Floor
Location Number:	023	Location Description:	Stairwell 2
Surveyor:	Martin Quigley	Survey Date:	06/01/2020

General Comments:
	Concrete ceiling with solid walls and a concrete floor beneath carpet tiles, timber doors and frames, solid concrete staircase with modern stair nosing, metal radiator to wall, metal window, plastic trunking to wall.

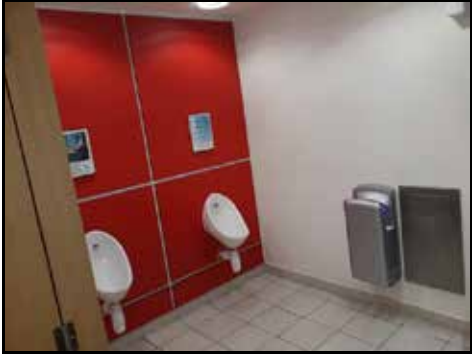
Building Name:	Space House (Tower)	Floor Level:	Fourteenth Floor
Location Number:	024	Location Description:	Male WC
Surveyor:	Martin Quigley	Survey Date:	06/01/2020

General Comments:
	Concrete ceiling above plasterboard with modern uninsulated ducting and MMMF insulated metal pipework with solid/plasterboard walls and a concrete floor beneath ceramic tiles, timber door and frame, timber boxing to wall containing plastic toilet cisterns and waste pipes to toilets and urinals, timber partitions to cubicles, 2x riser cupboards with MMMF insulated metal pipework and electrical units to wall with plastic pipework.
