Asbestos Refurbishment Survey Roof to 6th Floor (Kingsway)

**Space House
1 Kemble Street
London
WC2B 4AN**

Survey Date: 19 December 2019 and 06 January 2020 - 07 January 2020

Project Reference: P-358070B

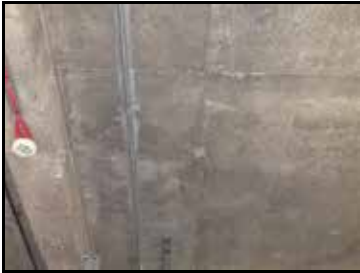
Building:	Space House (Kingsway Building)	Floor:	Eighth Floor				
Location:	001 - Tank Room	Sample No / ID (Type):	P-358070/001 (Sampled)				
Surveyor:	Danny Webber	Survey date:	07/01/2020				
Sample Details

Item description:	Ceiling infill					
	Material description:	Cement product					
	Quantity / Extent:	1 Number					
	Accessibility	Medium Access					
	Analysis:	No asbestos detected					
	Material identification:	Non-asbestos material					
Material Assessment Scoring:							
Product Type:	-	Condition:	-	Surface Treatment:	-	Asbestos Type:	-
Priority Assessment Scoring:							
Occupant Activity:	-	Disturbance:	-	Human Exposure:	-	Maintenance Activity:	-
Total Scores:							
Material Score:	-	Priority Score	-	Total Score:	0	Risk Rating:	N/A
Recommended action:	-						
Recommendation comments:	-						
Comments:	-

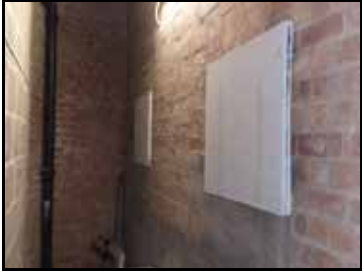
Building:	Space House (Kingsway Building)	Floor:	Eighth Floor				
Location:	001 - Tank Room	Sample No / ID (Type):	P-358070/003 (Sampled)				
Surveyor:	Danny Webber	Survey date:	07/01/2020				
Sample Details

Item description:	Wall panels					
	Material description:	Insulating board					
	Quantity / Extent:	2 Number					
	Accessibility	Easy Access					
	Analysis:	No asbestos detected					
	Material identification:	Non-asbestos material					
Material Assessment Scoring:							
Product Type:	-	Condition:	-	Surface Treatment:	-	Asbestos Type:	-
Priority Assessment Scoring:							
Occupant Activity:	-	Disturbance:	-	Human Exposure:	-	Maintenance Activity:	-
Total Scores:							
Material Score:	-	Priority Score	-	Total Score:	0	Risk Rating:	N/A
Recommended action:	-						
Recommendation comments:	-						
Comments:	-

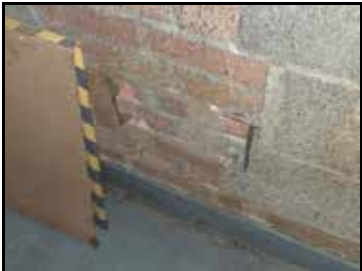
Building:	Space House (Kingsway Building)	Floor:	Eighth Floor				
Location:	001 - Tank Room	Sample No / ID (Type):	P-358070/004 (Sampled)				
Surveyor:	Danny Webber	Survey date:	07/01/2020				
Sample Details

Item description:	Residue on wall					
	Material description:	Mastics					
	Quantity / Extent:	3 Number					
	Accessibility	Easy Access					
	Analysis:	No asbestos detected					
	Material identification:	Non-asbestos material					
Material Assessment Scoring:							
Product Type:	-	Condition:	-	Surface Treatment:	-	Asbestos Type:	-
Priority Assessment Scoring:							
Occupant Activity:	-	Disturbance:	-	Human Exposure:	-	Maintenance Activity:	-
Total Scores:							
Material Score:	-	Priority Score	-	Total Score:	0	Risk Rating:	N/A
Recommended action:	-						
Recommendation comments:	-						
Comments:	-

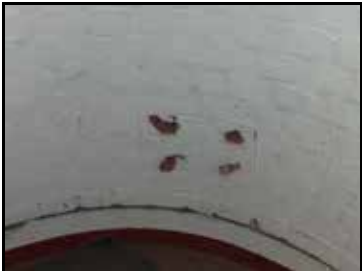
Building:	Space House (Kingsway Building)	Floor:	Eighth Floor				
Location:	002 - Lift Motor Room	Sample No / ID (Type):	P-358070/As 004 (Cross Referenced)				
Surveyor:	Danny Webber	Survey date:	07/01/2020				
Sample Details

Item description:	Residue on wall					
	Material description:	Mastics					
	Quantity / Extent:	2 Number					
	Accessibility	Easy Access					
	Analysis:	No asbestos detected					
	Material identification:	Non-asbestos material					
Material Assessment Scoring:							
Product Type:	-	Condition:	-	Surface Treatment:	-	Asbestos Type:	-
Priority Assessment Scoring:							
Occupant Activity:	-	Disturbance:	-	Human Exposure:	-	Maintenance Activity:	-
Total Scores:							
Material Score:	-	Priority Score	-	Total Score:	0	Risk Rating:	N/A
Recommended action:	-						
Recommendation comments:	-						
Comments:	-

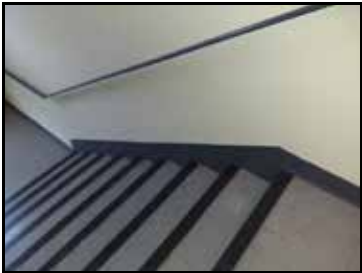
Building:	Space House (Kingsway Building)	Floor:	Seventh Floor				
Location:	004 - Kemble Street Staircase	Sample No / ID (Type):	P-358070/006 (Sampled)				
Surveyor:	Danny Webber	Survey date:	19/12/2019				
Sample Details

Item description:	Skirting board					
	Material description:	Vinyl product					
	Quantity / Extent:	200 m linear					
	Accessibility	Easy Access					
	Analysis:	No asbestos detected					
	Material identification:	Non-asbestos material					
Material Assessment Scoring:							
Product Type:	-	Condition:	-	Surface Treatment:	-	Asbestos Type:	-
Priority Assessment Scoring:							
Occupant Activity:	-	Disturbance:	-	Human Exposure:	-	Maintenance Activity:	-
Total Scores:							
Material Score:	-	Priority Score	-	Total Score:	0	Risk Rating:	N/A
Recommended action:	-						
Recommendation comments:	-						
Comments:	Material observed to continue from top to bottom of both staircases.

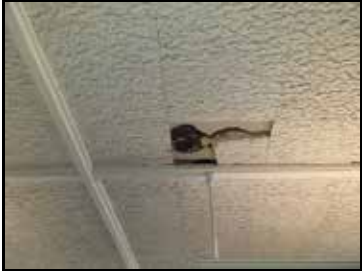
Building:	Space House (Kingsway Building)	Floor:	Seventh Floor				
Location:	006 - Offices Area (Open Plan & Partitioned)	Sample No / ID (Type):	P-358070/011 (Sampled)				
Surveyor:	Danny Webber	Survey date:	19/12/2019				
Sample Details

Item description:	MMMF ceiling tile adhesive					
	Material description:	Adhesive					
	Quantity / Extent:	890 m ²					
	Accessibility	Difficult Access					
	Analysis:	No asbestos detected					
	Material identification:	Non-asbestos material					
Material Assessment Scoring:							
Product Type:	-	Condition:	-	Surface Treatment:	-	Asbestos Type:	-
Priority Assessment Scoring:							
Occupant Activity:	-	Disturbance:	-	Human Exposure:	-	Maintenance Activity:	-
Total Scores:							
Material Score:	-	Priority Score	-	Total Score:	0	Risk Rating:	N/A
Recommended action:	-						
Recommendation comments:	-						
Comments:	Material present throughout MMMF ceiling tiled areas.

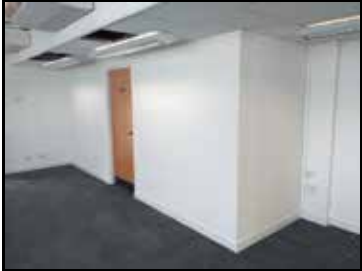
Building:	Space House (Kingsway Building)	Floor:	Seventh Floor				
Location:	006 - Offices Area (Open Plan & Partitioned)	Sample No / ID (Type):	P-358070/015 (Sampled)				
Surveyor:	Danny Webber	Survey date:	19/12/2019				
Sample Details

Item description:	Wall lining beneath plasterboard lining (risers)					
	Material description:	Insulating board					
	Quantity / Extent:	10 m ²					
	Accessibility	Easy Access					
	Analysis:	No asbestos detected					
	Material identification:	Non-asbestos material					
Material Assessment Scoring:							
Product Type:	-	Condition:	-	Surface Treatment:	-	Asbestos Type:	-
Priority Assessment Scoring:							
Occupant Activity:	-	Disturbance:	-	Human Exposure:	-	Maintenance Activity:	-
Total Scores:							
Material Score:	-	Priority Score	-	Total Score:	0	Risk Rating:	N/A
Recommended action:	-						
Recommendation comments:	-						
Comments:	-

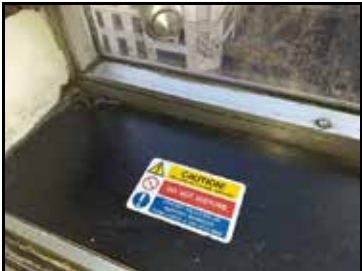
Building:	Space House (Kingsway Building)	Floor:	Seventh Floor				
Location:	006 - Offices Area (Open Plan & Partitioned)	Sample No / ID (Type):	P-358070/018 (Sampled)				
Surveyor:	Danny Webber	Survey date:	19/12/2019				
Sample Details

Item description:	Window glazing beading					
	Material description:	Mastics					
	Quantity / Extent:	440 m linear					
	Accessibility	Easy Access					
	Analysis:	No asbestos detected					
	Material identification:	Non-asbestos material					
Material Assessment Scoring:							
Product Type:	-	Condition:	-	Surface Treatment:	-	Asbestos Type:	-
Priority Assessment Scoring:							
Occupant Activity:	-	Disturbance:	-	Human Exposure:	-	Maintenance Activity:	-
Total Scores:							
Material Score:	-	Priority Score	-	Total Score:	0	Risk Rating:	N/A
Recommended action:	-						
Recommendation comments:	-						
Comments:	Material located throughout floor within all windows (beneath newer mastic in places).

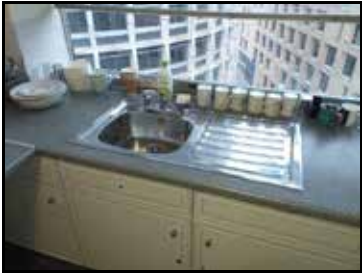
Building:	Space House (Kingsway Building)	Floor:	Seventh Floor				
Location:	007 - Kitchen	Sample No / ID (Type):	P-358070/019 (Sampled)				
Surveyor:	Danny Webber	Survey date:	19/12/2019				
Sample Details

Item description:	Sink & drainer pads					
	Material description:	Bituminous products					
	Quantity / Extent:	2 Number					
	Accessibility	Easy Access					
	Analysis:	No asbestos detected					
	Material identification:	Non-asbestos material					
Material Assessment Scoring:							
Product Type:	-	Condition:	-	Surface Treatment:	-	Asbestos Type:	-
Priority Assessment Scoring:							
Occupant Activity:	-	Disturbance:	-	Human Exposure:	-	Maintenance Activity:	-
Total Scores:							
Material Score:	-	Priority Score	-	Total Score:	0	Risk Rating:	N/A
Recommended action:	-						
Recommendation comments:	-						
Comments:	-

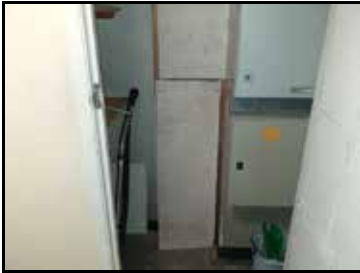
Building:	Space House (Kingsway Building)	Floor:	Seventh Floor				
Location:	007 - Kitchen	Sample No / ID (Type):	P-358070/021 (Sampled)				
Surveyor:	Danny Webber	Survey date:	19/12/2019				
Sample Details

Item description:	Riser panels within cupboard					
	Material description:	Insulating board					
	Quantity / Extent:	1 m ²					
	Accessibility	Easy Access					
	Analysis:	No asbestos detected					
	Material identification:	Non-asbestos material					
Material Assessment Scoring:							
Product Type:	-	Condition:	-	Surface Treatment:	-	Asbestos Type:	-
Priority Assessment Scoring:							
Occupant Activity:	-	Disturbance:	-	Human Exposure:	-	Maintenance Activity:	-
Total Scores:							
Material Score:	-	Priority Score	-	Total Score:	0	Risk Rating:	N/A
Recommended action:	-						
Recommendation comments:	-						
Comments:	Material present in all kitchen cupboards throughout property.

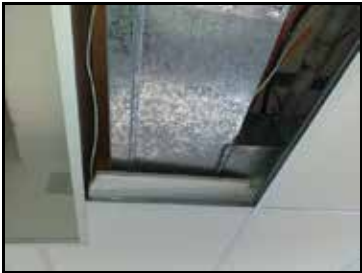
Building:	Space House (Kingsway Building)	Floor:	Seventh Floor				
Location:	009 - Male WC	Sample No / ID (Type):	P-358070/023 (Sampled)				
Surveyor:	Danny Webber	Survey date:	19/12/2019				
Sample Details

Item description:	Seals to ducting					
	Material description:	Mastics					
	Quantity / Extent:	1000 linear m					
	Accessibility	Medium Access					
	Analysis:	No asbestos detected					
	Material identification:	Non-asbestos material					
Material Assessment Scoring:							
Product Type:	-	Condition:	-	Surface Treatment:	-	Asbestos Type:	-
Priority Assessment Scoring:							
Occupant Activity:	-	Disturbance:	-	Human Exposure:	-	Maintenance Activity:	-
Total Scores:							
Material Score:	-	Priority Score	-	Total Score:	0	Risk Rating:	N/A
Recommended action:	-						
Recommendation comments:	-						
Comments:	Material observed throughout property within ducting.

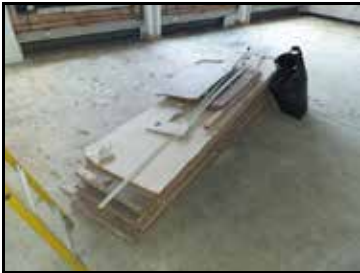
Building:	Space House (Kingsway Building)	Floor:	Sixth Floor				
Location:	015 - Offices Area (Open Plan)	Sample No / ID (Type):	P-358070/025 (Sampled)				
Surveyor:	Danny Webber	Survey date:	19/12/2019				
Sample Details

Item description:	Debris on floor					
	Material description:	Insulating board					
	Quantity / Extent:	10 m ²					
	Accessibility	Easy Access					
	Analysis:	No asbestos detected					
	Material identification:	Non-asbestos material					
Material Assessment Scoring:							
Product Type:	-	Condition:	-	Surface Treatment:	-	Asbestos Type:	-
Priority Assessment Scoring:							
Occupant Activity:	-	Disturbance:	-	Human Exposure:	-	Maintenance Activity:	-
Total Scores:							
Material Score:	-	Priority Score	-	Total Score:	0	Risk Rating:	N/A
Recommended action:	-						
Recommendation comments:	-						
Comments:	-

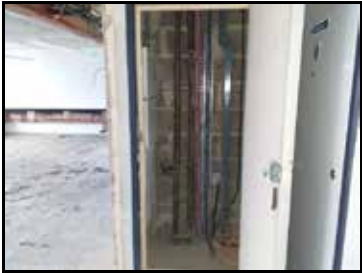
Building:	Space House (Kingsway Building)	Floor:	Sixth Floor				
Location:	015 - Offices Area (Open Plan)	Sample No / ID (Type):	P-358070/026 (Sampled)				
Surveyor:	Danny Webber	Survey date:	19/12/2019				
Sample Details

Item description:	Pipework insulation					
	Material description:	Paper					
	Quantity / Extent:	60 linear m					
	Accessibility	Easy Access					
	Analysis:	No asbestos detected					
	Material identification:	Non-asbestos material					
Material Assessment Scoring:							
Product Type:	-	Condition:	-	Surface Treatment:	-	Asbestos Type:	-
Priority Assessment Scoring:							
Occupant Activity:	-	Disturbance:	-	Human Exposure:	-	Maintenance Activity:	-
Total Scores:							
Material Score:	-	Priority Score	-	Total Score:	0	Risk Rating:	N/A
Recommended action:	-						
Recommendation comments:	-						
Comments:	Material located throughout property.

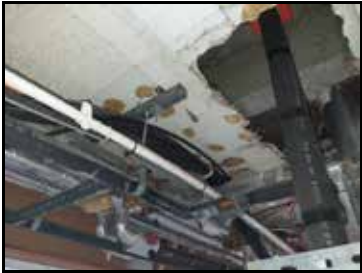
Building:	Space House (Kingsway Building)	Floor:	Sixth Floor				
Location:	015 - Offices Area (Open Plan)	Sample No / ID (Type):	P-358070/As 011 (Cross Referenced)				
Surveyor:	Danny Webber	Survey date:	19/12/2019				
Sample Details

Item description:	MMMF ceiling tile adhesive					
	Material description:	Adhesive					
	Quantity / Extent:	890 m ²					
	Accessibility	Difficult Access					
	Analysis:	No asbestos detected					
	Material identification:	Non-asbestos material					
Material Assessment Scoring:							
Product Type:	-	Condition:	-	Surface Treatment:	-	Asbestos Type:	-
Priority Assessment Scoring:							
Occupant Activity:	-	Disturbance:	-	Human Exposure:	-	Maintenance Activity:	-
Total Scores:							
Material Score:	-	Priority Score	-	Total Score:	0	Risk Rating:	N/A
Recommended action:	-						
Recommendation comments:	-						
Comments:	Material present throughout MMMF ceiling tiled areas.

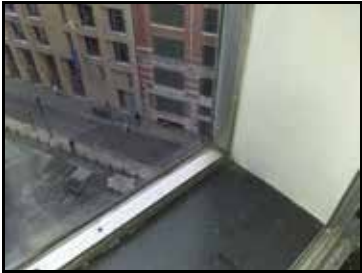
Building:	Space House (Kingsway Building)	Floor:	Sixth Floor				
Location:	015 - Offices Area (Open Plan)	Sample No / ID (Type):	P-358070/As 018 (Cross Referenced)				
Surveyor:	Danny Webber	Survey date:	19/12/2019				
Sample Details

Item description:	Window glazing beading					
	Material description:	Mastics					
	Quantity / Extent:	440 m linear					
	Accessibility	Easy Access					
	Analysis:	No asbestos detected					
	Material identification:	Non-asbestos material					
Material Assessment Scoring:							
Product Type:	-	Condition:	-	Surface Treatment:	-	Asbestos Type:	-
Priority Assessment Scoring:							
Occupant Activity:	-	Disturbance:	-	Human Exposure:	-	Maintenance Activity:	-
Total Scores:							
Material Score:	-	Priority Score	-	Total Score:	0	Risk Rating:	N/A
Recommended action:	-						
Recommendation comments:	-						
Comments:	Material located throughout floor within all windows (beneath newer mastic in places).

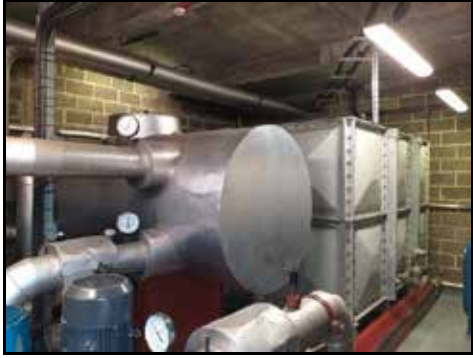
Building Name:	Space House (Kingsway Building)	Floor Level:	Eighth Floor
Location Number:	001	Location Description:	Tank Room
Surveyor:	Danny Webber	Survey Date:	07/01/2020
Room Data / Observations:

<p>General Comments:</p> <p>Concrete ceiling. Masonry walls. Cast iron soil pipes. Timber door & frame. Fibreglass water tank. Metal cylinder with galvanised MMMF insulation. MMMF & foam insulated pipework. Asphalted concrete floor.</p>
