Asbestos Refurbishment Survey **11th Floor to Basement**

SLQR Trustee No 1 Limited and SLQR Trustee No 2 Limited
as Co Trustees of SLQR Unit Trust No 3

Space House (Tower)
1 Kemble Street
London
WC2B 4AN

Project Reference: P-359273

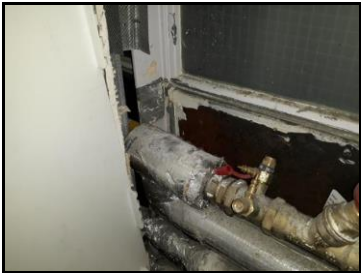
Building:	Block 1 Tower 11th Floor - Basement	Floor:	Eleventh Floor				
Location:	001 - Open plan office	Sample No / ID (Type):	P-359273/004 (Sampled)				
Surveyor:	Martin Quigley	Survey date:	14/01/2020				
Sample Details

Item description:	Mastic to internal windows behind plasterboard					
	Material description:	Mastics					
	Quantity / Extent:	100 m linear					
	Accessibility	Medium Access					
	Analysis:	No asbestos detected					
	Material identification:	Non-asbestos material					
Material Assessment Scoring:							
Product Type:	-	Condition:	-	Surface Treatment:	-	Asbestos Type:	-
Priority Assessment Scoring:							
Occupant Activity:	-	Disturbance:	-	Human Exposure:	-	Maintenance Activity:	-
Total Scores:							
Material Score:	-	Priority Score	-	Total Score:	0	Risk Rating:	N/A
Recommended action:	-						
Recommendation comments:	-						
Comments:	Material is representative of throughout.

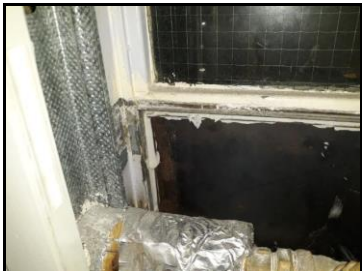
Building:	Block 1 Tower 11th Floor - Basement	Floor:	Fourth Floor				
Location:	051 - Open plan office	Sample No / ID (Type):	P-359273/023 (Sampled)				
Surveyor:	Martin Quigley	Survey date:	21/01/2020				
Sample Details

Item description:	Mastic to internal windows behind plasterboard					
	Material description:	Mastics					
	Quantity / Extent:	30 m linear					
	Accessibility	Medium Access					
	Analysis:	Chrysotile					
	Material identification:	Asbestos mastic					
Material Assessment Scoring:							
Product Type:	1	Condition:	1	Surface Treatment:	0	Asbestos Type:	1
Priority Assessment Scoring:							
Occupant Activity:	1	Disturbance:	1	Human Exposure:	3	Maintenance Activity:	1
Total Scores:							
Material Score:	3	Priority Score	6	Total Score:	3	Risk Rating:	Very Low
Recommended action:	Remove if likely to be disturbed by the refurbishment, otherwise monitor condition.						
Recommendation comments:	-

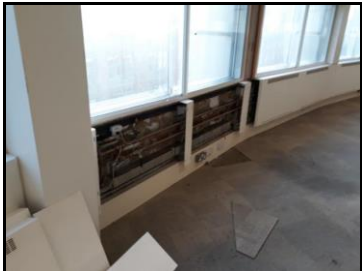
Building:	Block 1 Tower 11th Floor - Basement	Floor:	Fourth Floor				
Location:	051 - Open plan office	Sample No / ID (Type):	P-359273/As 001 (Cross Referenced)				
Surveyor:	Martin Quigley	Survey date:	21/01/2020				
Sample Details

Item description:	Panel beneath the window to the rear of the blockwork wall					
	Material description:	Insulating board					
	Quantity / Extent:	110 m²					
	Accessibility	Medium Access					
	Analysis:	Amosite Chrysotile					
	Material identification:	Asbestos insulating board					
Material Assessment Scoring:							
Product Type:	2	Condition:	0	Surface Treatment:	2	Asbestos Type:	2
Priority Assessment Scoring:							
Occupant Activity:	1	Disturbance:	2	Human Exposure:	3	Maintenance Activity:	1
Total Scores:							
Material Score:	6	Priority Score	7	Total Score:	6	Risk Rating:	Low
Recommended action:	Remove if likely to be disturbed by the refurbishment, otherwise monitor condition.

Recommendation comments:	-						
Comments:	Material is representative of throughout.

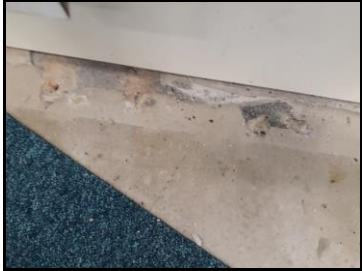
Building:	Block 1 Tower 11th Floor - Basement	Floor:	Second Floor				
Location:	065 - Open plan office	Sample No / ID (Type):	P-359273/027 (Sampled)				
Surveyor:	Martin Quigley	Survey date:	22/01/2020				
Sample Details

Item description:	Adhesive to floor beneath modern screed					
	Material description:	Floor screed					
	Quantity / Extent:	800 m²					
	Accessibility	Medium Access					
	Analysis:	Chrysotile					
	Material identification:	Non-asbestos screed/asbestos bitumen adhesive					
Material Assessment Scoring:							
Product Type:	1	Condition:	0	Surface Treatment:	0	Asbestos Type:	1
Priority Assessment Scoring:							
Occupant Activity:	1	Disturbance:	2	Human Exposure:	3	Maintenance Activity:	1
Total Scores:							
Material Score:	2	Priority Score	7	Total Score:	2	Risk Rating:	Very Low
Recommended action:	Remove if likely to be disturbed by the refurbishment, otherwise monitor condition.

Recommendation comments:	-						
Comments:	Material is representative of throughout.

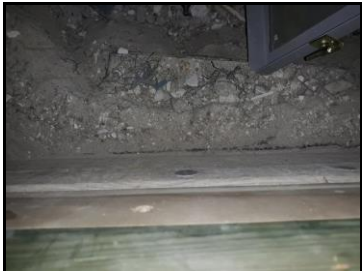
Building:	Block 1 Tower 11th Floor - Basement	Floor:	Second Floor				
Location:	065 - Open plan office	Sample No / ID (Type):	P-359273/028 (Sampled)				
Surveyor:	Martin Quigley	Survey date:	22/01/2020				
Sample Details

Item description:	Floor tile debris within cupboard					
	Material description:	Thermoplastic product					
	Quantity / Extent:	1 m²					
	Accessibility	Easy Access					
	Analysis:	Chrysotile					
	Material identification:	Asbestos thermoplastic/adhesive					
Material Assessment Scoring:							
Product Type:	1	Condition:	3	Surface Treatment:	0	Asbestos Type:	1
Priority Assessment Scoring:							
Occupant Activity:	1	Disturbance:	1	Human Exposure:	3	Maintenance Activity:	1
Total Scores:							
Material Score:	5	Priority Score	6	Total Score:	5	Risk Rating:	Low
Recommended action:	Remove.						
Recommendation comments:	-						
Comments:	Floor tile debris is also present to the opposite cupboard.

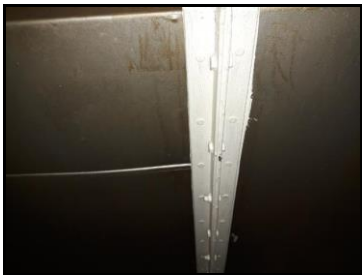
Building:	Block 1 Tower 11th Floor - Basement	Floor:	Basement Level				
Location:	106 - Parking Area	Sample No / ID (Type):	P-359273/051 (Sampled)				
Surveyor:	Martin Quigley	Survey date:	03/02/2020				
Sample Details

Item description:	Rope seal to ducting joints					
	Material description:	Woven product					
	Quantity / Extent:	30 m linear					
	Accessibility	Medium Access					
	Analysis:	Chrysotile					
	Material identification:	Asbestos woven material					
Material Assessment Scoring:							
Product Type:	2	Condition:	0	Surface Treatment:	1	Asbestos Type:	1
Priority Assessment Scoring:							
Occupant Activity:	0	Disturbance:	1	Human Exposure:	2	Maintenance Activity:	1
Total Scores:							
Material Score:	4	Priority Score	4	Total Score:	4	Risk Rating:	Very Low
Recommended action:	Remove if likely to be disturbed by the refurbishment, otherwise monitor condition.						
Recommendation comments:	-

Comments:	Material is representative of throughout.

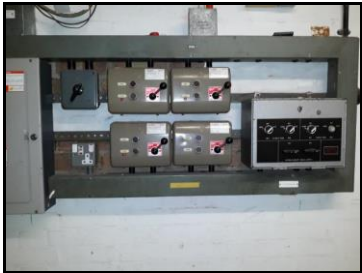
Building:	Block 1 Tower 11th Floor - Basement	Floor:	Basement Level				
Location:	106 - Parking Area	Sample No / ID (Type):	P-359273/P003 (Presumed)				
Surveyor:	Martin Quigley	Survey date:	03/02/2020				
Sample Details

Item description:	Electrical switchgear					
	Material description:	Woven product					
	Quantity / Extent:	6 Number					
	Accessibility	Difficult Access					
	Analysis:	Presumed to contain asbestos					
	Material identification:	Asbestos woven material					
Material Assessment Scoring:							
Product Type:	2	Condition:	0	Surface Treatment:	1	Asbestos Type:	3
Priority Assessment Scoring:							
Occupant Activity:	0	Disturbance:	1	Human Exposure:	2	Maintenance Activity:	1
Total Scores:							
Material Score:	6	Priority Score	4	Total Score:	6	Risk Rating:	Low
Recommended action:	Remove if likely to be disturbed by the refurbishment, otherwise monitor condition.						
Recommendation comments:	-

Comments:	No access due to electrics being live at the time of the survey.

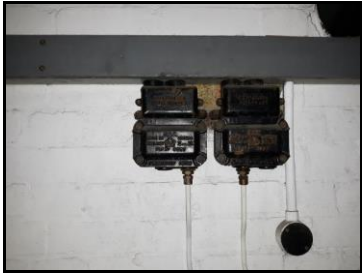
Building:	Block 1 Tower 11th Floor - Basement	Floor:	Basement Level				
Location:	106 - Parking Area	Sample No / ID (Type):	P-359273/P004 (Presumed)				
Surveyor:	Martin Quigley	Survey date:	03/02/2020				
Sample Details

Item description:	Electrical switchgear					
	Material description:	Woven product					
	Quantity / Extent:	2 Number					
	Accessibility	Difficult Access					
	Analysis:	Presumed to contain asbestos					
	Material identification:	Asbestos woven material					
Material Assessment Scoring:							
Product Type:	2	Condition:	0	Surface Treatment:	1	Asbestos Type:	3
Priority Assessment Scoring:							
Occupant Activity:	0	Disturbance:	1	Human Exposure:	2	Maintenance Activity:	1
Total Scores:							
Material Score:	6	Priority Score	4	Total Score:	6	Risk Rating:	Low
Recommended action:	Remove if likely to be disturbed by the refurbishment, otherwise monitor condition.						
Recommendation comments:	-

Comments:	No access due to electrics being live at the time of the survey.

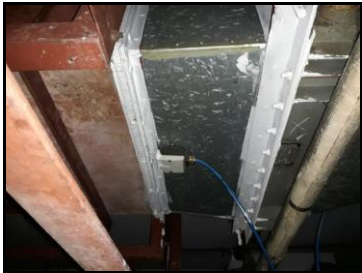
Building:	Block 1 Tower 11th Floor - Basement	Floor:	Basement Level				
Location:	107 - Stores	Sample No / ID (Type):	P-359273/053 (Sampled)				
Surveyor:	Martin Quigley	Survey date:	03/02/2020				
Sample Details

Item description:	Rope seal to ducting joints.					
	Material description:	Woven product					
	Quantity / Extent:	30 m linear					
	Accessibility	Medium Access					
	Analysis:	Chrysotile					
	Material identification:	Asbestos woven material					
Material Assessment Scoring:							
Product Type:	2	Condition:	0	Surface Treatment:	1	Asbestos Type:	1
Priority Assessment Scoring:							
Occupant Activity:	0	Disturbance:	2	Human Exposure:	1	Maintenance Activity:	1
Total Scores:							
Material Score:	4	Priority Score	4	Total Score:	4	Risk Rating:	Very Low
Recommended action:	Remove if likely to be disturbed by the refurbishment, otherwise monitor condition.						
Recommendation comments:	-

Comments:	Item is present within all stores.

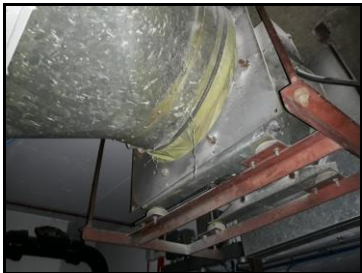
Building:	Block 1 Tower 11th Floor - Basement	Floor:	Basement Level				
Location:	107 - Stores	Sample No / ID (Type):	P-359273/054 (Sampled)				
Surveyor:	Martin Quigley	Survey date:	03/02/2020				
Sample Details

Item description:	Gator to ducting					
	Material description:	Woven product					
	Quantity / Extent:	1 m linear					
	Accessibility	Medium Access					
	Analysis:	No asbestos detected					
	Material identification:	Non-asbestos material					
Material Assessment Scoring:							
Product Type:	-	Condition:	-	Surface Treatment:	-	Asbestos Type:	-
Priority Assessment Scoring:							
Occupant Activity:	-	Disturbance:	-	Human Exposure:	-	Maintenance Activity:	-
Total Scores:							
Material Score:	-	Priority Score	-	Total Score:	0	Risk Rating:	N/A
Recommended action:	-						
Recommendation comments:	-						
Comments:	-

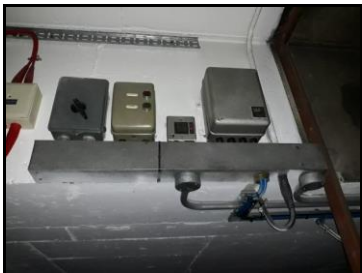
Building:	Block 1 Tower 11th Floor - Basement	Floor:	Basement Level				
Location:	107 - Stores	Sample No / ID (Type):	P-359273/P005 (Presumed)				
Surveyor:	Martin Quigley	Survey date:	03/02/2020				
Sample Details

Item description:	Electrical switchgear					
	Material description:	Woven product					
	Quantity / Extent:	3 Number					
	Accessibility	Difficult Access					
	Analysis:	Presumed to contain asbestos					
	Material identification:	Asbestos woven material					
Material Assessment Scoring:							
Product Type:	2	Condition:	0	Surface Treatment:	1	Asbestos Type:	3
Priority Assessment Scoring:							
Occupant Activity:	0	Disturbance:	1	Human Exposure:	1	Maintenance Activity:	1
Total Scores:							
Material Score:	6	Priority Score	3	Total Score:	6	Risk Rating:	Low
Recommended action:	Remove if likely to be disturbed by the refurbishment, otherwise monitor condition.						
Recommendation comments:	-

Comments:	No access due to electrics being live at the time of the survey.

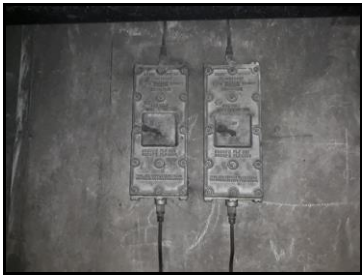
Building:	Block 1 Tower 11th Floor - Basement	Floor:	Basement Level				
Location:	113 - Store	Sample No / ID (Type):	P-359273/P008 (Presumed)				
Surveyor:	Martin Quigley	Survey date:	03/02/2020				
Sample Details

Item description:	Electrical switchgear					
	Material description:	Woven product					
	Quantity / Extent:	2 Number					
	Accessibility	Difficult Access					
	Analysis:	Presumed to contain asbestos					
	Material identification:	Asbestos woven material					
Material Assessment Scoring:							
Product Type:	2	Condition:	0	Surface Treatment:	1	Asbestos Type:	3
Priority Assessment Scoring:							
Occupant Activity:	0	Disturbance:	1	Human Exposure:	1	Maintenance Activity:	1
Total Scores:							
Material Score:	6	Priority Score	3	Total Score:	6	Risk Rating:	Low
Recommended action:	Remove if likely to be disturbed by the refurbishment, otherwise monitor condition.						
Recommendation comments:	-

Comments:	No access due to electrics being live at the time of the survey.

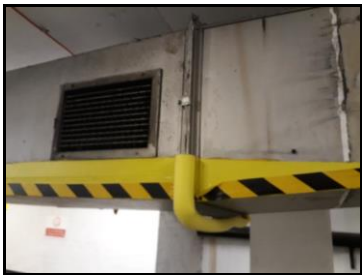
Building:	Block 1 Tower 11th Floor - Basement	Floor:	Basement Level				
Location:	114 - Parking Area	Sample No / ID (Type):	P-359273/055 (Sampled)				
Surveyor:	Martin Quigley	Survey date:	04/02/2020				
Sample Details

Item description:	Mastic seal to ducting joints					
	Material description:	Mastics					
	Quantity / Extent:	10 m linear					
	Accessibility	Medium Access					
	Analysis:	No asbestos detected					
	Material identification:	Non-asbestos material					
Material Assessment Scoring:							
Product Type:	-	Condition:	-	Surface Treatment:	-	Asbestos Type:	-
Priority Assessment Scoring:							
Occupant Activity:	-	Disturbance:	-	Human Exposure:	-	Maintenance Activity:	-
Total Scores:							
Material Score:	-	Priority Score	-	Total Score:	0	Risk Rating:	N/A
Recommended action:	-						
Recommendation comments:	-						
Comments:	-

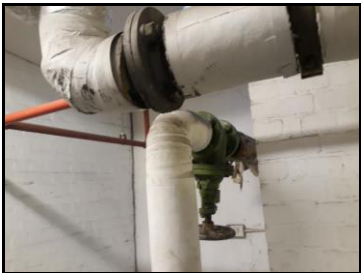
Building:	Block 1 Tower 11th Floor - Basement	Floor:	Basement Level
Location:	114 - Parking Area	Sample No / ID (Type):	P-359273/056 (Sampled)
Surveyor:	Martin Quigley	Survey date:	04/02/2020
Sample Details

Item description:	Gasket to pipework	
	Material description:	Gasket	
	Quantity / Extent:	6 Number	
	Accessibility	Easy Access	
	Analysis:	No asbestos detected	
	Material identification:	Non-asbestos material	
Material Assessment Scoring:			
Product Type:	-	Condition:	-
Surface Treatment:	-	Asbestos Type:	-
Priority Assessment Scoring:			
Occupant Activity:	-	Disturbance:	-
Human Exposure:	-	Maintenance Activity:	-
Total Scores:			
Material Score:	-	Priority Score	-
Total Score:	0	Risk Rating:	N/A
Recommended action:	-		
Recommendation comments:	-		
Comments:	-

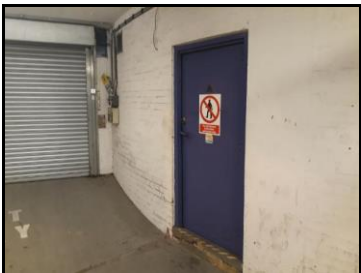
Building:	Block 1 Tower 11th Floor - Basement	Floor:	Basement Level
Location:	114 - Parking Area	Sample No / ID (Type):	P-359273/057 (Sampled)
Surveyor:	Martin Quigley	Survey date:	04/02/2020
Sample Details

Item description:	Durasteel doors	
	Material description:	Insulating board	
	Quantity / Extent:	5 Number	
	Accessibility	Easy Access	
	Analysis:	Chrysotile	
	Material identification:	Asbestos insulating board	
Material Assessment Scoring:			
Product Type:	2	Condition:	0
Surface Treatment:	1	Asbestos Type:	1
Priority Assessment Scoring:			
Occupant Activity:	0	Disturbance:	2
Human Exposure:	2	Maintenance Activity:	1
Total Scores:			
Material Score:	4	Priority Score	5
Total Score:	4	Risk Rating:	Very Low
Recommended action:	Remove if likely to be disturbed by the refurbishment, otherwise monitor condition.		
Recommendation comments:	-		
Comments:	Material is representative of throughout.

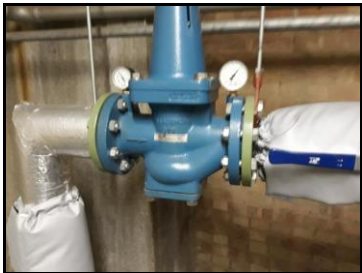
Building:	Block 1 Tower 11th Floor - Basement	Floor:	Basement Level				
Location:	117 - Water tank store	Sample No / ID (Type):	P-359273/058 (Sampled)				
Surveyor:	Martin Quigley	Survey date:	04/02/2020				
Sample Details

Item description:	Gasket to pipework					
	Material description:	Gasket					
	Quantity / Extent:	12 Number					
	Accessibility	Easy Access					
	Analysis:	No asbestos detected					
	Material identification:	Non-asbestos material					
Material Assessment Scoring:							
Product Type:	-	Condition:	-	Surface Treatment:	-	Asbestos Type:	-
Priority Assessment Scoring:							
Occupant Activity:	-	Disturbance:	-	Human Exposure:	-	Maintenance Activity:	-
Total Scores:							
Material Score:	-	Priority Score	-	Total Score:	0	Risk Rating:	N/A
Recommended action:	-						
Recommendation comments:	-						
Comments:	-

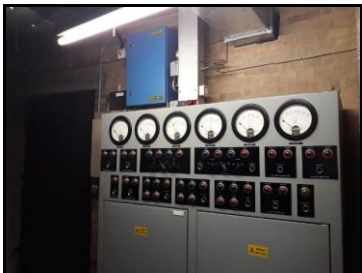
Building:	Block 1 Tower 11th Floor - Basement	Floor:	Basement Level				
Location:	117 - Water tank store	Sample No / ID (Type):	P-359273/P006 (Presumed)				
Surveyor:	Martin Quigley	Survey date:	04/02/2020				
Sample Details

Item description:	Electrical switchgear					
	Material description:	Woven product					
	Quantity / Extent:	2 Number					
	Accessibility	Difficult Access					
	Analysis:	Presumed to contain asbestos					
	Material identification:	Asbestos woven material					
Material Assessment Scoring:							
Product Type:	2	Condition:	0	Surface Treatment:	1	Asbestos Type:	3
Priority Assessment Scoring:							
Occupant Activity:	0	Disturbance:	1	Human Exposure:	1	Maintenance Activity:	1
Total Scores:							
Material Score:	6	Priority Score	3	Total Score:	6	Risk Rating:	Low
Recommended action:	Remove if likely to be disturbed by the refurbishment, otherwise monitor condition.						
Recommendation comments:	-

Comments:	No access due to electrics being live at the time of the survey.

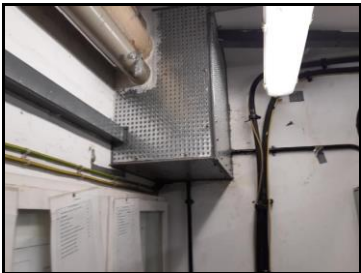
Building:	Block 1 Tower 11th Floor - Basement	Floor:	Basement Level
Location:	118 - Store	Sample No / ID (Type):	P-359273/059 (Sampled)
Surveyor:	Martin Quigley	Survey date:	04/02/2020
Sample Details

Item description:	Durasteel boxing	
	Material description:	Insulating board	
	Quantity / Extent:	1 m ²	
	Accessibility	Easy Access	
	Analysis:	No asbestos detected	
	Material identification:	Non-asbestos material	
Material Assessment Scoring:			
Product Type:	-	Condition:	-
Surface Treatment:	-	Asbestos Type:	-
Priority Assessment Scoring:			
Occupant Activity:	-	Disturbance:	-
Human Exposure:	-	Maintenance Activity:	-
Total Scores:			
Material Score:	-	Priority Score	-
Total Score:	0	Risk Rating:	N/A
Recommended action:	-		
Recommendation comments:	-		
Comments:	-

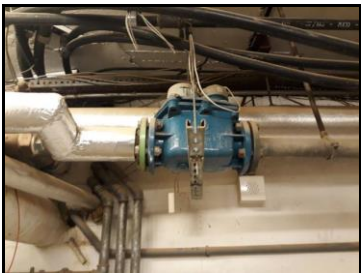
Building:	Block 1 Tower 11th Floor - Basement	Floor:	Basement Level
Location:	119 - Carpenters workshop	Sample No / ID (Type):	P-359273/As 058 (Cross Referenced)
Surveyor:	Martin Quigley	Survey date:	04/02/2020
Sample Details

Item description:	Gasket to pipework	
	Material description:	Gasket	
	Quantity / Extent:	2 Number	
	Accessibility	Easy Access	
	Analysis:	No asbestos detected	
	Material identification:	Non-asbestos material	
Material Assessment Scoring:			
Product Type:	-	Condition:	-
Surface Treatment:	-	Asbestos Type:	-
Priority Assessment Scoring:			
Occupant Activity:	-	Disturbance:	-
Human Exposure:	-	Maintenance Activity:	-
Total Scores:			
Material Score:	-	Priority Score	-
Total Score:	0	Risk Rating:	N/A
Recommended action:	-		
Recommendation comments:	-		
Comments:	-

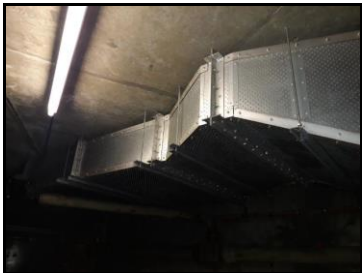
Building:	Block 1 Tower 11th Floor - Basement	Floor:	Basement Level
Location:	122 - Lobby	Sample No / ID (Type):	P-359273/As 059 (Cross Referenced)
Surveyor:	Martin Quigley	Survey date:	04/02/2020
Sample Details

Item description:	Durasteel boxing	
	Material description:	Insulating board	
	Quantity / Extent:	6 m linear	
	Accessibility	Easy Access	
	Analysis:	No asbestos detected	
	Material identification:	Non-asbestos material	
Material Assessment Scoring:			
Product Type:	-	Condition:	-
Surface Treatment:	-	Asbestos Type:	-
Priority Assessment Scoring:			
Occupant Activity:	-	Disturbance:	-
Human Exposure:	-	Maintenance Activity:	-
Total Scores:			
Material Score:	-	Priority Score	-
Total Score:	0	Risk Rating:	N/A
Recommended action:	-		
Recommendation comments:	-		
Comments:	-

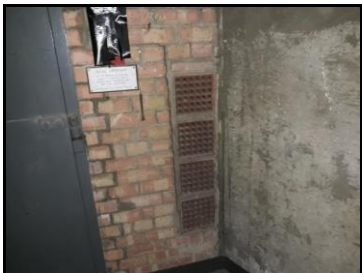
Building:	Block 1 Tower 11th Floor - Basement	Floor:	Basement Level
Location:	122 - Lobby	Sample No / ID (Type):	P-359273/P007 (Presumed)
Surveyor:	Martin Quigley	Survey date:	04/02/2020
Sample Details

Item description:	Liming within air bricks	
	Material description:	Cement product	
	Quantity / Extent:	4 Number	
	Accessibility	Difficult Access	
	Analysis:	Presumed to contain asbestos	
	Material identification:	Asbestos cement	
Material Assessment Scoring:			
Product Type:	1	Condition:	0
Surface Treatment:	1	Asbestos Type:	3
Priority Assessment Scoring:			
Occupant Activity:	0	Disturbance:	1
Human Exposure:	1	Maintenance Activity:	1
Total Scores:			
Material Score:	5	Priority Score	3
Total Score:	5	Risk Rating:	Low
Recommended action:	Remove if likely to be disturbed by the refurbishment, otherwise monitor condition.		
Recommendation comments:	-		
Comments:	No access due to causing excessive damage and area linked to UKPN area.

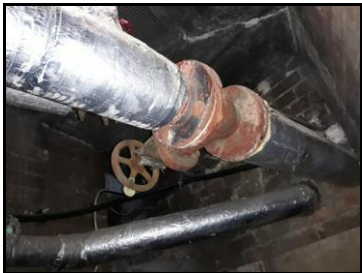
Building:	Block 1 Tower 11th Floor - Basement	Floor:	Basement Level				
Location:	123 - Store	Sample No / ID (Type):	P-359273/062 (Sampled)				
Surveyor:	Martin Quigley	Survey date:	04/02/2020				
Sample Details

Item description:	Gasket to pipework					
	Material description:	Gasket					
	Quantity / Extent:	2 Number					
	Accessibility	Easy Access					
	Analysis:	Chrysotile					
	Material identification:	Asbestos gasket					
Material Assessment Scoring:							
Product Type:	2	Condition:	0	Surface Treatment:	1	Asbestos Type:	1
Priority Assessment Scoring:							
Occupant Activity:	0	Disturbance:	1	Human Exposure:	1	Maintenance Activity:	1
Total Scores:							
Material Score:	4	Priority Score	3	Total Score:	4	Risk Rating:	Very Low
Recommended action:	Remove if likely to be disturbed by the refurbishment, otherwise monitor condition.						
Recommendation comments:	-						
Comments:	-

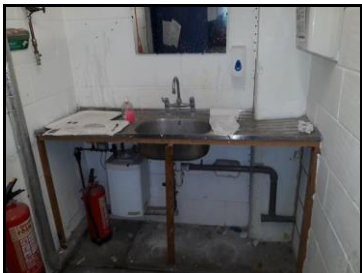
Building:	Block 1 Tower 11th Floor - Basement	Floor:	Basement Level				
Location:	125 - Staff room	Sample No / ID (Type):	P-359273/061 (Sampled)				
Surveyor:	Martin Quigley	Survey date:	04/02/2020				
Sample Details

Item description:	Sink pad					
	Material description:	Bituminous products					
	Quantity / Extent:	3 Number					
	Accessibility	Easy Access					
	Analysis:	Chrysotile					
	Material identification:	Asbestos bitumen					
Material Assessment Scoring:							
Product Type:	1	Condition:	1	Surface Treatment:	0	Asbestos Type:	1
Priority Assessment Scoring:							
Occupant Activity:	0	Disturbance:	2	Human Exposure:	1	Maintenance Activity:	1
Total Scores:							
Material Score:	3	Priority Score	4	Total Score:	3	Risk Rating:	Very Low
Recommended action:	Remove if likely to be disturbed by the refurbishment, otherwise monitor condition.						
Recommendation comments:	-						
Comments:	-

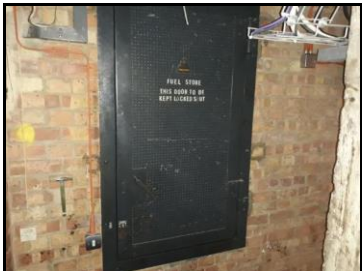
Building:	Block 1 Tower 11th Floor - Basement	Floor:	Basement Level				
Location:	126 - Water tanks & stores	Sample No / ID (Type):	P-359273/060 (Sampled)				
Surveyor:	Martin Quigley	Survey date:	04/02/2020				
Sample Details

Item description:	Durasteel doors x2					
	Material description:	Insulating board					
	Quantity / Extent:	2 Number					
	Accessibility	Easy Access					
	Analysis:	Crocidolite Amosite Chrysotile					
	Material identification:	Asbestos insulating board					
Material Assessment Scoring:							
Product Type:	2	Condition:	0	Surface Treatment:	1	Asbestos Type:	3
Priority Assessment Scoring:							
Occupant Activity:	0	Disturbance:	2	Human Exposure:	2	Maintenance Activity:	1
Total Scores:							
Material Score:	6	Priority Score	5	Total Score:	6	Risk Rating:	Low
Recommended action:	Remove if likely to be disturbed by the refurbishment, otherwise monitor condition.						
Recommendation comments:	-

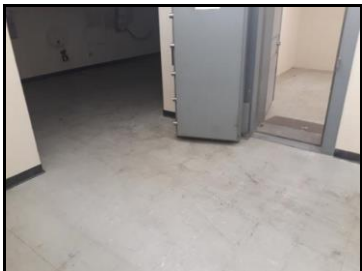
Building:	Block 1 Tower 11th Floor - Basement	Floor:	Basement Level				
Location:	128 - Store	Sample No / ID (Type):	P-359273/063 (Sampled)				
Surveyor:	Martin Quigley	Survey date:	05/02/2020				
Sample Details

Item description:	Floor covering					
	Material description:	Thermoplastic product					
	Quantity / Extent:	80 m²					
	Accessibility	Easy Access					
	Analysis:	No asbestos detected					
	Material identification:	Non-asbestos material					
Material Assessment Scoring:							
Product Type:	-	Condition:	-	Surface Treatment:	-	Asbestos Type:	-
Priority Assessment Scoring:							
Occupant Activity:	-	Disturbance:	-	Human Exposure:	-	Maintenance Activity:	-
Total Scores:							
Material Score:	-	Priority Score	-	Total Score:	0	Risk Rating:	N/A
Recommended action:	-						
Recommendation comments:	-						
Comments:	-

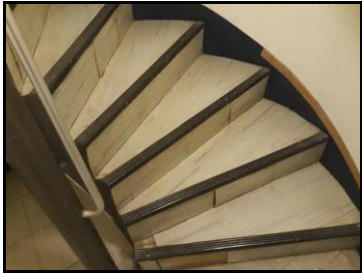
Building:	Block 1 Tower 11th Floor - Basement	Floor:	Basement Level
Location:	128 - Store	Sample No / ID (Type):	P-359273/064 (Sampled)
Surveyor:	Martin Quigley	Survey date:	05/02/2020
Sample Details

Item description:	Floor covering to staircase	
	Material description:	Thermoplastic product	
	Quantity / Extent:	10 m²	
	Accessibility	Easy Access	
	Analysis:	No asbestos detected	
	Material identification:	Non-asbestos material	
Material Assessment Scoring:			
Product Type:	-	Condition:	-
Surface Treatment:	-	Asbestos Type:	-
Priority Assessment Scoring:			
Occupant Activity:	-	Disturbance:	-
Human Exposure:	-	Maintenance Activity:	-
Total Scores:			
Material Score:	-	Priority Score	-
Total Score:	0	Risk Rating:	N/A
Recommended action:	-		
Recommendation comments:	-		
Comments:	-

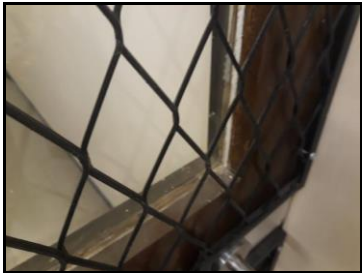
Building:	Block 1 Tower 11th Floor - Basement	Floor:	Basement Level
Location:	128 - Store	Sample No / ID (Type):	P-359273/065 (Sampled)
Surveyor:	Martin Quigley	Survey date:	05/02/2020
Sample Details

Item description:	Mastic to door window	
	Material description:	Mastics	
	Quantity / Extent:	1 m²	
	Accessibility	Easy Access	
	Analysis:	No asbestos detected	
	Material identification:	Non-asbestos material	
Material Assessment Scoring:			
Product Type:	-	Condition:	-
Surface Treatment:	-	Asbestos Type:	-
Priority Assessment Scoring:			
Occupant Activity:	-	Disturbance:	-
Human Exposure:	-	Maintenance Activity:	-
Total Scores:			
Material Score:	-	Priority Score	-
Total Score:	0	Risk Rating:	N/A
Recommended action:	-		
Recommendation comments:	-		
Comments:	-

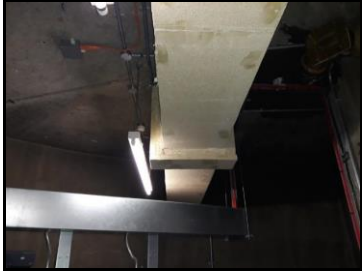
Building:	Block 1 Tower 11th Floor - Basement	Floor:	Basement Level
Location:	129 - Store	Sample No / ID (Type):	P-359273/066 (Sampled)
Surveyor:	Martin Quigley	Survey date:	05/02/2020
Sample Details

Item description:	Board boxing	
	Material description:	Insulating board	
	Quantity / Extent:	4 m ²	
	Accessibility	Easy Access	
	Analysis:	No asbestos detected	
	Material identification:	Non-asbestos material	
Material Assessment Scoring:			
Product Type:	-	Condition:	-
Surface Treatment:	-	Asbestos Type:	-
Priority Assessment Scoring:			
Occupant Activity:	-	Disturbance:	-
Human Exposure:	-	Maintenance Activity:	-
Total Scores:			
Material Score:	-	Priority Score	-
Total Score:	0	Risk Rating:	N/A
Recommended action:	-		
Recommendation comments:	-		
Comments:	-

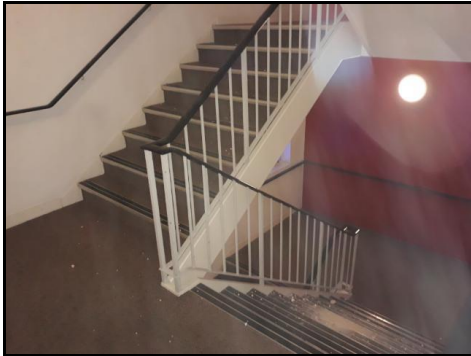
Building Name:	Block 1 Tower 11th Floor - Basement	Floor Level:	Tenth Floor
Location Number:	011	Location Description:	Stairwell 2
Surveyor:	Martin Quigley	Survey Date:	15/01/2020

Concrete ceiling, solid walls and a concrete floor beneath carpet tiles, timber doors and frames, metal and concrete staircase with mesh and plaster, modern stair nosing, plastic trunking to wall, metal window frame.

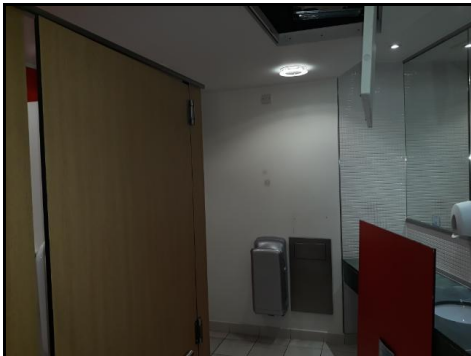
Building Name:	Block 1 Tower 11th Floor - Basement	Floor Level:	Tenth Floor
Location Number:	012	Location Description:	Male WC
Surveyor:	Martin Quigley	Survey Date:	15/01/2020

Concrete ceiling, modern uninsulated ducting and MMMF insulated metal pipework, solid and plasterboard walls and a concrete floor beneath ceramic tiles. Timber door and frame, plastic toilet cisterns and waste pipes to toilets and urinals, timber partitions to cubicles, 2x riser cupboards with MMMF insulated metal pipework and electrical units to wall with plastic pipework.

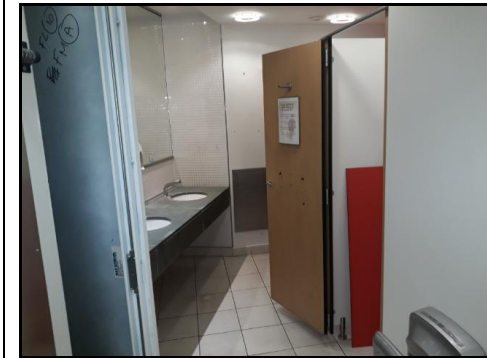
Building Name:	Block 1 Tower 11th Floor - Basement	Floor Level:	Tenth Floor
Location Number:	013	Location Description:	Female WC
Surveyor:	Martin Quigley	Survey Date:	15/01/2020

Plasterboard ceiling, inspection above revealed a concrete ceiling, modern uninsulated ducting and MMMF insulated metal pipework, solid and plasterboard walls and a concrete floor beneath ceramic tiles. Timber door and frame, timber boxing to wall containing plastic toilet cisterns and waste pipes to toilets and urinals, timber partitions to cubicles, 2x riser cupboards with MMMF insulated metal pipework and electrical units to wall with plastic pipework.

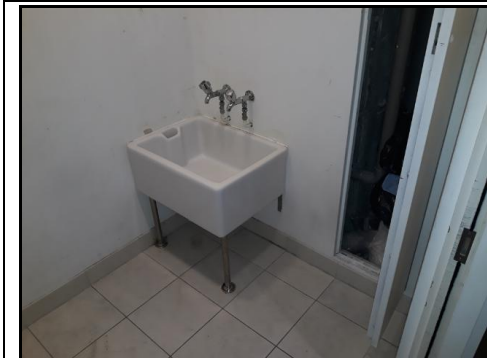
Building Name:	Block 1 Tower 11th Floor - Basement	Floor Level:	Tenth Floor
Location Number:	014	Location Description:	Cleaners Cupboard
Surveyor:	Martin Quigley	Survey Date:	15/01/2020

Plasterboard ceiling, solid and plasterboard walls and a concrete floor beneath ceramic tiles. Timber door and frame, ceramic sink unit with uninsulated metal pipework. Riser cupboard within room containing plastic waste pipes and uninsulated metal pipework with MMMF fire break to ceiling.

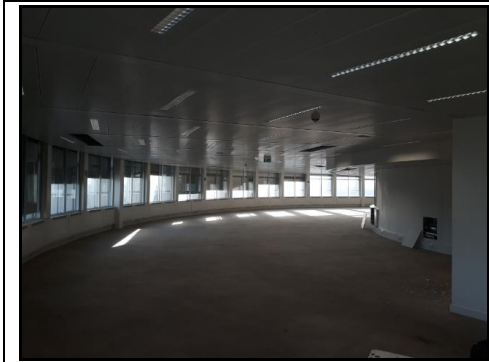
Building Name:	Block 1 Tower 11th Floor - Basement	Floor Level:	Ninth Floor
Location Number:	015	Location Description:	Open plan office
Surveyor:	Martin Quigley	Survey Date:	15/01/2020

Suspended metal ceiling, inspection above revealed a concrete ceiling, modern ducting with MMMF insulation and modern services, solid brick and plasterboard walls with MMMF insulation within cavity, concrete floor beneath modern vinyl and carpet tiles, timber doors and frames with 2x metal glazing to windows, uninsulated and MMMF insulated metal pipework to heaters to walls, modern electrical units within riser cupboards, modern sink pads to sinks, plasterboard partition walls with MMMF insulation within cavity to built in offices, glass fronts to some of the offices, modern pipework and gaskets with MMMF insulation within metal boxing to outer window divides.

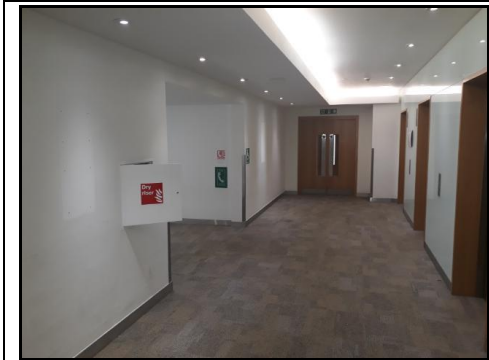
Building Name:	Block 1 Tower 11th Floor - Basement	Floor Level:	Ninth Floor
Location Number:	016	Location Description:	Lift lobby
Surveyor:	Martin Quigley	Survey Date:	14/01/2020

Concrete ceiling above metal suspended ceiling tiles, solid and plasterboard walls with solid walls behind the plasterboard and a timber and concrete floor to lobby. Timber doors and frames, timber and plasterboard boxing with strip lighting inset. Concrete ceiling, solid brick walls and a concrete floor to electrical riser cupboard, modern electrical units mounted onto metal frame, metal trunking. Riser cupboard with water shut off valve, uninsulated metal pipework, concrete ceiling and floor and solid brick walls. 2x cupboards with metal window frame inside and solid ceiling, walls and floors.

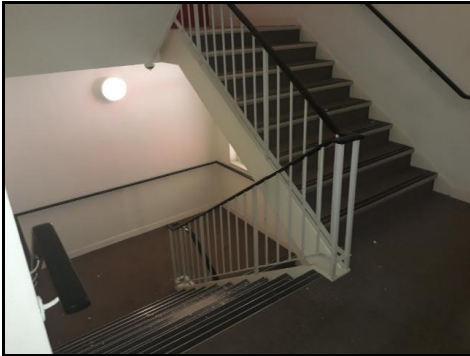
Building Name:	Block 1 Tower 11th Floor - Basement	Floor Level:	Ninth Floor
Location Number:	017	Location Description:	Stairwell 1
Surveyor:	Martin Quigley	Survey Date:	15/01/2020

Concrete ceiling, solid walls and a concrete floor beneath carpet tiles, timber doors and frames, metal and concrete staircase with mesh and plaster, modern stair nosing, plastic trunking to wall, metal window frame.

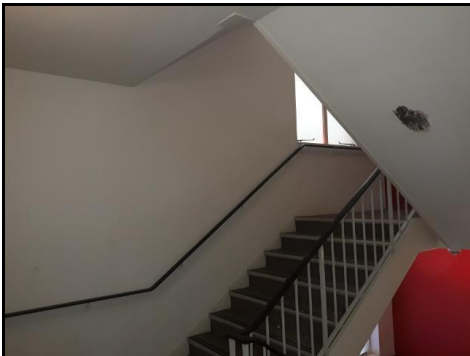
Building Name:	Block 1 Tower 11th Floor - Basement	Floor Level:	Ninth Floor
Location Number:	018	Location Description:	Stairwell 2
Surveyor:	Martin Quigley	Survey Date:	15/01/2020

Concrete ceiling, solid walls and a concrete floor beneath carpet tiles, timber doors and frames, metal and concrete staircase with mesh and plaster, modern stair nosing, plastic trunking to wall, metal window frame.

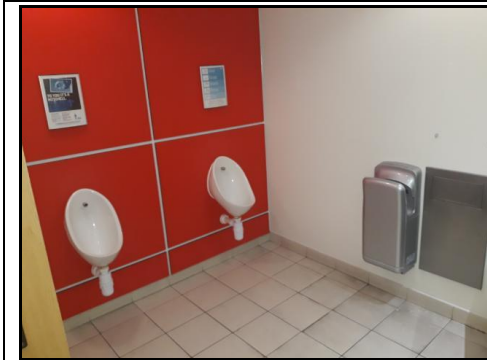
Building Name:	Block 1 Tower 11th Floor - Basement	Floor Level:	Ninth Floor
Location Number:	019	Location Description:	Male WC
Surveyor:	Martin Quigley	Survey Date:	15/01/2020

Concrete ceiling above plasterboard, modern uninsulated ducting and MMMF insulated metal pipework, solid and plasterboard walls and a concrete floor beneath ceramic tiles, timber door and frame, plastic toilet cisterns and waste pipes to toilets and urinals, timber partitions to cubicles, 2x riser cupboards with MMMF insulated metal pipework and electrical units to wall with plastic pipework.

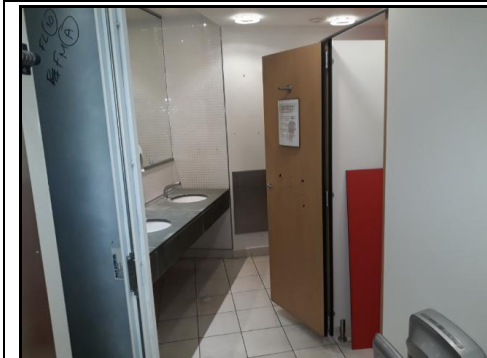
Building Name:	Block 1 Tower 11th Floor - Basement	Floor Level:	Ninth Floor
Location Number:	020	Location Description:	Female WC
Surveyor:	Martin Quigley	Survey Date:	15/01/2020

Concrete ceiling above plasterboard, modern uninsulated ducting and MMMF insulated metal pipework, solid and plasterboard walls and a concrete floor beneath ceramic tiles. Timber door and frame, timber boxing to wall containing plastic toilet cisterns and waste pipes to toilets and urinals, timber partitions to cubicles, 2x riser cupboards with MMMF insulated metal pipework and electrical units to wall with plastic pipework.

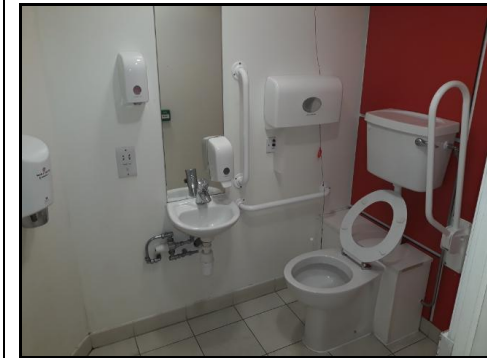
Building Name:	Block 1 Tower 11th Floor - Basement	Floor Level:	Ninth Floor
Location Number:	021	Location Description:	Disabled WC
Surveyor:	Martin Quigley	Survey Date:	15/01/2020

Plasterboard ceiling, solid and plasterboard walls and a concrete floor beneath ceramic tiles. Timber door and frame with timber boxing behind toilet containing a plastic waste pipe, ceramic toilet cistern, uninsulated metal and plastic pipework, timber frame and panels to rear of toilet containing plastic waste pipes.

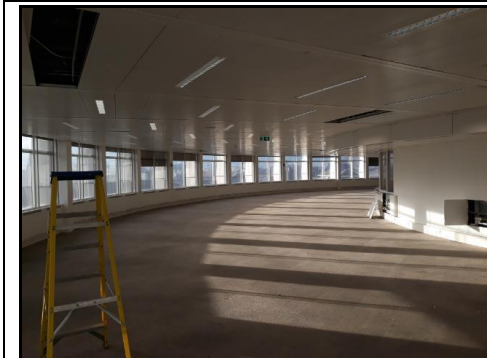
Building Name:	Block 1 Tower 11th Floor - Basement	Floor Level:	Eighth Floor
Location Number:	022	Location Description:	Open plan office
Surveyor:	Martin Quigley	Survey Date:	16/01/2020

Concrete ceiling above suspended metal ceiling, modern ducting with MMMF insulation and modern services, solid brick and plasterboard walls areas containing MMMF insulation within the cavity, concrete floor beneath modern vinyl and carpet tiles. Timber doors and frames with 2x metal glazing to windows, uninsulated and MMMF insulated metal pipework within heaters to walls, modern electrical units within riser cupboards, modern sink pads to sinks, plasterboard partition walls with MMMF insulation within cavity to built in offices, glass fronts to some of the offices, modern pipework and gaskets with MMMF insulation within metal boxing to outer window divides.

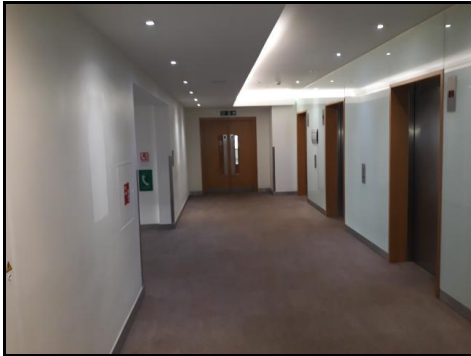
Building Name:	Block 1 Tower 11th Floor - Basement	Floor Level:	Eighth Floor
Location Number:	023	Location Description:	Lift lobby
Surveyor:	Martin Quigley	Survey Date:	16/01/2020

Concrete ceiling above metal suspended ceiling tiles, solid and plasterboard walls with solid walls behind the plasterboard and a timber and concrete floor to lobby. Timber doors and frames, timber and plasterboard boxing with strip lighting inset. Concrete ceiling, solid brick walls and a concrete floor to electrical riser cupboard, modern electrical units mounted onto metal frame, metal trunking. Riser cupboard with water shut off valve and uninsulated metal pipework with concrete ceiling and floor and solid brick walls. 2x cupboards with metal windows inside and solid ceilings, walls and floors.

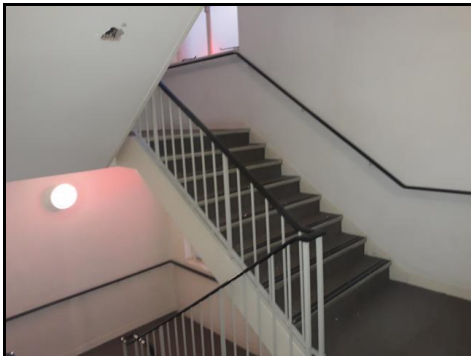
Building Name:	Block 1 Tower 11th Floor - Basement	Floor Level:	Eighth Floor
Location Number:	024	Location Description:	Stairwell 1
Surveyor:	Martin Quigley	Survey Date:	16/01/2020

Concrete ceiling, solid walls and a concrete floor beneath carpet tiles. Timber doors and frames, metal and concrete staircase with mesh and plaster, modern stair nosing, plastic trunking to wall, metal window frame.

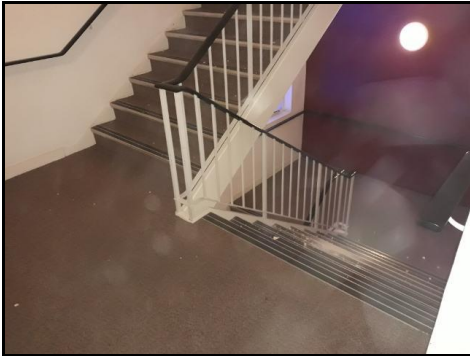
Building Name:	Block 1 Tower 11th Floor - Basement	Floor Level:	Eighth Floor
Location Number:	025	Location Description:	Stairwell 2
Surveyor:	Martin Quigley	Survey Date:	16/01/2020

Concrete ceiling, solid walls and a concrete floor beneath carpet tiles. Timber doors and frames, metal and concrete staircase with mesh and plaster, modern stair nosing, plastic trunking to wall, metal window frame.

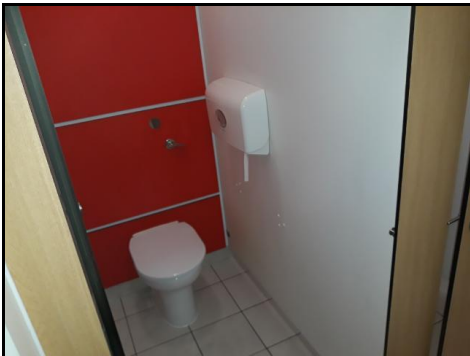
Building Name:	Block 1 Tower 11th Floor - Basement	Floor Level:	Eighth Floor
Location Number:	026	Location Description:	Male WC
Surveyor:	Martin Quigley	Survey Date:	16/01/2020

Concrete ceiling, modern uninsulated ducting and MMMF insulated metal pipework, solid and plasterboard walls and a concrete floor beneath ceramic tiles, timber door and frame, plastic toilet cisterns and waste pipes to toilets and urinals, timber partitions to cubicles, 2x riser cupboards with MMMF insulated metal pipework and electrical units to wall with plastic pipework.

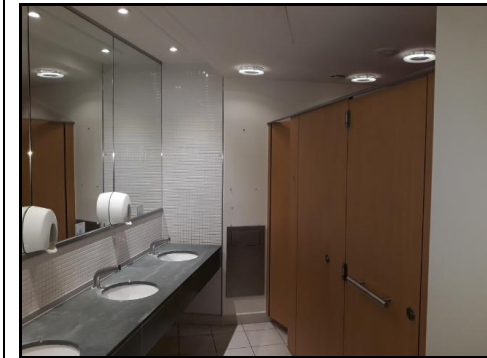
Building Name:	Block 1 Tower 11th Floor - Basement	Floor Level:	Eighth Floor
Location Number:	027	Location Description:	Female WC
Surveyor:	Martin Quigley	Survey Date:	16/01/2020

Concrete ceiling above plasterboard, modern uninsulated ducting and MMMF insulated metal pipework, solid and plasterboard walls and a concrete floor beneath ceramic tiles. Timber door and frame, timber boxing to wall containing plastic toilet cisterns and waste pipes to toilets and urinals, timber partitions to cubicles, 2x riser cupboards with MMMF insulated metal pipework and electrical units to wall with plastic pipework.

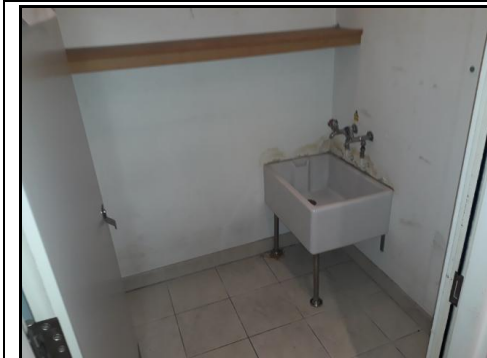
Building Name:	Block 1 Tower 11th Floor - Basement	Floor Level:	Eighth Floor
Location Number:	028	Location Description:	Cleaners Cupboard
Surveyor:	Martin Quigley	Survey Date:	16/01/2020

Plasterboard ceiling, solid and plasterboard walls and a concrete floor beneath ceramic tiles. Timber door and frame, ceramic sink unit with uninsulated metal pipework. Riser cupboard within room containing plastic waste pipes and uninsulated metal pipework with MMMF fire break to ceiling.

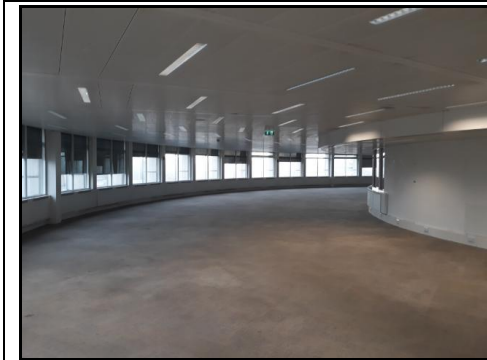
Building Name:	Block 1 Tower 11th Floor - Basement	Floor Level:	Seventh Floor
Location Number:	029	Location Description:	Open plan office
Surveyor:	Martin Quigley	Survey Date:	17/01/2020

Concrete ceiling above suspended metal ceiling, modern ducting with MMMF insulation and modern services, solid brick and plasterboard walls with areas containing MMMF insulation within the cavity, concrete floor beneath modern vinyl and carpet tiles. Timber doors and frames, 2x metal glazing to windows, uninsulated and MMMF insulated metal pipework within heaters to walls, modern electrical units within riser cupboards, modern sink pads to sinks, plasterboard partition walls with MMMF insulation within cavity to built in offices, glass fronts to some of the offices, modern pipework and gaskets with MMMF insulation within metal boxing to outer window divides.

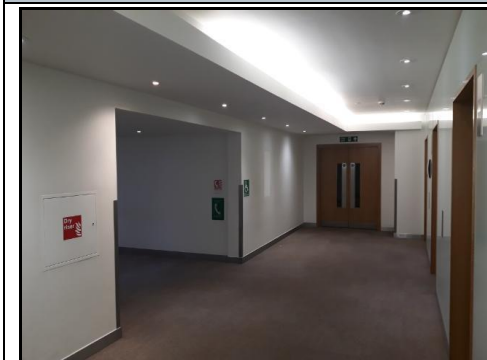
Building Name:	Block 1 Tower 11th Floor - Basement	Floor Level:	Seventh Floor
Location Number:	030	Location Description:	Lift lobby
Surveyor:	Martin Quigley	Survey Date:	17/01/2020

Concrete ceiling above metal suspended ceiling tiles, solid and plasterboard walls with solid walls behind the plasterboard and a timber and concrete floor to lobby. Timber doors and frames, timber and plasterboard boxing with strip lighting inset. Concrete ceiling, solid brick walls and a concrete floor to electrical riser cupboard, modern electrical units mounted onto metal frame, metal trunking. Riser cupboard with water shut off valve, uninsulated metal pipework, concrete ceiling and floor and solid brick walls. 2x cupboards with metal window frames inside and solid ceilings, walls and floors.

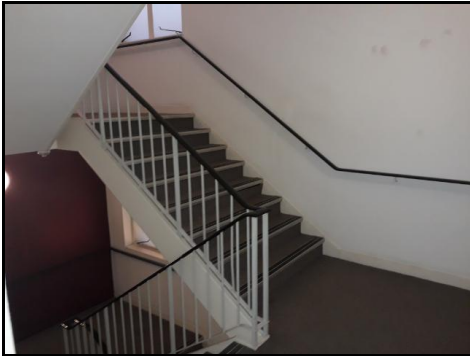
Building Name:	Block 1 Tower 11th Floor - Basement	Floor Level:	Seventh Floor
Location Number:	031	Location Description:	Stairwell 1
Surveyor:	Martin Quigley	Survey Date:	17/01/2020

Concrete ceiling, solid walls and a concrete floor beneath carpet tiles. Timber doors and frames, metal and concrete staircase with mesh and plaster, modern stair nosing, plastic trunking to wall, metal window frame.

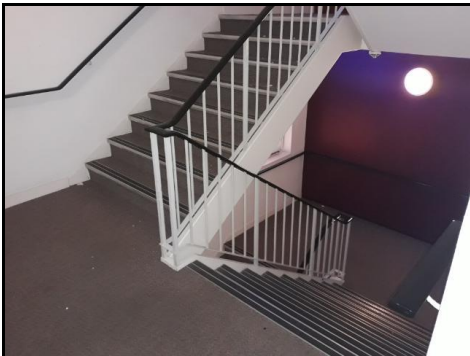
Building Name:	Block 1 Tower 11th Floor - Basement	Floor Level:	Seventh Floor
Location Number:	032	Location Description:	Stairwell 2
Surveyor:	Martin Quigley	Survey Date:	17/01/2020

Concrete ceiling, solid walls and a concrete floor beneath carpet tiles. Timber doors and frames, metal and concrete staircase with mesh and plaster, modern stair nosing, plastic trunking to wall, metal window frame.

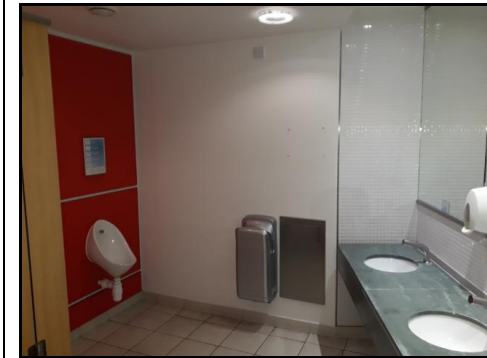
Building Name:	Block 1 Tower 11th Floor - Basement	Floor Level:	Seventh Floor
Location Number:	033	Location Description:	Male WC
Surveyor:	Martin Quigley	Survey Date:	17/01/2020

Concrete ceiling, modern uninsulated ducting and MMMF insulated metal pipework, solid and plasterboard walls and a concrete floor beneath ceramic tiles. Timber door and frame, plastic toilet cisterns and waste pipes to toilets and urinals, timber partitions to cubicles, 2x riser cupboards with MMMF insulated metal pipework and electrical units to wall with plastic pipework.

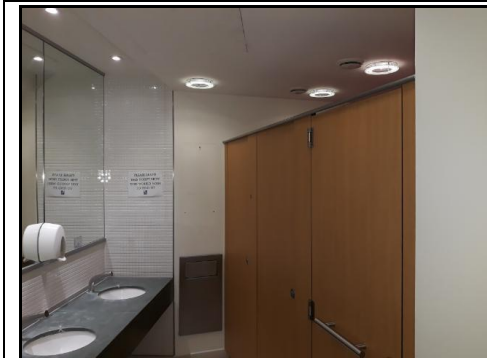
Building Name:	Block 1 Tower 11th Floor - Basement	Floor Level:	Seventh Floor
Location Number:	034	Location Description:	Female WC
Surveyor:	Martin Quigley	Survey Date:	17/01/2020

Concrete ceiling above plasterboard, modern uninsulated ducting and MMMF insulated metal pipework, solid and plasterboard walls and a concrete floor beneath ceramic tiles. Timber door and frame, timber boxing to wall containing plastic toilet cisterns and waste pipes to toilets and urinals, timber partitions to cubicles, 2x riser cupboards with MMMF insulated metal pipework and electrical units to wall with plastic pipework.

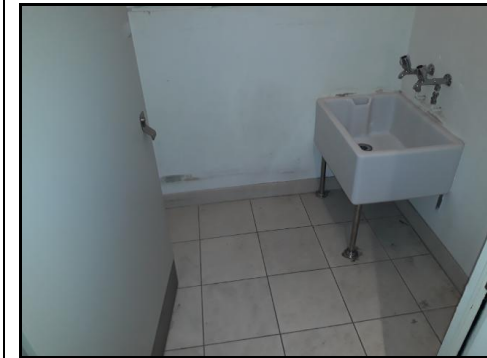
Building Name:	Block 1 Tower 11th Floor - Basement	Floor Level:	Seventh Floor
Location Number:	035	Location Description:	Cleaners Cupboard
Surveyor:	Martin Quigley	Survey Date:	17/01/2020

Plasterboard ceiling, solid and plasterboard walls and a concrete floor beneath ceramic tiles. Timber door and frame, ceramic sink unit with uninsulated metal pipework. Riser cupboard within room containing plastic waste pipes and uninsulated metal pipework with MMMF fire break to ceiling.

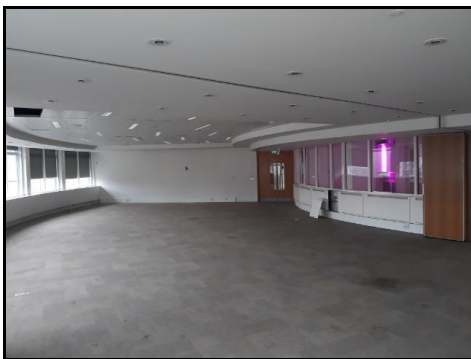
Building Name:	Block 1 Tower 11th Floor - Basement	Floor Level:	Sixth Floor
Location Number:	036	Location Description:	Open plan office
Surveyor:	Martin Quigley	Survey Date:	20/01/2020

Concrete ceiling above suspended metal ceiling, modern ducting with MMMF insulation and modern services, solid brick and plasterboard walls with areas containing MMMF insulation within the cavity, concrete floor beneath modern vinyl and carpet tiles. Timber doors and frames, 2x metal glazing to windows, uninsulated and MMMF insulated metal pipework within heaters to walls, modern electrical units within riser cupboards, modern sink pads to sinks, plasterboard partition walls with MMMF insulation within cavity to built in offices, glass front to some of the offices, modern pipework and gaskets with MMMF insulation within metal boxing to outer window divides. Section of partition room has raised metal flooring with modern electrics and ducting to cooler units, metal trunking and MMMF insulation fire breaks.

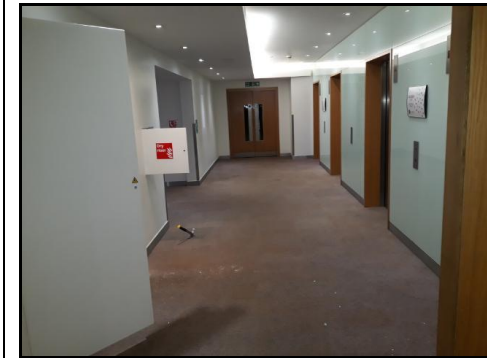
Building Name:	Block 1 Tower 11th Floor - Basement	Floor Level:	Sixth Floor
Location Number:	037	Location Description:	Lift lobby
Surveyor:	Martin Quigley	Survey Date:	20/01/2020

Concrete ceiling above metal suspended ceiling tiles, solid and plasterboard walls with solid walls behind the plasterboard and a timber and concrete floor to lobby, timber doors and frames, timber and plasterboard boxing with strip lighting inset. Concrete ceiling, solid brick walls and a concrete floor to electrical riser cupboard, modern electrical units mounted onto metal frame, metal trunking. Riser cupboard with water shut off valve, uninsulated metal pipework, concrete ceiling and floor and solid brick walls. 2x cupboards with metal windows inside and solid ceilings, walls and floors.

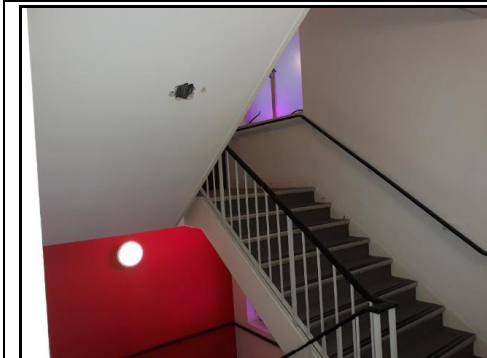
Building Name:	Block 1 Tower 11th Floor - Basement	Floor Level:	Sixth Floor
Location Number:	038	Location Description:	Stairwell 1
Surveyor:	Martin Quigley	Survey Date:	20/01/2020

Concrete ceiling, solid walls and a concrete floor beneath carpet tiles. Timber doors and frames, metal and concrete staircase with mesh and plaster, modern stair nosing, plastic trunking to wall, metal window frame.

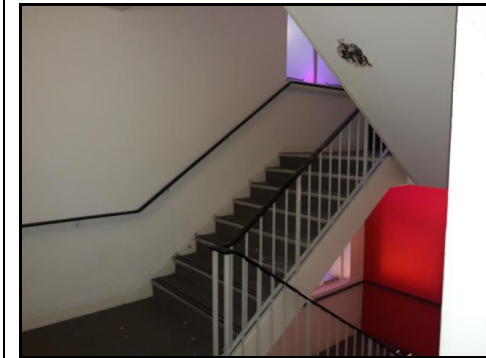
Building Name:	Block 1 Tower 11th Floor - Basement	Floor Level:	Sixth Floor
Location Number:	039	Location Description:	Stairwell 2
Surveyor:	Martin Quigley	Survey Date:	20/01/2020

Concrete ceiling, solid walls and a concrete floor beneath carpet tiles. Timber doors and frames, metal and concrete staircase with mesh and plaster, modern stair nosing, plastic trunking to wall, metal window frame.

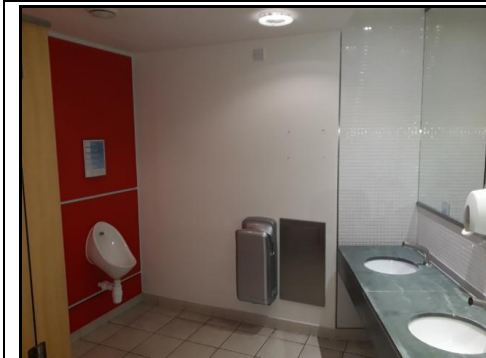
Building Name:	Block 1 Tower 11th Floor - Basement	Floor Level:	Eighth Floor
Location Number:	040	Location Description:	Male WC
Surveyor:	Martin Quigley	Survey Date:	17/01/2020

Concrete ceiling, modern uninsulated ducting and MMMF insulated metal pipework, solid and plasterboard walls and a concrete floor beneath ceramic tiles. Timber door and frame, plastic toilet cisterns and waste pipes to toilets and urinals, timber partitions to cubicles, 2x riser cupboards with MMMF insulated metal pipework and electrical units to wall with plastic pipework.

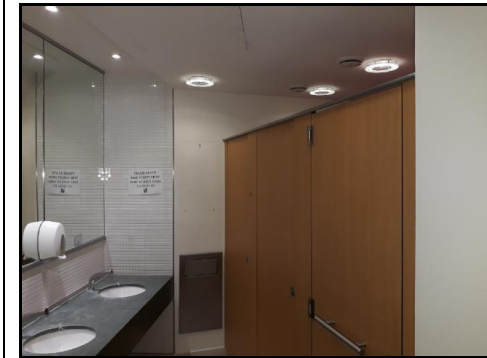
Building Name:	Block 1 Tower 11th Floor - Basement	Floor Level:	Eighth Floor
Location Number:	041	Location Description:	Female WC
Surveyor:	Martin Quigley	Survey Date:	17/01/2020

Concrete ceiling above plasterboard, modern uninsulated ducting and MMMF insulated metal pipework, solid and plasterboard walls and a concrete floor beneath ceramic tiles. Timber door and frame, timber boxing to wall containing plastic toilet cisterns and waste pipes to toilets and urinals, timber partitions to cubicles, 2x riser cupboards with MMMF insulated metal pipework and electrical units to wall with plastic pipework.

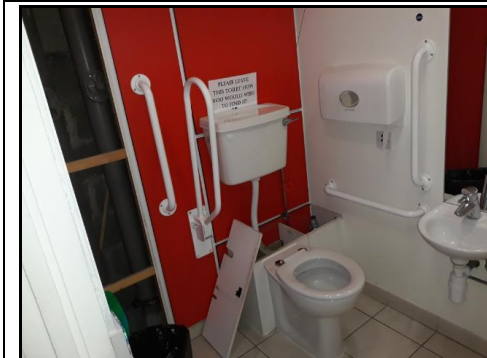
Building Name:	Block 1 Tower 11th Floor - Basement	Floor Level:	Sixth Floor
Location Number:	042	Location Description:	Disabled WC
Surveyor:	Martin Quigley	Survey Date:	20/01/2020

Plasterboard ceiling, solid and plasterboard walls and a concrete floor beneath ceramic tiles. Timber door and frame, timber boxing behind toilet containing a plastic waste pipe, ceramic toilet cistern, uninsulated metal and plastic pipework, timber frame and panels to rear of toilet containing plastic waste pipes.

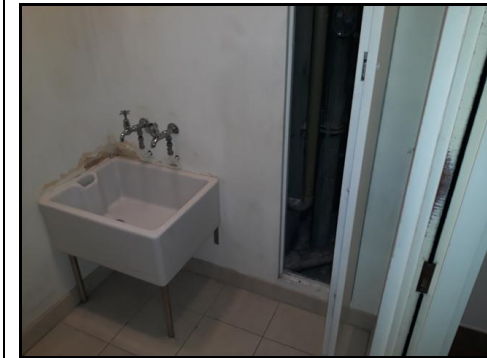
Building Name:	Block 1 Tower 11th Floor - Basement	Floor Level:	Sixth Floor
Location Number:	043	Location Description:	Cleaners Cupboard
Surveyor:	Martin Quigley	Survey Date:	20/01/2020

Plasterboard ceiling, solid and plasterboard walls and a concrete floor beneath ceramic tiles. Timber door and frame, ceramic sink unit with uninsulated metal pipework. Riser cupboard within room containing plastic waste pipes and uninsulated metal pipework with MMMF fire break to ceiling.

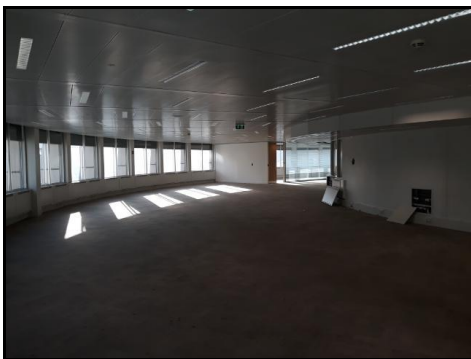
Building Name:	Block 1 Tower 11th Floor - Basement	Floor Level:	Fifth Floor
Location Number:	044	Location Description:	Open plan office
Surveyor:	Martin Quigley	Survey Date:	20/01/2020

Concrete ceiling above suspended metal ceiling, modern ducting with MMMF insulation and modern services, solid brick and plasterboard walls with areas containing MMMF insulation within the cavity, concrete floor beneath modern vinyl and carpet tiles. Timber doors and frames with 2x metal glazing to windows, uninsulated and MMMF insulated metal pipework within heaters to walls, modern electrical units within riser cupboards, modern sink pads to sinks, plasterboard partition walls with MMMF insulation within cavity to built in offices, glass fronts to some of the offices, modern pipework and gaskets with MMMF insulation within metal boxing to outer window divides. Section of partition room has raised metal flooring with modern electrics and ducting to cooler units, metal trunking and MMMF insulation fire breaks.

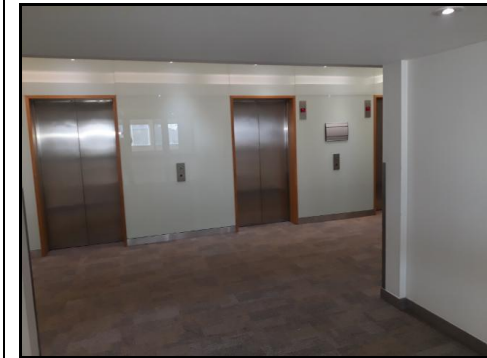
Building Name:	Block 1 Tower 11th Floor - Basement	Floor Level:	Fifth Floor
Location Number:	045	Location Description:	Lift lobby
Surveyor:	Martin Quigley	Survey Date:	20/01/2020

Concrete ceiling above metal suspended ceiling tiles, solid and plasterboard walls with solid walls behind the plasterboard and a timber and concrete floor to lobby, timber doors and frames, timber and plasterboard boxing with strip lighting inset. Concrete ceiling, solid brick walls and a concrete floor to electrical riser cupboard, modern electrical units mounted onto metal frame, metal trunking. Riser cupboard with water shut off valve, uninsulated metal pipework, concrete ceiling and floor and solid brick walls. 2x cupboards with metal windows inside and solid ceilings, walls and floors.

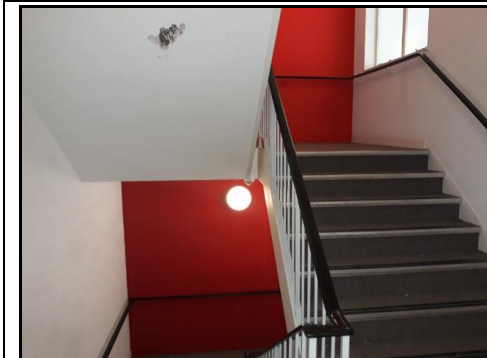
Building Name:	Block 1 Tower 11th Floor - Basement	Floor Level:	Fifth Floor
Location Number:	046	Location Description:	Stairwell 1
Surveyor:	Martin Quigley	Survey Date:	20/01/2020

Concrete ceiling, solid walls and a concrete floor beneath carpet tiles. Timber doors and frames, metal and concrete staircase with mesh and plaster, modern stair nosing, plastic trunking to wall, metal window frame.
