Asbestos Refurbishment Survey **11th Floor to Basement**

SLQR Trustee No 1 Limited and SLQR Trustee No 2 Limited
as Co Trustees of SLQR Unit Trust No 3

Space House (Tower)
1 Kemble Street
London
WC2B 4AN

Project Reference: P-359273

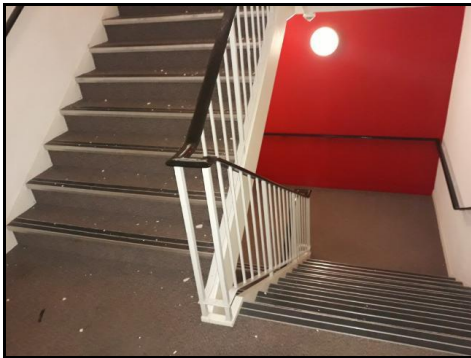
Building Name:	Block 1 Tower 11th Floor - Basement	Floor Level:	Fifth Floor
Location Number:	047	Location Description:	Stairwell 2
Surveyor:	Martin Quigley	Survey Date:	20/01/2020

Concrete ceiling, solid walls and a concrete floor beneath carpet tiles. Timber doors and frames, metal and concrete staircase with mesh and plaster, modern stair nosing, plastic trunking to wall, metal window frame.

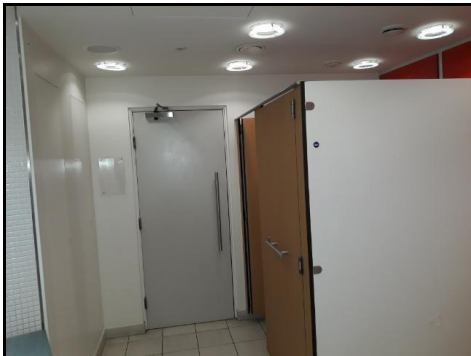
Building Name:	Block 1 Tower 11th Floor - Basement	Floor Level:	Fifth Floor
Location Number:	048	Location Description:	Male WC
Surveyor:	Martin Quigley	Survey Date:	20/01/2020

Concrete ceiling, modern uninsulated ducting and MMMF insulated metal pipework, solid and plasterboard walls and a concrete floor beneath ceramic tiles. Timber door and frame, plastic toilet cisterns and waste pipes to toilets and urinals, timber partitions to cubicles, 2x riser cupboards with MMMF insulated metal pipework and electrical units to wall with plastic pipework.

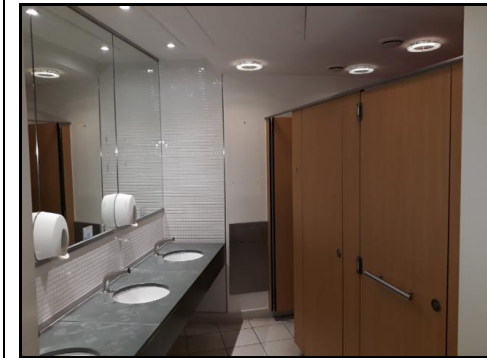
Building Name:	Block 1 Tower 11th Floor - Basement	Floor Level:	Fifth Floor
Location Number:	049	Location Description:	Female WC
Surveyor:	Martin Quigley	Survey Date:	20/01/2020

Concrete ceiling above plasterboard, modern uninsulated ducting and MMMF insulated metal pipework, solid and plasterboard walls and a concrete floor beneath ceramic tiles. Timber door and frame, timber boxing to wall containing plastic toilet cisterns and waste pipes to toilets and urinals, timber partitions to cubicles, 2x riser cupboards with MMMF insulated metal pipework and electrical units to wall with plastic pipework.

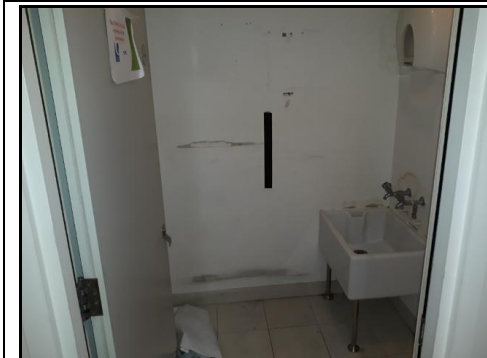
Building Name:	Block 1 Tower 11th Floor - Basement	Floor Level:	Fifth Floor
Location Number:	050	Location Description:	Cleaners Cupboard
Surveyor:	Martin Quigley	Survey Date:	20/01/2020

Plasterboard ceiling, solid and plasterboard walls and a concrete floor beneath ceramic tiles. Timber door and frame, ceramic sink unit with uninsulated metal pipework. Riser cupboard within room containing plastic waste pipes and uninsulated metal pipework with MMMF fire break to ceiling.

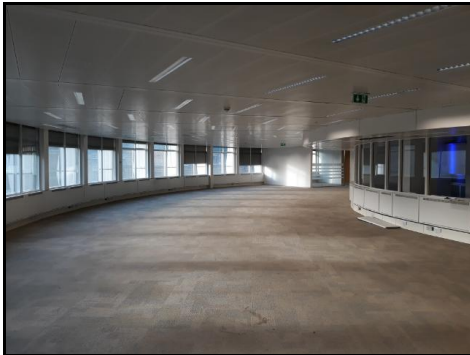
Building Name:	Block 1 Tower 11th Floor - Basement	Floor Level:	Fourth Floor
Location Number:	051	Location Description:	Open plan office
Surveyor:	Martin Quigley	Survey Date:	21/01/2020

Concrete ceiling above suspended metal ceiling, modern ducting with MMMF insulation and modern services, solid brick and plasterboard walls with areas containing MMMF insulation within the cavity, concrete floor beneath modern vinyl and carpet tiles. Timber doors and frames with 2x metal glazing to windows, uninsulated and MMMF insulated metal pipework within heaters to walls, modern electrical units within riser cupboards, modern sink pads to sinks, plasterboard partition walls with MMMF insulation within cavity to built in offices, glass fronts to some of the offices, modern pipework and gaskets with MMMF insulation within metal boxing to outer window divides. Section of partition room has raised metal flooring with modern electrics and ducting to cooler units, metal trunking and MMMF insulation fire breaks.

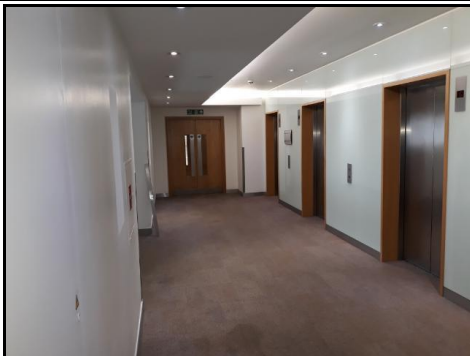
Building Name:	Block 1 Tower 11th Floor - Basement	Floor Level:	Fourth Floor
Location Number:	052	Location Description:	Lift lobby
Surveyor:	Martin Quigley	Survey Date:	21/01/2020

Concrete ceiling above metal suspended ceiling tiles, solid and plasterboard walls with solid walls behind the plasterboard and a timber and concrete floor to lobby. Timber doors and frames, timber and plasterboard boxing with strip lighting inset. Concrete ceiling, solid brick walls and a concrete floor to electrical riser cupboard, modern electrical units mounted onto metal frame, metal trunking. Riser cupboard with water shut off valve, uninsulated metal pipework with concrete ceiling and floor and solid brick walls. 2x cupboards with metal windows inside and solid ceilings, walls and floors.

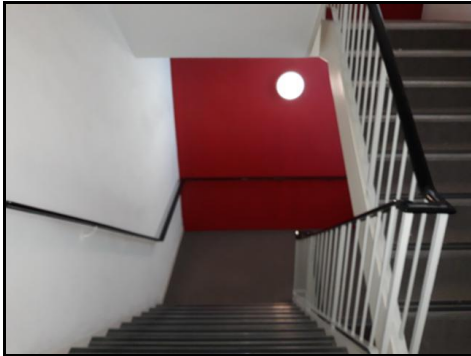
Building Name:	Block 1 Tower 11th Floor - Basement	Floor Level:	Fourth Floor
Location Number:	053	Location Description:	Stairwell 1
Surveyor:	Martin Quigley	Survey Date:	21/01/2020

Concrete ceiling, solid walls and a concrete floor beneath carpet tiles. Timber doors and frames, metal and concrete staircase with mesh and plaster, modern stair nosing, plastic trunking to wall, metal window frame.

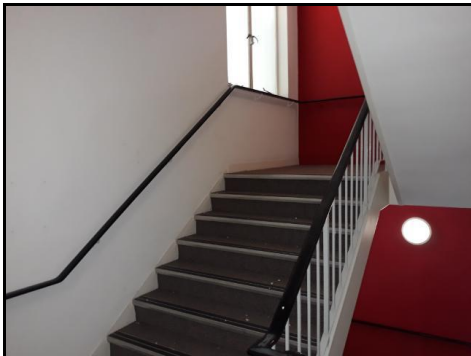
Building Name:	Block 1 Tower 11th Floor - Basement	Floor Level:	Fourth Floor
Location Number:	054	Location Description:	Stairwell 2
Surveyor:	Martin Quigley	Survey Date:	21/01/2020

Concrete ceiling, solid walls and a concrete floor beneath carpet tiles. Timber doors and frames, metal and concrete staircase with mesh and plaster, modern stair nosing, plastic trunking to wall, metal window frame.

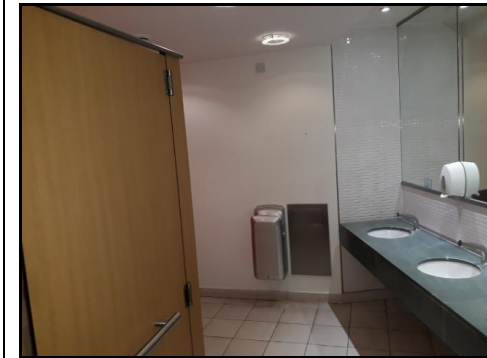
Building Name:	Block 1 Tower 11th Floor - Basement	Floor Level:	Fourth Floor
Location Number:	055	Location Description:	Male WC
Surveyor:	Martin Quigley	Survey Date:	21/01/2020

Concrete ceiling, modern uninsulated ducting and MMMF insulated metal pipework, solid and plasterboard walls and a concrete floor beneath ceramic tiles. Timber door and frame, plastic toilet cisterns and waste pipes to toilets and urinals, timber partitions to cubicles, 2x riser cupboards with MMMF insulated metal pipework and electrical units to wall with plastic pipework.

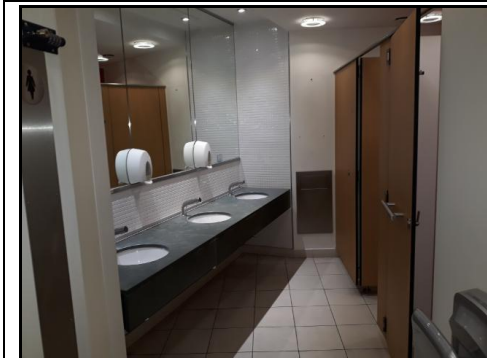
Building Name:	Block 1 Tower 11th Floor - Basement	Floor Level:	Fourth Floor
Location Number:	056	Location Description:	Female WC
Surveyor:	Martin Quigley	Survey Date:	21/01/2020

Concrete ceiling above plasterboard, modern uninsulated ducting and MMMF insulated metal pipework, solid and plasterboard walls and a concrete floor beneath ceramic tiles. Timber door and frame, timber boxing to wall containing plastic toilet cisterns and waste pipes to toilets and urinals, timber partitions to cubicles, 2x riser cupboards with MMMF insulated metal pipework and electrical units to wall with plastic pipework.

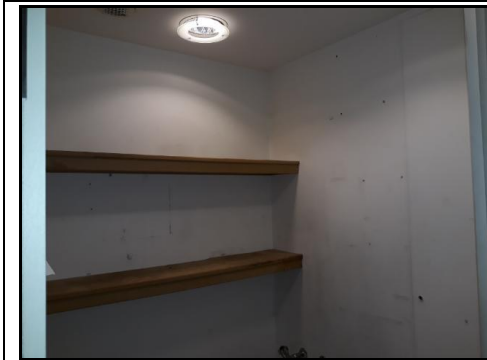
Building Name:	Block 1 Tower 11th Floor - Basement	Floor Level:	Fourth Floor
Location Number:	057	Location Description:	Cleaners Cupboard
Surveyor:	Martin Quigley	Survey Date:	21/01/2020

Plasterboard ceiling, solid and plasterboard walls and a concrete floor beneath ceramic tiles. Timber door and frame, ceramic sink unit with uninsulated metal pipework. Riser cupboard within room containing plastic waste pipes and uninsulated metal pipework with MMMF fire break to ceiling.

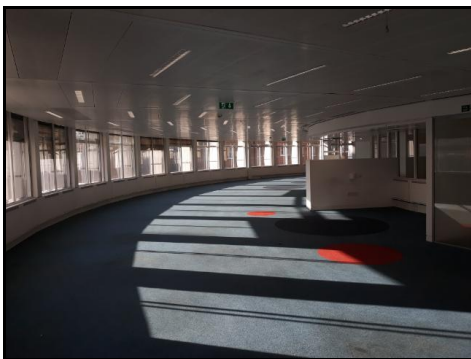
Building Name:	Block 1 Tower 11th Floor - Basement	Floor Level:	Third Floor
Location Number:	058	Location Description:	Open plan office
Surveyor:	Martin Quigley	Survey Date:	21/01/2020

Concrete ceiling above suspended metal ceiling, modern ducting with MMMF insulation and modern services, solid brick and plasterboard walls with areas containing MMMF insulation within the cavity, concrete floor beneath modern vinyl and carpet tiles. Timber doors and frames with 2x metal glazing to windows, uninsulated and MMMF insulated metal pipework within heaters to walls, modern electrical units within riser cupboards, modern sink pads to sinks, plasterboard partition walls with MMMF insulation within cavity to built in offices, glass fronts to some of the offices, modern pipework and gaskets with MMMF insulation within metal boxing to outer window divides. Section of partition room has raised metal flooring with modern electrics and ducting to cooler units, metal trunking and MMMF insulation fire breaks.

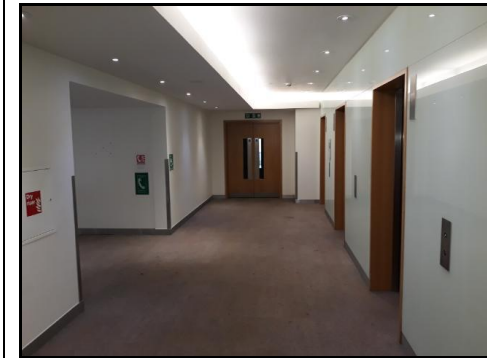
Building Name:	Block 1 Tower 11th Floor - Basement	Floor Level:	Third Floor
Location Number:	059	Location Description:	Lift lobby
Surveyor:	Martin Quigley	Survey Date:	21/01/2020

Concrete ceiling above metal suspended ceiling tiles, solid and plasterboard walls with solid walls behind the plasterboard and a timber and concrete floor to lobby. Timber doors and frames, timber and plasterboard boxing with strip lighting inset. Concrete ceiling, solid brick walls and a concrete floor to electrical riser cupboard, modern electrical units mounted onto metal frame, metal trunking. Riser cupboard with water shut off valve, uninsulated metal pipework with concrete ceiling and floor and solid brick walls. 2x cupboards with metal windows inside and solid ceilings, walls and floors.

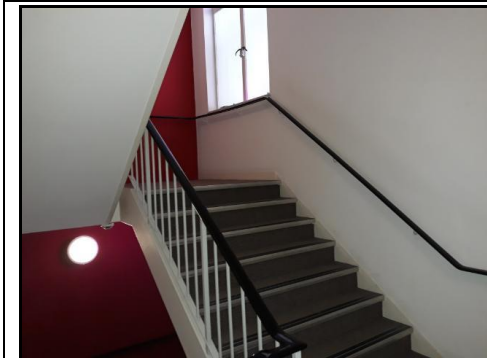
Building Name:	Block 1 Tower 11th Floor - Basement	Floor Level:	Third Floor
Location Number:	060	Location Description:	Stairwell 1
Surveyor:	Martin Quigley	Survey Date:	21/01/2020

Concrete ceiling, solid walls and a concrete floor beneath carpet tiles. Timber doors and frames, metal and concrete staircase with mesh and plaster, modern stair nosing, plastic trunking to wall, metal window frame.

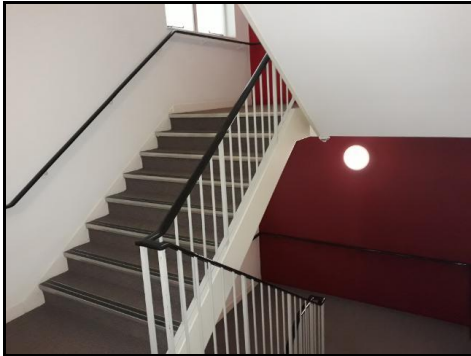
Building Name:	Block 1 Tower 11th Floor - Basement	Floor Level:	Third Floor
Location Number:	061	Location Description:	Stairwell 2
Surveyor:	Martin Quigley	Survey Date:	21/01/2020

Concrete ceiling, solid walls and a concrete floor beneath carpet tiles. Timber doors and frames, metal and concrete staircase with mesh and plaster, modern stair nosing, plastic trunking to wall, metal window frame.

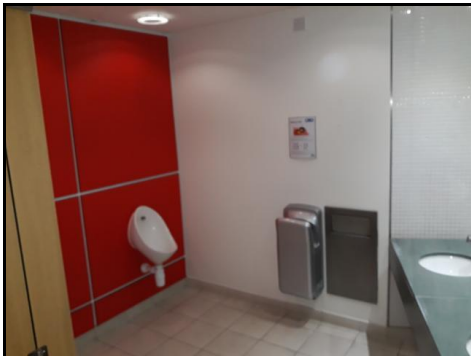
Building Name:	Block 1 Tower 11th Floor - Basement	Floor Level:	Third Floor
Location Number:	062	Location Description:	Male WC
Surveyor:	Martin Quigley	Survey Date:	21/01/2020

Concrete ceiling, modern uninsulated ducting and MMMF insulated metal pipework, solid and plasterboard walls and a concrete floor beneath ceramic tiles. Timber door and frame, plastic toilet cisterns and waste pipes to toilets and urinals, timber partitions to cubicles, 2x riser cupboards with MMMF insulated metal pipework and electrical units to wall with plastic pipework.

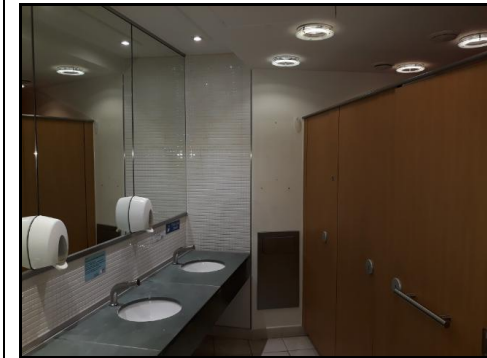
Building Name:	Block 1 Tower 11th Floor - Basement	Floor Level:	Third Floor
Location Number:	063	Location Description:	Female WC
Surveyor:	Martin Quigley	Survey Date:	21/01/2020

Concrete ceiling above plasterboard, modern uninsulated ducting and MMMF insulated metal pipework, solid and plasterboard walls and a concrete floor beneath ceramic tiles, timber door and frame, timber boxing to wall containing plastic toilet cisterns and waste pipes to toilets and urinals, timber partitions to cubicles, 2x riser cupboards with MMMF insulated metal pipework and electrical units to wall with plastic pipework.

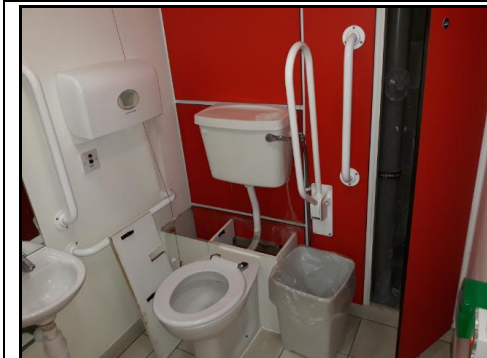
Building Name:	Block 1 Tower 11th Floor - Basement	Floor Level:	Third Floor
Location Number:	064	Location Description:	Disabled WC
Surveyor:	Martin Quigley	Survey Date:	21/01/2020

Plasterboard ceiling, solid and plasterboard walls and a concrete floor beneath ceramic tiles. Timber door and frame with timber boxing behind toilet containing a plastic waste pipe, ceramic toilet cistern, uninsulated metal and plastic pipework, timber frame and panels to rear of toilet containing plastic waste pipes.

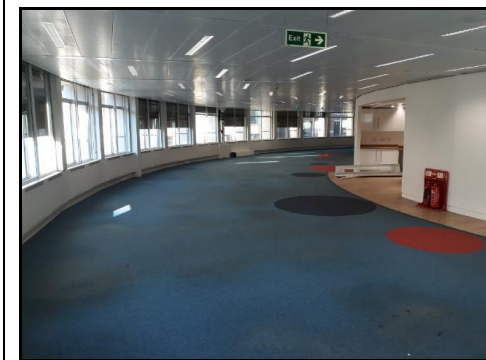
Building Name:	Block 1 Tower 11th Floor - Basement	Floor Level:	Second Floor
Location Number:	065	Location Description:	Open plan office
Surveyor:	Martin Quigley	Survey Date:	22/01/2020

Concrete ceiling above suspended metal ceiling, modern ducting with MMMF insulation and modern services, solid brick and plasterboard walls with areas containing MMMF insulation within the cavity, concrete floor beneath modern vinyl and carpet tiles. Timber doors and frames with 2x metal glazing to windows, uninsulated and MMMF insulated metal pipework within heaters to walls, modern electrical units within riser cupboards, modern sink pads to sinks, plasterboard partition walls with MMMF insulation within cavity to built in offices, glass fronts to some of the offices, modern pipework and gaskets with MMMF insulation within metal boxing to outer window divides. Section of partition room has raised metal flooring with modern electrics and ducting to cooler units, metal trunking and MMMF insulation fire breaks.

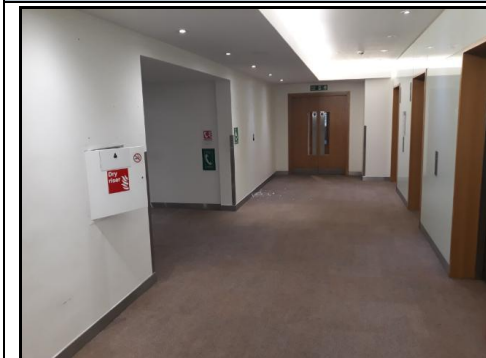
Building Name:	Block 1 Tower 11th Floor - Basement	Floor Level:	Second Floor
Location Number:	066	Location Description:	Lift lobby
Surveyor:	Martin Quigley	Survey Date:	22/01/2020

Concrete ceiling above metal suspended ceiling tiles, solid and plasterboard walls with solid walls behind the plasterboard and a timber and concrete floor to lobby. Timber doors and frames, timber and plasterboard boxing with strip lighting inset. Concrete ceiling, solid brick walls and a concrete floor to electrical riser cupboard, modern electrical units mounted onto metal frame, metal trunking. Riser cupboard with water shut off valve, uninsulated metal pipework, concrete ceiling and floor and solid brick walls. 2x cupboards with metal windows inside and solid ceilings, walls and floors.

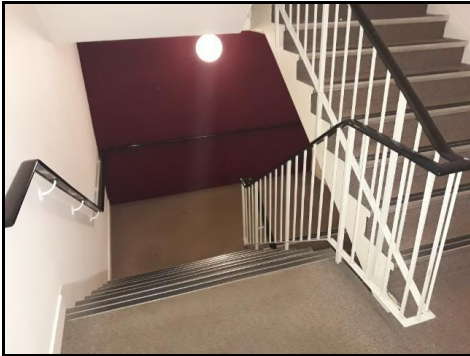
Building Name:	Block 1 Tower 11th Floor - Basement	Floor Level:	Second Floor
Location Number:	067	Location Description:	Stairwell 1
Surveyor:	Martin Quigley	Survey Date:	22/01/2020

Concrete ceiling, solid walls and a concrete floor beneath carpet tiles. Timber doors and frames, metal and concrete staircase with mesh and plaster, modern stair nosing, plastic trunking to wall, metal window frame.

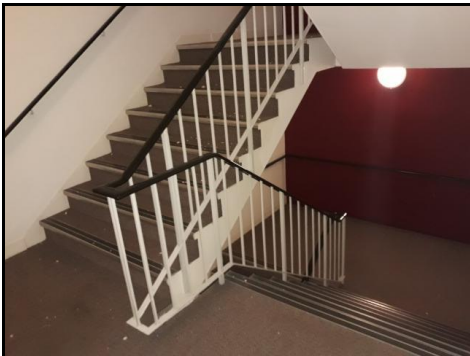
Building Name:	Block 1 Tower 11th Floor - Basement	Floor Level:	Second Floor
Location Number:	068	Location Description:	Stairwell 2
Surveyor:	Martin Quigley	Survey Date:	22/01/2020

Concrete ceiling, solid walls and a concrete floor beneath carpet tiles. Timber doors and frames, metal and concrete staircase with mesh and plaster, modern stair nosing, plastic trunking to wall, metal window frame.

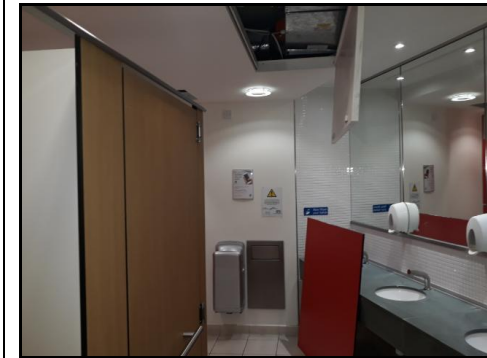
Building Name:	Block 1 Tower 11th Floor - Basement	Floor Level:	Second Floor
Location Number:	069	Location Description:	Male WC
Surveyor:	Martin Quigley	Survey Date:	22/01/2020

Concrete ceiling, modern uninsulated ducting and MMMF insulated metal pipework, solid and plasterboard walls and a concrete floor beneath ceramic tiles. Timber door and frame, plastic toilet cisterns and waste pipes to toilets and urinals, timber partitions to cubicles, 2x riser cupboards with MMMF insulated metal pipework and electrical units to wall with plastic pipework.

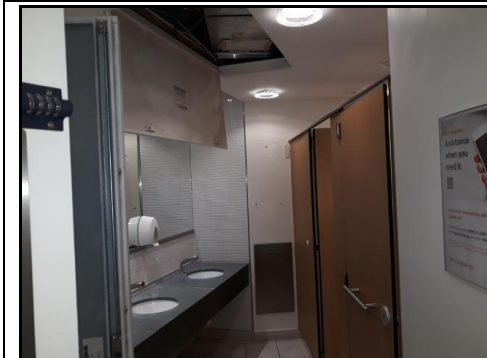
Building Name:	Block 1 Tower 11th Floor - Basement	Floor Level:	Second Floor
Location Number:	070	Location Description:	Female WC
Surveyor:	Martin Quigley	Survey Date:	22/01/2020

Concrete ceiling above plasterboard, modern uninsulated ducting and MMMF insulated metal pipework, solid and plasterboard walls and a concrete floor beneath ceramic tiles. Timber door and frame, timber boxing to wall containing plastic toilet cisterns and waste pipes to toilets and urinals, timber partitions to cubicles, 2x riser cupboards with MMMF insulated metal pipework and electrical units to wall with plastic pipework.

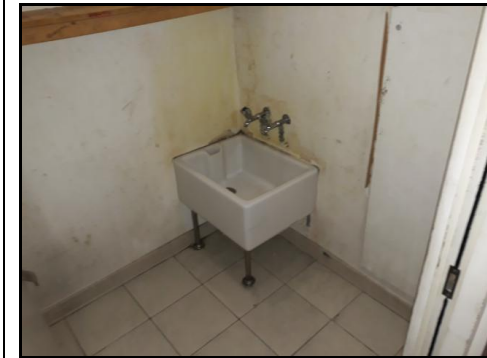
Building Name:	Block 1 Tower 11th Floor - Basement	Floor Level:	Second Floor
Location Number:	071	Location Description:	Cleaners Cupboard
Surveyor:	Martin Quigley	Survey Date:	22/01/2020

Plasterboard ceiling, solid and plasterboard walls and a concrete floor beneath ceramic tiles. Timber door and frame, ceramic sink unit with uninsulated metal pipework. Riser cupboard within room containing plastic waste pipes and uninsulated metal pipework with MMMF fire break to ceiling.

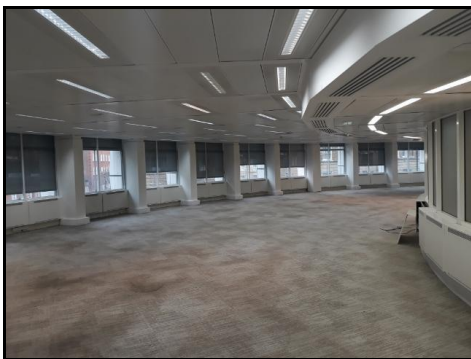
Building Name:	Block 1 Tower 11th Floor - Basement	Floor Level:	First Floor
Location Number:	072	Location Description:	Open plan office
Surveyor:	Martin Quigley	Survey Date:	22/01/2020

Concrete ceiling above suspended metal ceiling, modern ducting with MMMF insulation and modern services, solid brick and plasterboard walls with areas containing MMMF insulation within the cavity, concrete floor beneath modern vinyl and carpet tiles. Timber doors and frames with 2x metal glazing to windows, uninsulated and MMMF insulated metal pipework within heaters to walls, modern electrical units within riser cupboards, modern sink pads to sinks, plasterboard partition walls with MMMF insulation within cavity to built in offices, glass fronts to some of the offices, modern pipework and gaskets with MMMF insulation within metal boxing to outer window divides. Section of partition room has raised metal flooring with modern electrics and ducting to cooler units, metal trunking and MMMF insulation fire breaks.

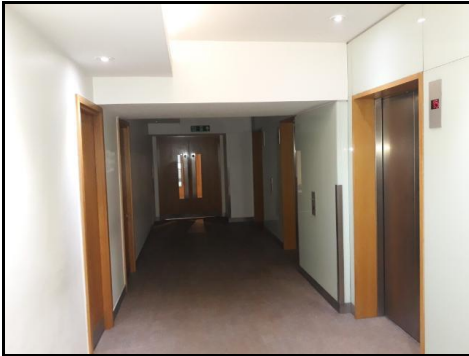
Building Name:	Block 1 Tower 11th Floor - Basement	Floor Level:	First Floor
Location Number:	073	Location Description:	Lift lobby
Surveyor:	Martin Quigley	Survey Date:	22/01/2020

Concrete ceiling above metal suspended ceiling tiles, solid and plasterboard walls with solid walls behind the plasterboard and a timber and concrete floor to lobby. Timber doors and frames, timber and plasterboard boxing with strip lighting inset. Concrete ceiling, solid brick walls and a concrete floor to electrical riser cupboard, modern electrical units mounted onto metal frame, metal trunking. Riser cupboard with water shut off valve, uninsulated metal pipework, concrete ceiling and floor and solid brick walls. 2x cupboards with metal windows inside and solid ceilings, walls and floors.

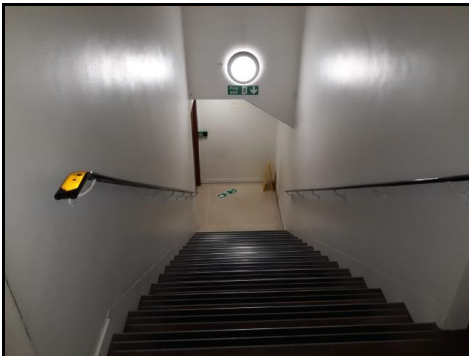
Building Name:	Block 1 Tower 11th Floor - Basement	Floor Level:	First Floor
Location Number:	074	Location Description:	Stairwell 1
Surveyor:	Martin Quigley	Survey Date:	22/01/2020

Concrete ceiling, solid walls and a concrete floor beneath carpet tiles. Timber doors and frames, metal and concrete staircase with mesh and plaster, modern stair nosing, plastic trunking to wall, metal window frame.

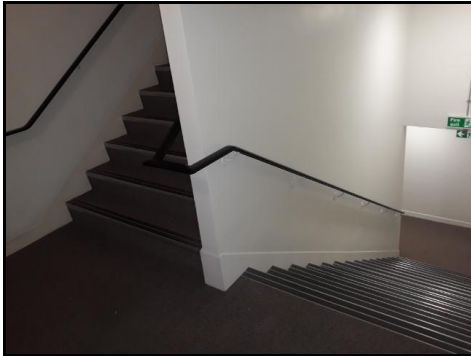
Building Name:	Block 1 Tower 11th Floor - Basement	Floor Level:	First Floor
Location Number:	075	Location Description:	Stairwell 2
Surveyor:	Martin Quigley	Survey Date:	22/01/2020

Concrete ceiling, solid walls and a concrete floor beneath carpet tiles. Timber doors and frames, metal and concrete staircase with mesh and plaster, modern stair nosing, plastic trunking to wall, metal window frame.

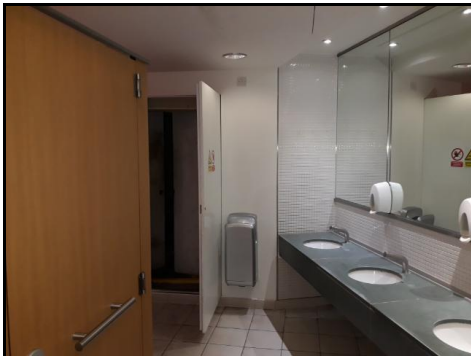
Building Name:	Block 1 Tower 11th Floor - Basement	Floor Level:	First Floor
Location Number:	076	Location Description:	Male WC
Surveyor:	Martin Quigley	Survey Date:	23/01/2020

Concrete ceiling, modern uninsulated ducting and MMMF insulated metal pipework, solid and plasterboard walls and a concrete floor beneath ceramic tiles. Timber door and frame, plastic toilet cisterns and waste pipes to toilets and urinals, timber partitions to cubicles, 2x riser cupboards with MMMF insulated metal pipework and electrical units to wall with plastic pipework.

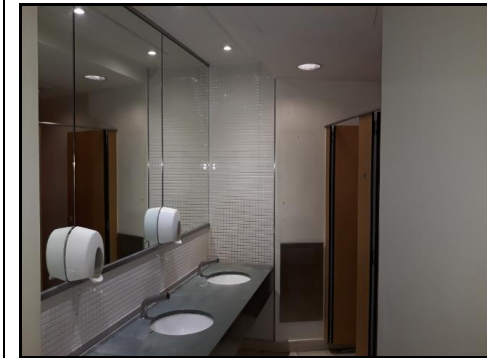
Building Name:	Block 1 Tower 11th Floor - Basement	Floor Level:	First Floor
Location Number:	077	Location Description:	Female WC
Surveyor:	Martin Quigley	Survey Date:	23/01/2020

Concrete ceiling above plasterboard, modern uninsulated ducting and MMMF insulated metal pipework, solid and plasterboard walls and a concrete floor beneath ceramic tiles. Timber door and frame, timber boxing to wall containing plastic toilet cisterns and waste pipes to toilets and urinals, timber partitions to cubicles, 2x riser cupboards with MMMF insulated metal pipework and electrical units to wall with plastic pipework.

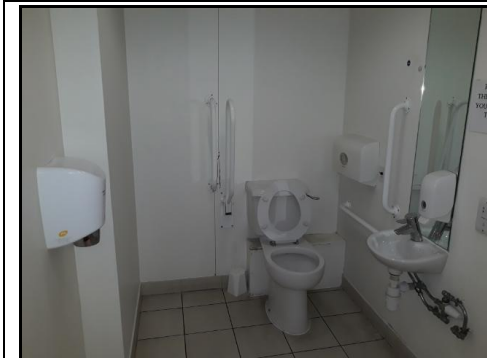
Building Name:	Block 1 Tower 11th Floor - Basement	Floor Level:	First Floor
Location Number:	078	Location Description:	Disabled WC
Surveyor:	Martin Quigley	Survey Date:	23/01/2020

Plasterboard ceiling, solid and plasterboard walls and a concrete floor beneath ceramic tiles. Timber door and frame with timber boxing behind toilet containing a plastic waste pipe, ceramic toilet cistern, uninsulated metal and plastic pipework, timber frame and panels to rear of toilet containing plastic waste pipes.

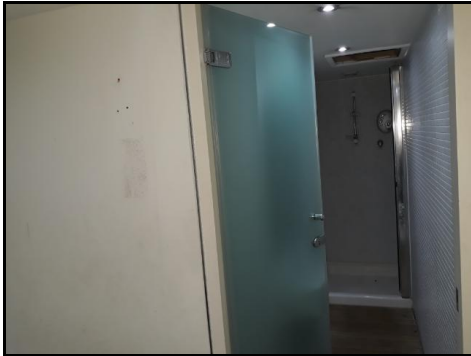
Building Name:	Block 1 Tower 11th Floor - Basement	Floor Level:	First Floor
Location Number:	079	Location Description:	Shower
Surveyor:	Martin Quigley	Survey Date:	23/01/2020

Plasterboard ceiling with concrete and modern metal ducting above, solid and plasterboard walls with ceramic tiles applied and a concrete floor beneath ceramic tiles and raised timber to shower area. Timber and glass doors, uPVC window frames with timber sill.
