Asbestos Refurbishment Survey 5th Floor to Ground Floor (Kingsway)

**Space House
1 Kemble Street
London
WC2B 4AN**

Survey Date: 14 -17 January 2020, 20-24 January 2020 and 29 January 2020

Project Reference: P-359298

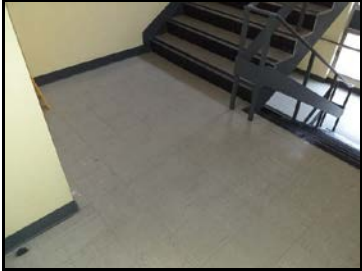
Building:	Space House (Kingsway Building)	Floor:	Fifth Floor				
Location:	001 - Kemble Street Staircase	Sample No / ID (Type):	P-359298/003 (Sampled)				
Surveyor:	Danny Webber	Survey date:	19/12/2019				
Sample Details

Item description:	Floor tiles (grey & black) & bitumen adhesive					
	Material description:	Thermoplastic product					
	Quantity / Extent:	12 m ²					
	Accessibility	Easy Access					
	Analysis:	Chrysotile					
	Material identification:	Asbestos thermoplastic/adhesive					
Material Assessment Scoring:							
Product Type:	1	Condition:	1	Surface Treatment:	0	Asbestos Type:	1
Priority Assessment Scoring:							
Occupant Activity:	0	Disturbance:	2	Human Exposure:	0	Maintenance Activity:	0
Total Scores:							
Material Score:	3	Priority Score	2	Total Score:	3	Risk Rating:	Very Low
Recommended action:	Remove if likely to be disturbed by the refurbishment, otherwise monitor condition.

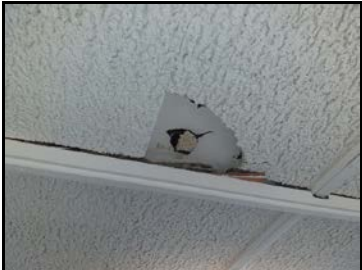
Building:	Space House (Kingsway Building)	Floor:	Fifth Floor				
Location:	003 - Offices Area (Open Plan & Partitioned)	Sample No / ID (Type):	P-359298/012 (Sampled)				
Surveyor:	Danny Webber	Survey date:	19/12/2019				
Sample Details

Item description:	Packing above ceiling timber beams					
	Material description:	Thermoplastic product					
	Quantity / Extent:	650 m linear					
	Accessibility	Difficult Access					
	Analysis:	Chrysotile					
	Material identification:	Asbestos thermoplastic/adhesive					
Material Assessment Scoring:							
Product Type:	1	Condition:	1	Surface Treatment:	0	Asbestos Type:	1
Priority Assessment Scoring:							
Occupant Activity:	0	Disturbance:	2	Human Exposure:	0	Maintenance Activity:	0
Total Scores:							
Material Score:	3	Priority Score	2	Total Score:	3	Risk Rating:	Very Low
Recommended action:	Remove if likely to be disturbed by the refurbishment, otherwise monitor condition.

Recommendation comments:	-						
Comments:	Material located above original MMMF ceiling tiles sporadically throughout area. It should be presumed to be present throughout above all timber beams.

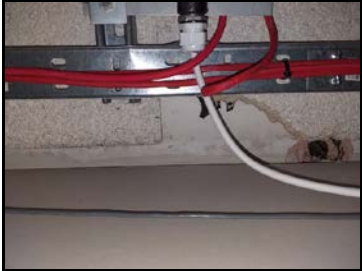
Building:	Space House (Kingsway Building)	Floor:	Fifth Floor				
Location:	003 - Offices Area (Open Plan & Partitioned)	Sample No / ID (Type):	P-359298/035 (Sampled)				
Surveyor:	Danny Webber	Survey date:	19/12/2019				
Sample Details

Item description:	Residue on ceiling above original MMMF ceiling tiles					
	Material description:	Insulation					
	Quantity / Extent:	650 m linear					
	Accessibility	Difficult Access					
	Analysis:	Amosite					
	Material identification:	Asbestos insulation					
Material Assessment Scoring:							
Product Type:	3	Condition:	3	Surface Treatment:	3	Asbestos Type:	2
Priority Assessment Scoring:							
Occupant Activity:	0	Disturbance:	2	Human Exposure:	0	Maintenance Activity:	0
Total Scores:							
Material Score:	11	Priority Score	2	Total Score:	11	Risk Rating:	High
Recommended action:	Remove if likely to be disturbed by the refurbishment, otherwise encapsulate and then monitor condition

Recommendation comments:	-						
Comments:	Material located above original MMMF ceiling tiles sporadically throughout area. It should be presumed to be present throughout above all timber beams.

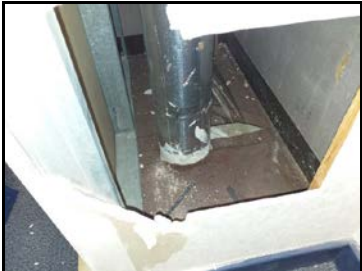
Building:	Space House (Kingsway Building)	Floor:	Fifth Floor				
Location:	003 - Offices Area (Open Plan & Partitioned)	Sample No / ID (Type):	P-359298/As 003 (Cross Referenced)				
Surveyor:	Danny Webber	Survey date:	19/12/2019				
Sample Details

Item description:	Floor tiles (grey) & bitumen adhesive within plasterboard boxing outside risers at kemble Street staircase end of building					
	Material description:	Thermoplastic product					
	Quantity / Extent:	1 m ²					
	Accessibility	Medium Access					
	Analysis:	Chrysotile					
	Material identification:	Asbestos thermoplastic/adhesive					
Material Assessment Scoring:							
Product Type:	1	Condition:	1	Surface Treatment:	0	Asbestos Type:	1
Priority Assessment Scoring:							
Occupant Activity:	0	Disturbance:	1	Human Exposure:	0	Maintenance Activity:	0
Total Scores:							
Material Score:	3	Priority Score	1	Total Score:	3	Risk Rating:	Very Low

Recommended action:	Remove if likely to be disturbed by the refurbishment, otherwise monitor condition.						
Recommendation comments:	-						
Comments:	Includes small pieces present beneath perimeter electrical trunking & skirting boards.

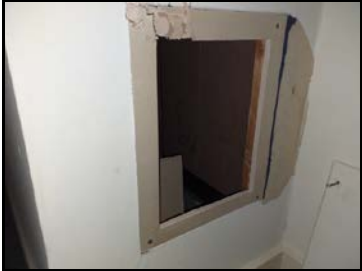
Building:	Space House (Kingsway Building)	Floor:	Third Floor				
Location:	020 - Offices Area (Open Plan & Partitioned)	Sample No / ID (Type):	P-359298/042 (Sampled)				
Surveyor:	Danny Webber	Survey date:	19/12/2019				
Sample Details

Item description:	Wall lining beneath plasterboard lining (risers)					
	Material description:	Cement product					
	Quantity / Extent:	10 m ²					
	Accessibility	Difficult Access					
	Analysis:	Chrysotile					
	Material identification:	Asbestos cement					
Material Assessment Scoring:							
Product Type:	1	Condition:	1	Surface Treatment:	1	Asbestos Type:	1
Priority Assessment Scoring:							
Occupant Activity:	0	Disturbance:	1	Human Exposure:	0	Maintenance Activity:	0
Total Scores:							
Material Score:	4	Priority Score	1	Total Score:	4	Risk Rating:	Very Low
Recommended action:	Remove if likely to be disturbed by the refurbishment, otherwise encapsulate and then monitor condition

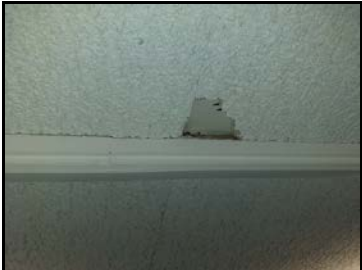
Building:	Space House (Kingsway Building)	Floor:	Third Floor				
Location:	020 - Offices Area (Open Plan & Partitioned)	Sample No / ID (Type):	P-359298/043 (Sampled)				
Surveyor:	Danny Webber	Survey date:	19/12/2019				
Sample Details

Item description:	Packing above ceiling timber beams					
	Material description:	Insulating board					
	Quantity / Extent:	650 m linear					
	Accessibility	Difficult Access					
	Analysis:	Chrysotile					
	Material identification:	Asbestos insulating board					
Material Assessment Scoring:							
Product Type:	2	Condition:	1	Surface Treatment:	1	Asbestos Type:	1
Priority Assessment Scoring:							
Occupant Activity:	0	Disturbance:	2	Human Exposure:	0	Maintenance Activity:	0
Total Scores:							
Material Score:	5	Priority Score	2	Total Score:	5	Risk Rating:	Low
Recommended action:	Remove if likely to be disturbed by the refurbishment, otherwise encapsulate and then monitor condition

Recommendation comments:	-						
Comments:	Material located above original MMMF ceiling tiles sporadically throughout area. It should be presumed to be present throughout above all timber beams.

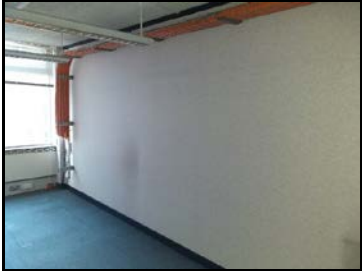
Building:	Space House (Kingsway Building)	Floor:	Third Floor				
Location:	020 - Offices Area (Open Plan & Partitioned)	Sample No / ID (Type):	P-359298/046 (Sampled)				
Surveyor:	Danny Webber	Survey date:	19/12/2019				
Sample Details

Item description:	Wall lining beneath plasterboard lining (kitchen)					
	Material description:	Insulating board					
	Quantity / Extent:	18 m ²					
	Accessibility	Difficult Access					
	Analysis:	Chrysotile					
	Material identification:	Asbestos insulating board					
Material Assessment Scoring:							
Product Type:	2	Condition:	1	Surface Treatment:	1	Asbestos Type:	1
Priority Assessment Scoring:							
Occupant Activity:	0	Disturbance:	1	Human Exposure:	0	Maintenance Activity:	0
Total Scores:							
Material Score:	5	Priority Score	1	Total Score:	5	Risk Rating:	Low
Recommended action:	Remove if likely to be disturbed by the refurbishment, otherwise monitor condition.

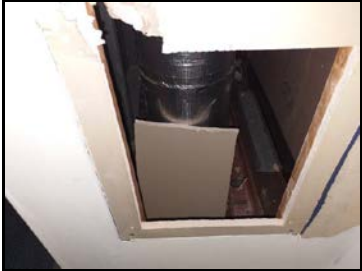
Building:	Space House (Kingsway Building)	Floor:	Third Floor				
Location:	020 - Offices Area (Open Plan & Partitioned)	Sample No / ID (Type):	P-359298/As 037 (Cross Referenced)				
Surveyor:	Danny Webber	Survey date:	19/12/2019				
Sample Details

Item description:	Floor tiles (grey) & bitumen adhesive					
	Material description:	Thermoplastic product					
	Quantity / Extent:	1 m ²					
	Accessibility	Medium Access					
	Analysis:	Chrysotile					
	Material identification:	Asbestos thermoplastic/adhesive					
Material Assessment Scoring:							
Product Type:	1	Condition:	1	Surface Treatment:	0	Asbestos Type:	1
Priority Assessment Scoring:							
Occupant Activity:	0	Disturbance:	1	Human Exposure:	0	Maintenance Activity:	0
Total Scores:							
Material Score:	3	Priority Score	1	Total Score:	3	Risk Rating:	Very Low
Recommended action:	Remove if likely to be disturbed by the refurbishment, otherwise monitor condition.

Recommendation comments:	-						
Comments:	Material located within plasterboard boxing outside risers at Kemble Street Staircase end of building. Also includes small pieces present beneath perimeter electrical trunking & skirting boards.

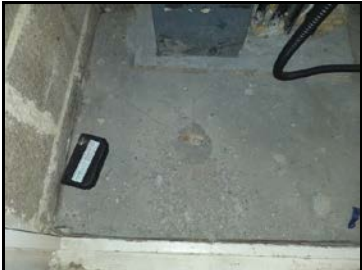
Building:	Space House (Kingsway Building)	Floor:	Third Floor				
Location:	021 - Kitchen	Sample No / ID (Type):	P-359298/048 (Sampled)				
Surveyor:	Danny Webber	Survey date:	19/12/2019				
Sample Details

Item description:	Panel beneath floor screed within risers (x3)					
	Material description:	Insulating board					
	Quantity / Extent:	3 Number					
	Accessibility	Difficult Access					
	Analysis:	Chrysotile					
	Material identification:	Asbestos insulating board					
Material Assessment Scoring:							
Product Type:	2	Condition:	1	Surface Treatment:	1	Asbestos Type:	1
Priority Assessment Scoring:							
Occupant Activity:	0	Disturbance:	1	Human Exposure:	0	Maintenance Activity:	0
Total Scores:							
Material Score:	5	Priority Score	1	Total Score:	5	Risk Rating:	Low
Recommended action:	Remove if likely to be disturbed by the refurbishment, otherwise monitor condition.						
Recommendation comments:	-

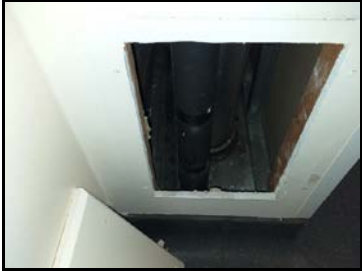
Building:	Space House (Kingsway Building)	Floor:	Third Floor				
Location:	021 - Kitchen	Sample No / ID (Type):	P-359298/As 037 (Cross Referenced)				
Surveyor:	Danny Webber	Survey date:	19/12/2019				
Sample Details

Item description:	Floor tiles (grey) & bitumen adhesive within plasterboard boxing					
	Material description:	Thermoplastic product					
	Quantity / Extent:	1 m ²					
	Accessibility	Medium Access					
	Analysis:	Chrysotile					
	Material identification:	Asbestos thermoplastic/adhesive					
Material Assessment Scoring:							
Product Type:	1	Condition:	1	Surface Treatment:	0	Asbestos Type:	1
Priority Assessment Scoring:							
Occupant Activity:	0	Disturbance:	1	Human Exposure:	0	Maintenance Activity:	0
Total Scores:							
Material Score:	3	Priority Score	1	Total Score:	3	Risk Rating:	Very Low
Recommended action:	Remove if likely to be disturbed by the refurbishment, otherwise monitor condition.

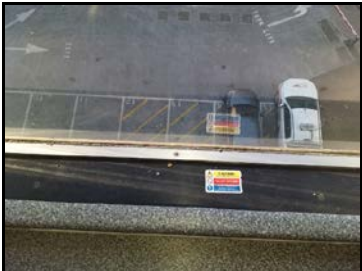
Building:	Space House (Kingsway Building)	Floor:	Third Floor				
Location:	021 - Kitchen	Sample No / ID (Type):	P-359298/As 041 (Cross Referenced)				
Surveyor:	Danny Webber	Survey date:	19/12/2019				
Sample Details

Item description:	Window sill					
	Material description:	Cement product					
	Quantity / Extent:	2 m linear					
	Accessibility	Easy Access					
	Analysis:	Chrysotile					
	Material identification:	Asbestos cement					
Material Assessment Scoring:							
Product Type:	1	Condition:	1	Surface Treatment:	1	Asbestos Type:	1
Priority Assessment Scoring:							
Occupant Activity:	0	Disturbance:	2	Human Exposure:	0	Maintenance Activity:	0
Total Scores:							
Material Score:	4	Priority Score	2	Total Score:	4	Risk Rating:	Very Low
Recommended action:	Remove if likely to be disturbed by the refurbishment, otherwise monitor condition.						
Recommendation comments:	It is strongly presumed after discussions on site that asbestos packing material and/or AIB panels beneath the window may also be present.

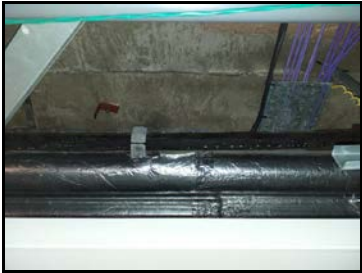
Building:	Space House (Kingsway Building)	Floor:	Second Floor				
Location:	028 - Offices Area (Partitioned)	Sample No / ID (Type):	P-359298/P001 (Presumed)				
Surveyor:	Danny Webber	Survey date:	07/01/2020				
Sample Details

Item description:	Electrical intake cable above suspended ceiling					
	Material description:	Woven product					
	Quantity / Extent:	50 m linear					
	Accessibility	Medium Access					
	Analysis:	Presumed to contain asbestos					
	Material identification:	Asbestos woven material					
Material Assessment Scoring:							
Product Type:	2	Condition:	1	Surface Treatment:	2	Asbestos Type:	3
Priority Assessment Scoring:							
Occupant Activity:	0	Disturbance:	2	Human Exposure:	0	Maintenance Activity:	0
Total Scores:							
Material Score:	8	Priority Score	2	Total Score:	8	Risk Rating:	Medium
Recommended action:	Remove if likely to be disturbed by the refurbishment, otherwise monitor condition.

Recommendation comments:	-						
Comments:	Material also present within center riser in kitchen from top to bottom of building.

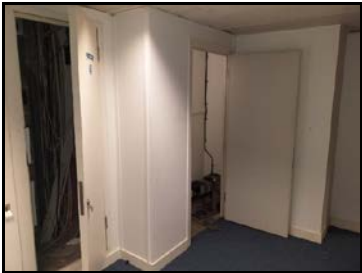
Building:	Space House (Kingsway Building)	Floor:	Second Floor				
Location:	029 - Former Kitchen	Sample No / ID (Type):	P-359298/055 (Sampled)				
Surveyor:	Danny Webber	Survey date:	19/12/2019				
Sample Details

Item description:	Wall forming cupboard					
	Material description:	Insulating board					
	Quantity / Extent:	4 m ²					
	Accessibility	Easy Access					
	Analysis:	Chrysotile					
	Material identification:	Asbestos insulating board					
Material Assessment Scoring:							
Product Type:	2	Condition:	1	Surface Treatment:	1	Asbestos Type:	1
Priority Assessment Scoring:							
Occupant Activity:	0	Disturbance:	1	Human Exposure:	0	Maintenance Activity:	0
Total Scores:							
Material Score:	5	Priority Score	1	Total Score:	5	Risk Rating:	Low
Recommended action:	Remove if likely to be disturbed by the refurbishment, otherwise monitor condition.						
Recommendation comments:	-						
Comments:	-

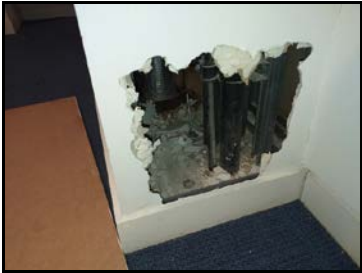
Building:	Space House (Kingsway Building)	Floor:	Second Floor				
Location:	029 - Former Kitchen	Sample No / ID (Type):	P-359298/056 (Sampled)				
Surveyor:	Danny Webber	Survey date:	19/12/2019				
Sample Details

Item description:	Floor tiles (grey) & bitumen adhesive					
	Material description:	Thermoplastic product					
	Quantity / Extent:	1 m ²					
	Accessibility	Difficult Access					
	Analysis:	Chrysotile					
	Material identification:	Asbestos thermoplastic/adhesive					
Material Assessment Scoring:							
Product Type:	1	Condition:	1	Surface Treatment:	0	Asbestos Type:	1
Priority Assessment Scoring:							
Occupant Activity:	0	Disturbance:	1	Human Exposure:	0	Maintenance Activity:	0
Total Scores:							
Material Score:	3	Priority Score	1	Total Score:	3	Risk Rating:	Very Low
Recommended action:	Remove if likely to be disturbed by the refurbishment, otherwise monitor condition.						
Recommendation comments:	-

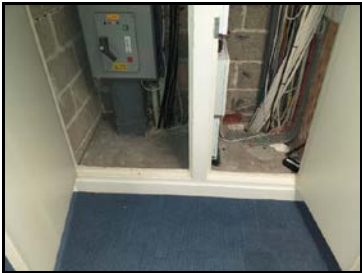
Building:	Space House (Kingsway Building)	Floor:	Second Floor				
Location:	029 - Former Kitchen	Sample No / ID (Type):	P-359298/057 (Sampled)				
Surveyor:	Danny Webber	Survey date:	19/12/2019				
Sample Details

Item description:	Panel beneath floor screed within risers (x3)					
	Material description:	Insulating board					
	Quantity / Extent:	3 Number					
	Accessibility	Difficult Access					
	Analysis:	Chrysotile					
	Material identification:	Asbestos insulating board					
Material Assessment Scoring:							
Product Type:	2	Condition:	1	Surface Treatment:	1	Asbestos Type:	1
Priority Assessment Scoring:							
Occupant Activity:	0	Disturbance:	1	Human Exposure:	0	Maintenance Activity:	0
Total Scores:							
Material Score:	5	Priority Score	1	Total Score:	5	Risk Rating:	Low
Recommended action:	Remove if likely to be disturbed by the refurbishment, otherwise monitor condition.						
Recommendation comments:	-

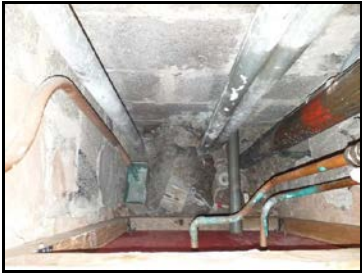
Building:	Space House (Kingsway Building)	Floor:	Second Floor				
Location:	030 - Female WC	Sample No / ID (Type):	P-359298/058 (Sampled)				
Surveyor:	Danny Webber	Survey date:	19/12/2019				
Sample Details

Item description:	Debris within hand dryer & cistern voids					
	Material description:	Cement product					
	Quantity / Extent:	<1 m ²					
	Accessibility	Medium Access					
	Analysis:	Chrysotile Amosite					
	Material identification:	Asbestos cement					
Material Assessment Scoring:							
Product Type:	1	Condition:	3	Surface Treatment:	1	Asbestos Type:	2
Priority Assessment Scoring:							
Occupant Activity:	0	Disturbance:	1	Human Exposure:	0	Maintenance Activity:	0
Total Scores:							
Material Score:	7	Priority Score	1	Total Score:	7	Risk Rating:	Medium
Recommended action:	Remove.						
Recommendation comments:	-						
Comments:	-

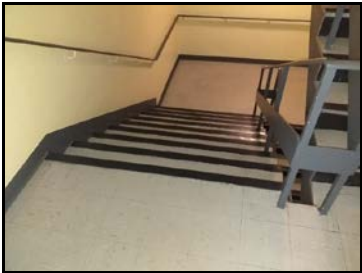
Building:	Space House (Kingsway Building)	Floor:	Second Floor				
Location:	034 - Keeley Street Staircase	Sample No / ID (Type):	P-359298/059 (Sampled)				
Surveyor:	Danny Webber	Survey date:	19/12/2019				
Sample Details

Item description:	Stair nosings					
	Material description:	Thermoplastic product					
	Quantity / Extent:	18 Number					
	Accessibility	Easy Access					
	Analysis:	Chrysotile					
	Material identification:	Asbestos thermoplastic material					
Material Assessment Scoring:							
Product Type:	1	Condition:	1	Surface Treatment:	0	Asbestos Type:	1
Priority Assessment Scoring:							
Occupant Activity:	0	Disturbance:	2	Human Exposure:	0	Maintenance Activity:	0
Total Scores:							
Material Score:	3	Priority Score	2	Total Score:	3	Risk Rating:	Very Low
Recommended action:	Remove if likely to be disturbed by the refurbishment, otherwise monitor condition.						
Recommendation comments:	-

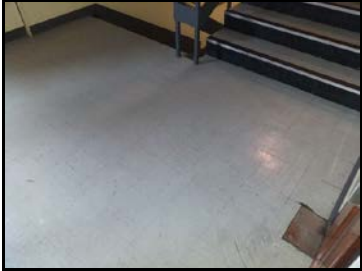
Building:	Space House (Kingsway Building)	Floor:	Second Floor				
Location:	034 - Keeley Street Staircase	Sample No / ID (Type):	P-359298/060 (Sampled)				
Surveyor:	Danny Webber	Survey date:	19/12/2019				
Sample Details

Item description:	Floor tiles (grey & black) & bitumen adhesive					
	Material description:	Thermoplastic product					
	Quantity / Extent:	12 m ²					
	Accessibility	Easy Access					
	Analysis:	Chrysotile					
	Material identification:	Asbestos thermoplastic/adhesive					
Material Assessment Scoring:							
Product Type:	1	Condition:	1	Surface Treatment:	0	Asbestos Type:	1
Priority Assessment Scoring:							
Occupant Activity:	0	Disturbance:	2	Human Exposure:	0	Maintenance Activity:	0
Total Scores:							
Material Score:	3	Priority Score	2	Total Score:	3	Risk Rating:	Very Low
Recommended action:	Remove if likely to be disturbed by the refurbishment, otherwise monitor condition.

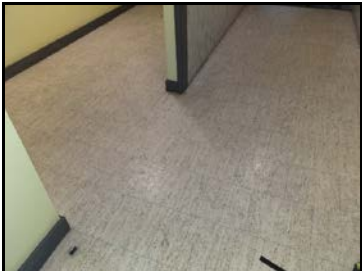
Building:	Space House (Kingsway Building)	Floor:	First Floor				
Location:	035 - Kemble Street Staircase	Sample No / ID (Type):	P-359298/061 (Sampled)				
Surveyor:	Danny Webber	Survey date:	19/12/2019				
Sample Details

Item description:	Floor tiles (grey) & bitumen adhesive					
	Material description:	Vinyl product					
	Quantity / Extent:	12 m ²					
	Accessibility	Easy Access					
	Analysis:	Chrysotile					
	Material identification:	Non-asbestos vinyl/asbestos adhesive					
Material Assessment Scoring:							
Product Type:	1	Condition:	1	Surface Treatment:	0	Asbestos Type:	1
Priority Assessment Scoring:							
Occupant Activity:	0	Disturbance:	2	Human Exposure:	0	Maintenance Activity:	0
Total Scores:							
Material Score:	3	Priority Score	2	Total Score:	3	Risk Rating:	Very Low
Recommended action:	Remove if likely to be disturbed by the refurbishment, otherwise monitor condition.						
Recommendation comments:	-

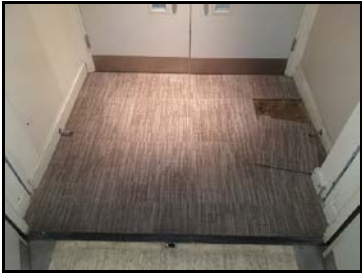
Building:	Space House (Kingsway Building)	Floor:	First Floor				
Location:	036 - Kemble Street Lobby & Riser	Sample No / ID (Type):	P-359298/062 (Sampled)				
Surveyor:	Danny Webber	Survey date:	19/12/2019				
Sample Details

Item description:	Adhesive residue beneath carpet tiles					
	Material description:	Bituminous products					
	Quantity / Extent:	890 m ²					
	Accessibility	Medium Access					
	Analysis:	Chrysotile					
	Material identification:	Asbestos bitumen					
Material Assessment Scoring:							
Product Type:	1	Condition:	1	Surface Treatment:	0	Asbestos Type:	1
Priority Assessment Scoring:							
Occupant Activity:	0	Disturbance:	2	Human Exposure:	0	Maintenance Activity:	0
Total Scores:							
Material Score:	3	Priority Score	2	Total Score:	3	Risk Rating:	Very Low
Recommended action:	Remove if likely to be disturbed by the refurbishment, otherwise monitor condition.						
Recommendation comments:	-

Comments:	Material located throughout floor beneath all flooring & floor screed.

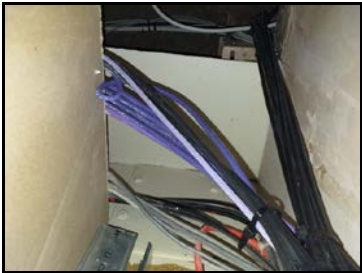
Building:	Space House (Kingsway Building)	Floor:	First Floor				
Location:	036 - Kemble Street Lobby & Riser	Sample No / ID (Type):	P-359298/063 (Sampled)				
Surveyor:	Danny Webber	Survey date:	19/12/2019				
Sample Details

Item description:	Board above false plasterboard ceiling					
	Material description:	Insulating board					
	Quantity / Extent:	1 m ²					
	Accessibility	Difficult Access					
	Analysis:	Amosite Chrysotile					
	Material identification:	Asbestos insulating board					
Material Assessment Scoring:							
Product Type:	2	Condition:	1	Surface Treatment:	1	Asbestos Type:	2
Priority Assessment Scoring:							
Occupant Activity:	0	Disturbance:	1	Human Exposure:	0	Maintenance Activity:	0
Total Scores:							
Material Score:	6	Priority Score	1	Total Score:	6	Risk Rating:	Low
Recommended action:	Remove if likely to be disturbed by the refurbishment, otherwise monitor condition.

Recommendation comments:	-						
Comments:	Material located above metal roller shutter.

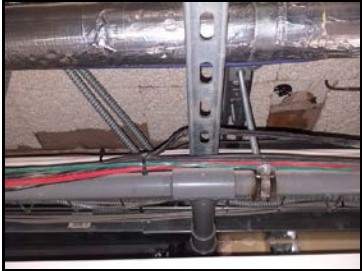
Building:	Space House (Kingsway Building)	Floor:	First Floor				
Location:	037 - Offices Area (Open Plan & Partitioned)	Sample No / ID (Type):	P-359298/064 (Sampled)				
Surveyor:	Danny Webber	Survey date:	19/12/2019				
Sample Details

Item description:	Packing above suspended ceiling					
	Material description:	Insulating board					
	Quantity / Extent:	650 m linear					
	Accessibility	Medium Access					
	Analysis:	Chrysotile					
	Material identification:	Asbestos insulating board					
Material Assessment Scoring:							
Product Type:	2	Condition:	2	Surface Treatment:	1	Asbestos Type:	1
Priority Assessment Scoring:							
Occupant Activity:	0	Disturbance:	2	Human Exposure:	0	Maintenance Activity:	0
Total Scores:							
Material Score:	6	Priority Score	2	Total Score:	6	Risk Rating:	Low
Recommended action:	Remove if likely to be disturbed by the refurbishment, otherwise encapsulate and then monitor condition

Recommendation comments:	-						
Comments:	Material located above original MMMF ceiling tiles sporadically throughout area. It should be presumed to be present throughout above suspended ceiling.

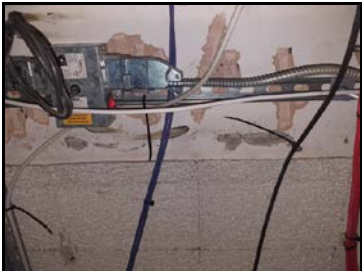
Building:	Space House (Kingsway Building)	Floor:	First Floor				
Location:	037 - Offices Area (Open Plan & Partitioned)	Sample No / ID (Type):	P-359298/065 (Sampled)				
Surveyor:	Danny Webber	Survey date:	19/12/2019				
Sample Details

Item description:	Residue on ceiling					
	Material description:	Insulation					
	Quantity / Extent:	650 m linear					
	Accessibility	Medium Access					
	Analysis:	Amosite					
	Material identification:	Asbestos insulation					
Material Assessment Scoring:							
Product Type:	3	Condition:	3	Surface Treatment:	3	Asbestos Type:	2
Priority Assessment Scoring:							
Occupant Activity:	0	Disturbance:	2	Human Exposure:	0	Maintenance Activity:	0
Total Scores:							
Material Score:	11	Priority Score	2	Total Score:	11	Risk Rating:	High
Recommended action:	Remedial - Restrict access and plan abatement works.						
Recommendation comments:	-						
Comments:	Material located above original MMMF ceiling tiles sporadically throughout area. It should be presumed to be present throughout above suspended ceiling.

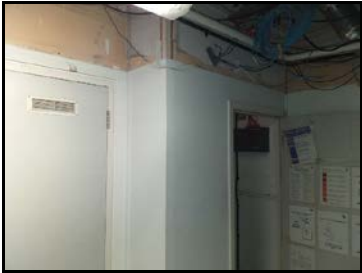
Building:	Space House (Kingsway Building)	Floor:	First Floor				
Location:	038 - Plant Room	Sample No / ID (Type):	P-359298/066 (Sampled)				
Surveyor:	Danny Webber	Survey date:	19/12/2019				
Sample Details

Item description:	Wall forming cupboard					
	Material description:	Insulating board					
	Quantity / Extent:	4 m ²					
	Accessibility	Easy Access					
	Analysis:	Chrysotile					
	Material identification:	Asbestos insulating board					
Material Assessment Scoring:							
Product Type:	2	Condition:	1	Surface Treatment:	1	Asbestos Type:	1
Priority Assessment Scoring:							
Occupant Activity:	0	Disturbance:	1	Human Exposure:	0	Maintenance Activity:	0
Total Scores:							
Material Score:	5	Priority Score	1	Total Score:	5	Risk Rating:	Low
Recommended action:	Remove if likely to be disturbed by the refurbishment, otherwise monitor condition.						
Recommendation comments:	-						
Comments:	-

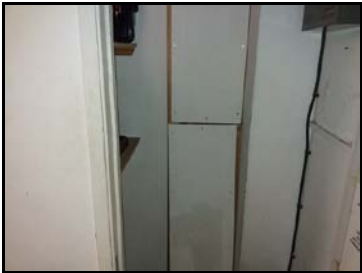
Building:	Space House (Kingsway Building)	Floor:	First Floor				
Location:	038 - Plant Room	Sample No / ID (Type):	P-359298/067 (Sampled)				
Surveyor:	Danny Webber	Survey date:	19/12/2019				
Sample Details

Item description:	Riser panels within cupboard					
	Material description:	Insulating board					
	Quantity / Extent:	1 m ²					
	Accessibility	Easy Access					
	Analysis:	No asbestos detected					
	Material identification:	Non-asbestos material					
Material Assessment Scoring:							
Product Type:	-	Condition:	-	Surface Treatment:	-	Asbestos Type:	-
Priority Assessment Scoring:							
Occupant Activity:	-	Disturbance:	-	Human Exposure:	-	Maintenance Activity:	-
Total Scores:							
Material Score:	-	Priority Score	-	Total Score:	0	Risk Rating:	N/A
Recommended action:	-						
Recommendation comments:	-						
Comments:	-

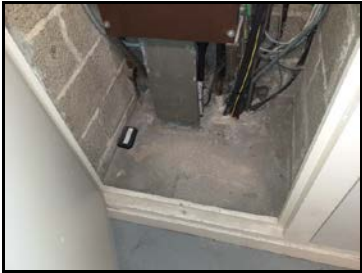
Building:	Space House (Kingsway Building)	Floor:	First Floor				
Location:	038 - Plant Room	Sample No / ID (Type):	P-359298/068 (Sampled)				
Surveyor:	Danny Webber	Survey date:	19/12/2019				
Sample Details

Item description:	Panel beneath floor screed within risers (x3)					
	Material description:	Insulating board					
	Quantity / Extent:	3 Number					
	Accessibility	Difficult Access					
	Analysis:	Chrysotile					
	Material identification:	Asbestos insulating board					
Material Assessment Scoring:							
Product Type:	2	Condition:	1	Surface Treatment:	1	Asbestos Type:	1
Priority Assessment Scoring:							
Occupant Activity:	0	Disturbance:	1	Human Exposure:	0	Maintenance Activity:	0
Total Scores:							
Material Score:	5	Priority Score	1	Total Score:	5	Risk Rating:	Low
Recommended action:	Remove if likely to be disturbed by the refurbishment, otherwise monitor condition.						
Recommendation comments:	-

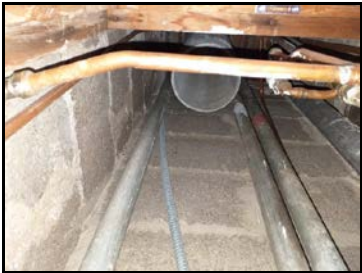
Building:	Space House (Kingsway Building)	Floor:	First Floor				
Location:	039 - Female WC	Sample No / ID (Type):	P-359298/069 (Sampled)				
Surveyor:	Danny Webber	Survey date:	19/12/2019				
Sample Details

Item description:	Flue pipe within hand dryer voids					
	Material description:	Cement product					
	Quantity / Extent:	<1 m linear					
	Accessibility	Medium Access					
	Analysis:	Amosite Chrysotile					
	Material identification:	Asbestos cement					
Material Assessment Scoring:							
Product Type:	1	Condition:	1	Surface Treatment:	1	Asbestos Type:	2
Priority Assessment Scoring:							
Occupant Activity:	0	Disturbance:	1	Human Exposure:	0	Maintenance Activity:	0
Total Scores:							
Material Score:	5	Priority Score	1	Total Score:	5	Risk Rating:	Low
Recommended action:	Remove if likely to be disturbed by the refurbishment, otherwise encapsulate and then monitor condition						
Recommendation comments:	-

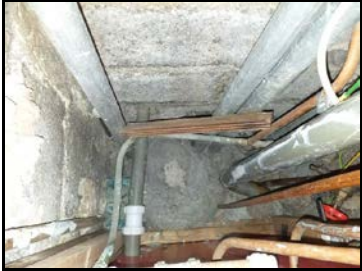
Building:	Space House (Kingsway Building)	Floor:	First Floor				
Location:	039 - Female WC	Sample No / ID (Type):	P-359298/070 (Sampled)				
Surveyor:	Danny Webber	Survey date:	19/12/2019				
Sample Details

Item description:	Debris within hand dryer voids					
	Material description:	Cement product					
	Quantity / Extent:	<1 m ²					
	Accessibility	Medium Access					
	Analysis:	Chrysotile Amosite					
	Material identification:	Asbestos cement					
Material Assessment Scoring:							
Product Type:	1	Condition:	3	Surface Treatment:	1	Asbestos Type:	2
Priority Assessment Scoring:							
Occupant Activity:	0	Disturbance:	1	Human Exposure:	0	Maintenance Activity:	0
Total Scores:							
Material Score:	7	Priority Score	1	Total Score:	7	Risk Rating:	Medium
Recommended action:	Remove.						
Recommendation comments:	-						
Comments:	-

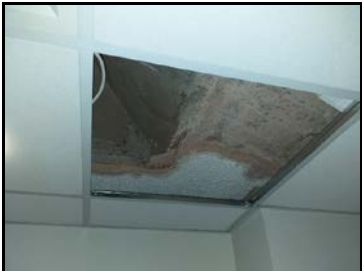
Building:	Space House (Kingsway Building)	Floor:	Ground Floor				
Location:	044 - Changing Rooms / Voids	Sample No / ID (Type):	P-359298/071 (Sampled)				
Surveyor:	Danny Webber	Survey date:	30/01/2020				
Sample Details

Item description:	Applied to concrete ceiling above MMMF ceiling tiles					
	Material description:	Textured coatings					
	Quantity / Extent:	20 m ²					
	Accessibility	Medium Access					
	Analysis:	No asbestos detected					
	Material identification:	Non-asbestos material					
Material Assessment Scoring:							
Product Type:	-	Condition:	-	Surface Treatment:	-	Asbestos Type:	-
Priority Assessment Scoring:							
Occupant Activity:	-	Disturbance:	-	Human Exposure:	-	Maintenance Activity:	-
Total Scores:							
Material Score:	-	Priority Score	-	Total Score:	0	Risk Rating:	N/A
Recommended action:	-						
Recommendation comments:	-						
Comments:	-

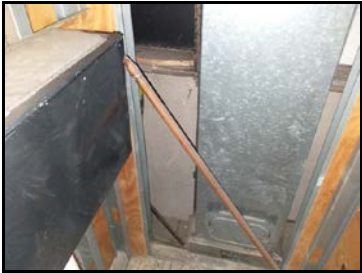
Building:	Space House (Kingsway Building)	Floor:	Ground Floor				
Location:	044 - Changing Rooms / Voids	Sample No / ID (Type):	P-359298/072 (Sampled)				
Surveyor:	Danny Webber	Survey date:	30/01/2020				
Sample Details

Item description:	Lining walls behind plasterboard					
	Material description:	Insulating board					
	Quantity / Extent:	150m ²					
	Accessibility	Medium Access					
	Analysis:	Amosite Chrysotile					
	Material identification:	Asbestos insulating board					
Material Assessment Scoring:							
Product Type:	2	Condition:	1	Surface Treatment:	2	Asbestos Type:	2
Priority Assessment Scoring:							
Occupant Activity:	0	Disturbance:	2	Human Exposure:	0	Maintenance Activity:	0
Total Scores:							
Material Score:	7	Priority Score	2	Total Score:	7	Risk Rating:	Medium
Recommended action:	Remove if likely to be disturbed by the refurbishment, otherwise encapsulate and then monitor condition

Recommendation comments:	-						
Comments:	Material extent is located behind metal & glass external wall (viewed externally)

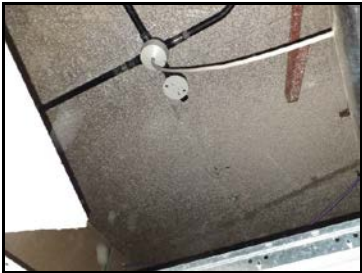
Building:	Space House (Kingsway Building)	Floor:	Ground Floor				
Location:	044 - Changing Rooms / Voids	Sample No / ID (Type):	P-359298/073 (Sampled)				
Surveyor:	Danny Webber	Survey date:	30/01/2020				
Sample Details

Item description:	Residue on concrete ceiling above MMMF ceiling tiles					
	Material description:	Sprayed coating					
	Quantity / Extent:	50 m ²					
	Accessibility	Medium Access					
	Analysis:	No asbestos detected					
	Material identification:	Non-asbestos material					
Material Assessment Scoring:							
Product Type:	-	Condition:	-	Surface Treatment:	-	Asbestos Type:	-
Priority Assessment Scoring:							
Occupant Activity:	-	Disturbance:	-	Human Exposure:	-	Maintenance Activity:	-
Total Scores:							
Material Score:	-	Priority Score	-	Total Score:	0	Risk Rating:	N/A
Recommended action:	-						
Recommendation comments:	-						
Comments:	-

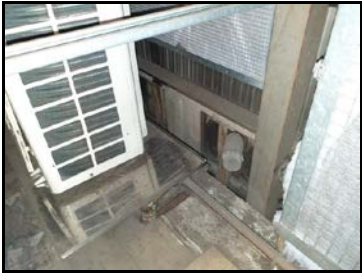
Building:	Space House (Kingsway Building)	Floor:	Ground Floor				
Location:	045 - Plant Room (Kemble Street)	Sample No / ID (Type):	P-359298/As 072 (Cross Referenced)				
Surveyor:	Danny Webber	Survey date:	30/01/2020				
Sample Details

Item description:	Lining walls partially behind masonry					
	Material description:	Insulating board					
	Quantity / Extent:	150 (total) m ²					
	Accessibility	Medium Access					
	Analysis:	Amosite Chrysotile					
	Material identification:	Asbestos insulating board					
Material Assessment Scoring:							
Product Type:	2	Condition:	1	Surface Treatment:	2	Asbestos Type:	2
Priority Assessment Scoring:							
Occupant Activity:	0	Disturbance:	2	Human Exposure:	0	Maintenance Activity:	0
Total Scores:							
Material Score:	7	Priority Score	2	Total Score:	7	Risk Rating:	Medium
Recommended action:	Remove if likely to be disturbed by the refurbishment, otherwise encapsulate and then monitor condition

Recommendation comments:	-						
Comments:	Material extent is located behind metal & glass external wall (viewed externally)

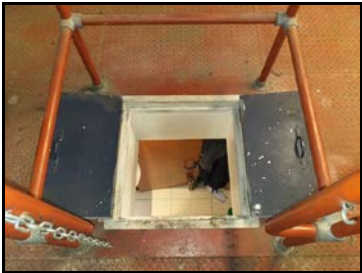
Building:	Space House (Kingsway Building)	Floor:	Ground Floor				
Location:	046 - Plant Room (above WCs)	Sample No / ID (Type):	P-359298/074 (Sampled)				
Surveyor:	Danny Webber	Survey date:	30/01/2020				
Sample Details

Item description:	Lining access hatch					
	Material description:	Insulating board					
	Quantity / Extent:	1 m ²					
	Accessibility	Medium Access					
	Analysis:	No asbestos detected					
	Material identification:	Non-asbestos material					
Material Assessment Scoring:							
Product Type:	-	Condition:	-	Surface Treatment:	-	Asbestos Type:	-
Priority Assessment Scoring:							
Occupant Activity:	-	Disturbance:	-	Human Exposure:	-	Maintenance Activity:	-
Total Scores:							
Material Score:	-	Priority Score	-	Total Score:	0	Risk Rating:	N/A
Recommended action:	-						
Recommendation comments:	-						
Comments:	-

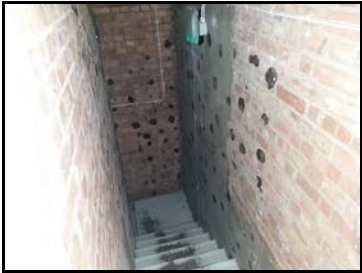
Building:	Space House (Kingsway Building)	Floor:	Ground Floor				
Location:	047 - Former Office (above UKPN)	Sample No / ID (Type):	P-359298/075 (Sampled)				
Surveyor:	Danny Webber	Survey date:	30/01/2020				
Sample Details

Item description:	Adhesive residue on masonry walls					
	Material description:	Bituminous products					
	Quantity / Extent:	8 m ²					
	Accessibility	Easy Access					
	Analysis:	No asbestos detected					
	Material identification:	Non-asbestos material					
Material Assessment Scoring:							
Product Type:	-	Condition:	-	Surface Treatment:	-	Asbestos Type:	-
Priority Assessment Scoring:							
Occupant Activity:	-	Disturbance:	-	Human Exposure:	-	Maintenance Activity:	-
Total Scores:							
Material Score:	-	Priority Score	-	Total Score:	0	Risk Rating:	N/A
Recommended action:	-						
Recommendation comments:	-						
Comments:	-

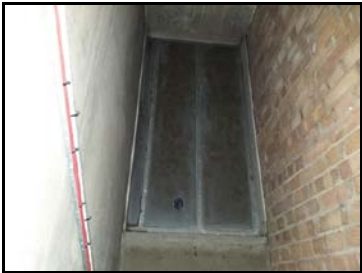
Building:	Space House (Kingsway Building)	Floor:	Ground Floor				
Location:	047 - Former Office (above UKPN)	Sample No / ID (Type):	P-359298/As 072 (Cross Referenced)				
Surveyor:	Danny Webber	Survey date:	30/01/2020				
Sample Details

Item description:	Edging strips above door at ground floor level					
	Material description:	Insulating board					
	Quantity / Extent:	1 m ²					
	Accessibility	Easy Access					
	Analysis:	Amosite Chrysotile					
	Material identification:	Asbestos insulating board					
Material Assessment Scoring:							
Product Type:	2	Condition:	1	Surface Treatment:	2	Asbestos Type:	2
Priority Assessment Scoring:							
Occupant Activity:	0	Disturbance:	1	Human Exposure:	0	Maintenance Activity:	0
Total Scores:							
Material Score:	7	Priority Score	1	Total Score:	7	Risk Rating:	Medium
Recommended action:	Remove if likely to be disturbed by the refurbishment, otherwise encapsulate and then monitor condition

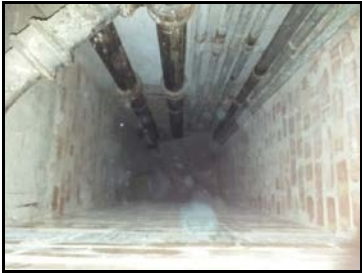
Building:	Space House (Kingsway Building)	Floor:	Ground Floor				
Location:	047 - Former Office (above UKPN)	Sample No / ID (Type):	P-359298/P002 (Presumed)				
Surveyor:	Danny Webber	Survey date:	30/01/2020				
Sample Details

Item description:	Loose panel at bottom of riser					
	Material description:	Insulating board					
	Quantity / Extent:	1 m ²					
	Accessibility	Difficult Access					
	Analysis:	Presumed to contain asbestos					
	Material identification:	Asbestos insulating board					
Material Assessment Scoring:							
Product Type:	2	Condition:	3	Surface Treatment:	2	Asbestos Type:	3
Priority Assessment Scoring:							
Occupant Activity:	0	Disturbance:	1	Human Exposure:	0	Maintenance Activity:	0
Total Scores:							
Material Score:	10	Priority Score	1	Total Score:	10	Risk Rating:	High
Recommended action:	Remedial - Restrict access and plan abatement works.						
Recommendation comments:	-

Comments:	Presumed due to item being inaccessible. Visually inspected from hatches only.

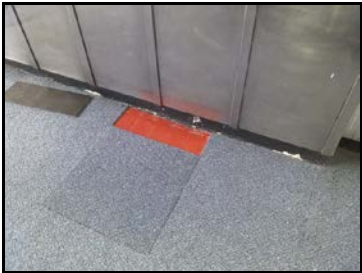
Building:	Space House (Kingsway Building)	Floor:	Ground Floor				
Location:	048 - Kemble Street Staircase	Sample No / ID (Type):	P-359298/076 (Sampled)				
Surveyor:	Danny Webber	Survey date:	19/12/2019				
Sample Details

Item description:	Applied to low level skirting					
	Material description:	Textured coatings					
	Quantity / Extent:	25 m linear					
	Accessibility	Easy Access					
	Analysis:	No asbestos detected					
	Material identification:	Non-asbestos material					
Material Assessment Scoring:							
Product Type:	-	Condition:	-	Surface Treatment:	-	Asbestos Type:	-
Priority Assessment Scoring:							
Occupant Activity:	-	Disturbance:	-	Human Exposure:	-	Maintenance Activity:	-
Total Scores:							
Material Score:	-	Priority Score	-	Total Score:	0	Risk Rating:	N/A
Recommended action:	-						
Recommendation comments:	-						
Comments:	-

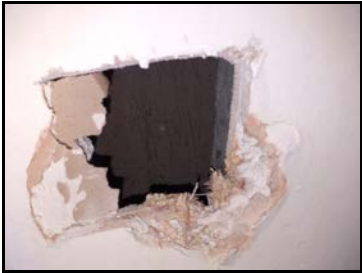
Building:	Space House (Kingsway Building)	Floor:	Ground Floor				
Location:	049 - Security / Staff Entrance	Sample No / ID (Type):	P-359298/077 (Sampled)				
Surveyor:	Danny Webber	Survey date:	30/01/2020				
Sample Details

Item description:	Lining walls behind plasterboard, timber & MMMF insulation					
	Material description:	Insulating board					
	Quantity / Extent:	150 (total) m ²					
	Accessibility	Difficult Access					
	Analysis:	Chrysotile Amosite					
	Material identification:	Asbestos insulating board					
Material Assessment Scoring:							
Product Type:	2	Condition:	1	Surface Treatment:	2	Asbestos Type:	2
Priority Assessment Scoring:							
Occupant Activity:	0	Disturbance:	2	Human Exposure:	0	Maintenance Activity:	0
Total Scores:							
Material Score:	7	Priority Score	2	Total Score:	7	Risk Rating:	Medium
Recommended action:	Remove if likely to be disturbed by the refurbishment, otherwise encapsulate and then monitor condition

Recommendation comments:	-						
Comments:	Material extent is located behind metal & glass external wall (viewed externally)

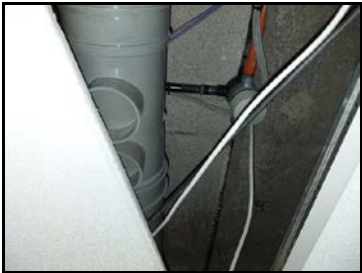
Building:	Space House (Kingsway Building)	Floor:	Ground Floor				
Location:	049 - Security / Staff Entrance	Sample No / ID (Type):	P-359298/078 (Sampled)				
Surveyor:	Danny Webber	Survey date:	30/01/2020				
Sample Details

Item description:	Residue on concrete ceiling above MMMF ceiling tiles					
	Material description:	Sprayed coating					
	Quantity / Extent:	50 m ²					
	Accessibility	Difficult Access					
	Analysis:	No asbestos detected					
	Material identification:	Non-asbestos material					
Material Assessment Scoring:							
Product Type:	-	Condition:	-	Surface Treatment:	-	Asbestos Type:	-
Priority Assessment Scoring:							
Occupant Activity:	-	Disturbance:	-	Human Exposure:	-	Maintenance Activity:	-
Total Scores:							
Material Score:	-	Priority Score	-	Total Score:	0	Risk Rating:	N/A
Recommended action:	-						
Recommendation comments:	-						
Comments:	-

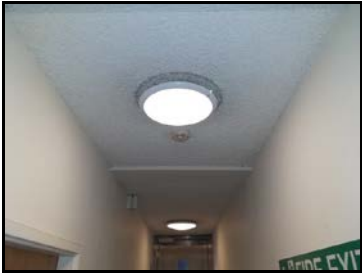
Building:	Space House (Kingsway Building)	Floor:	Ground Floor				
Location:	049 - Security / Staff Entrance	Sample No / ID (Type):	P-359298/079 (Sampled)				
Surveyor:	Danny Webber	Survey date:	30/01/2020				
Sample Details

Item description:	Applied to meshed plaster ceiling					
	Material description:	Textured coatings					
	Quantity / Extent:	6 m ²					
	Accessibility	Medium Access					
	Analysis:	No asbestos detected					
	Material identification:	Non-asbestos material					
Material Assessment Scoring:							
Product Type:	-	Condition:	-	Surface Treatment:	-	Asbestos Type:	-
Priority Assessment Scoring:							
Occupant Activity:	-	Disturbance:	-	Human Exposure:	-	Maintenance Activity:	-
Total Scores:							
Material Score:	-	Priority Score	-	Total Score:	0	Risk Rating:	N/A
Recommended action:	-						
Recommendation comments:	-						
Comments:	-

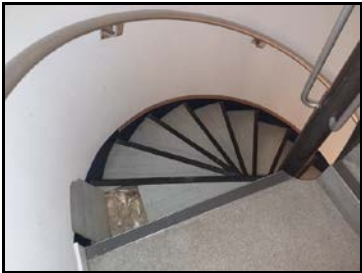
Building:	Space House (Kingsway Building)	Floor:	Ground Floor				
Location:	049 - Security / Staff Entrance	Sample No / ID (Type):	P-359298/080 (Sampled)				
Surveyor:	Danny Webber	Survey date:	30/01/2020				
Sample Details

Item description:	Floor tiles (grey) on spiral staircase					
	Material description:	Vinyl product					
	Quantity / Extent:	10 m ²					
	Accessibility	Easy Access					
	Analysis:	Chrysotile					
	Material identification:	Non-asbestos vinyl/asbestos adhesive					
Material Assessment Scoring:							
Product Type:	1	Condition:	1	Surface Treatment:	0	Asbestos Type:	1
Priority Assessment Scoring:							
Occupant Activity:	1	Disturbance:	2	Human Exposure:	2	Maintenance Activity:	0
Total Scores:							
Material Score:	3	Priority Score	5	Total Score:	3	Risk Rating:	Very Low
Recommended action:	Remove if likely to be disturbed by the refurbishment, otherwise monitor condition.

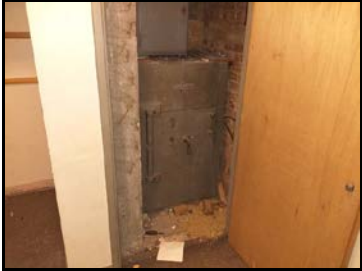
Building:	Space House (Kingsway Building)	Floor:	Ground Floor				
Location:	049 - Security / Staff Entrance	Sample No / ID (Type):	P-359298/P003 (Presumed)				
Surveyor:	Danny Webber	Survey date:	30/01/2020				
Sample Details

Item description:	Internal linings of safe unit					
	Material description:	Insulation					
	Quantity / Extent:	1 Number					
	Accessibility	Difficult Access					
	Analysis:	Presumed to contain asbestos					
	Material identification:	Asbestos insulation					
Material Assessment Scoring:							
Product Type:	3	Condition:	1	Surface Treatment:	2	Asbestos Type:	3
Priority Assessment Scoring:							
Occupant Activity:	0	Disturbance:	1	Human Exposure:	0	Maintenance Activity:	0
Total Scores:							
Material Score:	9	Priority Score	1	Total Score:	9	Risk Rating:	Medium
Recommended action:	Remove if likely to be disturbed by the refurbishment, otherwise monitor condition.						
Recommendation comments:	-

Comments:	Presumed due to security reasons therefore no access was gained within safe.

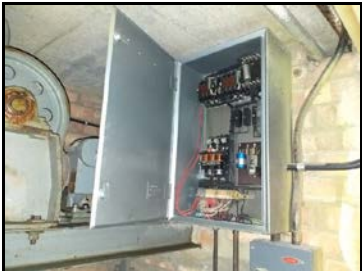
Building:	Space House (Kingsway Building)	Floor:	Ground Floor				
Location:	049 - Security / Staff Entrance	Sample No / ID (Type):	P-359298/P004 (Presumed)				
Surveyor:	Danny Webber	Survey date:	30/01/2020				
Sample Details

Item description:	Arc shield spacers					
	Material description:	Cement product					
	Quantity / Extent:	1 Number					
	Accessibility	Medium Access					
	Analysis:	Presumed to contain asbestos					
	Material identification:	Asbestos cement					
Material Assessment Scoring:							
Product Type:	1	Condition:	1	Surface Treatment:	1	Asbestos Type:	3
Priority Assessment Scoring:							
Occupant Activity:	0	Disturbance:	1	Human Exposure:	0	Maintenance Activity:	0
Total Scores:							
Material Score:	6	Priority Score	1	Total Score:	6	Risk Rating:	Low
Recommended action:	Remove if likely to be disturbed by the refurbishment, otherwise monitor condition.						
Recommendation comments:	-

Comments:	Presumed due to electrics being live.

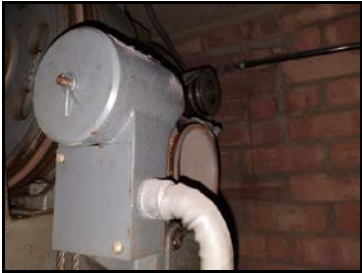
Building:	Space House (Kingsway Building)	Floor:	Ground Floor				
Location:	049 - Security / Staff Entrance	Sample No / ID (Type):	P-359298/P005 (Presumed)				
Surveyor:	Danny Webber	Survey date:	30/01/2020				
Sample Details

Item description:	Lift machinery brake shoes					
	Material description:	Woven product					
	Quantity / Extent:	2 Number					
	Accessibility	Medium Access					
	Analysis:	Presumed to contain asbestos					
	Material identification:	Asbestos woven material					
Material Assessment Scoring:							
Product Type:	2	Condition:	2	Surface Treatment:	2	Asbestos Type:	3
Priority Assessment Scoring:							
Occupant Activity:	0	Disturbance:	1	Human Exposure:	0	Maintenance Activity:	0
Total Scores:							
Material Score:	9	Priority Score	1	Total Score:	9	Risk Rating:	Medium
Recommended action:	Remove if likely to be disturbed by the refurbishment, otherwise monitor condition.						
Recommendation comments:	-

Comments:	Presumed due to being live.

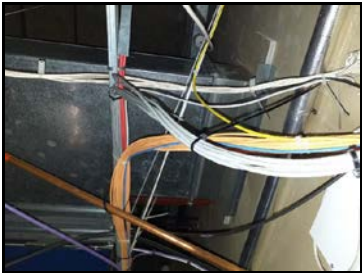
Building:	Space House (Kingsway Building)	Floor:	Ground Floor				
Location:	050 - Meeting & Comms Rooms	Sample No / ID (Type):	P-359298/081 (Sampled)				
Surveyor:	Danny Webber	Survey date:	30/01/2020				
Sample Details

Item description:	Ducting seals above MMMF ceiling tiles					
	Material description:	Mastics					
	Quantity / Extent:	100 m linear					
	Accessibility	Difficult Access					
	Analysis:	No asbestos detected					
	Material identification:	Non-asbestos material					
Material Assessment Scoring:							
Product Type:	-	Condition:	-	Surface Treatment:	-	Asbestos Type:	-
Priority Assessment Scoring:							
Occupant Activity:	-	Disturbance:	-	Human Exposure:	-	Maintenance Activity:	-
Total Scores:							
Material Score:	-	Priority Score	-	Total Score:	0	Risk Rating:	N/A
Recommended action:	-						
Recommendation comments:	-						
Comments:	Material present throughout property

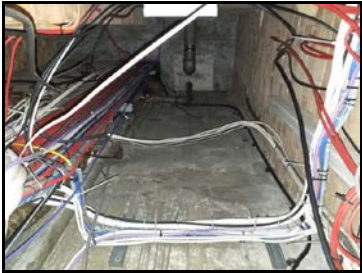
Building:	Space House (Kingsway Building)	Floor:	Ground Floor				
Location:	051 - Entrance / WCs	Sample No / ID (Type):	P-359298/P006 (Presumed)				
Surveyor:	Danny Webber	Survey date:	30/01/2020				
Sample Details

Item description:	Panel on ceiling in male WC cupboard					
	Material description:	Insulating board					
	Quantity / Extent:	1 Number					
	Accessibility	Difficult Access					
	Analysis:	Presumed to contain asbestos					
	Material identification:	Asbestos insulating board					
Material Assessment Scoring:							
Product Type:	2	Condition:	2	Surface Treatment:	2	Asbestos Type:	3
Priority Assessment Scoring:							
Occupant Activity:	0	Disturbance:	1	Human Exposure:	0	Maintenance Activity:	0
Total Scores:							
Material Score:	9	Priority Score	1	Total Score:	9	Risk Rating:	Medium
Recommended action:	Remove if likely to be disturbed by the refurbishment, otherwise encapsulate and then monitor condition

Recommendation comments:	-						
Comments:	Presumed due to sample being inaccessible.

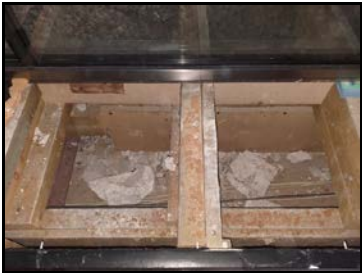
Building:	Space House (Kingsway Building)	Floor:	Ground Floor				
Location:	052 - Keeley Street Staircase	Sample No / ID (Type):	P-359298/082 (Sampled)				
Surveyor:	Danny Webber	Survey date:	30/01/2020				
Sample Details

Item description:	Ceiling & debris within timber bulkhead					
	Material description:	Insulating board					
	Quantity / Extent:	30 m ²					
	Accessibility	Medium Access					
	Analysis:	No asbestos detected					
	Material identification:	Non-asbestos material					
Material Assessment Scoring:							
Product Type:	-	Condition:	-	Surface Treatment:	-	Asbestos Type:	-
Priority Assessment Scoring:							
Occupant Activity:	-	Disturbance:	-	Human Exposure:	-	Maintenance Activity:	-
Total Scores:							
Material Score:	-	Priority Score	-	Total Score:	0	Risk Rating:	N/A
Recommended action:	-						
Recommendation comments:	-						
Comments:	-

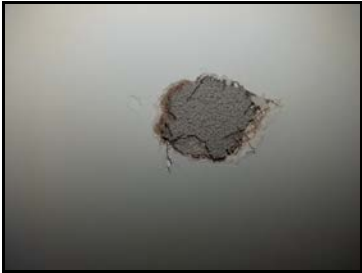
Building:	Space House (Kingsway Building)	Floor:	Ground Floor				
Location:	052 - Keeley Street Staircase	Sample No / ID (Type):	P-359298/As 079 (Cross Referenced)				
Surveyor:	Danny Webber	Survey date:	30/01/2020				
Sample Details

Item description:	Applied to meshed plaster ceiling above suspended ceiling					
	Material description:	Textured coatings					
	Quantity / Extent:	30 m ²					
	Accessibility	Medium Access					
	Analysis:	No asbestos detected					
	Material identification:	Non-asbestos material					
Material Assessment Scoring:							
Product Type:	-	Condition:	-	Surface Treatment:	-	Asbestos Type:	-
Priority Assessment Scoring:							
Occupant Activity:	-	Disturbance:	-	Human Exposure:	-	Maintenance Activity:	-
Total Scores:							
Material Score:	-	Priority Score	-	Total Score:	0	Risk Rating:	N/A
Recommended action:	-						
Recommendation comments:	-						
Comments:	-

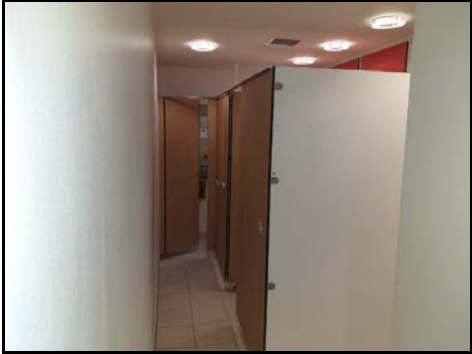
Building Name:	Space House (Kingsway Building)	Floor Level:	Second Floor
Location Number:	030	Location Description:	Female WC
Surveyor:	Danny Webber	Survey Date:	19/12/2019

General Comments:
	<p>Partially plaster skimmed concrete ceiling above plasterboard ceiling with metal ducting above. Foam & MMMF insulated pipework. Plaster skimmed masonry & plasterboard walls. Timber boxing. Plastic toilet cisterns. Cast iron spill pipe. Metal windows with timber sills. Timber doors & frames. Ceramic tiled skirting board. Concrete floor beneath ceramic tiles.</p>

P-359298/058 (S)	Space House (Kingsway Building) - Second Floor - Female WC	Debris within hand dryer & cistern voids	Asbestos cement	Chrysotile Amosite	<1 m2	7	-	7	Remove.
P-359298/059 (S)	Space House (Kingsway Building) - Second Floor - Keeley Street Staircase	Stair nosings	Asbestos thermoplastic material	Chrysotile	18 Number	3	-	3	Remove if likely to be disturbed by the refurbishment, otherwise monitor condition.

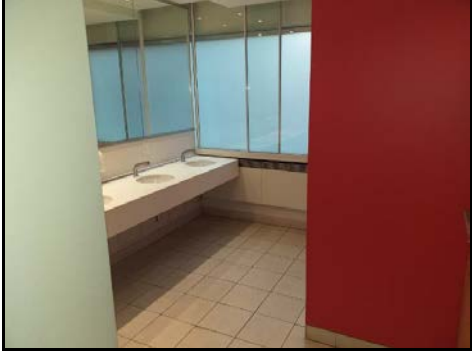
Building Name:	Space House (Kingsway Building)	Floor Level:	Second Floor
Location Number:	031	Location Description:	Male WC
Surveyor:	Danny Webber	Survey Date:	19/12/2019

General Comments:
	<p>Partially plaster skimmed concrete ceiling above plasterboard ceiling with metal ducting above. Foam & MMMF insulated pipework. Plaster skimmed masonry & plasterboard walls. Plastic toilet cisterns. Cast iron spill pipe. Metal windows with timber sills. Timber doors & frames. Ceramic tiled skirting board. Concrete floor beneath ceramic tiles.</p>

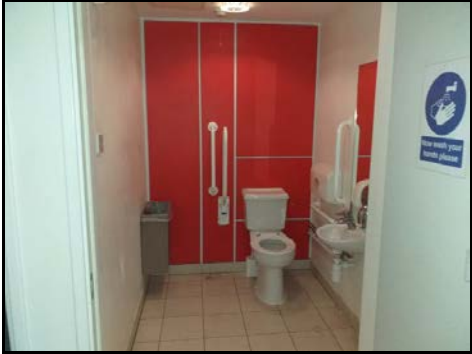
Building Name:	Space House (Kingsway Building)	Floor Level:	Second Floor
Location Number:	032	Location Description:	Disabled WC
Surveyor:	Danny Webber	Survey Date:	19/12/2019

General Comments:
	<p>Partially plaster skimmed concrete ceiling above plasterboard ceiling with metal ducting above. Foam & MMMF insulated pipework. Plaster skimmed masonry & plasterboard walls. Ceramic toilet cistern. Timber door & frame. Ceramic tiled skirting board. Concrete floor beneath ceramic tiles.</p>

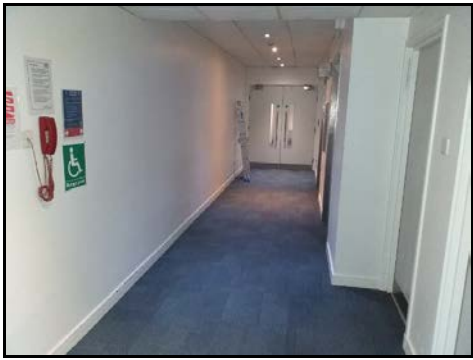
Building Name:	Space House (Kingsway Building)	Floor Level:	Second Floor
Location Number:	033	Location Description:	Lift Lobby
Surveyor:	Danny Webber	Survey Date:	19/12/2019

General Comments:
	<p>Concrete ceiling above meshed plaster above MMMF ceiling tiles above suspended metal ceiling tiles on a metal grid. Plaster skimmed masonry walls. Rubber gasket within metal dry riser pipework flange. Metal windows. Timber doors & frames. Timber skirting board. Concrete floor beneath carpet tiles.</p>

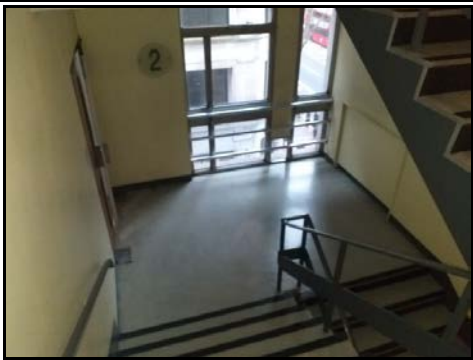
Building Name:	Space House (Kingsway Building)	Floor Level:	Second Floor
Location Number:	034	Location Description:	Keeley Street Staircase
Surveyor:	Danny Webber	Survey Date:	19/12/2019

General Comments:
	<p>Plaster skimmed concrete ceiling. Plaster skimmed masonry walls. Timber doors & frame. Metal window. Metal radiator. Sampled composite skirting board. Sampled composite stair nosings. Sampled concrete floor beneath floor tiles.</p>

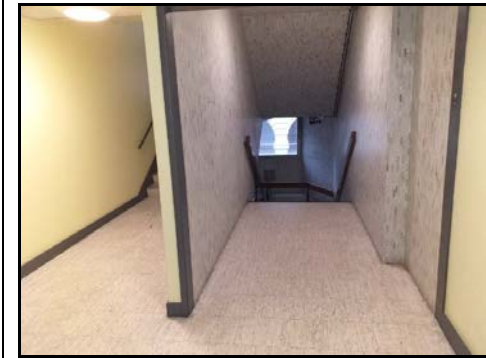
Building Name:	Space House (Kingsway Building)	Floor Level:	First Floor
Location Number:	035	Location Description:	Kemble Street Staircase
Surveyor:	Danny Webber	Survey Date:	19/12/2019

Concrete ceiling above metal ceiling tiles on a metal grid with MMMF insulated pipework & cast iron soil pipes. Plaster skimmed masonry walls with partial ceramic mosaic tiling. Timber doors & frame. Metal window. Metal radiator. Sampled composite skirting board. Rubber stair nosings. Sampled concrete floor beneath floor tiles.

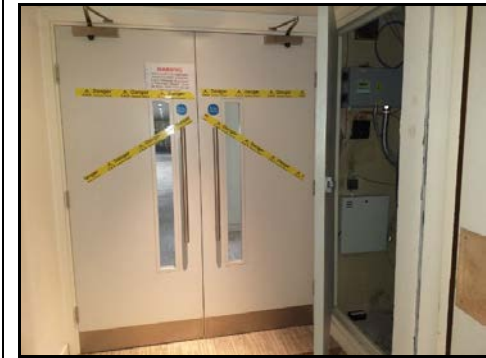
Building Name:	Space House (Kingsway Building)	Floor Level:	First Floor
Location Number:	036	Location Description:	Kemble Street Lobby & Riser
Surveyor:	Danny Webber	Survey Date:	19/12/2019

Concrete ceiling above plasterboard ceiling with cast iron soil pipe above. Plaster skimmed masonry walls. Timber & metal doors & frames. Metal roller shutter. Timber skirting board. Concrete floor beneath carpet tiles.

P-359298/063 (S)	Space House (Kingsway Building) - First Floor - Kemble Street Lobby & Riser	Board above false plasterboard ceiling	Asbestos insulating board	Amosite Chrysotile	1 m2	6	-	6	Remove if likely to be disturbed by the refurbishment, otherwise monitor condition.
P-359298/064 (S)	Space House (Kingsway Building) - First Floor - Offices Area (Open Plan & Partitioned)	Packing above suspended ceiling	Asbestos insulating board	Chrysotile	650 m linear	6	-	6	Remove if likely to be disturbed by the refurbishment, otherwise encapsulate and then monitor condition
P-359298/065 (S)	Space House (Kingsway Building) - First Floor - Offices Area (Open Plan & Partitioned)	Residue on ceiling	Asbestos insulation	Amosite	650 m linear	11	-	11	Remedial - Restrict access and plan abatement works.
P-359298/066 (S)	Space House (Kingsway Building) - First Floor - Plant Room	Wall forming cupboard	Asbestos insulating board	Chrysotile	4 m2	5	-	5	Remove if likely to be disturbed by the refurbishment, otherwise monitor condition.

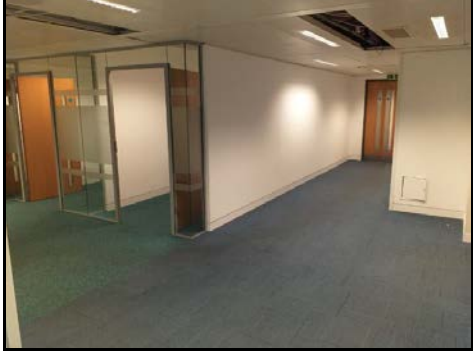
Building Name:	Space House (Kingsway Building)	Floor Level:	First Floor
Location Number:	037	Location Description:	Offices Area (Open Plan & Partitioned)
Surveyor:	Danny Webber	Survey Date:	19/12/2019

General Comments:
	<p>Partially plaster skimmed concrete ceiling above metal ceiling tiles on a metal grid. Metal ducting within ceiling void &. Foam & MMMF insulated pipework. Glass, plaster skimmed masonry & plasterboard walls. Meshed plaster skim beneath plasterboard beam cladding with concrete beams & cast iron rainwater pipe within. Metal windows with timber sills. Timber & glass doors with timber frames. Modern textile fire blankets. Modern bitumen sink pads. Timber skirting board. Concrete floor beneath carpet tiles & modern linoleum.</p>

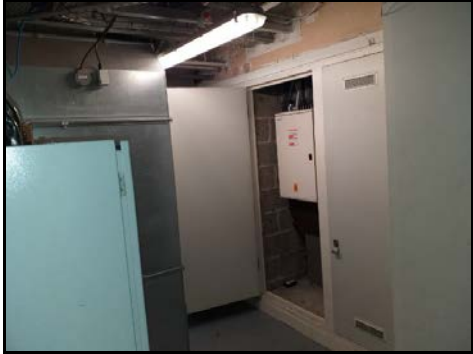
Building Name:	Space House (Kingsway Building)	Floor Level:	First Floor
Location Number:	038	Location Description:	Plant Room
Surveyor:	Danny Webber	Survey Date:	19/12/2019

General Comments:
	<p>Partially plaster skimmed concrete ceiling. Metal ducting. Foam & MMMF insulated pipework. Plaster skimmed masonry, plasterboard & sampled walls. Sampled fibreboard riser panel in cupboard. Timber skirting board. Concrete floor.</p>

P-359298/067 (S)	Space House (Kingsway Building) - First Floor - Plant Room	Riser panels within cupboard	Non-asbestos material	No asbestos detected	1 m2	0	-	0	-
P-359298/068 (S)	Space House (Kingsway Building) - First Floor - Plant Room	Panel beneath floor screed within risers (x3)	Asbestos insulating board	Chrysotile	3 Number	5	-	5	Remove if likely to be disturbed by the refurbishment, otherwise monitor condition.
P-359298/069 (S)	Space House (Kingsway Building) - First Floor - Female WC	Flue pipe within hand dryer voids	Asbestos cement	Amosite Chrysotile	<1 m linear	5	-	5	Remove if likely to be disturbed by the refurbishment, otherwise encapsulate and then monitor condition
P-359298/070 (S)	Space House (Kingsway Building) - First Floor - Female WC	Debris within hand dryer voids	Asbestos cement	Chrysotile Amosite	<1 m2	7	-	7	Remove.
P-359298/071 (S)	Space House (Kingsway Building) - Ground Floor - Changing Rooms / Voids	Applied to concrete ceiling above MMMF ceiling tiles	Non-asbestos material	No asbestos detected	20 m2	0	-	0	-

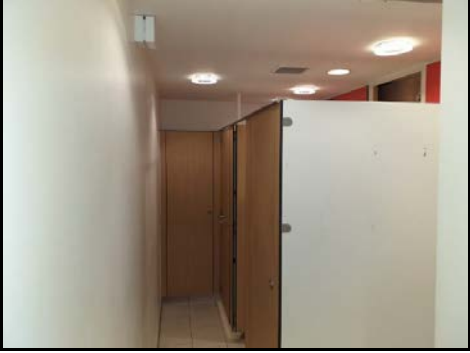
Building Name:	Space House (Kingsway Building)	Floor Level:	First Floor
Location Number:	039	Location Description:	Female WC
Surveyor:	Danny Webber	Survey Date:	19/12/2019

General Comments:
	<p>Partially plaster skimmed concrete ceiling above plasterboard ceiling with metal ducting above. Foam & MMMF insulated pipework. Plaster skimmed masonry & plasterboard walls. Timber boxing. Plastic toilet cisterns. Cast iron spill pipe. Metal windows with timber sills. Timber doors & frames. Ceramic tiled skirting board. Concrete floor beneath ceramic tiles.</p>
