Asbestos Refurbishment Survey 5th Floor to Ground Floor (Kingsway)

**Space House
1 Kemble Street
London
WC2B 4AN**

Survey Date: 14 -17 January 2020, 20-24 January 2020 and 29 January 2020

Project Reference: P-359298

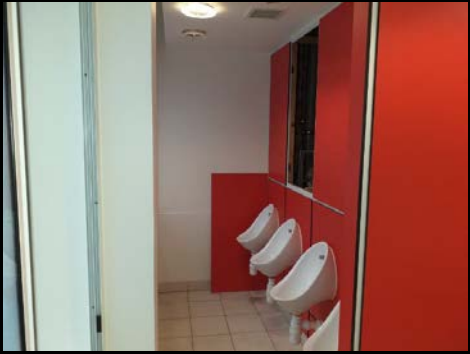
Building Name:	Space House (Kingsway Building)	Floor Level:	First Floor
Location Number:	040	Location Description:	Male WC
Surveyor:	Danny Webber	Survey Date:	19/12/2019

General Comments:
	<p>Partially plaster skimmed concrete ceiling above plasterboard ceiling with metal ducting above. Foam & MMMF insulated pipework. Plaster skimmed masonry & plasterboard walls. Plastic toilet cisterns. Cast iron spill pipe. Metal windows with timber sills. Timber doors & frames. Ceramic tiled skirting board. Concrete floor beneath ceramic tiles.</p>

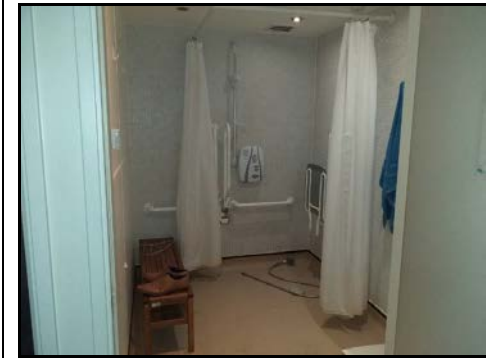
Building Name:	Space House (Kingsway Building)	Floor Level:	First Floor
Location Number:	041	Location Description:	Shower Room
Surveyor:	Danny Webber	Survey Date:	19/12/2019

Partially plaster skimmed concrete ceiling above plasterboard ceiling with metal ducting & cast iron soil pipe above. Foam & MMMF insulated pipework. Plaster skimmed masonry & plasterboard walls. Plastic toilet cistern. Timber door & frame. Concrete floor beneath modern linoleum.

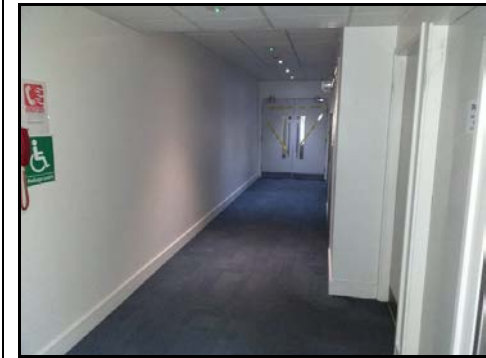
Building Name:	Space House (Kingsway Building)	Floor Level:	First Floor
Location Number:	042	Location Description:	Lift Lobby
Surveyor:	Danny Webber	Survey Date:	19/12/2019

Concrete ceiling above meshed plaster above MMMF ceiling tiles above suspended metal ceiling tiles on a metal grid. Plaster skimmed masonry walls. Rubber gasket within metal dry riser pipework flange. Metal windows. Timber doors & frames. Timber skirting board. Concrete floor beneath carpet tiles.

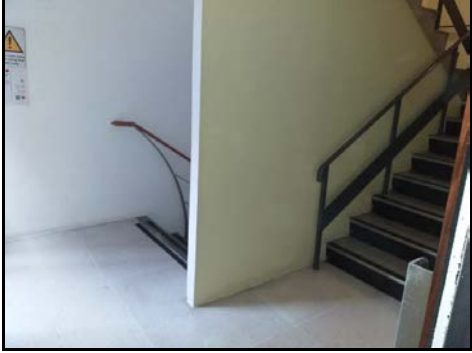
Building Name:	Space House (Kingsway Building)	Floor Level:	First Floor
Location Number:	043	Location Description:	Keeley Street Staircase
Surveyor:	Danny Webber	Survey Date:	19/12/2019

General Comments:
	<p>Plaster skimmed concrete ceiling. Plaster skimmed masonry walls. Timber doors & frame. Metal window. Sampled composite skirting board. Rubber stair nosings on metal staircase. Concrete floor beneath terrazzo flooring.</p>

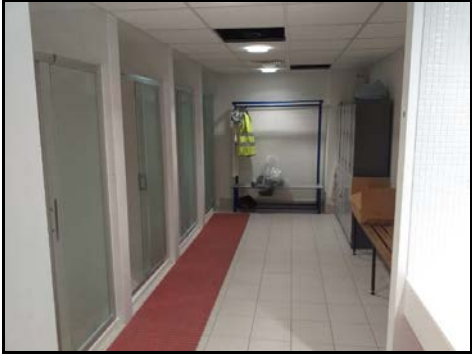
Building Name:	Space House (Kingsway Building)	Floor Level:	Ground Floor
Location Number:	044	Location Description:	Changing Rooms / Voids
Surveyor:	Danny Webber	Survey Date:	30/01/2020

General Comments:
	<p>Concrete ceiling with partial plaster / sampled textured render, foam & MMMF insulated pipework & metal ducting above MMMF ceiling tiles on a metal grid with cast iron soil pipes above. Glass & metal insulating board wall cladding (sampled) behind plasterboard walls. Timber walls. Timber doors & frames. Plastic soil pipes & toilet cisterns within service void. Meshed plaster partially covering masonry walls, foam & MMMF insulated ducting, steel RSJ beams supporting a metal grid flooring in ceiling void above ground floor. Ceramic skirting boards in changing rooms. Timber shelf to top of spiral staircase. Concrete floor beneath ceramic tiles in changing rooms & beneath rubber stair nosings & modern linoleum in spiral staircase.</p>

P-359298/072 (S)	Space House (Kingsway Building) - Ground Floor - Changing Rooms / Voids	Lining walls behind plasterboard	Asbestos insulating board	Amosite Chrysotile	150m2	7	-	7	Remove if likely to be disturbed by the refurbishment, otherwise encapsulate and then monitor condition
P-359298/073 (S)	Space House (Kingsway Building) - Ground Floor - Changing Rooms / Voids	Residue on concrete ceiling above MMMF ceiling tiles	Non-asbestos material	No asbestos detected	50 m2	0	-	0	-
P-359298/074 (S)	Space House (Kingsway Building) - Ground Floor - Plant Room (above WCs)	Lining access hatch	Non-asbestos material	No asbestos detected	1 m2	0	-	0	-

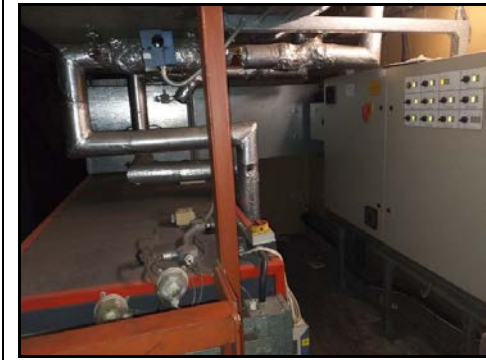
Building Name:	Space House (Kingsway Building)	Floor Level:	Ground Floor
Location Number:	045	Location Description:	Plant Room (Kemble Street)
Surveyor:	Danny Webber	Survey Date:	30/01/2020

Concrete ceiling. Foam & MMMF insulated pipework. Metal ducting. Glass & metal walls with sampled insulating board cladding. Plasterboard walls. Timber access hatch. Concrete floor.

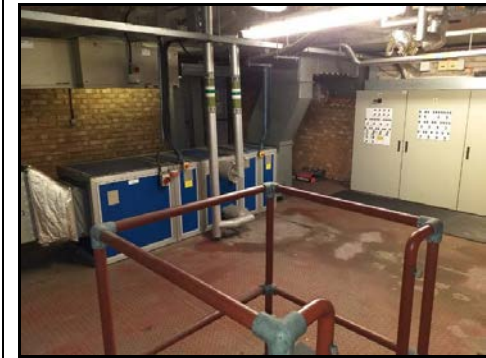
Building Name:	Space House (Kingsway Building)	Floor Level:	Ground Floor
Location Number:	046	Location Description:	Plant Room (above WCs)
Surveyor:	Danny Webber	Survey Date:	30/01/2020

Concrete ceiling with partial plaster skim. Foam & galvanised MMMF insulated pipework. Metal ducting. Masonry & plasterboard walls. Timber doors & frame. Insulating board lined timber access hatch (sampled). Metal chequer plate floor.

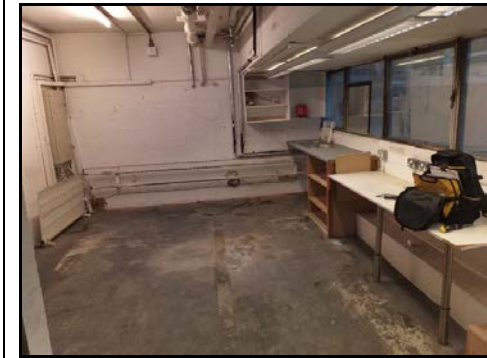
Building Name:	Space House (Kingsway Building)	Floor Level:	Ground Floor
Location Number:	047	Location Description:	Former Office (above UKPN)
Surveyor:	Danny Webber	Survey Date:	30/01/2020

Concrete ceiling. Foam & MMMF insulated pipework. Masonry walls partially timber clad at stairs. Metal windows. Timber wall access hatches. Modern textile fire blanket. Modern bitumen sink pad. Cast iron soil pipes. Concrete floor. Metal door & frame at ground floor level. Limited access gained behind 2 timber access panels, visually inspected from access hatches only.

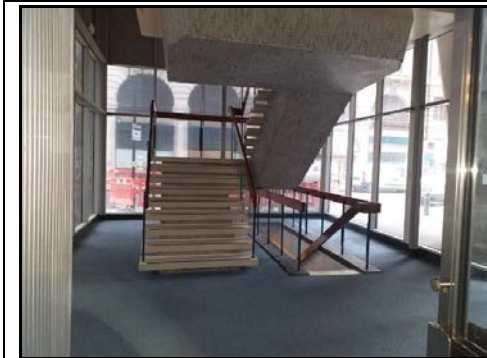
Building Name:	Space House (Kingsway Building)	Floor Level:	Ground Floor
Location Number:	048	Location Description:	Kemble Street Staircase
Surveyor:	Danny Webber	Survey Date:	19/12/2019

Concrete ceiling above mosaic ceramic tiles. Glass & metal walls. Metal doors & frames. Concrete stairs. Concrete floor beneath carpet tiles.

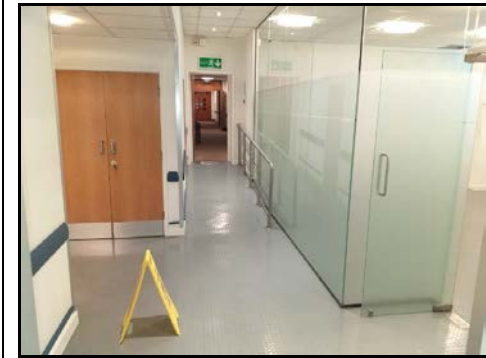
Building Name:	Space House (Kingsway Building)	Floor Level:	Ground Floor
Location Number:	049	Location Description:	Security / Staff Entrance
Surveyor:	Danny Webber	Survey Date:	30/01/2020

Concrete ceiling with partial plaster skim above meshed plaster, plasterboard & MMMF ceiling tiles on a metal grid also with metal access hatch. Plastic soil pipes. Foam & galvanised MMMF insulated pipework. Metal ducting. Masonry, timber, meshed plaster, glass, metal & plasterboard walls. Plasterboard boxings. Modern textile fire blanket. Timber & glass doors & frames. Metal dumb waiter. Rubber stair nosings. Concrete floor beneath timber panels, vinyl tiles, carpet tiles & modern linoleum.

P-359298/079 (S)	Space House (Kingsway Building) - Ground Floor - Security / Staff Entrance	Applied to meshed plaster ceiling	Non-asbestos material	No asbestos detected	6 m2	0	-	0	-
P-359298/080 (S)	Space House (Kingsway Building) - Ground Floor - Security / Staff Entrance	Floor tiles (grey) on spiral staircase	Non-asbestos vinyl/asbestos adhesive	Chrysotile	10 m2	3	-	3	Remove if likely to be disturbed by the refurbishment, otherwise monitor condition.
P-359298/081 (S)	Space House (Kingsway Building) - Ground Floor - Meeting & Comms Rooms	Ducting seals above MMMF ceiling tiles	Non-asbestos material	No asbestos detected	100 m linear	0	-	0	-
P-359298/082 (S)	Space House (Kingsway Building) - Ground Floor - Keeley Street Staircase	Ceiling & debris within timber bulkhead	Non-asbestos material	No asbestos detected	30 m2	0	-	0	-
P-359298/083 (S)	Space House (Kingsway Building) - Third Floor - Female WC	Debris within hand dryer voids	Asbestos cement	Amosite Chrysotile	<1 m2	7	-	7	Remove.

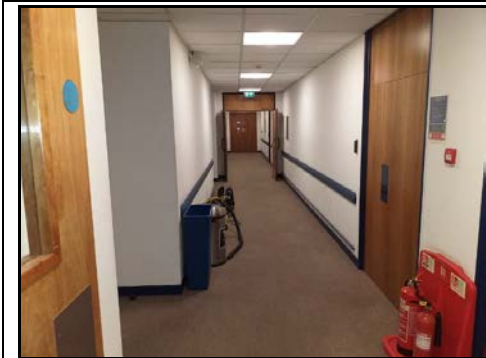
Building Name:	Space House (Kingsway Building)	Floor Level:	Ground Floor
Location Number:	050	Location Description:	Meeting & Comms Rooms
Surveyor:	Danny Webber	Survey Date:	30/01/2020

Concrete ceiling with partial plaster skim above MMMF ceiling tiles on a metal grid. Cast iron soil pipes. Foam & MMMF insulated pipework. Metal ducting. Masonry, timber, meshed plaster & plasterboard walls. Plasterboard & meshed plaster boxings. Timber door headers, doors & frames. Concrete floor beneath raised timber flooring, vinyl tiles, carpet tiles.

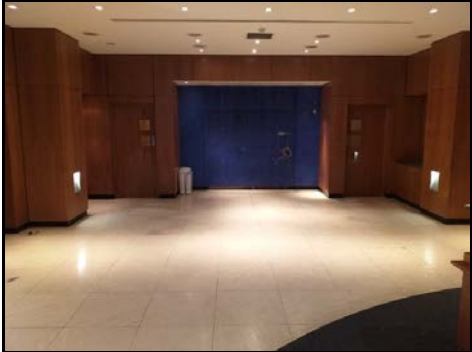
Building Name:	Space House (Kingsway Building)	Floor Level:	Ground Floor
Location Number:	051	Location Description:	Entrance / WCs
Surveyor:	Danny Webber	Survey Date:	30/01/2020

General Comments:
	<p>Concrete ceiling with partial plaster skim above plasterboard ceiling (in entrance) & MMMF ceiling tiles on a metal grid (in WCs). Steel RSJ beams. Plastic soil pipes. Foam & MMMF insulated pipework. Metal ducting. Partially plaster skimmed masonry (in entrance), ceramic tiled masonry (in WCs) timber & stone walls. Timber bulkhead extending externally to canopy. Plasterboard & timber boxings. Timber doors & frames. Concrete floor beneath ceramic, marble & carpet tiles.</p>
